Phase I – Environmental Site Assessment

1296 and 1300 Carling Avenue,
Ottawa, Ontario

Prepared for Ambassador Realty Inc.

Report: PE3966-2
October 10, 2025

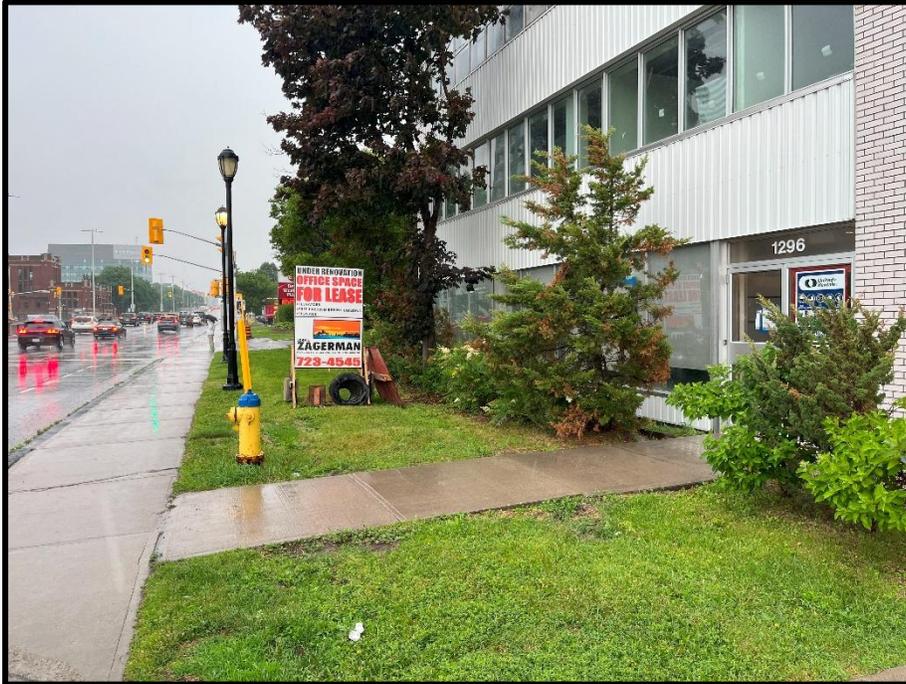
The building addressed 1296 Carling Avenue consists of a three-storey multi tenant commercial office building, with one basement level, constructed in approximately 1961. The building is finished on the exterior with brick and aluminum siding, and features a poured concrete foundation and a flat rolled roof. The building is municipally serviced, and heated via natural gas.

Photograph 1: View of the front (north) building face of 1296 Carling Avenue.

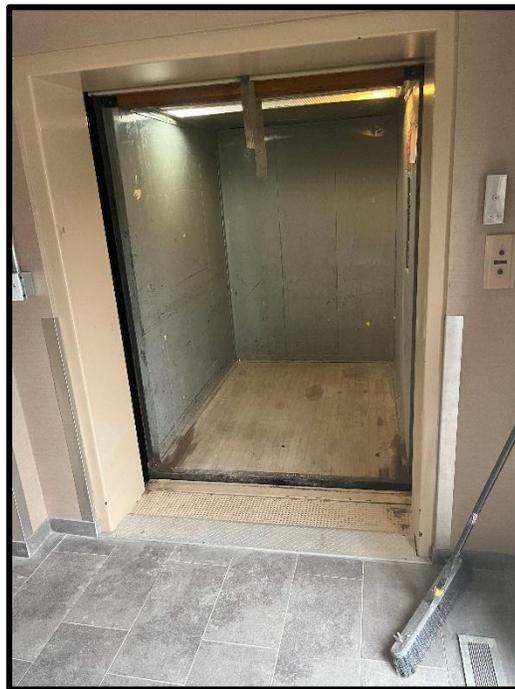
Photograph 10: View of the freight elevator in the interior of the 1296 Carling Avenue building.
