Phase I Environmental Site Assessment

2701 Pagé Road, Ottawa, Ontario

Prepared for 1001263920 ONTARIO INC.

Report: PE7228-1
October 16, 2025

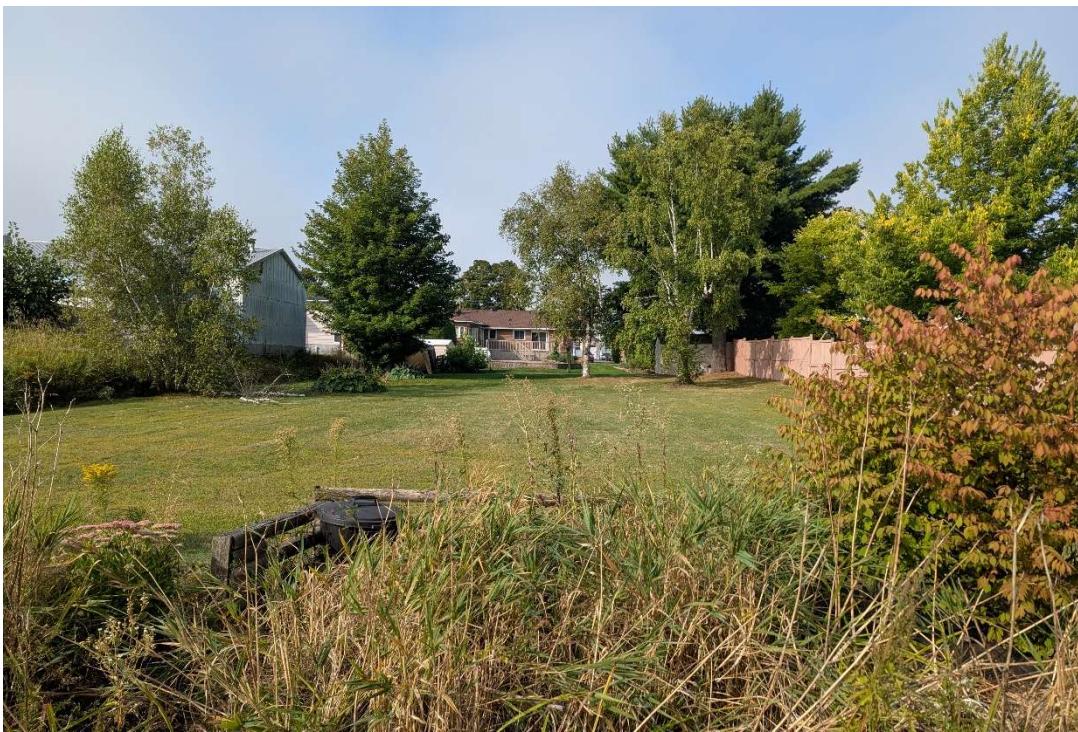
Photograph 1: View of Phase I Property from eastern property boundary.

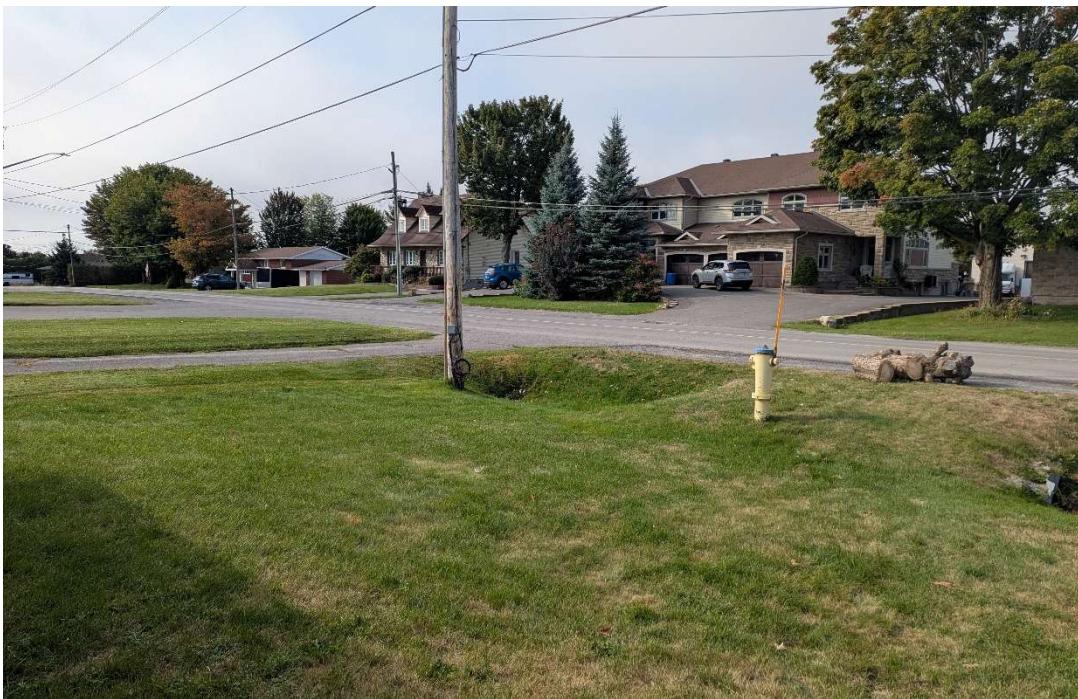
Photograph 2: View of southwest corner of Phase I Property.
