Muncaster
Environmental
Planning Inc.

RE: 2505 and 2707 Solandt Road
Tree Conservation Report and Environmental Impact Study

ENVIRONMENTAL IMPACT STATEMENT/TCR CURRENT CONDITIONS

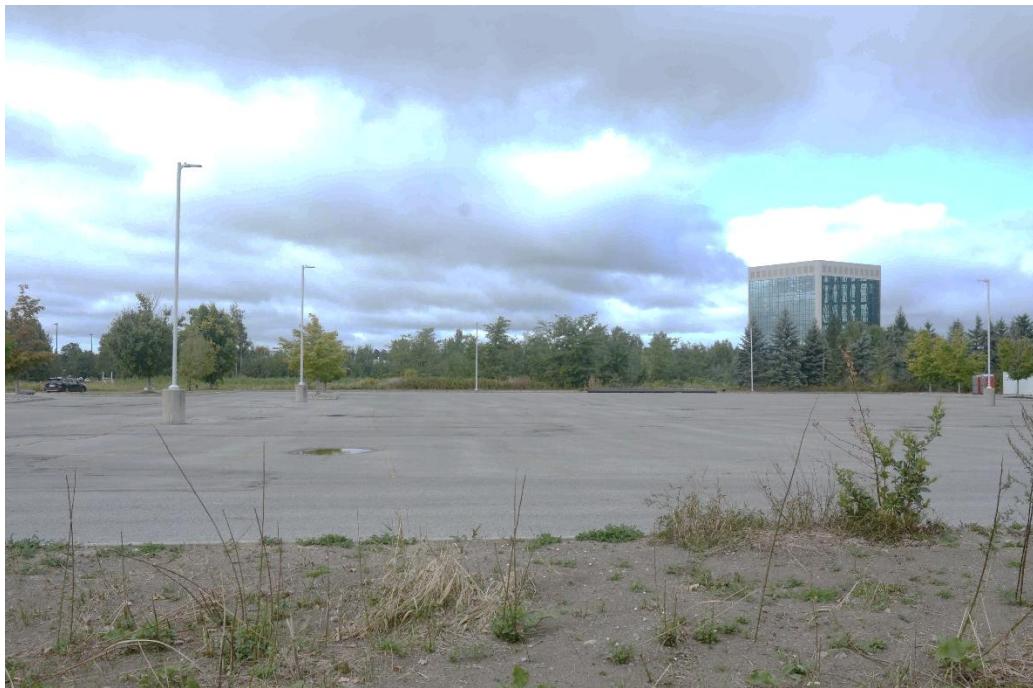
Photo 1 – An existing parking lot dominates the east portion of the site. View looking west

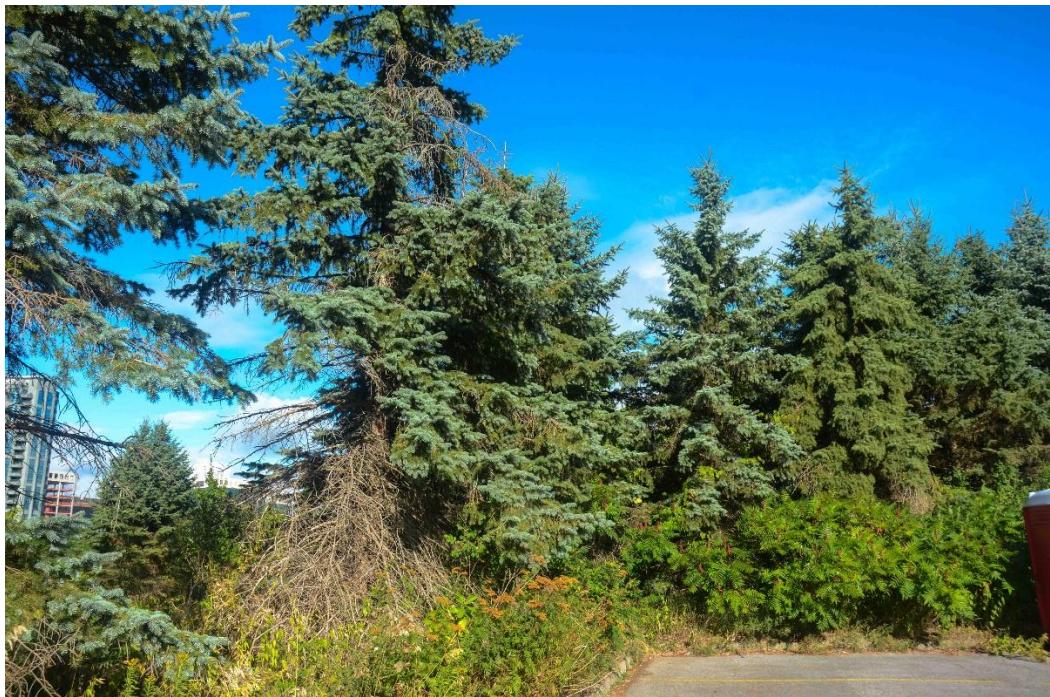
Plantings, completed around 2007, are on a berm on and adjacent to the north site boundary and portions of the east boundary. Colorado spruce, white spruce, white pine, and Norway spruce are common plantings, with sugar maple and green ash also planted (Photos 2 and 3). The larger plantings are now in the 28cm to 32cm dbh range and generally appear to be in good condition except for the ash plantings which were only observed adjacent to the southeast corner of the site. The critical root zone of these trees would extend onto the north edge of the site by up to three metres (Map 2). Staghorn sumac shrubs are very common along the north berm among the conifer plantings.

Photo 2 – Spruce in and adjacent to the northeast corner of the site. View looking east

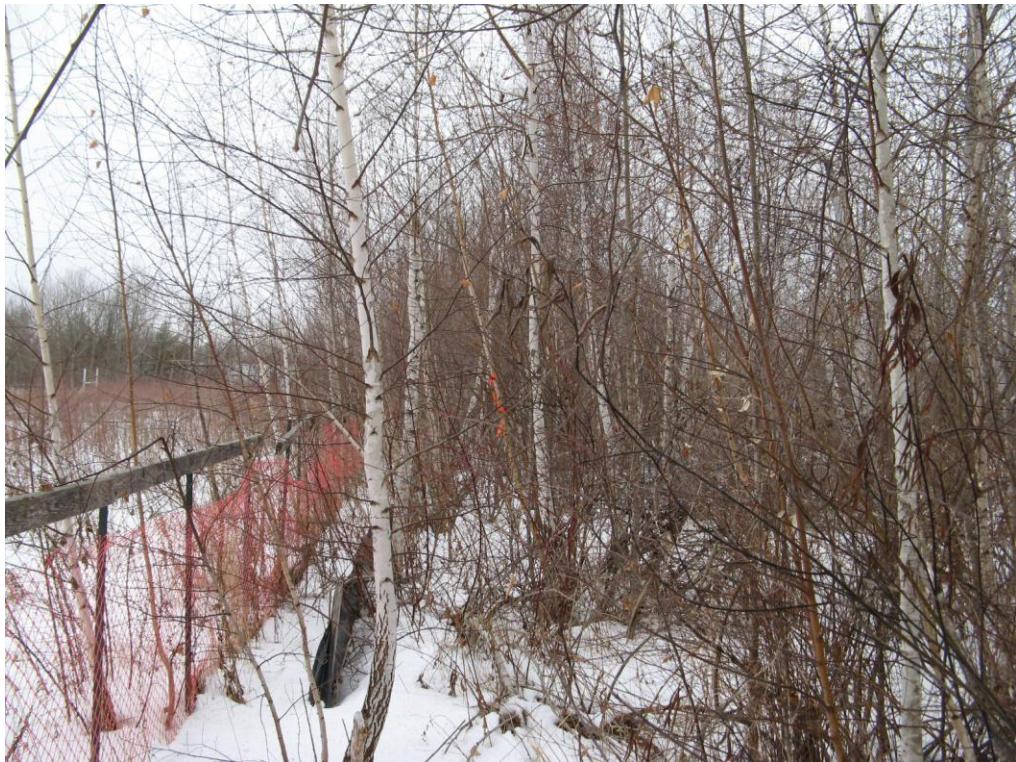
As indicated above, the majority of trees have been removed except for the northwest portion adjacent to Shirley's Brook. Here and along the west edge of the site, grey birch are dominant (Photo 3), with trembling aspens up to 26cm dbh also well represented in areas and Scot's pine also present. The critical root zone of these trees would extend onto the west edge of the site by up to two metres

*Photo 3 – Young upland deciduous forest immediately adjacent to the west site boundary.
View looking south*

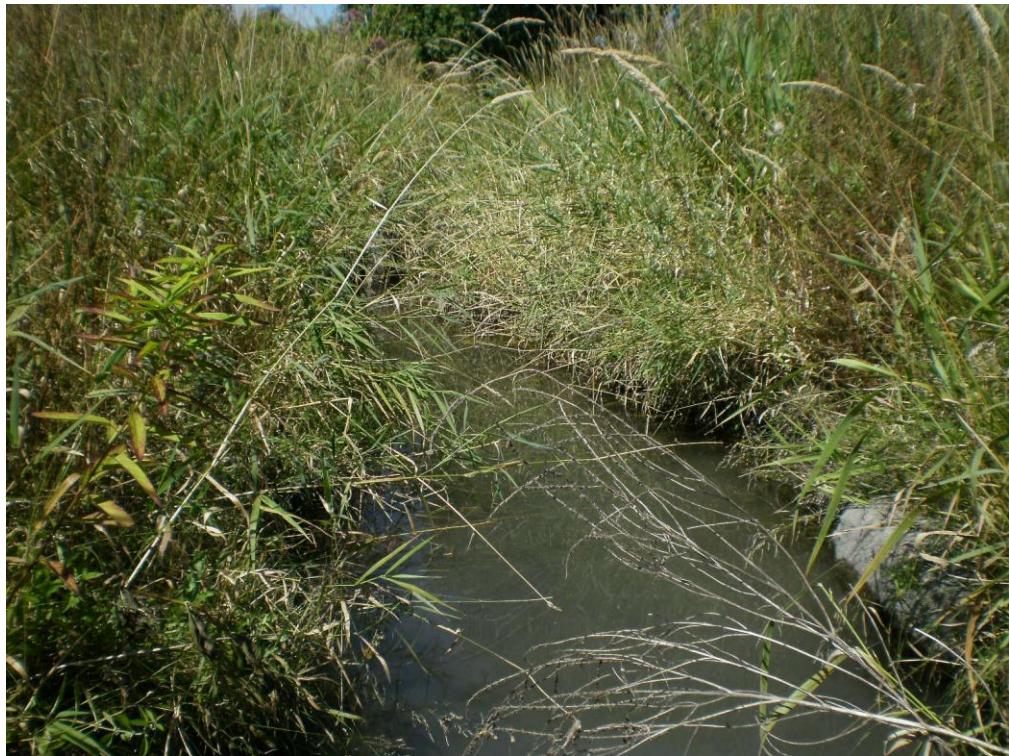
The Kanata North Environmental /Stormwater Management Plan (CH2MHill, 2000) concluded that the aquatic habitat potential of Shirley's Brook in the general vicinity of the site is generally limited by the lack of runs and riffle habitat and the dominance of clay, silts or exposed bedrock substrate. This appears to still be the situation in the northwest corner of the site where fines were the dominant substrate and the channel is clearly entrenched as part of an extended homogeneous reach (Photo 5). However, some cobble substrate was present and other forms of aquatic habitat structure included undercut banks, a meandering alignment with permanent flow, clear water, and submerged and floating vegetation (common waterweed and variable-leaved pondweed). Several forage fish were observed, including brook stickleback. Fish diversity was low in past fish community sampling in the general vicinity of the site, with common shiner, white sucker, brook stickleback, central mudminnow, and bluntnose minnow noted. Shirley's Brook was considered to support a tolerant warm-water fish community. The wetted width of the channel on July 7th, 2019 averaged 1.8 metres, with average water depths estimated in the 50cm range. After an extended period of minimal precipitation, flow was still present in Shirley's Brook in the northwest corner of the site on August 26th, 2019 with water depths averaging 30cm, and with shallower water depths after a very dry period in August, 2025. The Shirley's Brook and Watt's Creek Subwatershed Study (Dillon, 1999) noted that groundwater flows in the clay and till surficial geology units were too slow to be of significance in terms of base flow contributions to the channel.

Photo 5 – Shirley's Brook on the northwest edge of the site. View looking north

1. No tree removal or other site disturbances, other than a security fence and a potential permeable pathway in the future, within 30 metres of Shirley's Brook as shown on Map 2 and described above;

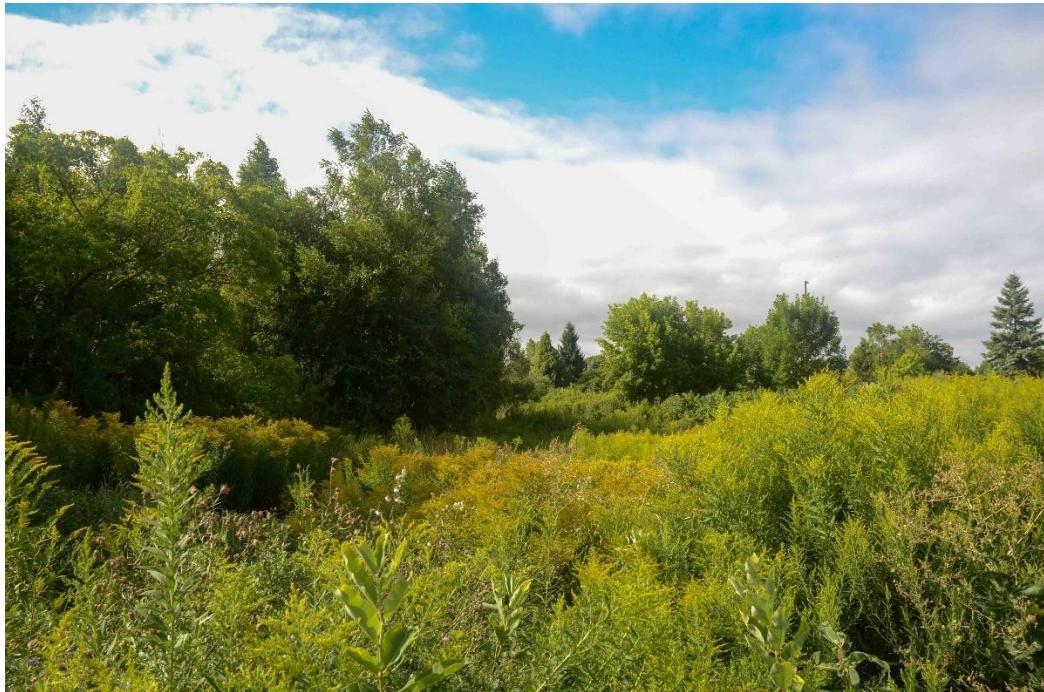
No wetland habitat was present adjacent to Shirley's Brook in the northwest corner of the site, as there is a clear rise in elevation to the east of the channel, and off-site to the west. Small areas of culture meadow upland habitat along the Shirley's Brook corridor were dominated by June meadow grass, orchard grass, reed canary grass, tufted vetch, crown vetch, thicket creeper, wild grape, bird's-foot trefoil, black swallowwort, ox-eye daisy, purple loosestrife, joe-pye-weed, stinging nettle, wild parsnip, Canada goldenrod, and Canada thistle, along with tartarian honeysuckle and red raspberry shrubs (Photo 6).

Photo 6 – Meadow habitat on-site to the east of Shirley's Brook. View looking southwest

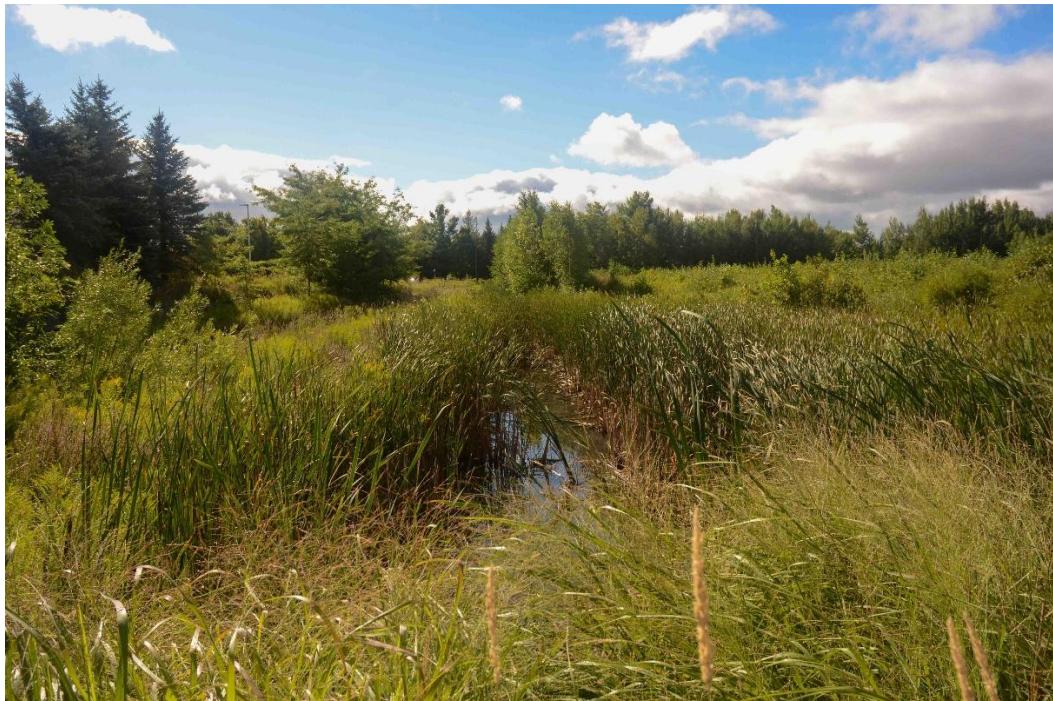
The City's north-south stormwater easement on the east edge includes an open channel dug in the late 1990s and modified in the 2000s with construction south of Solandt Dive (Photo 7). The

City's infrastructure mapping shows the channel is the outlet for all stormwater off Solandt Road east of March Road. It is a channel dug and maintained to provide a connection between two concrete headwalls. There was no natural channel in this area before the stormwater infrastructure was dug. The stormwater channel is open for approximately 125 metres between concrete headwalls. The water depth was generally less than 10cm, with some ponding south of the north headwall. Evidence of former beaver dams were noted adjacent to the channel and as indicated below beaver cuttings were common in the east portion of the upland forest. Reed canary grass, soft-stem bulrush and broad-leaved cattail were common vegetation along the channel, with a small area of cattails adjacent to the west side of the north portion of the channel. Regenerating Manitoba maple and grey birch are along the west side of the channel south of the cattail area. An area of European bur-reed closer to Solandt Road on the west side of the channel should be removed if the channel is retained.

*Photo 7 – North-south stormwater channel in the stormwater easement in the middle of the site.
View looking south from south edge of golf course*

Although the north-south stormwater channel in the east portion of the site is not fish habitat by definition and no fish were observed in the stormwater channel during the field surveys, there is the potential for forage fish to be in the channel. The following additional mitigation measures are recommended for the installation of culverts for two proposed pathways over the channel:

- The summer period is recommended for the installation of culverts due to the generally reduced flow, decreased potential for sediment input, and the greater growing season afforded for re-vegetation of disturbed areas. If the proposed timing of the work is to take place between October 15th and April 15th, it may be necessary to have any exposed areas covered with erosion control blankets to keep the soil in place and prevent erosion from occurring during the spring freshet time period;

- As required, rock protection is to be installed at the culvert ends to stabilize the channel and culvert. All material placed in the channel must be washed and clean of fines;

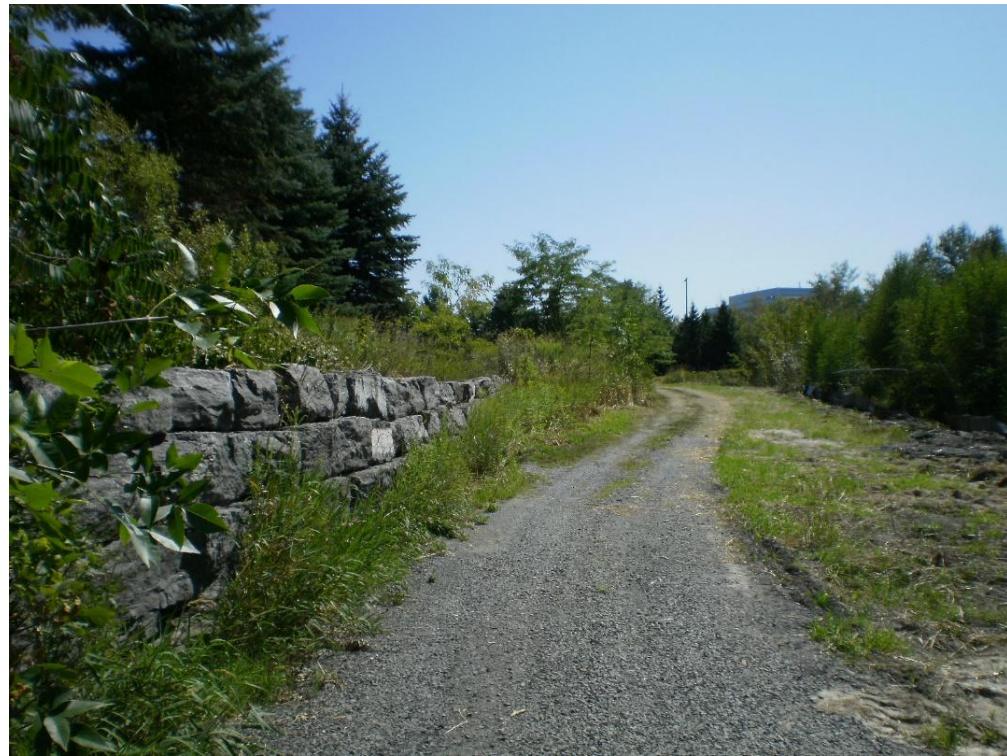
An access trail from Solandt Road to the golf course north of the site and a sanitary sewer is in the centre of the site (Photo 8). Common ground flora in the meadow habitat of this area included June meadow grass, timothy, common brome grass, common burdock, cow vetch, bladder campion, field horsetail, thicket creeper, tall goldenrod, white clover, wild carrot, common yarrow, ox-eye daisy, and black swallowwort.

A retaining wall and berm separate are to the east of the meadow described above, west of the surface parking lot to the east. Colorado spruce plantings up to 27cm dbh and smaller honey locusts are to the east of the retaining wall on the berm. Some of the spruce are in poor condition with decreased needle coverage and wild grape coverage is extensive on many of the locust.

Photo 8 – Access trail, retaining wall, berm and coniferous plantings in the middle portion of the site, east of the stormwater channel. View looking south from the north property line
