FINAL REPORT

Phase One Environmental Site Assessment

4639 Bank Street, Ottawa, Ontario

Golder Associates Ltd.

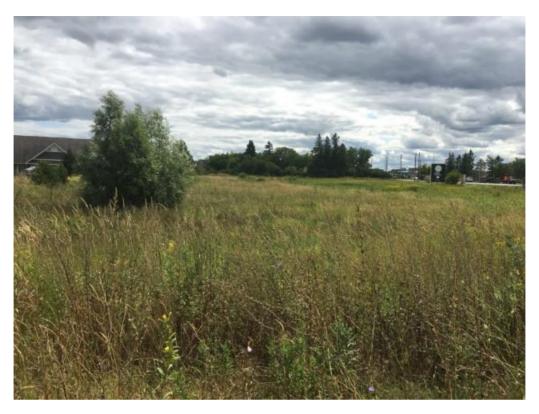
Photo 1: Looking southwest at the Site.

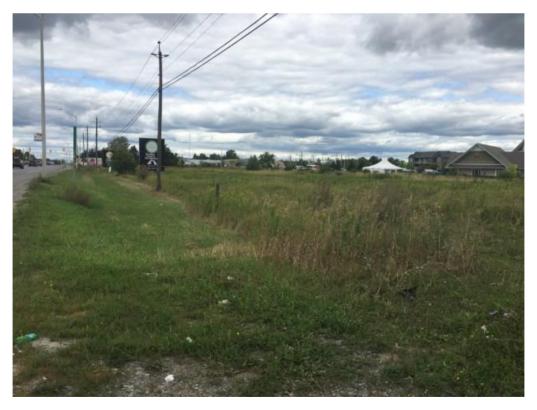
Photo 2: Looking northeast at the Site followed by the church to the east of the Site.

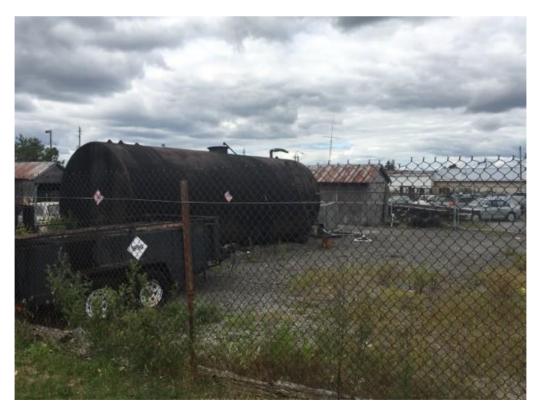
Photo 4: Photo of the tar or asphalt AST on the former asphalting company property north of the Site at 4603 Bank Street.

The surrounding properties within the Phase One Study Area included residential, commercial and community (general mixed use) land uses. During the Site visit, several PCAs were observed on the surrounding lands within the Phase One Study Area including a hydro station at 4564 and 4601 Bank Street (approximately 85 m northeast of the Site), a car dealership property with and old fuel AST at 4605 Bank Street (approximately 40 m northeast of the Site), a cemetery located approximately 90 m west of the Site on 4660 Bank Street, a nursey with associated greenhouses at 4590 Bank Street (approximately 85 m northwest of the Site), a retail fuel outlet with associated lubricants storage building at 4726 Bank Street (approximately 90 m southwest of the Site), a retail fuel outlet at 4727 Bank Street (approximately 110 m south of the Site) as well as an old tar or asphalt AST and a trailer with pails of tar or asphalt approximately 40 m northeast of the Site the former asphalting company property (4603 Bank Street.

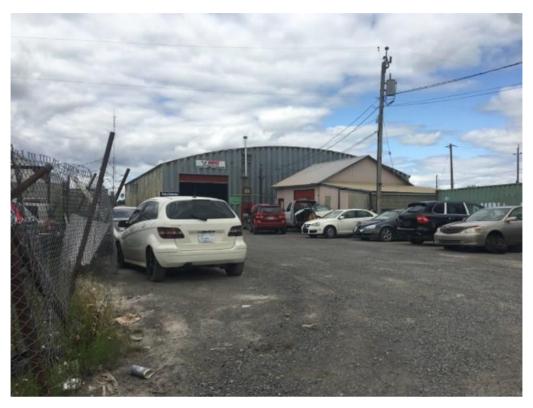
Photo 5: Looking north at the automotive garage on the surrounding lands north of the Site at 4605 Bank Street.

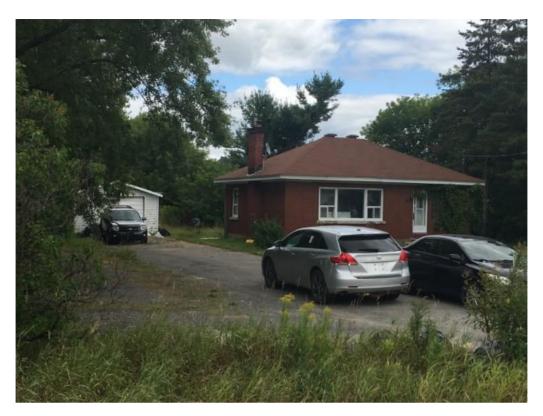
Photo 7: Photo of the fill and vent pipes observed on a residential house south of the Site at 4695 Bank Street.

The TSSA Incidents (INC) database has records of TSSA incidents within the Phase One Study Area. Both records were for fuel oil spills that occurred at a private residence at 4695 Bank Street, approximately 25 m south of the Site. One spill occurred in 2009 and the other occurred in 2011. Although no other information was provided, it is likely that the 2009 spill was the 454 L fuel oil spill to basement that was noted in the Ontario Spills database mentioned above and that the 2011 fuel oil spill was also from a fuel AST in the basement.

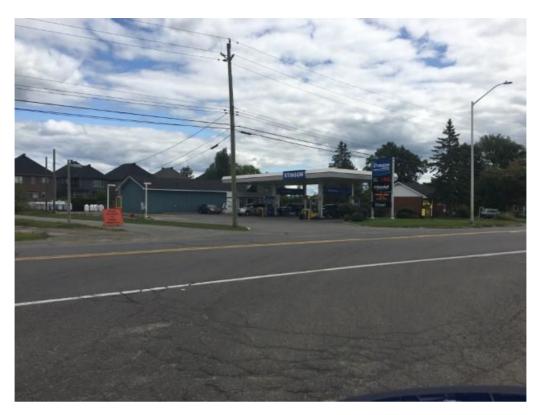
Photo 9: View of the retail fuel outlet located on the surrounding lands west of the Site at 4727 Bank Street, looking southeast.

South: A mix of residential houses and a few commercial properties including two retail fuel outlets. One was located approximately 90 m southwest of the Site at 4726 Bank Street and was noted to have a lubricant storage building. The other approximately 110 m south of the Site at 4727 Bank Street.

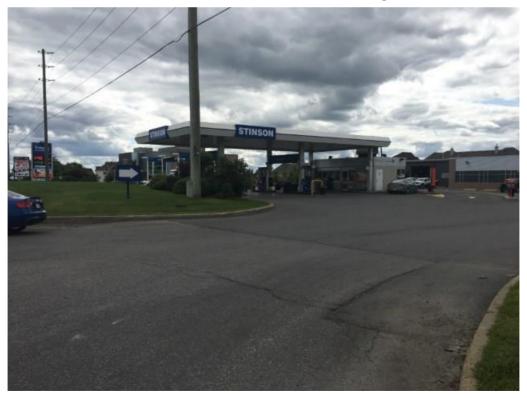
Photo 10: Looking southwest at the retail fuel outlet at 4726 Bank Street on the surrounding lands southwest of the Site.
