Golder Associates Ltd.

October 10, 2006

**RE: PHASE I ENVIRONMENTAL SITE ASSESSMENT UPDATE
280 SLATER STREET, 333 LAURIER AVENUE, 132-138 AND 148 BANK
STREET, OTTAWA, ONTARIO**

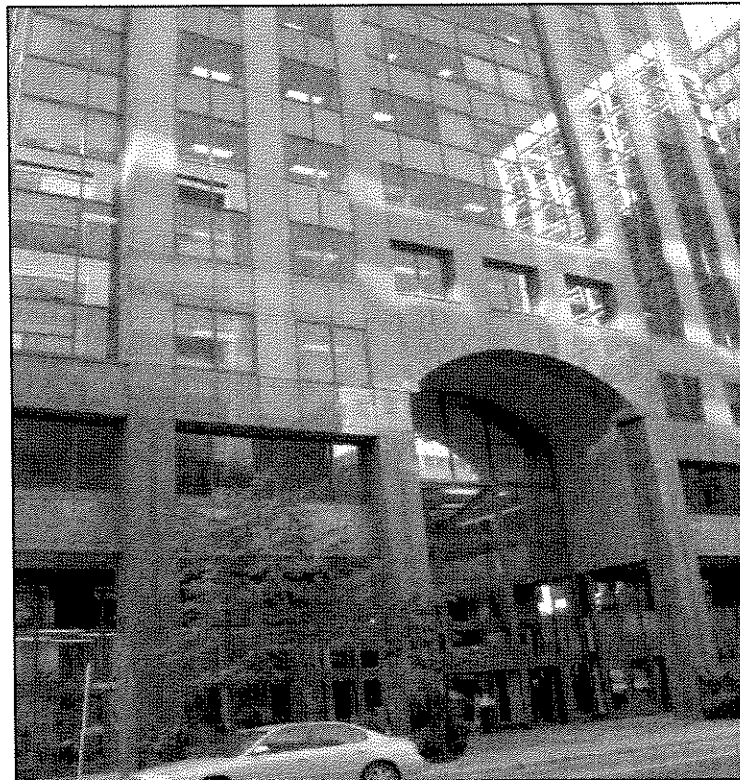
Photo 2 - 333 Laurier Avenue office tower, from Laurier Avenue.

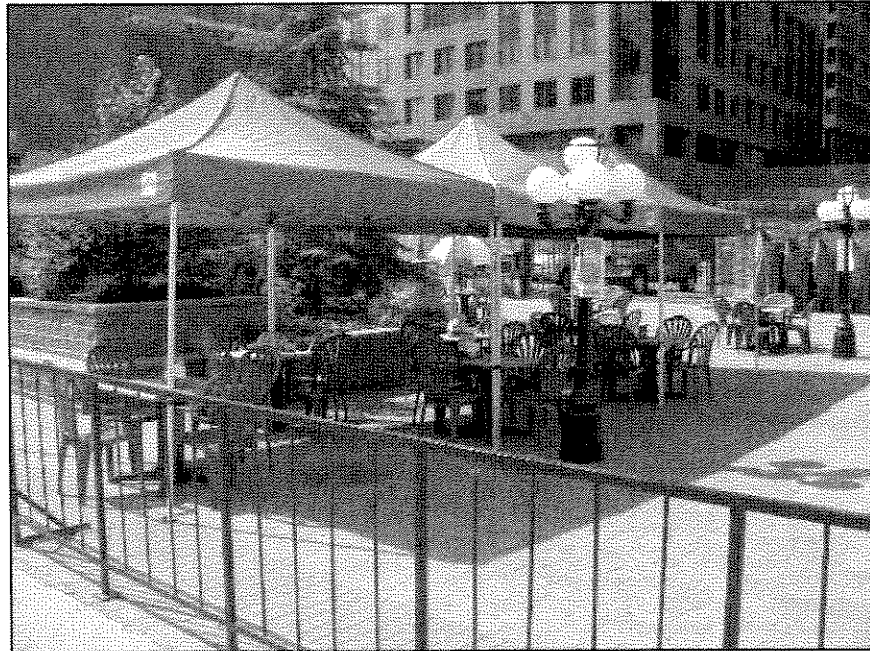
Photo 3 - View of the courtyard property at 148 Bank Street

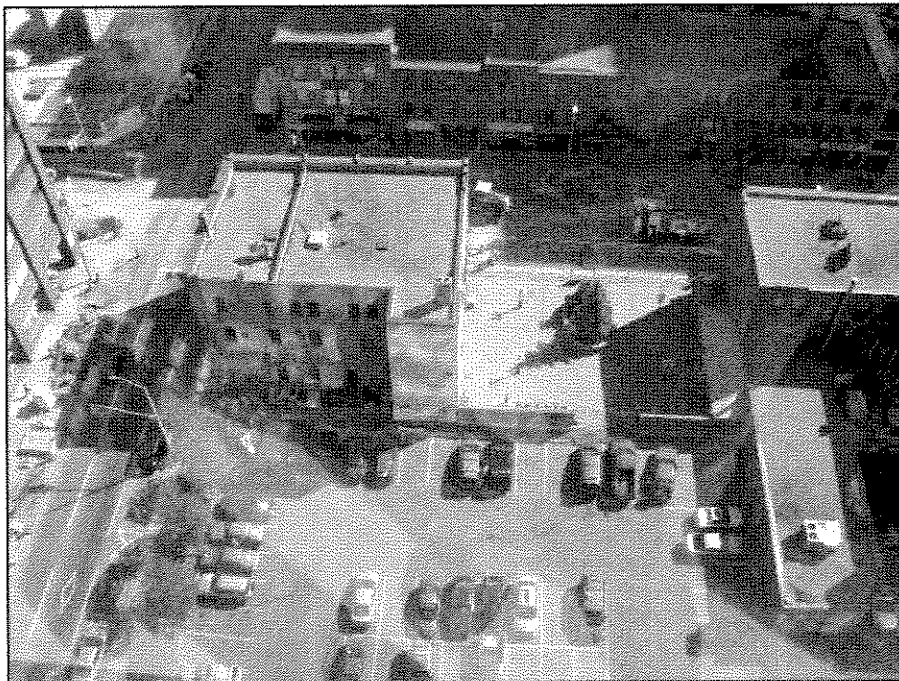
With the exception of the dry cleaner on the north side of Slater Street, the current surrounding land use is not a concern, however, a former retail fuel outlet was located adjacent to the subject property, south of 148 Bank Street and a dry cleaner was located on south of the subject property, opposite 333 Laurier. In addition, three historical industrial operations were located northeast of the subject property, across Bank Street and Slater Street. The historical surrounding land use is an issue of potential environmental concern.

Photo 4 - View to the east of 280 Slater Street, showing the parking area, the Bank Street heritage building and courtyard. The property to the right of the courtyard is the location of the former retail fuel outlet.

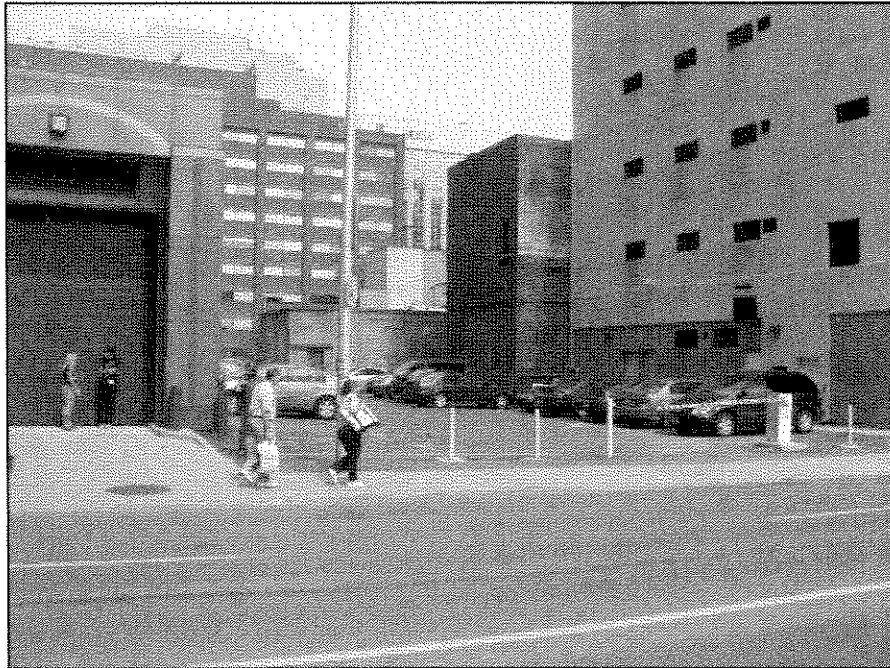
- A former retail fuel outlet was located adjacent to the site, south of 148 Bank Street. Additionally, the previous Phase II ESA identified the potential presence of combustible vapours in the soil on the subject property. Based on the observations of the previous Phase II ESA, the historical presence of a retail fuel outlet adjacent to the subject property is an issue of potential environmental concern.

Photo 5 - Office tower to the right is the site of the former retail fuel outlet. Parking garage entrance for 333 Laurier visible to the left.

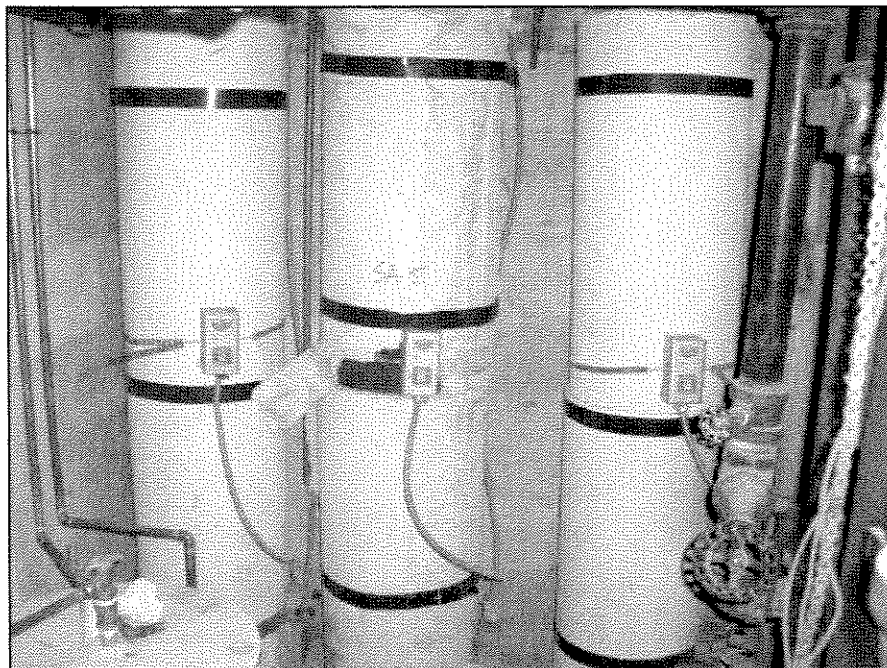
Of the above nine samples ACM samples, only the boiler insulation and transite tile in the basement of 138 Bank Street contained any detectable asbestos fibres. In addition to the above materials, several areas of vinyl floor tiles were observed throughout the building. The material was considered as asbestos containing based on the age of the building. The sample results of the suspected mould did not contain detectable mould however did contain low levels of bacteria. A copy of the asbestos and mould laboratory results are included in Attachment C.

- Friable ACMs in poor condition were identified in the boiler room of 138 Bank Street.
- Fill beneath the parking lot was identified to contain waste material, likely associated with the former buildings on the site. The presence of waste containing fill is an issue of potential environmental concern.

Photo 6 - Friable asbestos boiler insulation, basement 138 Bank Street.

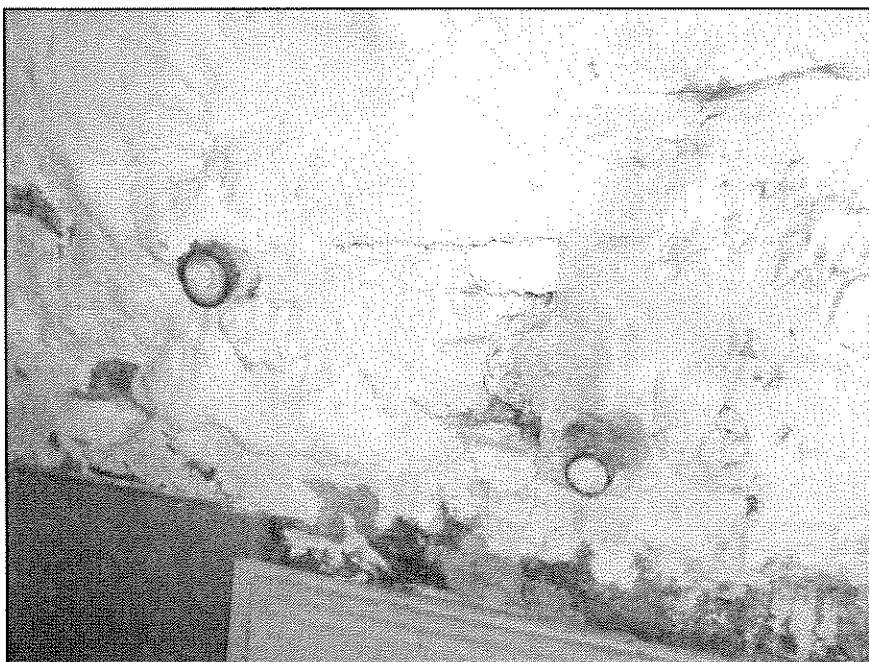
- Potential vent/fill pipes were noted in the basement wall of 136 and 138 Bank Street on the Bank Street side. No evidence of these pipes was visible on the building exterior. On August 25, 2006 Golder carried out a limit geophysical survey on the exterior of the 136 and 138 Bank Street building in order to identify the extent of the buried pipes and to identify the potential presence of a buried tank. Based on the findings of the survey, it was determined that the pipes terminate approximately 0.5 metres from the building foundation wall and that there was no evidence of buried objects beyond the pipe terminations. In addition, City of Ottawa contractors completing infrastructure work in the Bank Street right-of-way indicated that several old abandoned natural gas lines were removed from the area in front of the subject property buildings.

Photo 8 - Vent fill pipes in the basement wall of 136 Bank Street.
