Phase I Environmental Site Assessment 101 Wurtemberg Street Ottawa, Ontario

Report Number: 1651694

APPENDIX C
Site Photographs, 101 Wurtemberg Street, Ottawa, ON

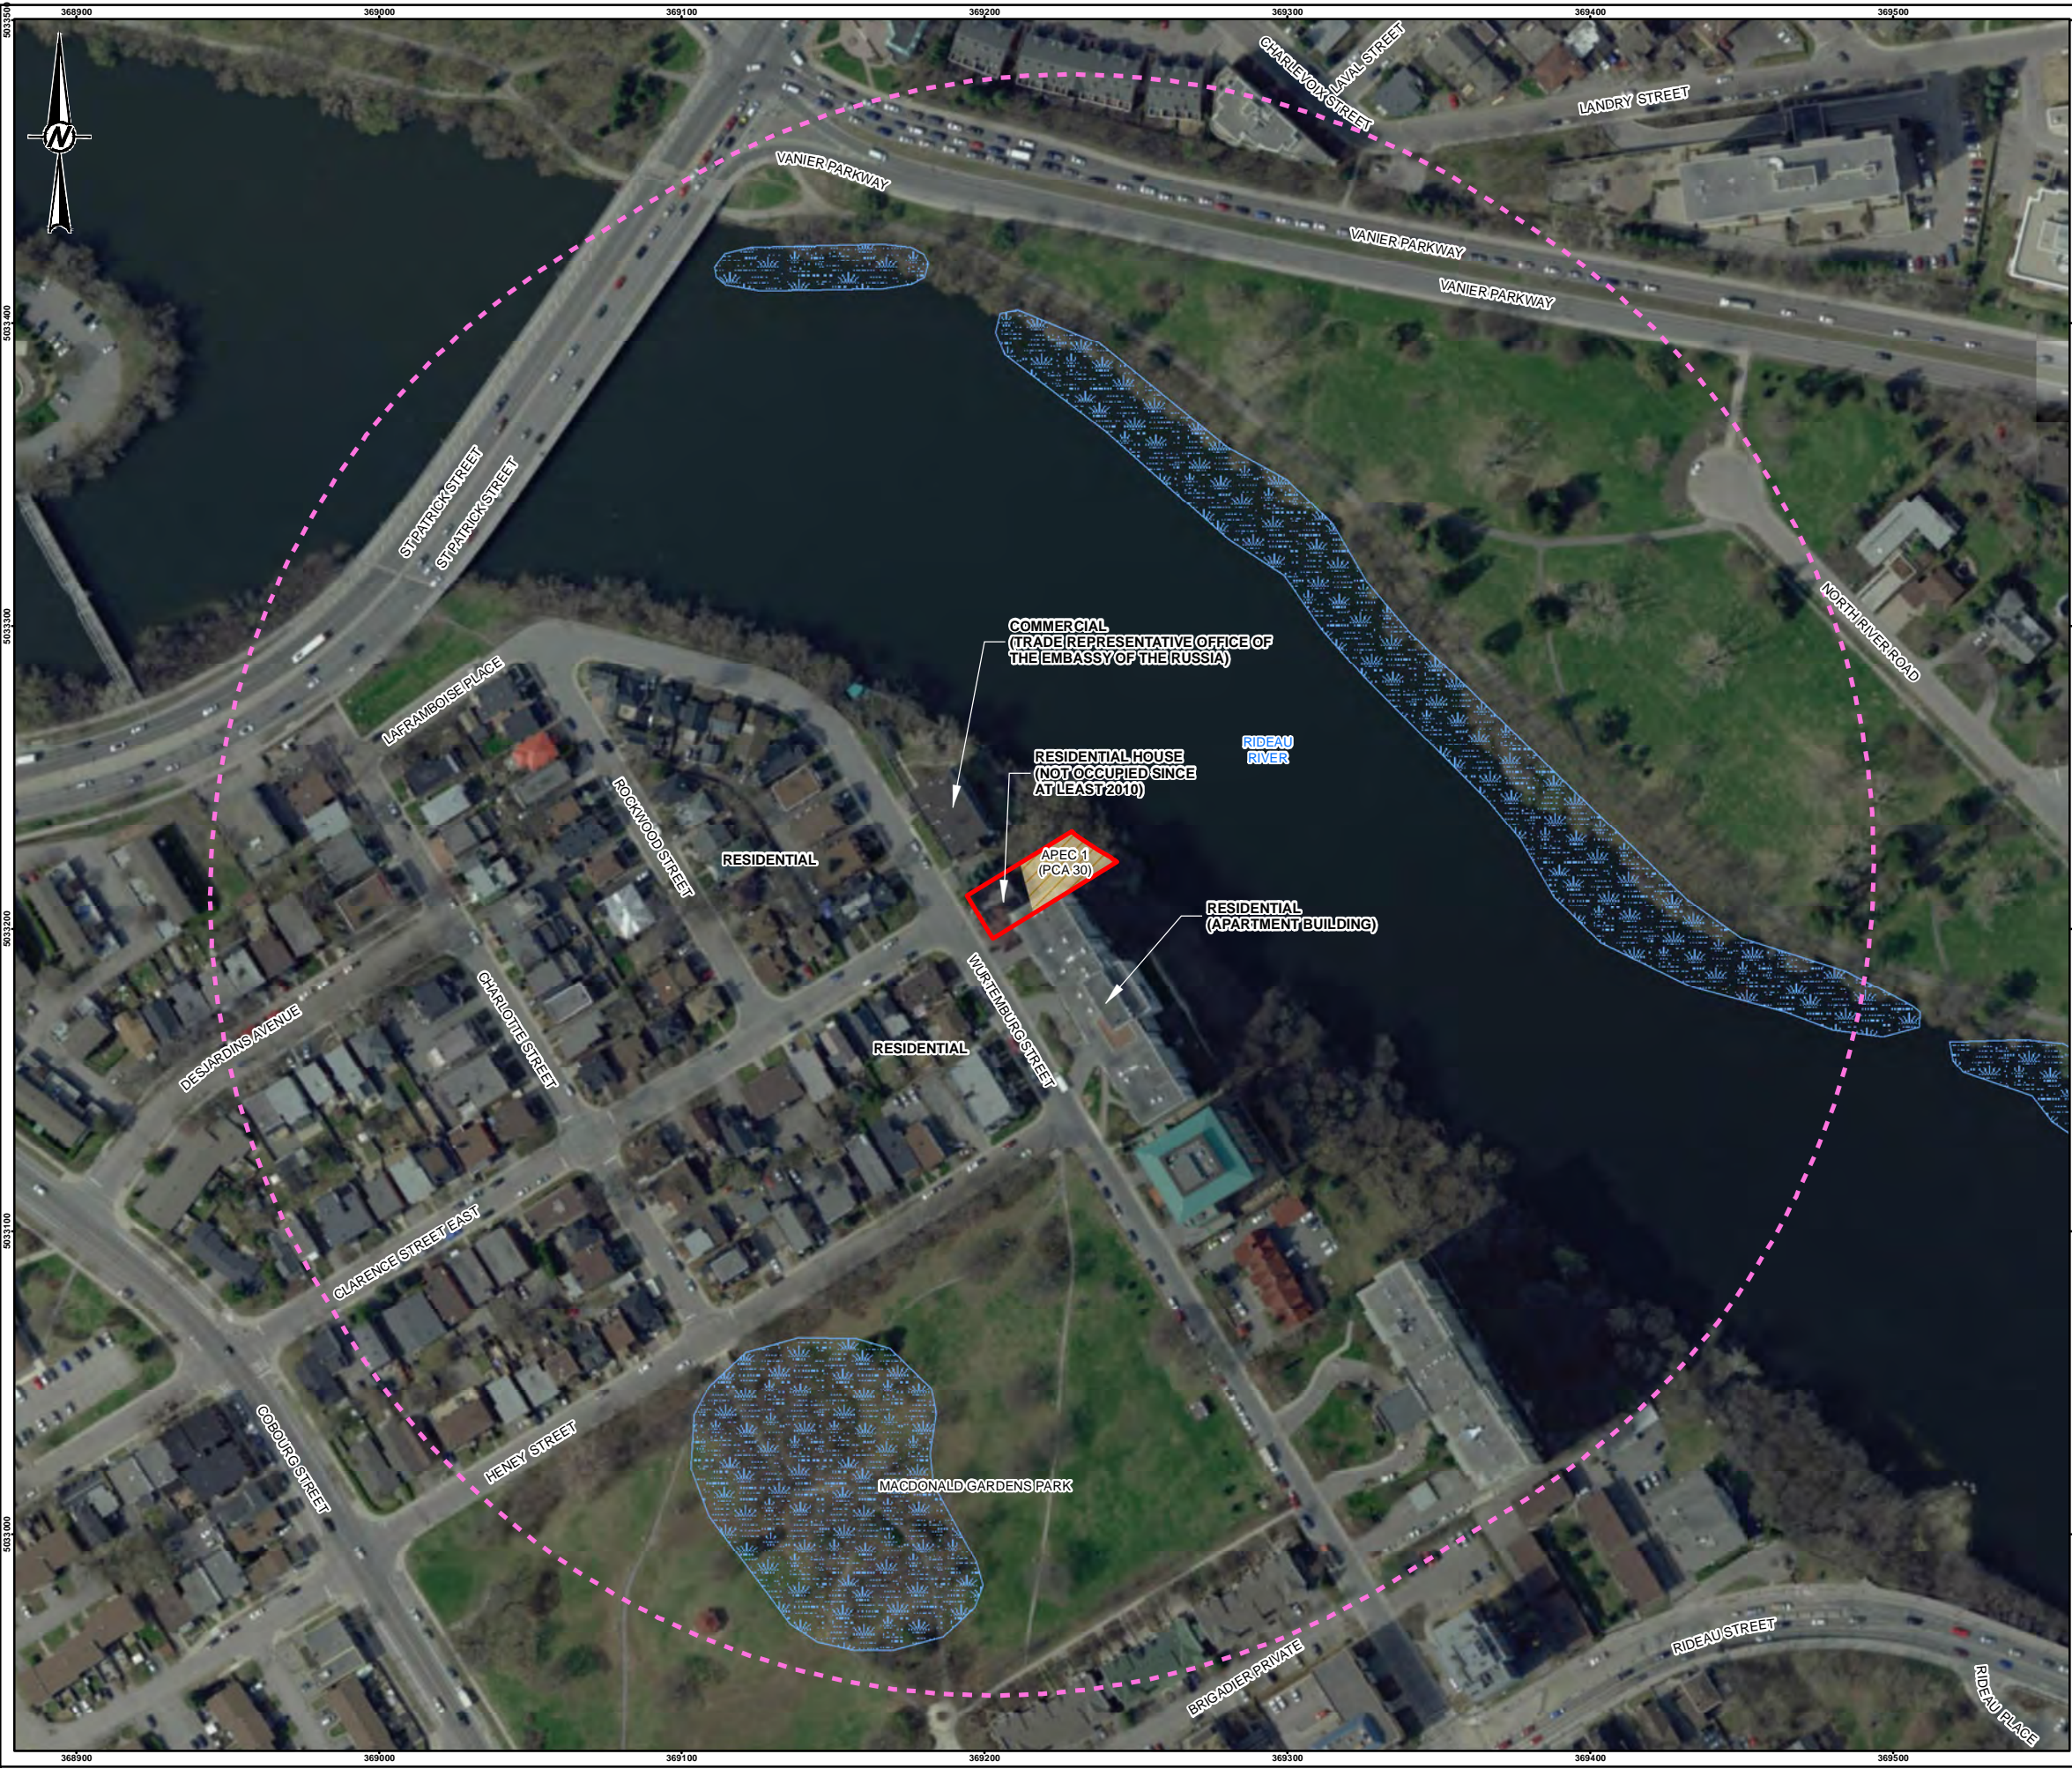
Based on the information collected as part of this Phase One ESA, one PCA#30 (Importation of fill of unknown quality) was identified on the Site. Based on the 2010 Slope Stability Assessment completed by Golder for the Site, fill of unknown quality was placed in the east part of the Site. The fill thickness was found to be up to 3 m. In addition, fill material was used to fill in the former in-ground swimming pool that existed on Site between 1988 and 2002. This PCA resulted in one APEC (APEC1) as shown on Figure 2.

POTENTIALLY CONTAMINATING ACTIVITY (PCA):
 PCA #30- IMPORTATION OF FILL MATERIAL OF UNKNOWN QUALITY - FILL MATERIAL OF UNKNOWN QUALITY IS PRESENT AT THE EAST END OF THE SITE WITH A RANGE IN THICKNESS BETWEEN 0-3 M (BASED ON THE INFORMATION OBTAINED FROM THE 2010 SLOPE STABILITY ASSESSMENT). IN ADDITION, IN-GROUND SWIMMING POOL EXISTED ON SITE BETWEEN 1988 AND 2002 THAT WAS FILLED IN WITH FILL MATERIAL OF UNKNOWN QUALITY.

AREAS OF POTENTIAL ENVIRONMENTAL CONCERNS:
 APEC 1- ASSOCIATED WITH THE PCA#30 (IMPORTATION OF FILL MATERIAL OF UNKNOWN QUALITY).

In order to address the fill quality issues, the following is recommended in conjunction with re-developing the Site:

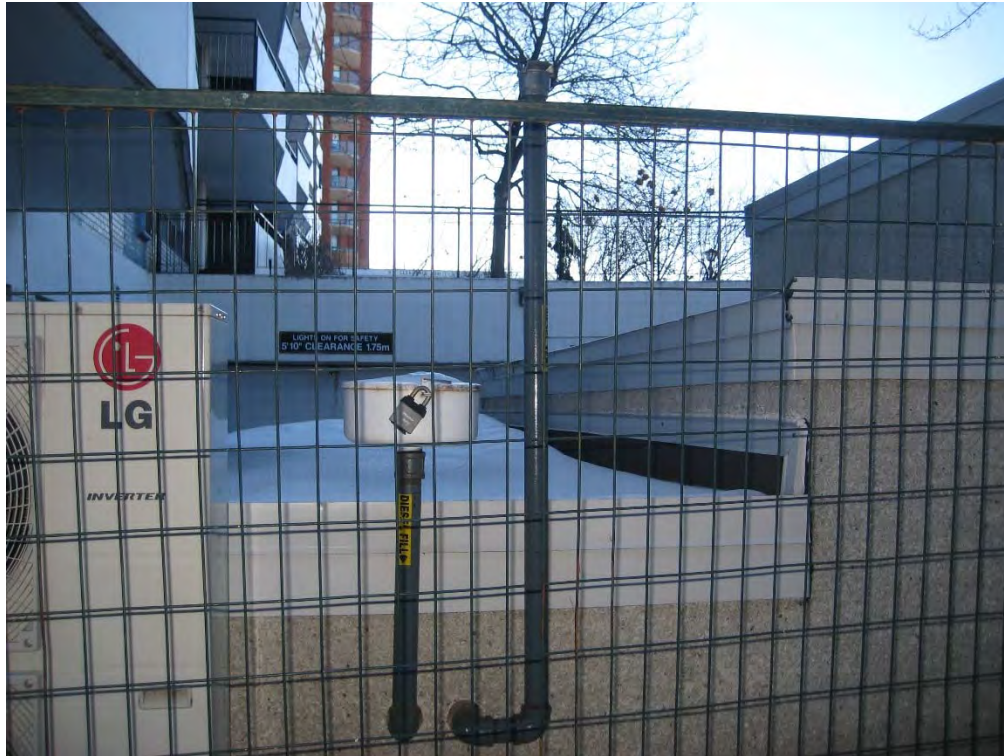
- The Seignior apartment buildings. Vent and fill pipes labelled as diesel likely associated with an AST were observed to extend from the wall of the parking garage associated with the adjacent apartment building. The pipes are likely associated with a backup generator for the apartment building complex. A tank fill monitor was mounted on the exterior of the parking garage, indicating that there is a system in place to prevent spills and overfills of the AST. This AST is not considered to be a PCA that results in an APEC on the Site.

Photograph 5: View of the fill and vent pipes noted on the adjacent apartment building complex to the south.

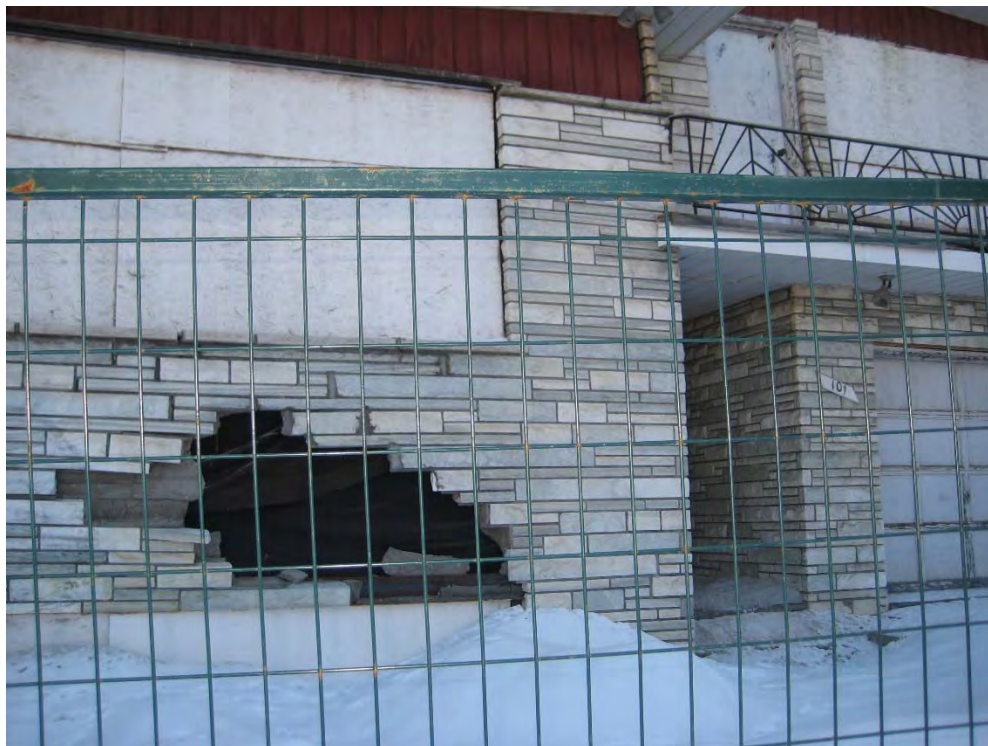
As the house has not been heated for long period of time there was significant accumulation of ice on the stairs and the floors. In addition, there was no power, the house was structurally damaged and it was in very poor condition. Golder only accessed the entrance of the house and did not inspect the basement or the other parts of the house due to the unsafe structural conditions.

Photograph 6: View of the Site building and the wall damage on the façade.

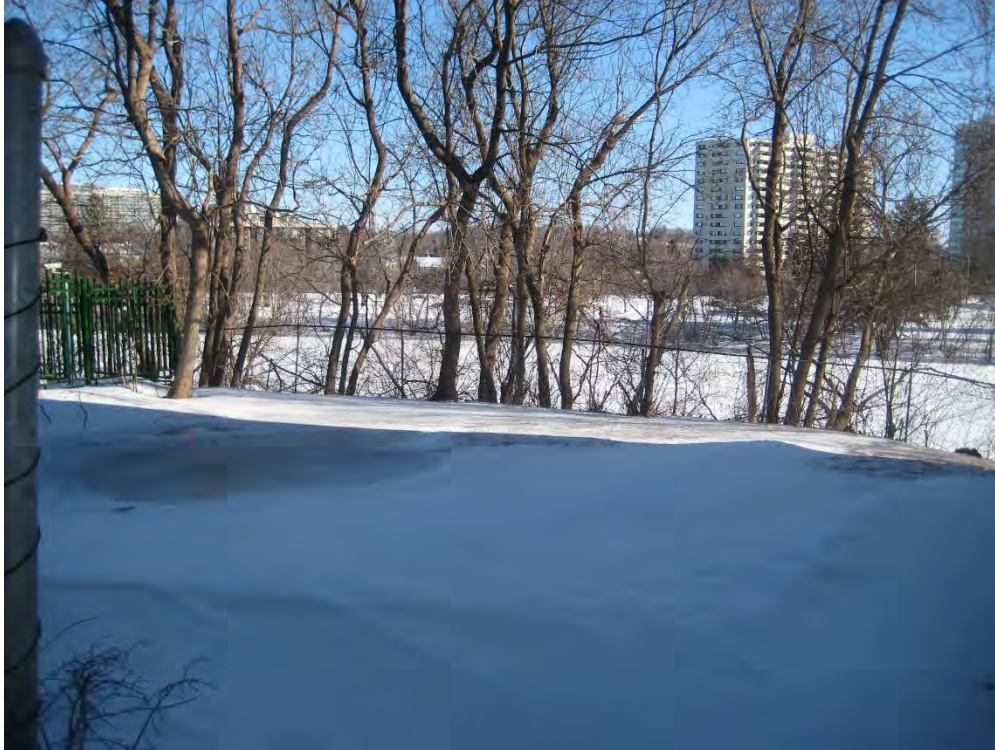
The Site is generally flat but there is a significant elevation difference between the Site and the surrounding lands east of the Site (Rideau River). At the time of the Site visit the ground surface was snow covered which limited the observations for potential presence of staining or distressed vegetation.

Photograph 7: View of the backyard on the Site looking east towards the Rideau River.

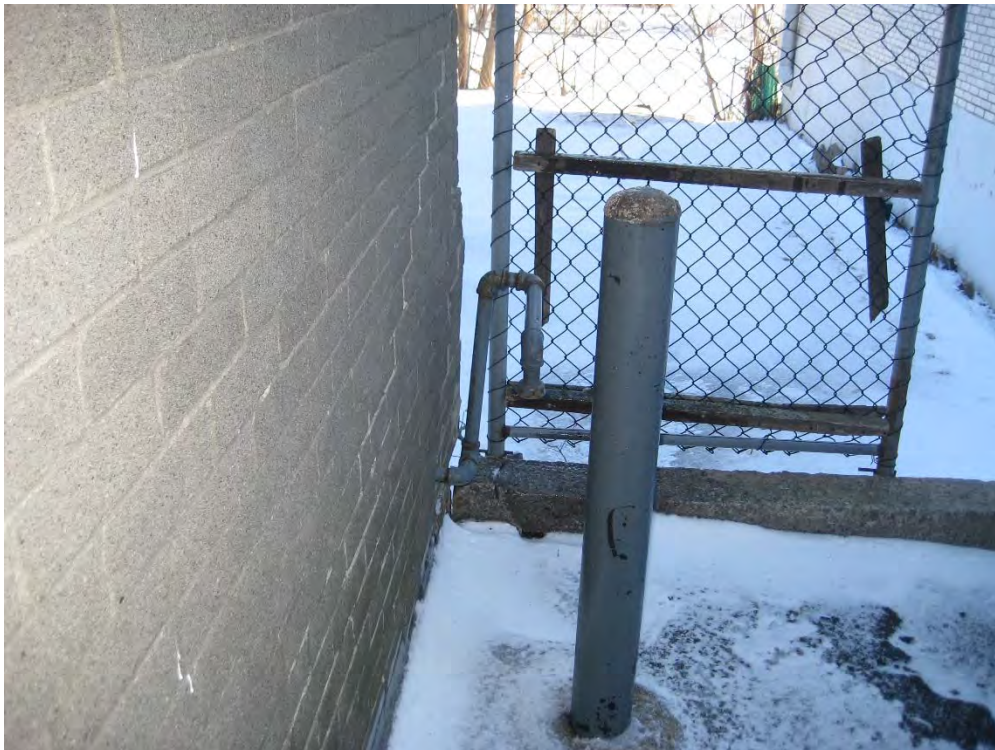
Photograph 8: View of the disconnected natural gas piping previously supplying gas to the house.

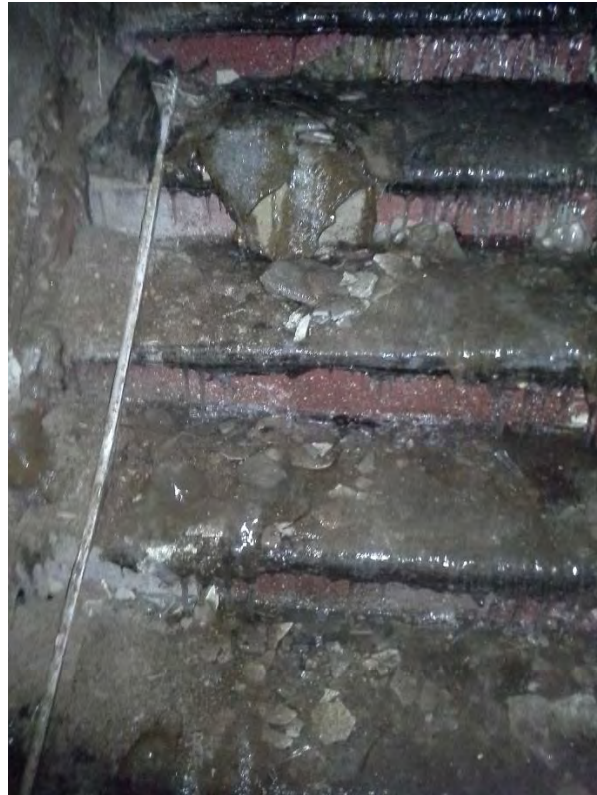
At the time of the Site visit, the Site was occupied by an abandoned house and no operations or any other activities were being carried out at the Site. As the house has not been heated for a long period of time there was significant accumulation of ice on the stairs and the floors. In addition, there was no power, the house was structurally damaged and it was in very poor condition. Golder accessed only the entrance of the house and did not inspect the basement or the other parts of the house due to the unsafe conditions.

Photograph 9: View of the ice covered stairs in the house.

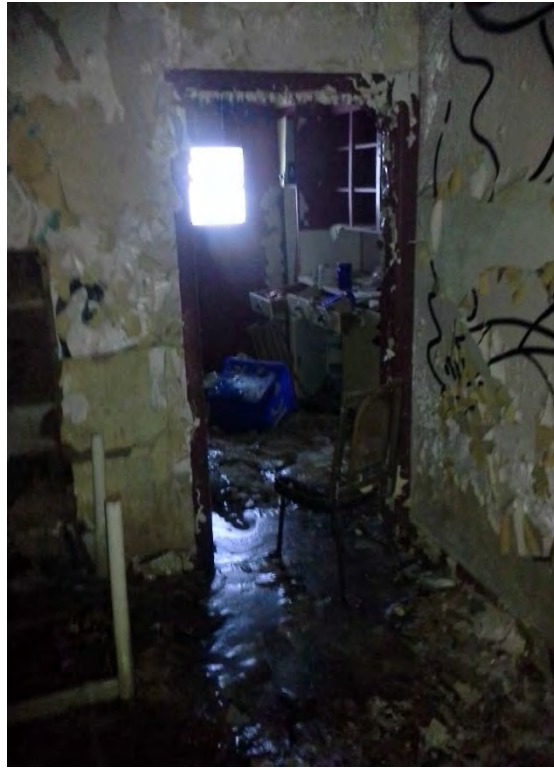
Photograph 11: View of the interior and the ice covered floors in the house.
