## Modified Phase I - Environmental Site Assessment

Vacant Property  
288 Booth Street  
Ottawa, Ontario

July 25, 2011

Report: PE2328-1

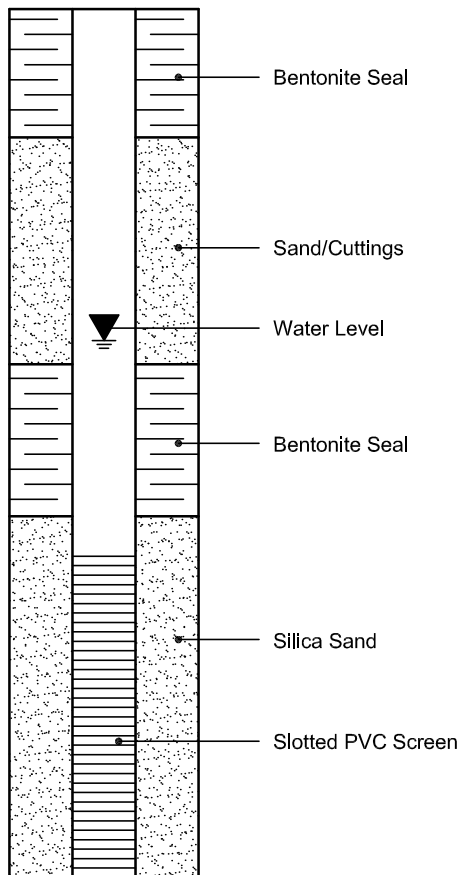
#### MONITORING WELL CONSTRUCTION

### MONITORING WELL AND PIEZOMETER CONSTRUCTION

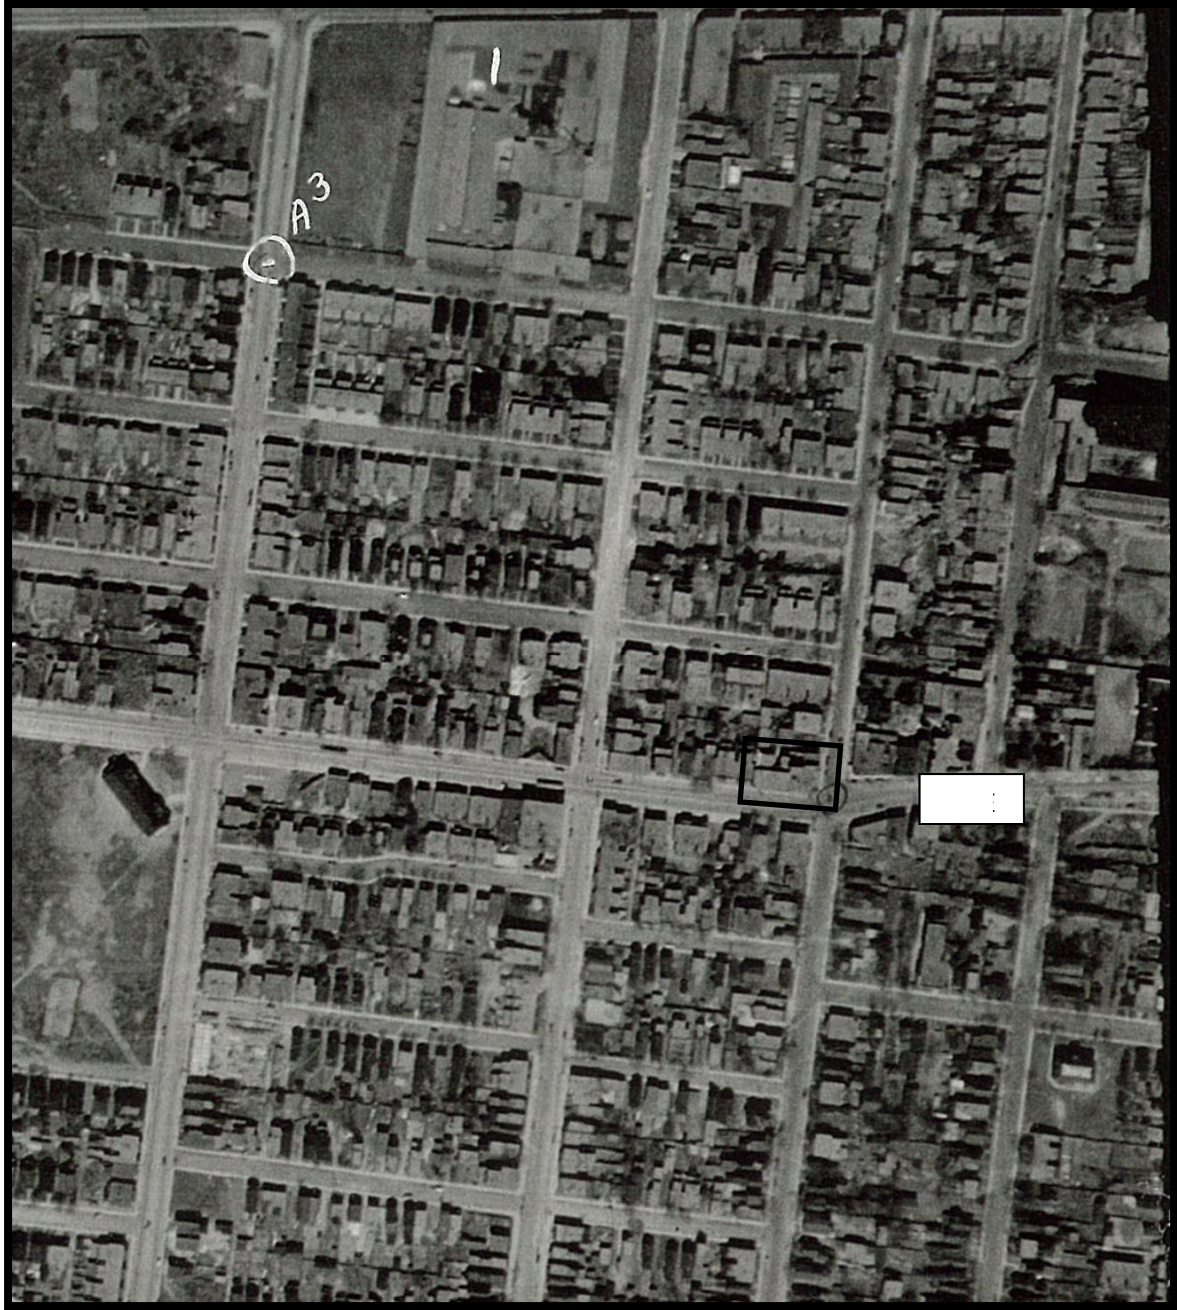
AERIAL PHOTOGRAPH  
1922

- 1922 The subject property is occupied by a commercial/residential building. Somerset Street and Booth Street border the property to the south and east, respectively. The adjacent properties and neighbouring properties also appear to be used for commercial and/or residential purposes. A railway line is present further to the west (west of Preston Street) of the subject site.

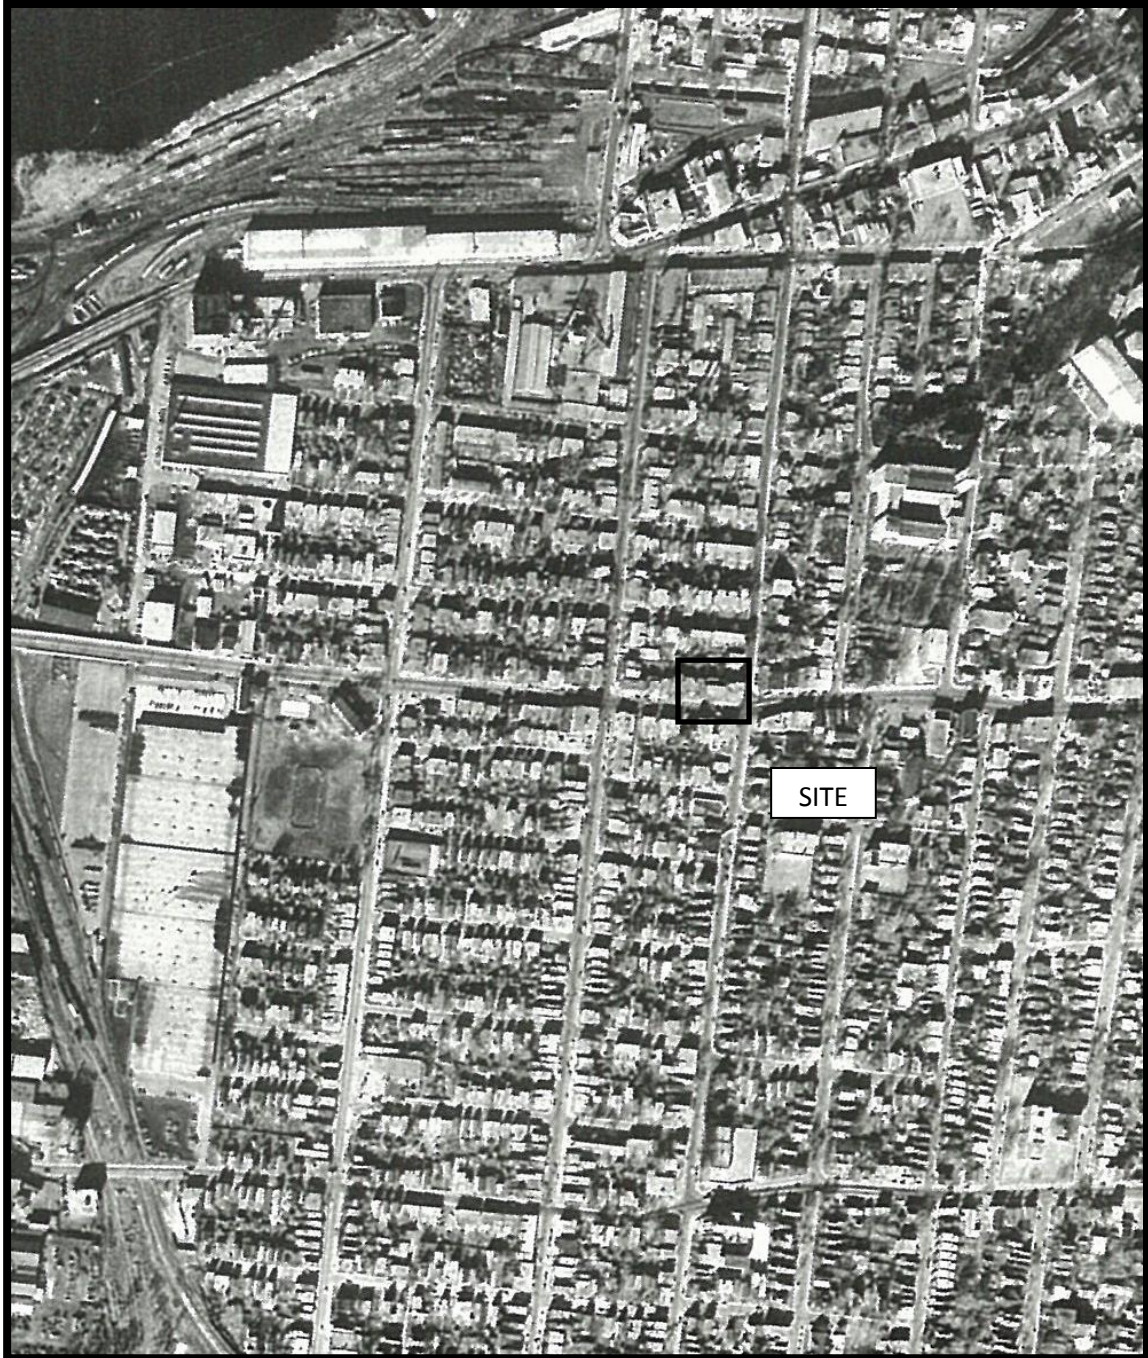
AERIAL PHOTOGRAPH  
1958

- 1958 No significant changes appear to have been made to the subject site or neighbouring properties.
- 1969 A building to the south of the subject site, located at the north west corner of the intersection between Eccles Street and Booth Street, has been removed and the property is now vacant. Otherwise no significant changes have been made to the subject site or neighbouring properties.

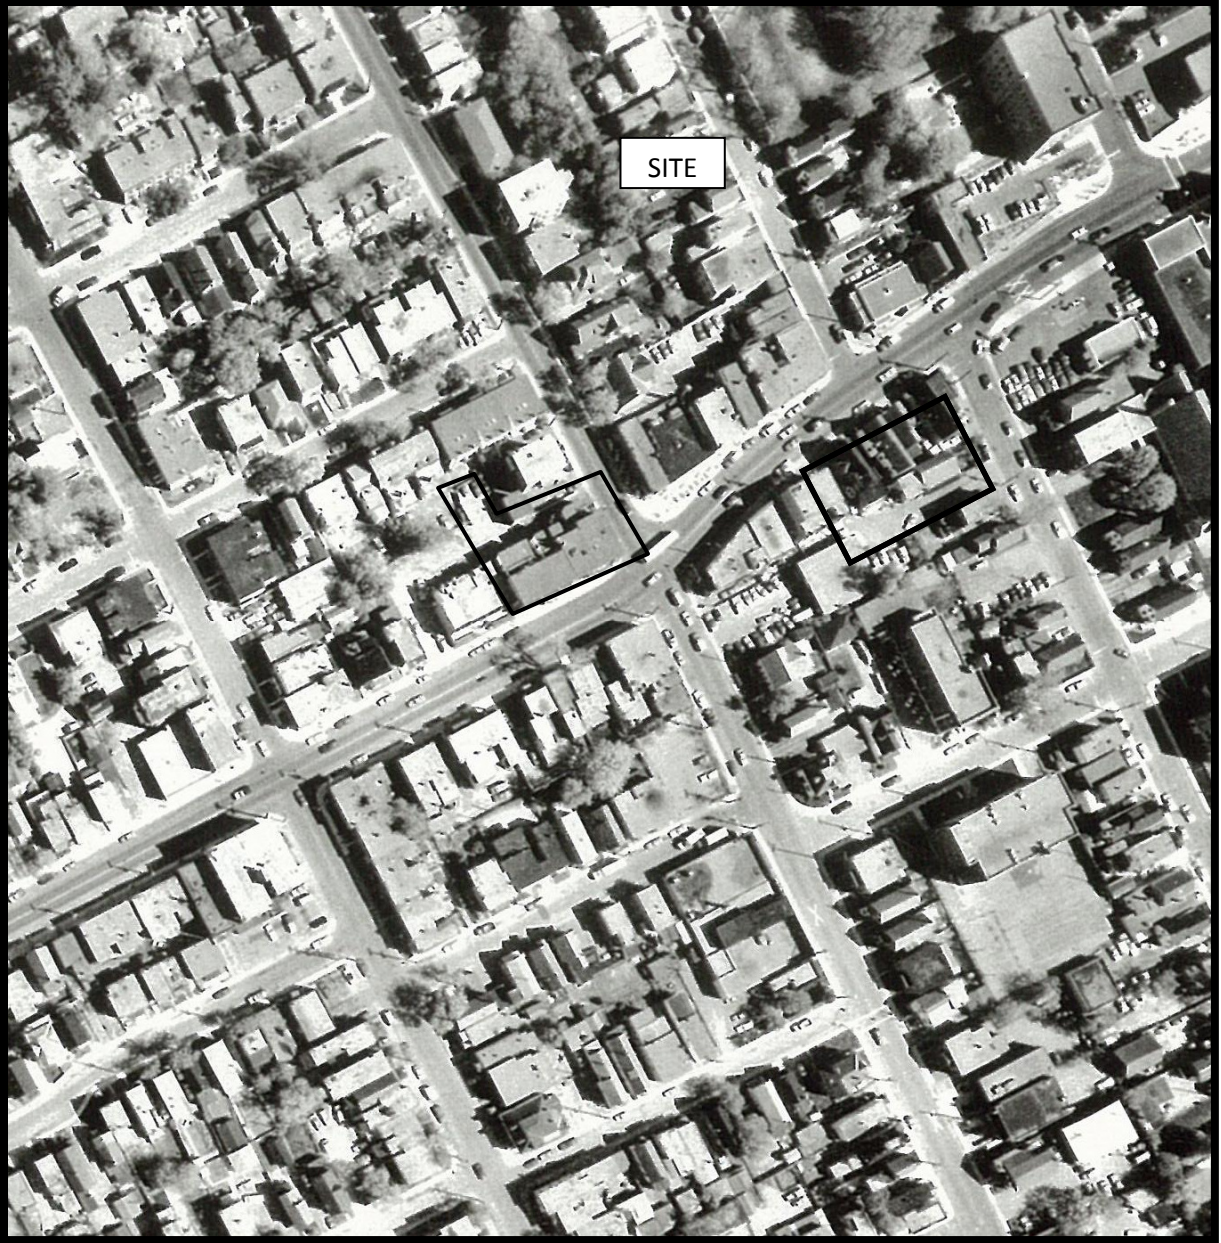
AERIAL PHOTOGRAPH  
1984

- 1984 It appears as though the west portion of the building on the adjacent property to the west has been removed, opening up an access lane from Somerset Street to the rear of the building. Otherwise no significant changes have been made to the subject site or neighbouring properties.

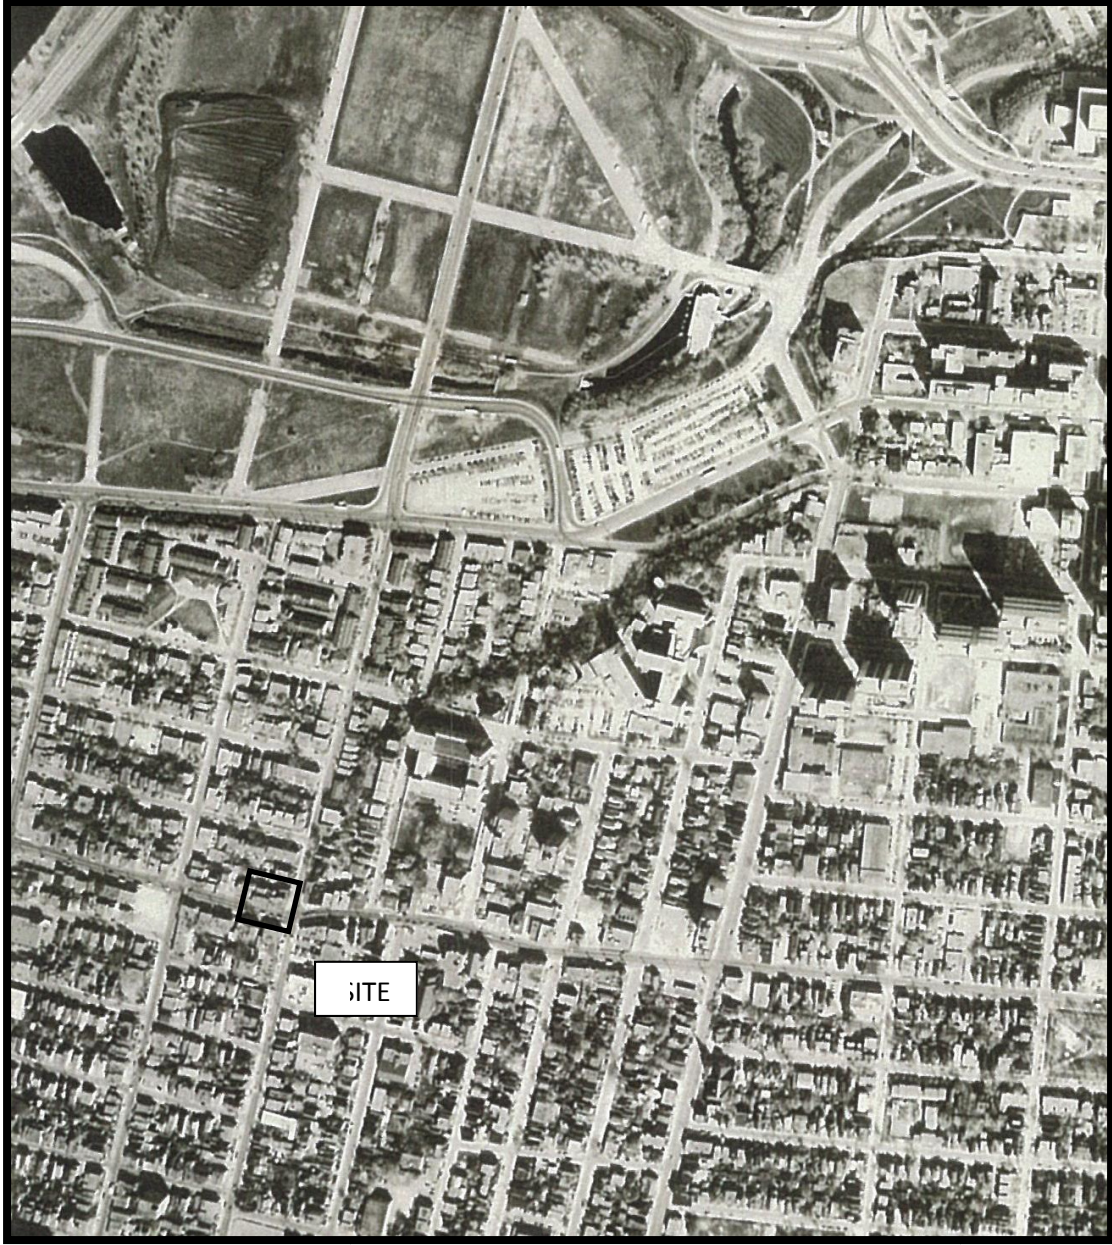
AERIAL PHOTOGRAPH  
1992

- 1992 No significant changes appear to have been made to the subject site or neighbouring properties.
- 2002 (City of Ottawa Website) No significant changes appear to have been made to the subject site or adjacent properties.
