**PHASE TWO ENVIRONMENTAL ASSESSMENT
INVESTIGATION OF SUBSURFACE SOIL AND
GROUNDWATER CONDITIONS**

**401 March Road,
Ottawa, Ontario**

Project No. 1609-13

October 30th, 2013

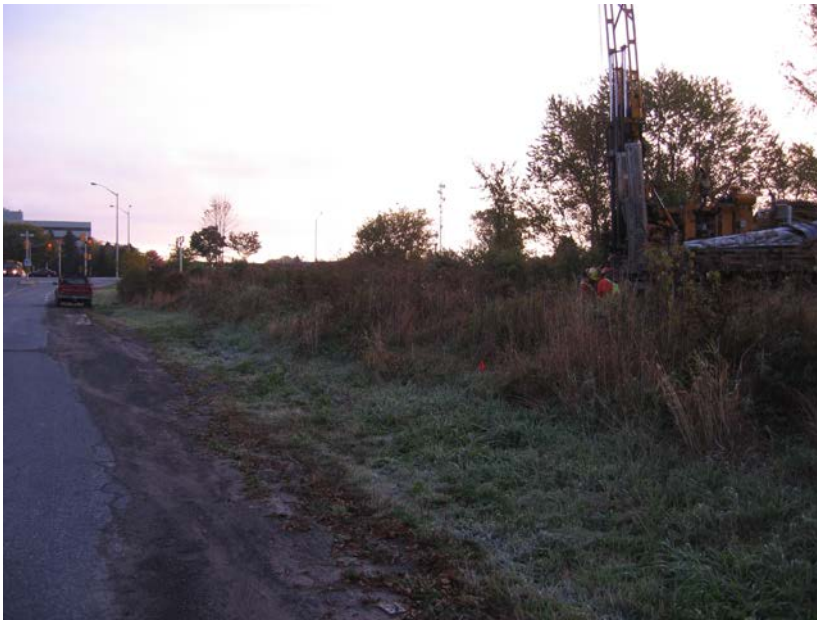
Photo 1:

The subject site is a parcel of vacant and undeveloped land. We completed a Phase Two Environmental Study that consisted of 16 boreholes, advanced to a maximum depth of 25 feet below adjacent grade, and the installation of 11 groundwater monitoring wells. View of Borehole MW101 located in the north portion of the site, in proximity to Station Road.

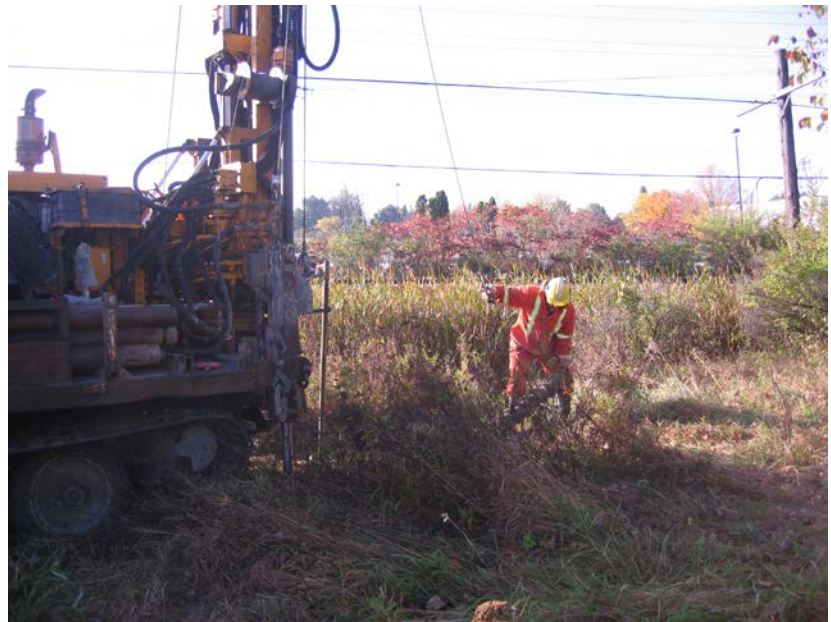
Photo 2:

Viewing along the south portion of the site at borehole MW102. This monitoring well was advanced to a depth of 20 feet in close proximity to a raised CP rail line, located on the south adjacent property. The typical soil profile consisted of mixed clay fill varying from 29 to 94 inches deep, underlain by a layer of native top soil (10 to 18 inches deep). The top soil layer was underlain by wet to saturated clay or silty clay.

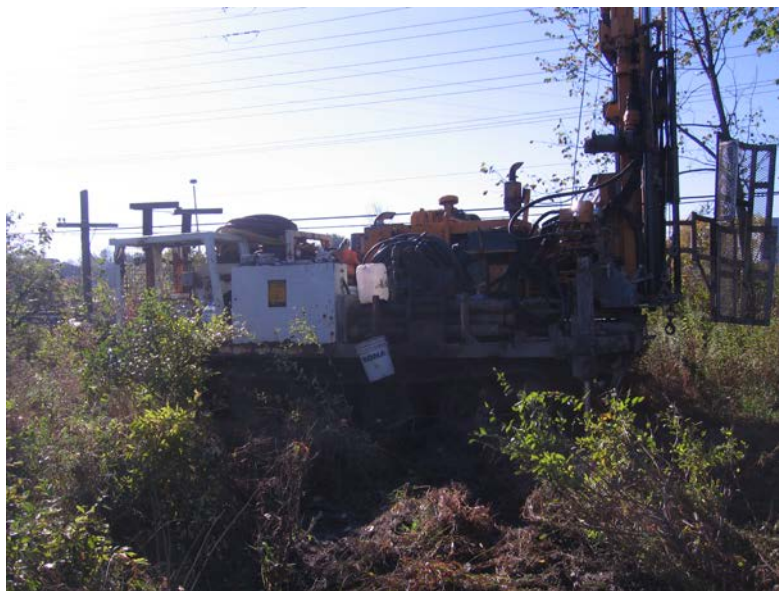
Photo 3:

Viewing borehole MW103 located in the south portion of the site. In this study, a total of 84 soil and water samples were collected from all boreholes and tested for presence of potential environmental contaminant. A total 43 soil samples and 19 groundwater samples were forwarded to the lab for specific chemical tests.

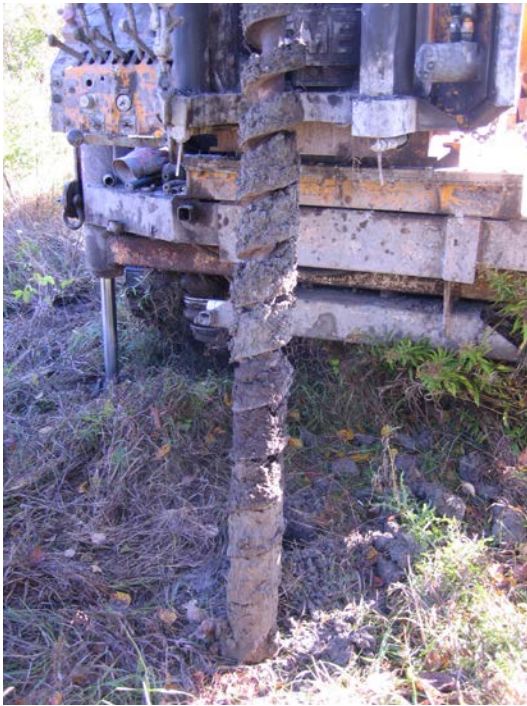
Photo 4:

View of typical sampling of mixed clay fill with gravel and clay observed at some test holes. The clay fill was generally loosely placed on the subject site. The stabilized groundwater levels on the subject site varied from 5.1 to 8.2 feet below adjacent grade. At most test locations, the stabilized groundwater was at or just beneath the native top soil layer. Notably, the current fall season has seen higher than usual rainfall.

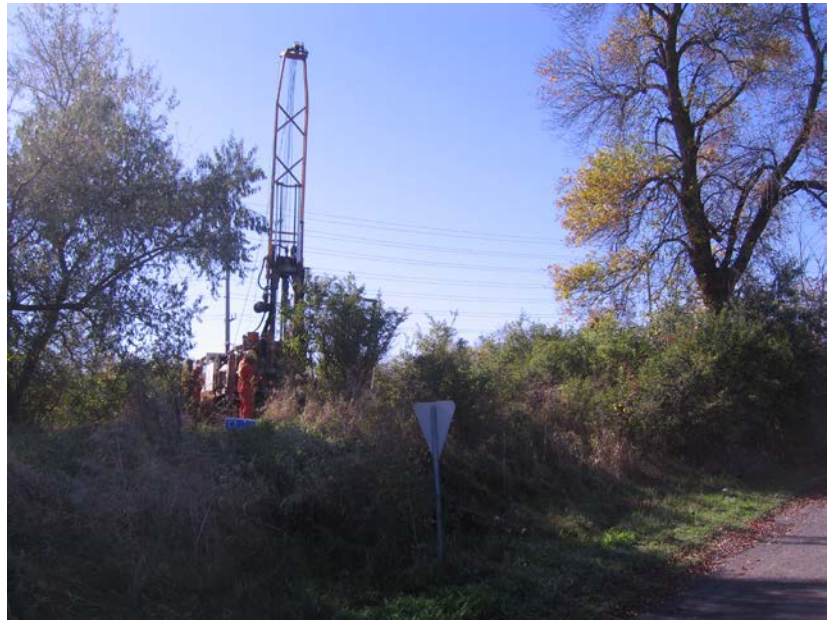
Photo 5:

Viewing MW104 located in the north portion of the site, adjacent to Station Road. The lab test results confirmed no significant chemical impacts to soil or groundwater samples in this ESA2 study.

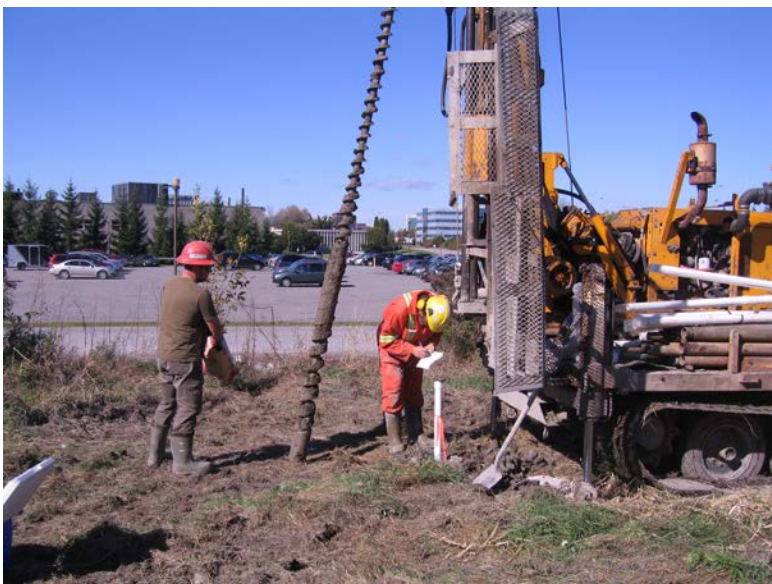
Photo 6:

Viewing borehole MW107 located in the north portion of the site. The ESA2 drilling work was completed on October 9th, 2013 including the installation of the 11 well units. EMG staff collected groundwater for field and lab testing on October 16th, 2013. Notably, there was no visible evidence of environmental impacts in the water samples.

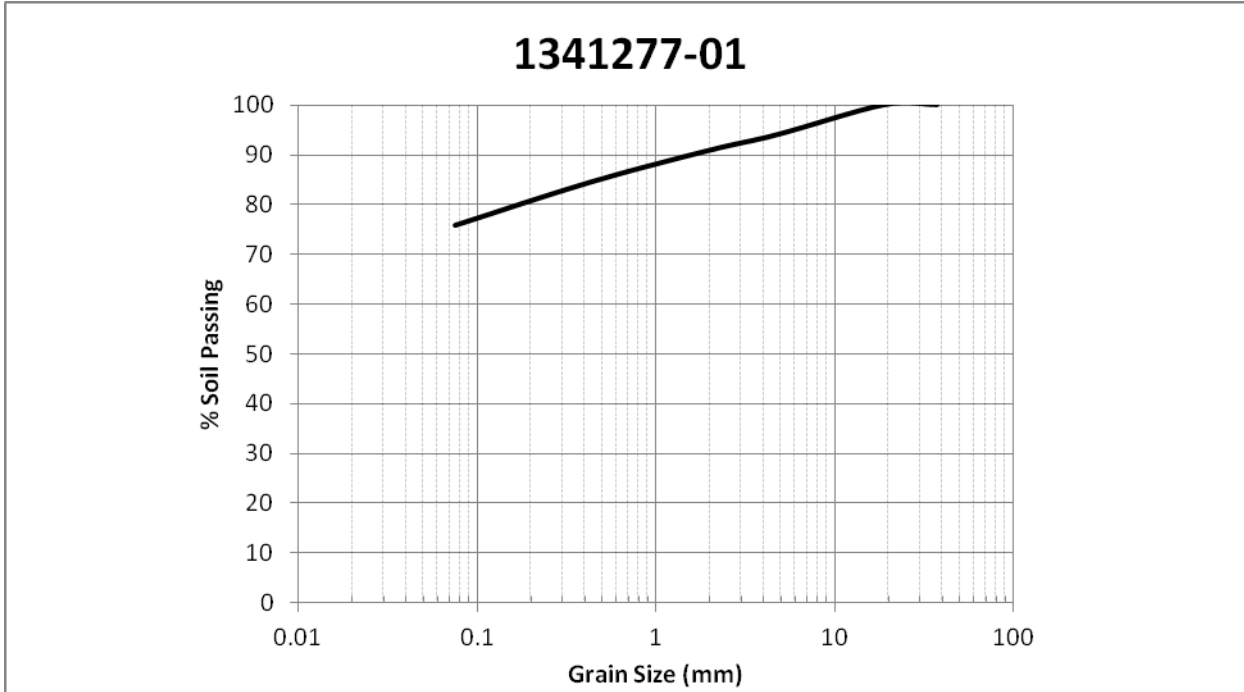
Figure 1: Grain Size Distribution for the sample 'Grain Size Analysis' ; Parcel ID: 1341277-01

Sieve Range	% Fraction Retained in Sieve range	Sieve Size	% Passing Sieve Size
<0.075	25.1	0.075	75.9
.425 - 0.075	50.8	0.425	84.5
2 - .425	14.8	2	90.9
4.75 - 2	6.4	4.75	94
19 -4.75	2.9	19	100
>19	0	19	100.0

Based on the above results, this soil can be classified as having a medium-fine grained texture (assuming all particles greater than 2mm are removed from the calculation).
