RE: SLOPE STABILITY ASSESSMENT AND RETAINING WALL DESIGN
Site Plan Control Application - City of Ottawa File Number: D07-12014-0038
Proposed Greely Commercial Center
5640 Bank Street, 7107 Marco Street, 701 Mitch Owens Road
Ottawa, Ontario

Kollaard Associates Inc. was retained to undertake a slope stability assessment and retaining wall design for the slope along the south side of the proposed Greely Commercial Center Site commonly known as 5640 Bank Street, 7107 Marco Street, 701 Mitch Owens Road, located in Greely, Ottawa, Ontario. The purpose of this assessment and design is to address the concern with respect to the stability of the existing slope along the south side of the site and to provide retaining wall design for the proposed retaining wall to be located along this slope.

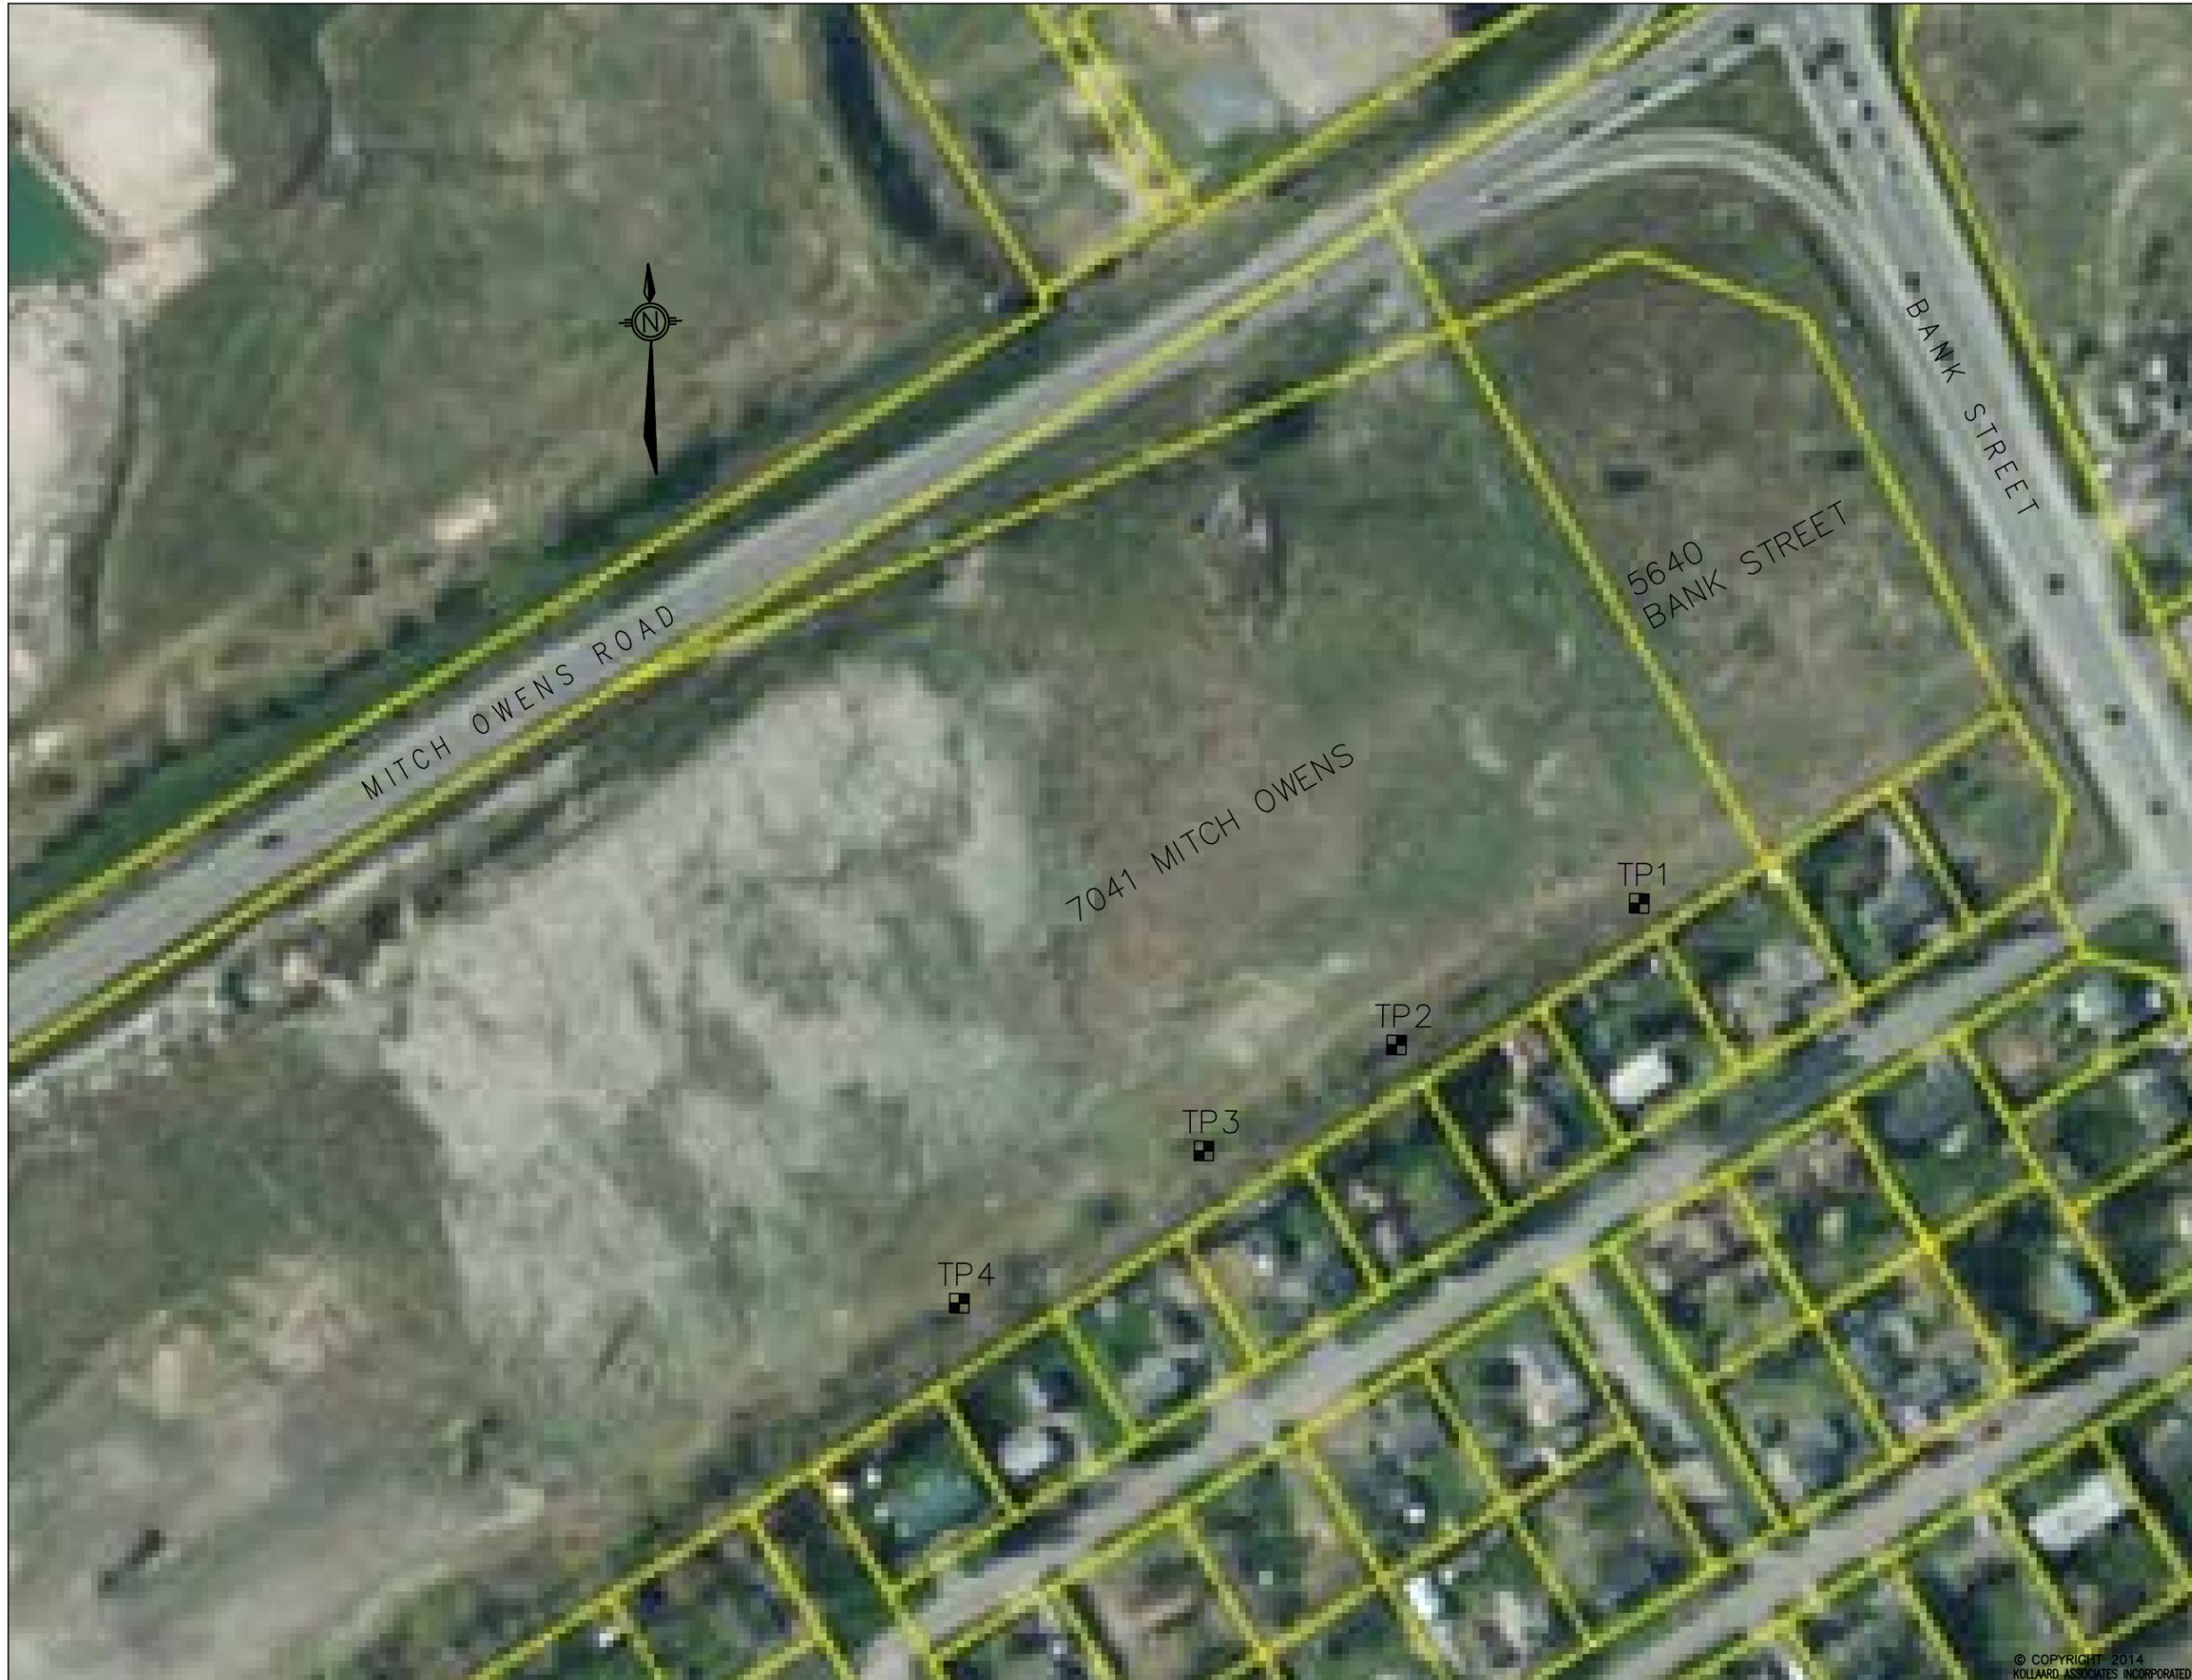
DRAWING NUMBER:
SITE PLAN, FIGURE 1

LEGEND:
TP1
■ APPROXIMATE TEST PIT LOCATION

Kollaard Associates Inc. returned to the site on April 25, 2014 to supervise the excavation of 4 test pits at the base of the slope. The test pits were put down using a backhoe supplied and operated by a local excavating contractor.

The test pits were put down on the face of the slope beginning at about 1 to 2 metres above the level ground surface at the toe of the slope. The test pits were advanced to about 1 to 1.5 metres below the level ground surface. The subsurface conditions were classified based on visual and tactile examination of the materials exposed on the sides and bottom of the test pits. The ground water conditions were observed in the open test pits at the time of excavating. The test pits were loosely backfilled with the excavated materials upon completion of the field work. A description of the subsurface conditions encountered at the test pits is given in the attached Record of Test pits sheets.

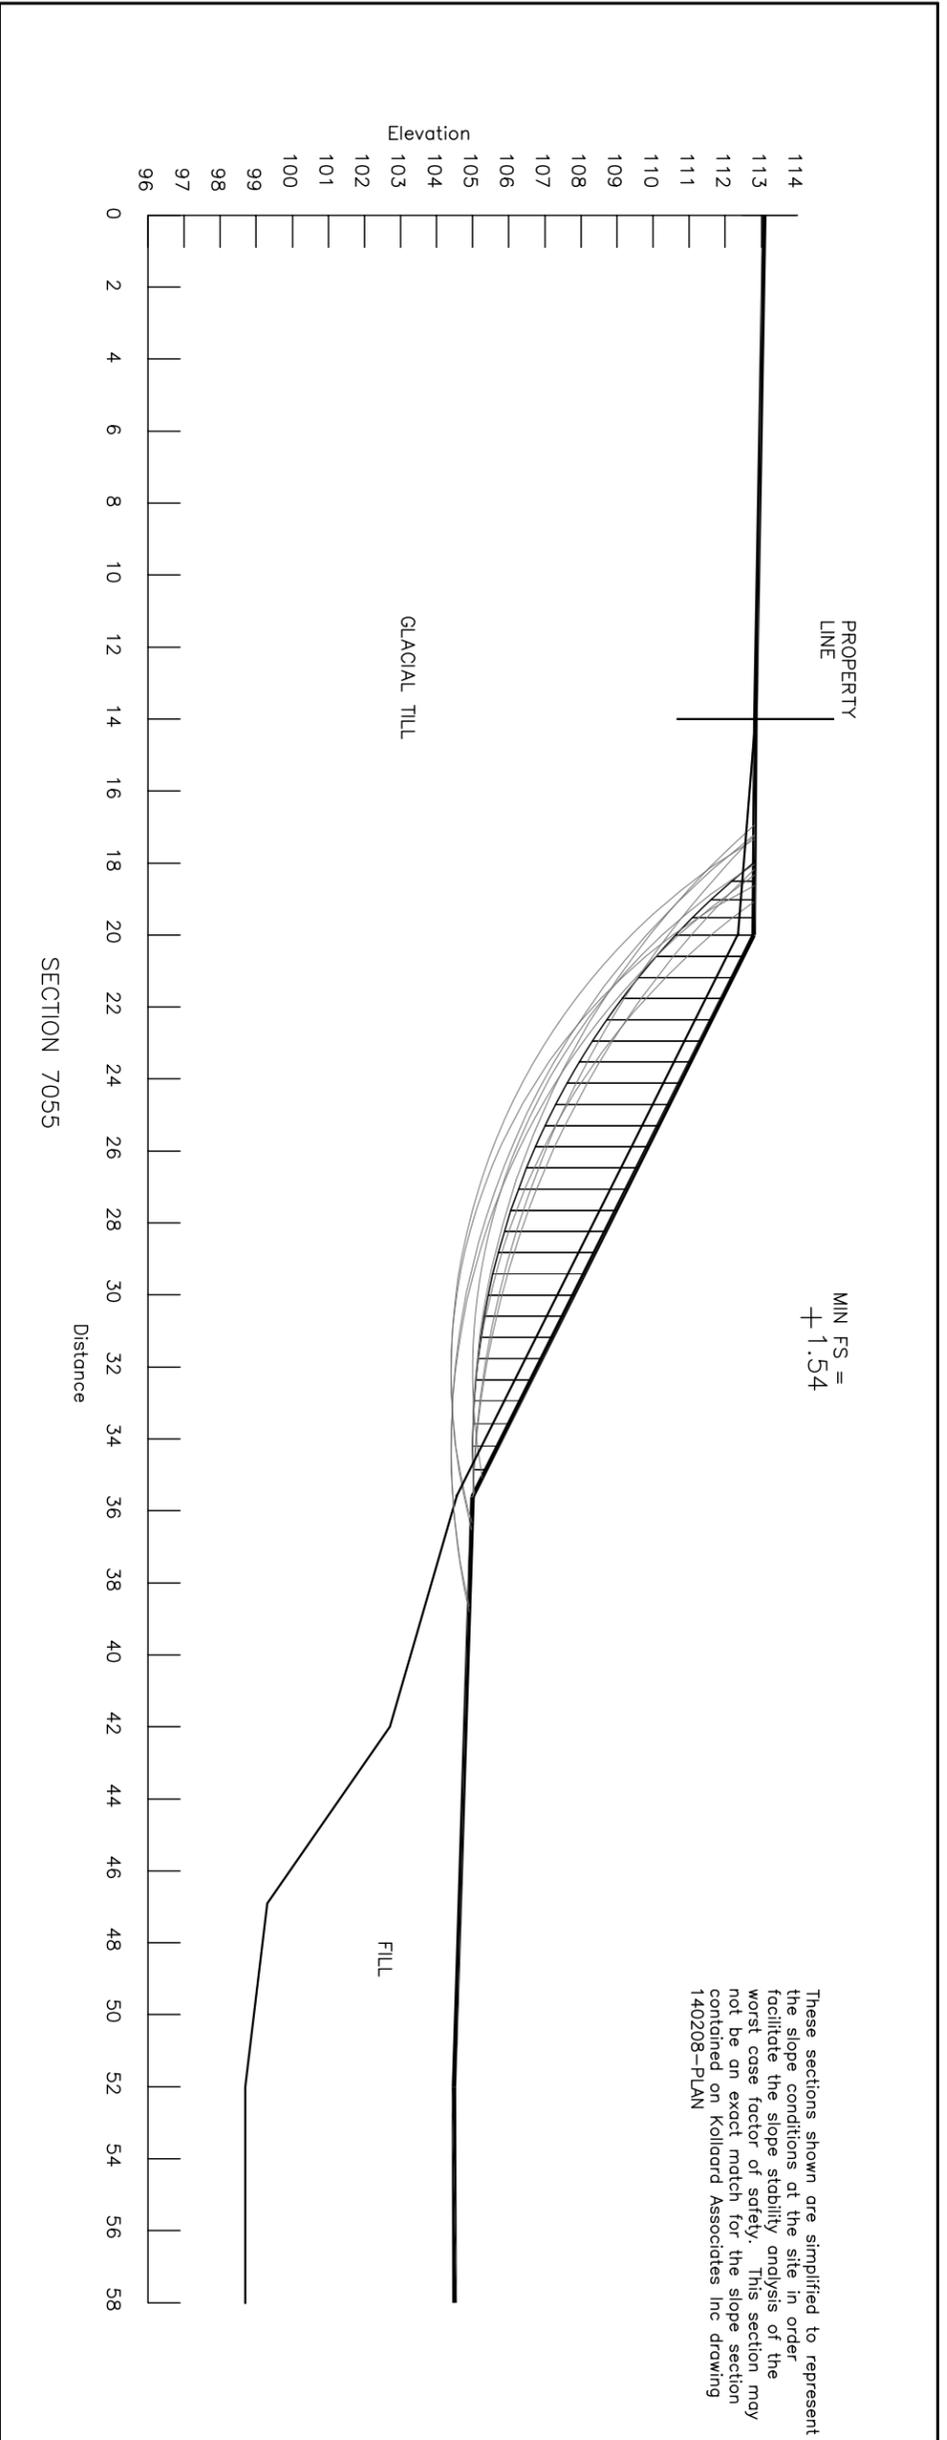
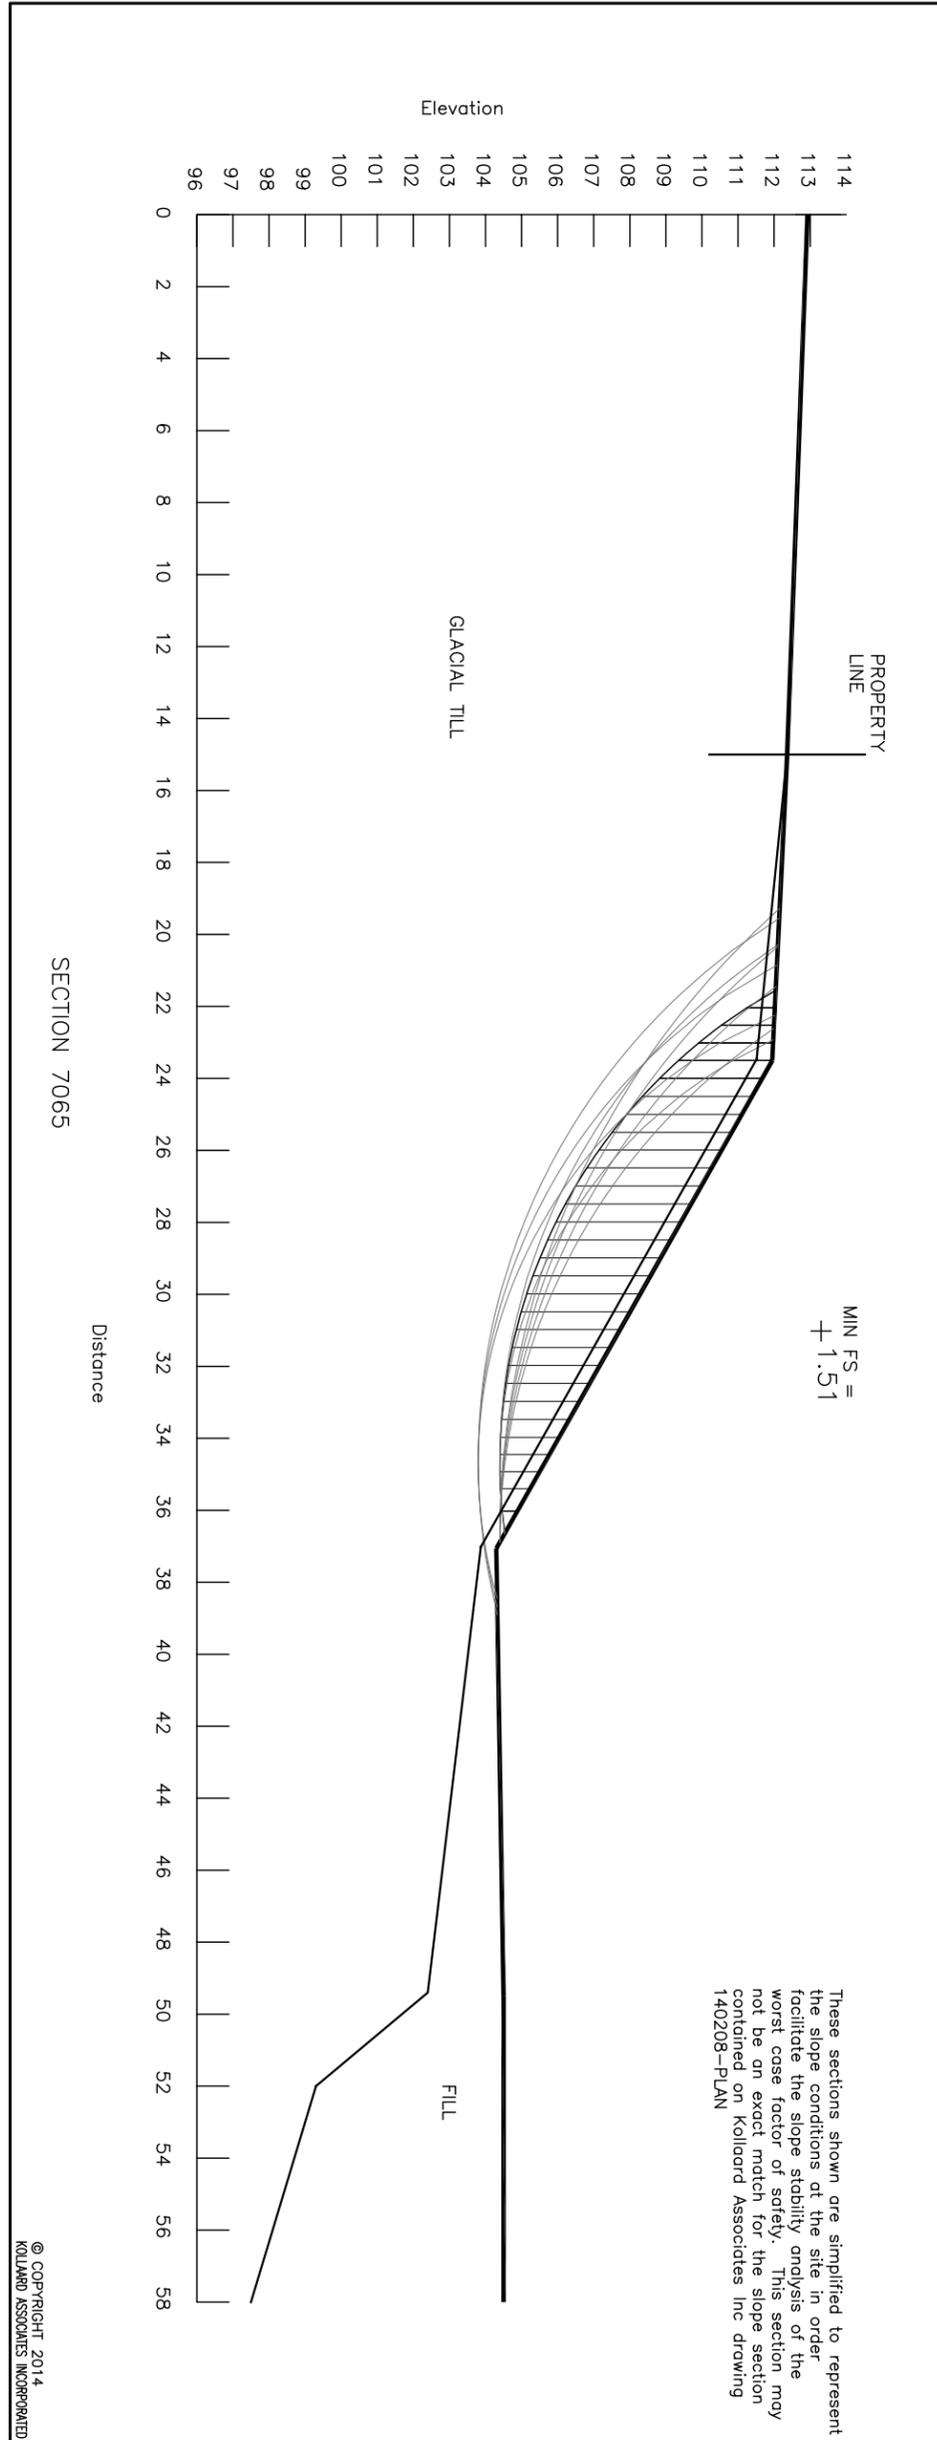
DRAWING NUMBER:
140208 -SL1

1. Dimensions and elevations are in metric as shown. Do not scale drawing.
2. Any changes made to drawings must be verified and approved by Kollaard Associates Inc.
3. This drawing is intended to indicate the minimum factor of safety of the indicated sections along the slope of the south side of the site known as 5640 Bank Street, 7107 Marco Street, and 701 Mitch Owens Road.

The slope stability analysis results for the existing slope geometry at the site is indicated on the attached Kollaard Associates Inc. drawings 140208-SL1 and 140208-SL2.

The overall slope stability factor for each section analyzed is as follows:

Section 7055 – min FS = 1.54

Section 7065 – min FS = 1.51

Section 7077 – min FS = 1.56

Section 7089 – min FS = 3.67

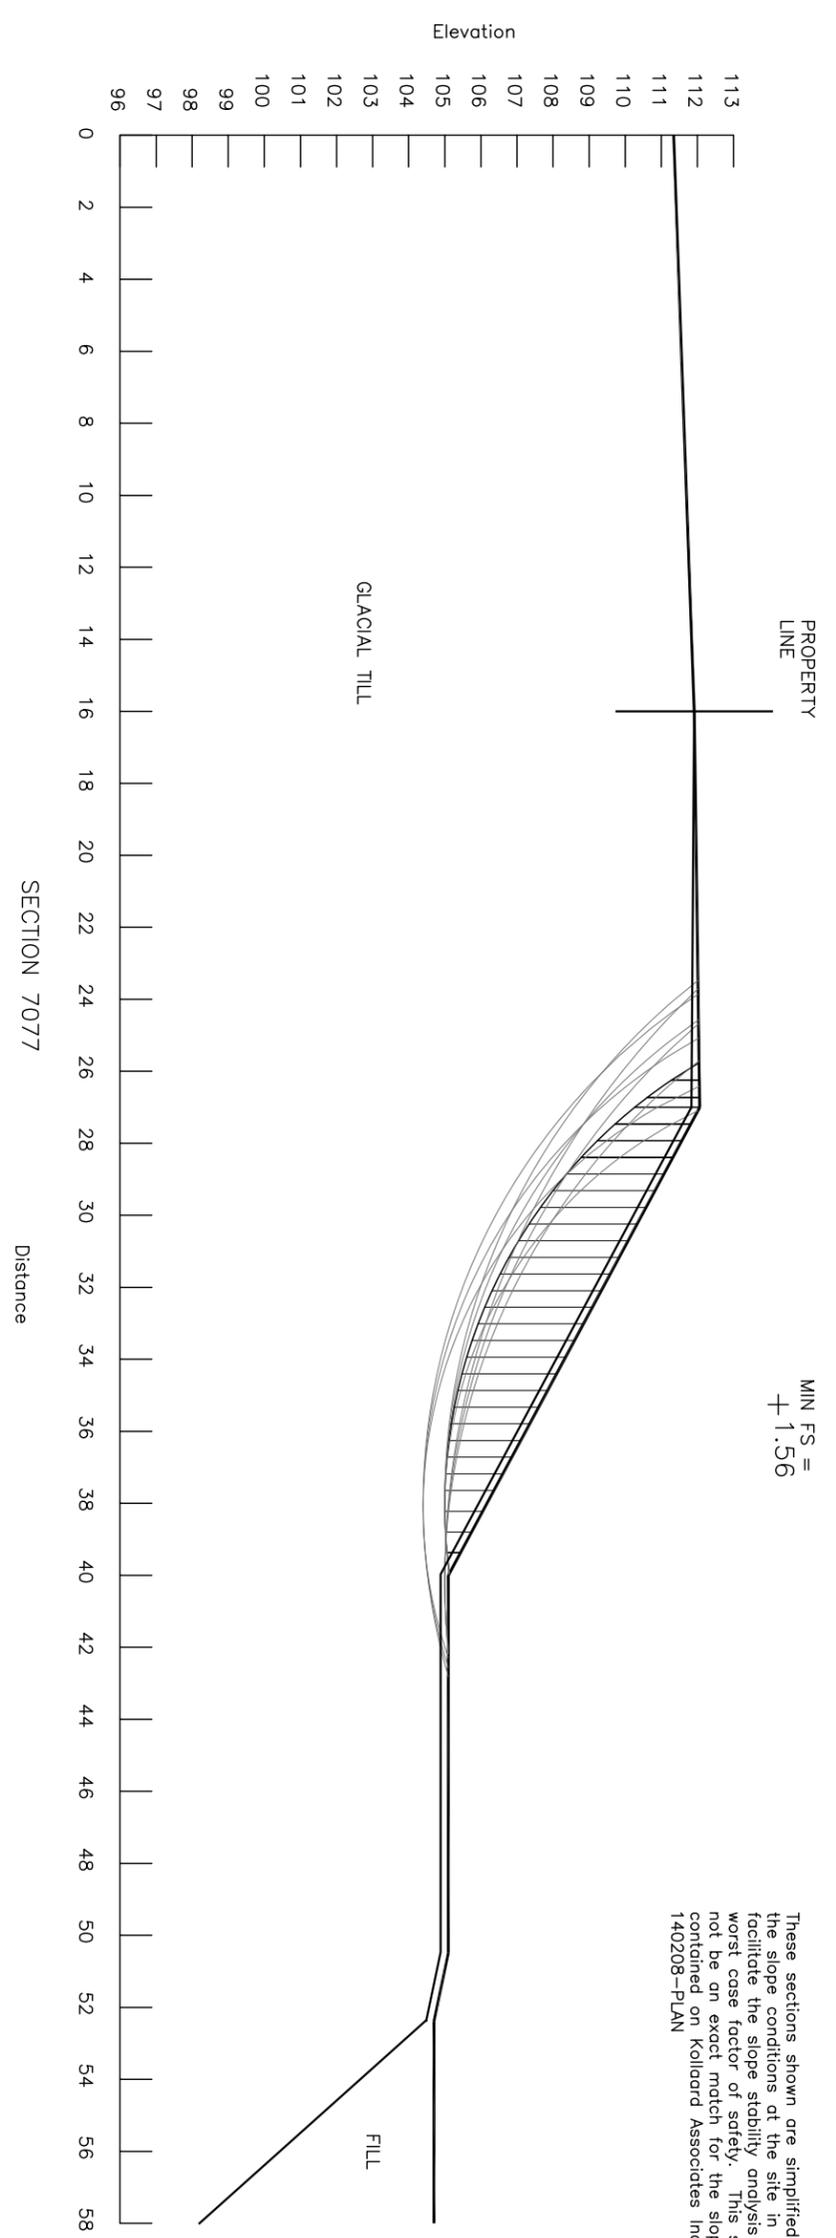
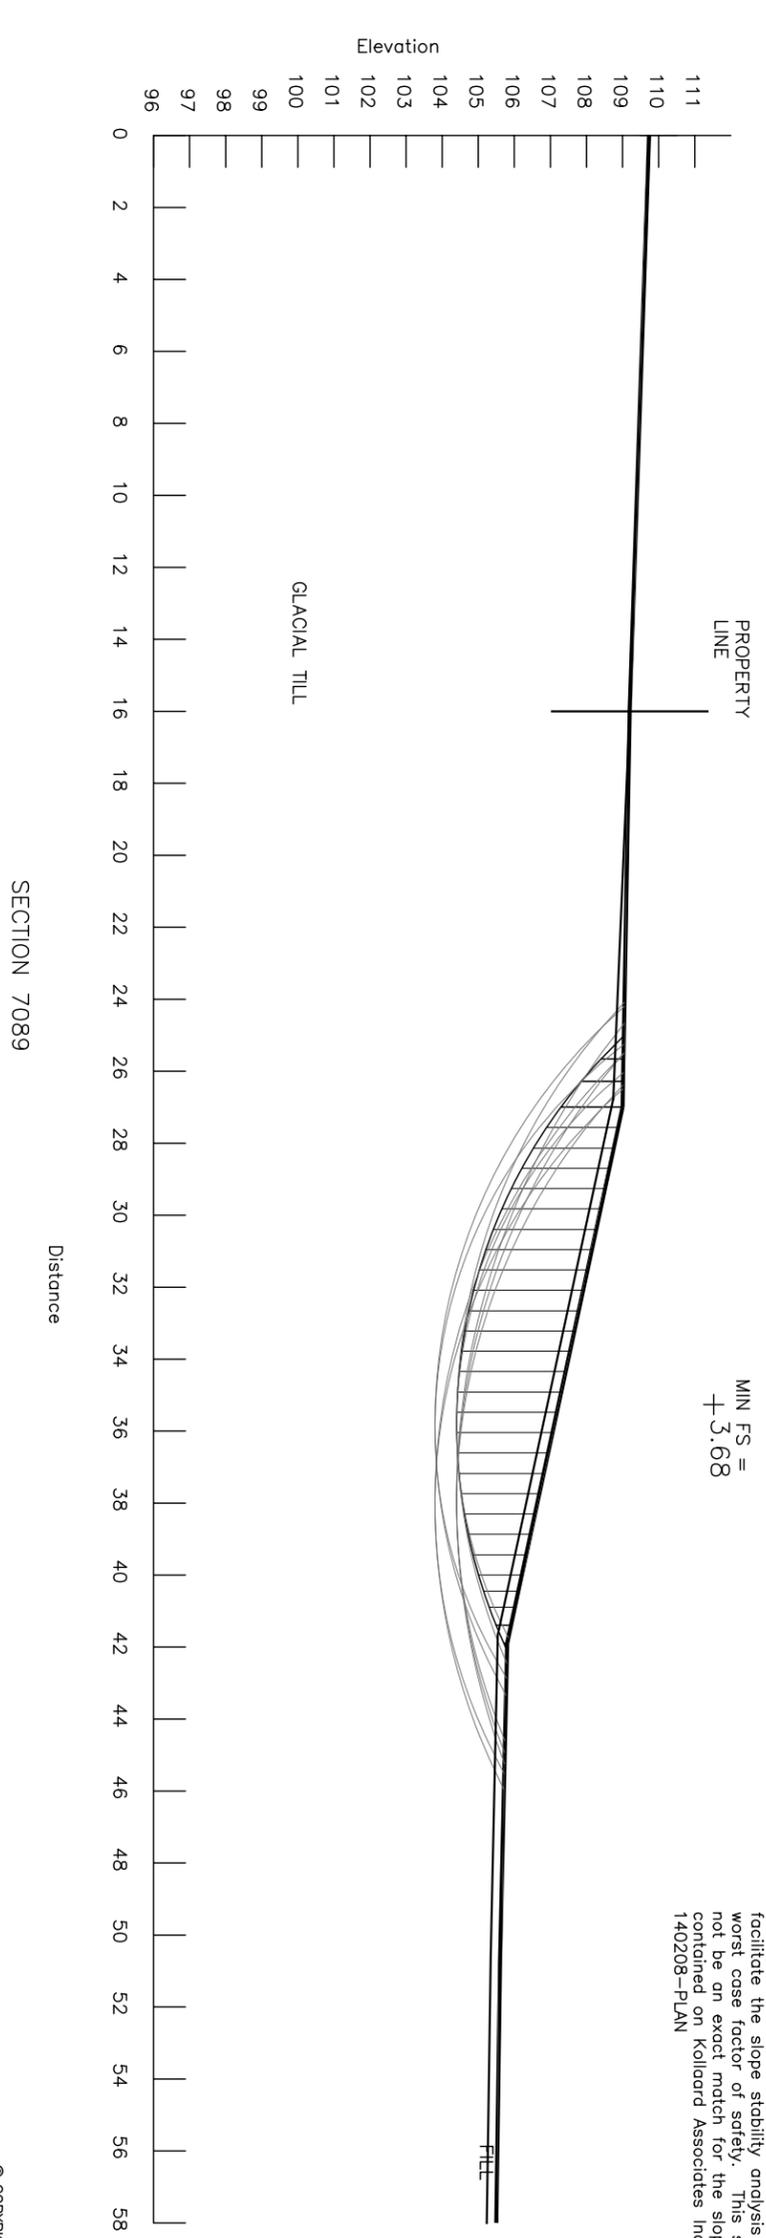
DRAWING NUMBER:
140208 -SL2

1. Dimensions and elevations are in metric as shown. Do not scale drawing.
2. Any changes made to drawings must be verified and approved by Kollaard Associates Inc.
3. This drawing is intended to indicate the minimum factor of safety at the indicated sections along the slope of the south side of the site known as 5640 Bank Street, 7107 Marco Street, and 701 Mitch Owens Road.

These sections shown are simplified to represent the slope conditions at the site in order to facilitate the slope stability analysis of the worst case factor of safety. This section may not be an exact match for the slope section contained on Kollaard Associates Inc drawing 140208-PLAN

The overall slope stability factor under seismic loading for each section analyzed is as follows:

Section 7055 – min FS = 1.11

Section 7065 – min FS = 1.10

Section 7077 – min FS = 1.13

Section 7089 – min FS = 1.88

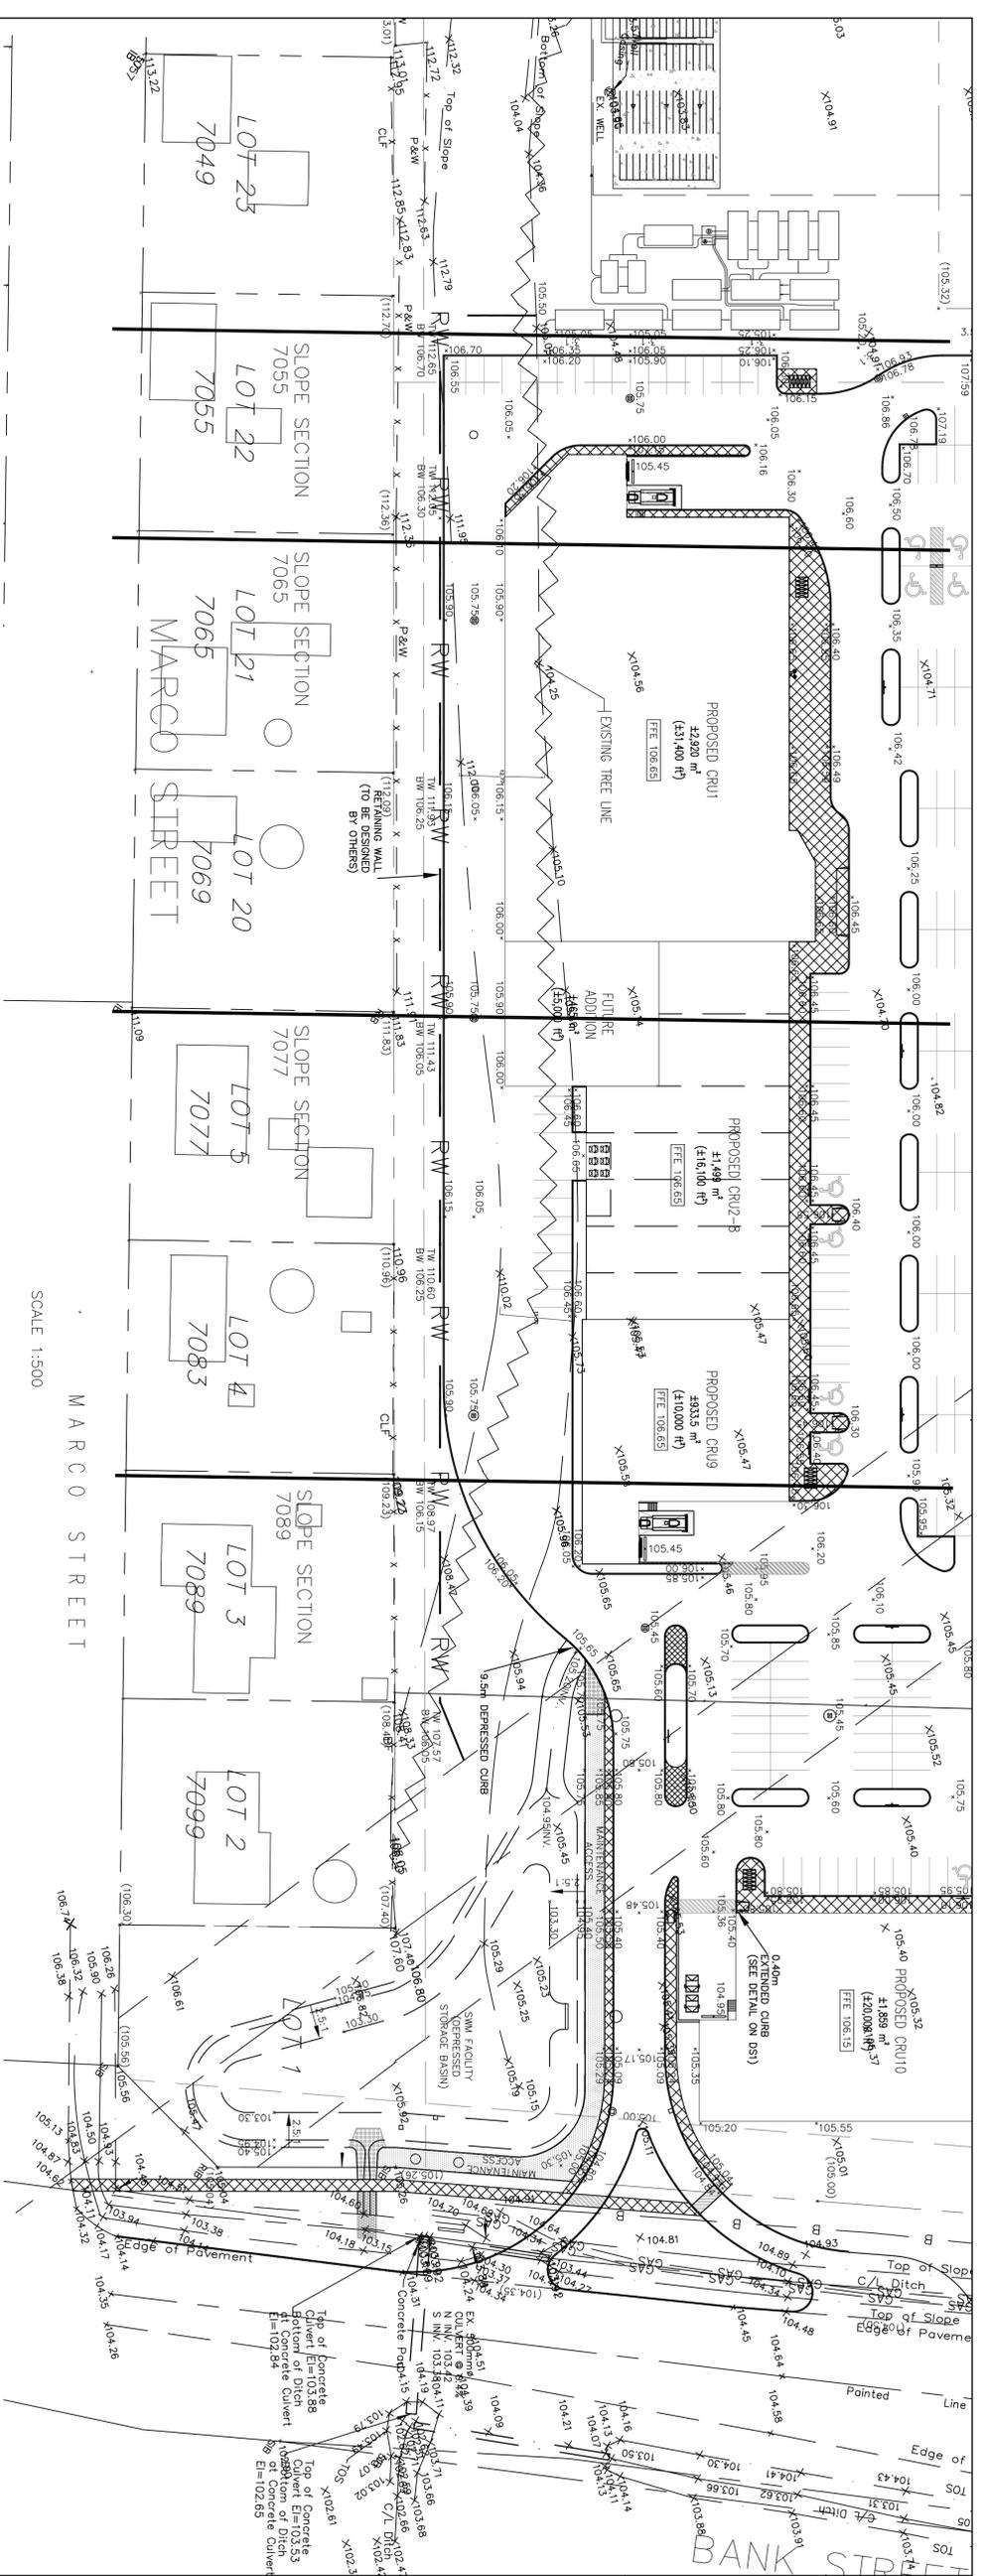
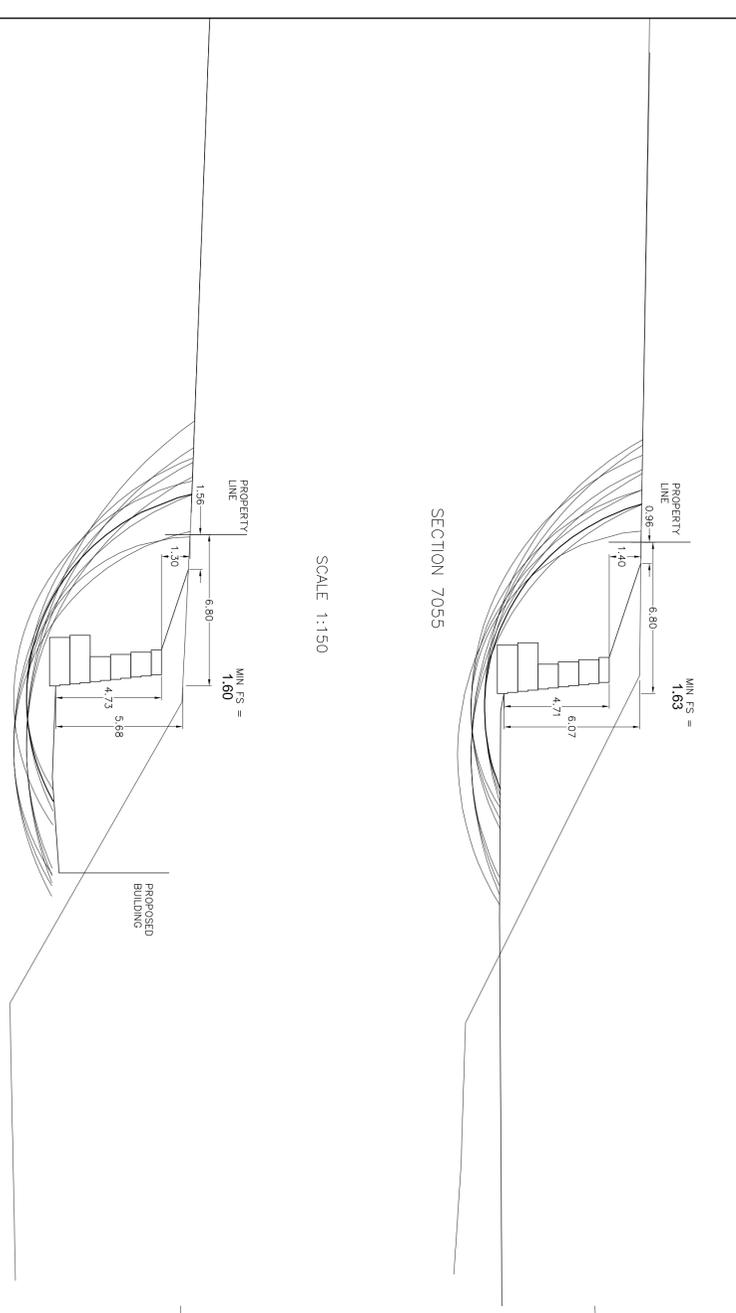
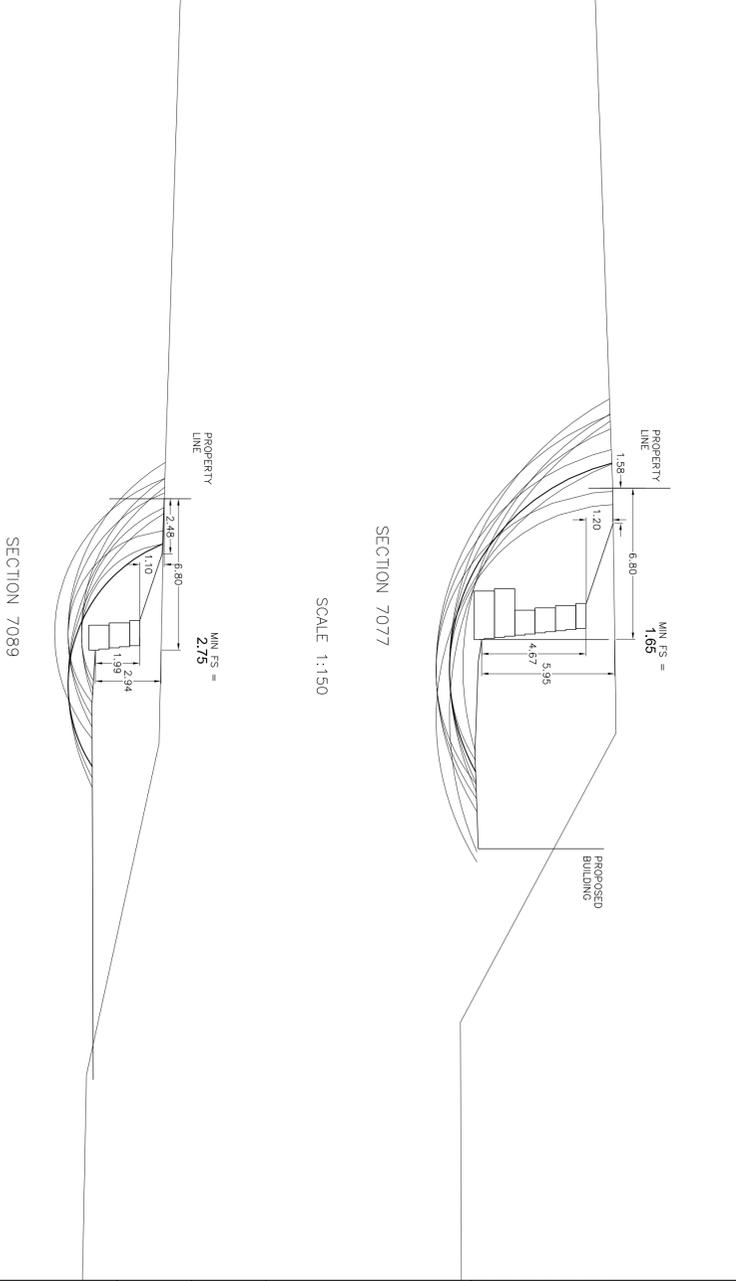
- NOTES:**
1. THE PLAN PROVIDED IN THIS DRAWING HAS BEEN OBTAINED FROM THE ASSOCIATION'S LIMITED TO THIS DRAWING WITH NO MODIFICATIONS TO THE EXISTING TOPOGRAPHY, BUILDING LOCATION OR RETAINING WALL LOCATION. IT IS NOT INTENDED TO BE MODIFIED BY THE INFORMATION PROVIDED ON THIS DRAWING, EXCEPT TO CORRECT THE HEIGHT OF THE RETAINING WALL. THE CUT ILLUSTRATED ABOVE THE RETAINING WALL IS THE RETAINING WALL. THE WALL SHALL VARY ABOVE THE LENGTH OF THE PROPOSED SECTIONS HAVE BEEN PROVIDED TO ILLUSTRATE THE MINIMUM FACTOR OF SAFETY WITH RESPECT TO GLOBAL STABILITY. THE RETAINED SLOPE IS CONSIDERED STABLE. AS SUCH THE STRUCTURE LOCATIONS INDICATED ON THE ADJACENT PROFILES WERE OBTAINED FROM AERIAL PHOTOGRAPHY AND THE STRUCTURE ON LOT 5 STREET ADDRESS 7077 IS A LIGHTLY LOADED GARAGE/SHED AND IS LOCATED GREATER THAN 2 METRES BEYOND THE MINIMUM SLIP SURFACE.

SECTION 7065
 SCALE 1:150

SECTION 7077
 SCALE 1:150

SECTION 7089
 SCALE 1:150

SECTION 7055
 SCALE 1:150

The slope stability analysis results for the proposed slope geometry with the retaining wall in place at the site is indicated on the attached Kollaard Associates Inc. drawing 140208-PLAN.

The global slope stability factor for each section analyzed under static load conditions is as follows:

Section 7055 – min FS = 1.63

Section 7065 – min FS = 1.60

Section 7077 – min FS = 1.65

Section 7089 – min FS = 2.75

The wall at sections 7055, 7065 and 7077 was designed with two 24-86 block units followed by three 24SF block units and 1 6SF block Unit. There is no geogrid reinforcement required.

The wall at section 7089 was designed with two 24SF block units and 1 6SF block Unit. There is no geogrid reinforcement required.
