**Phase One
Environmental Site Assessment
67-71 Marquette Avenue
Ottawa, Ontario**

April 8, 2014
Project: 13-521

EXECUTIVE SUMMARY

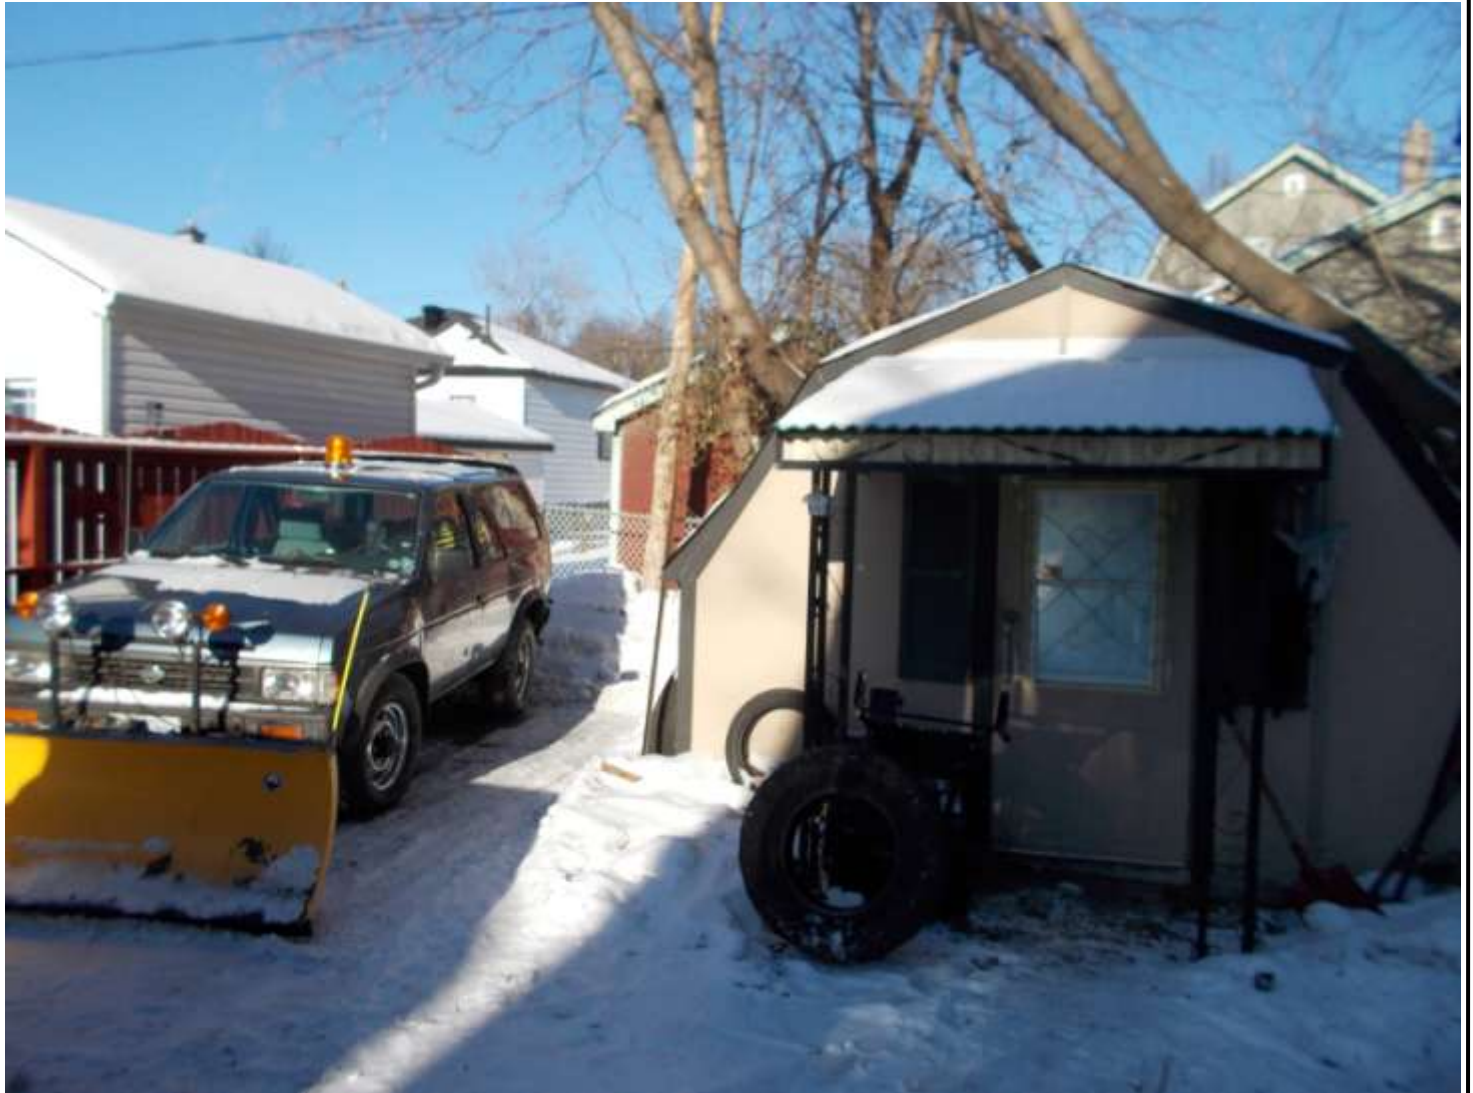
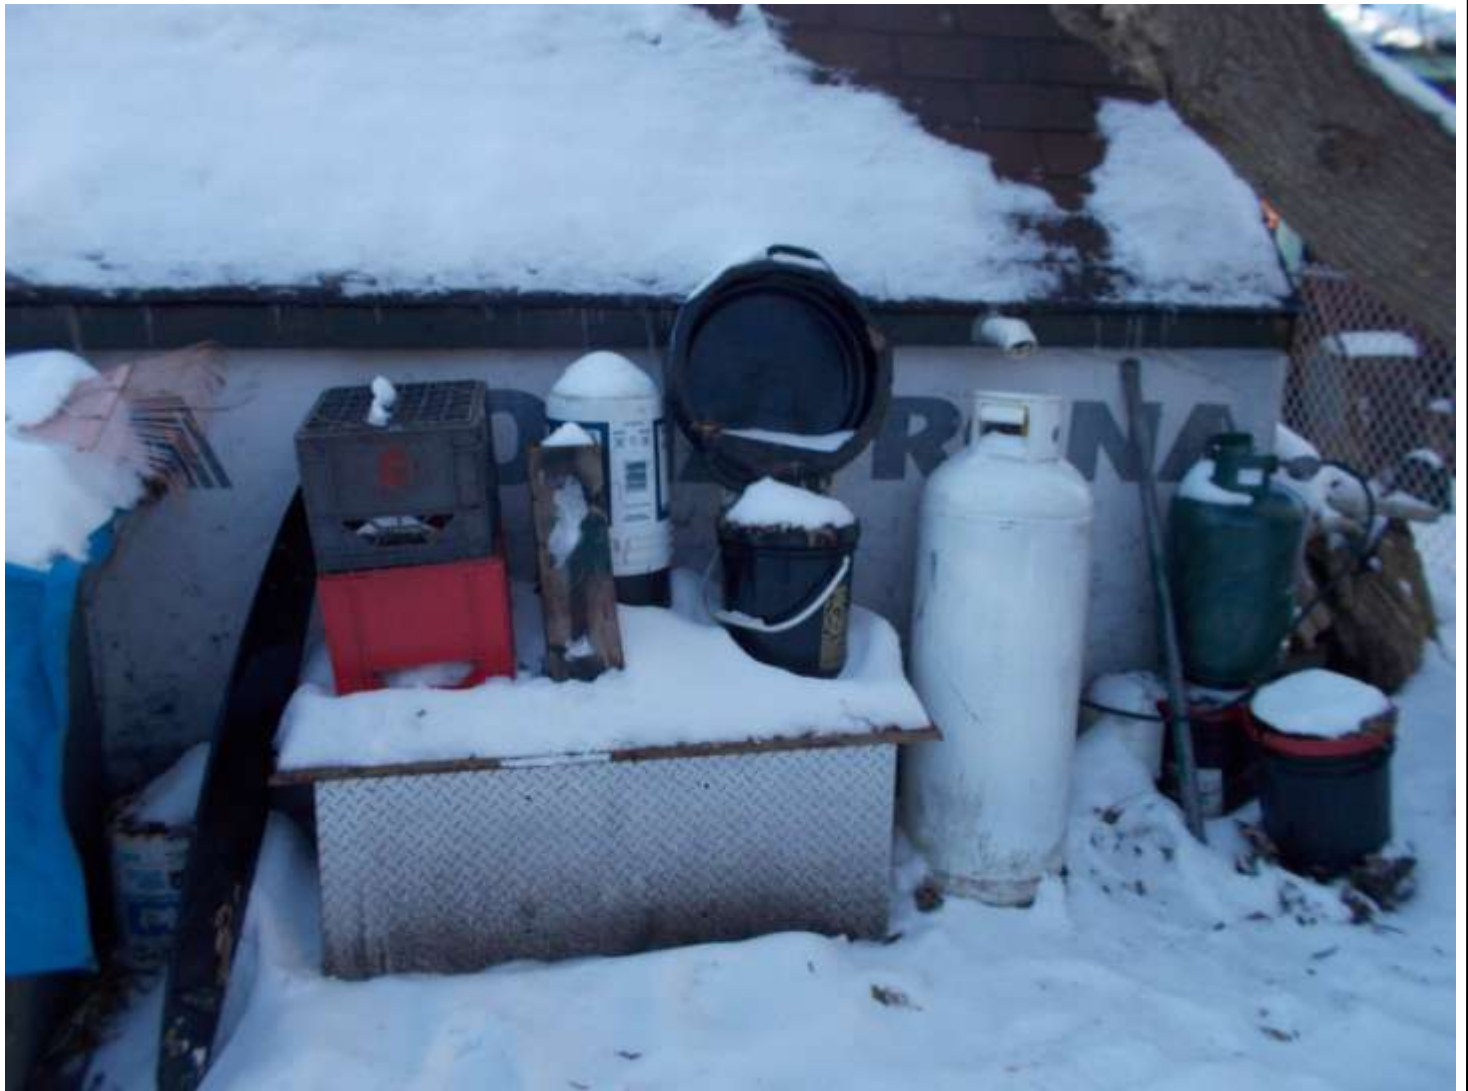
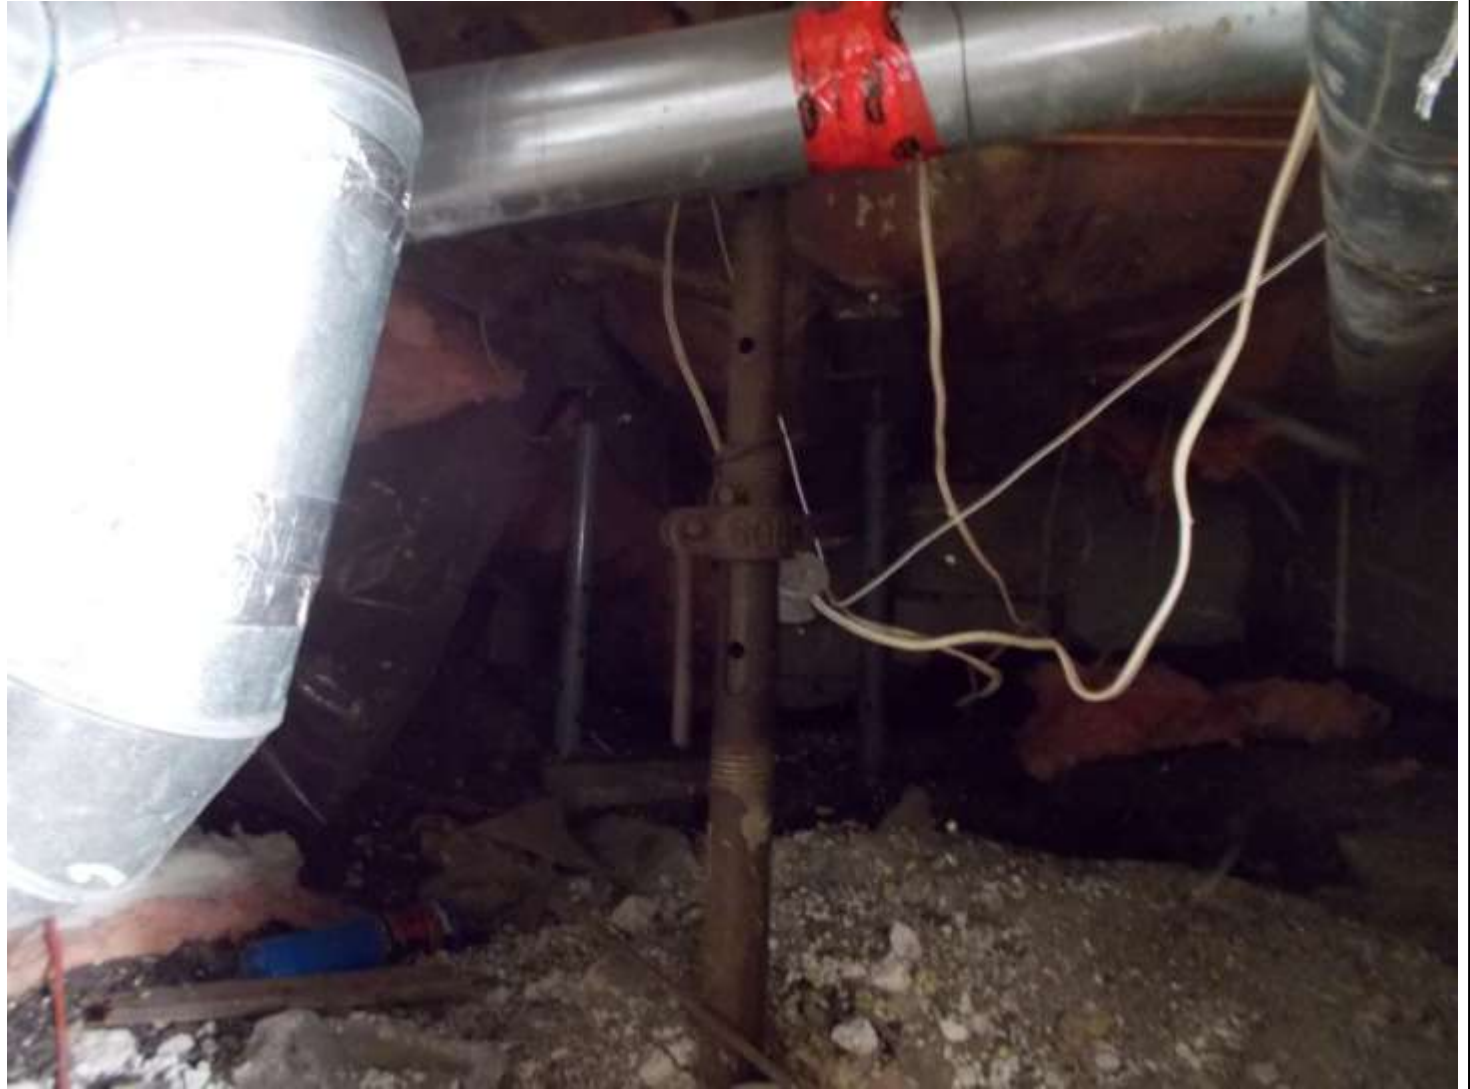
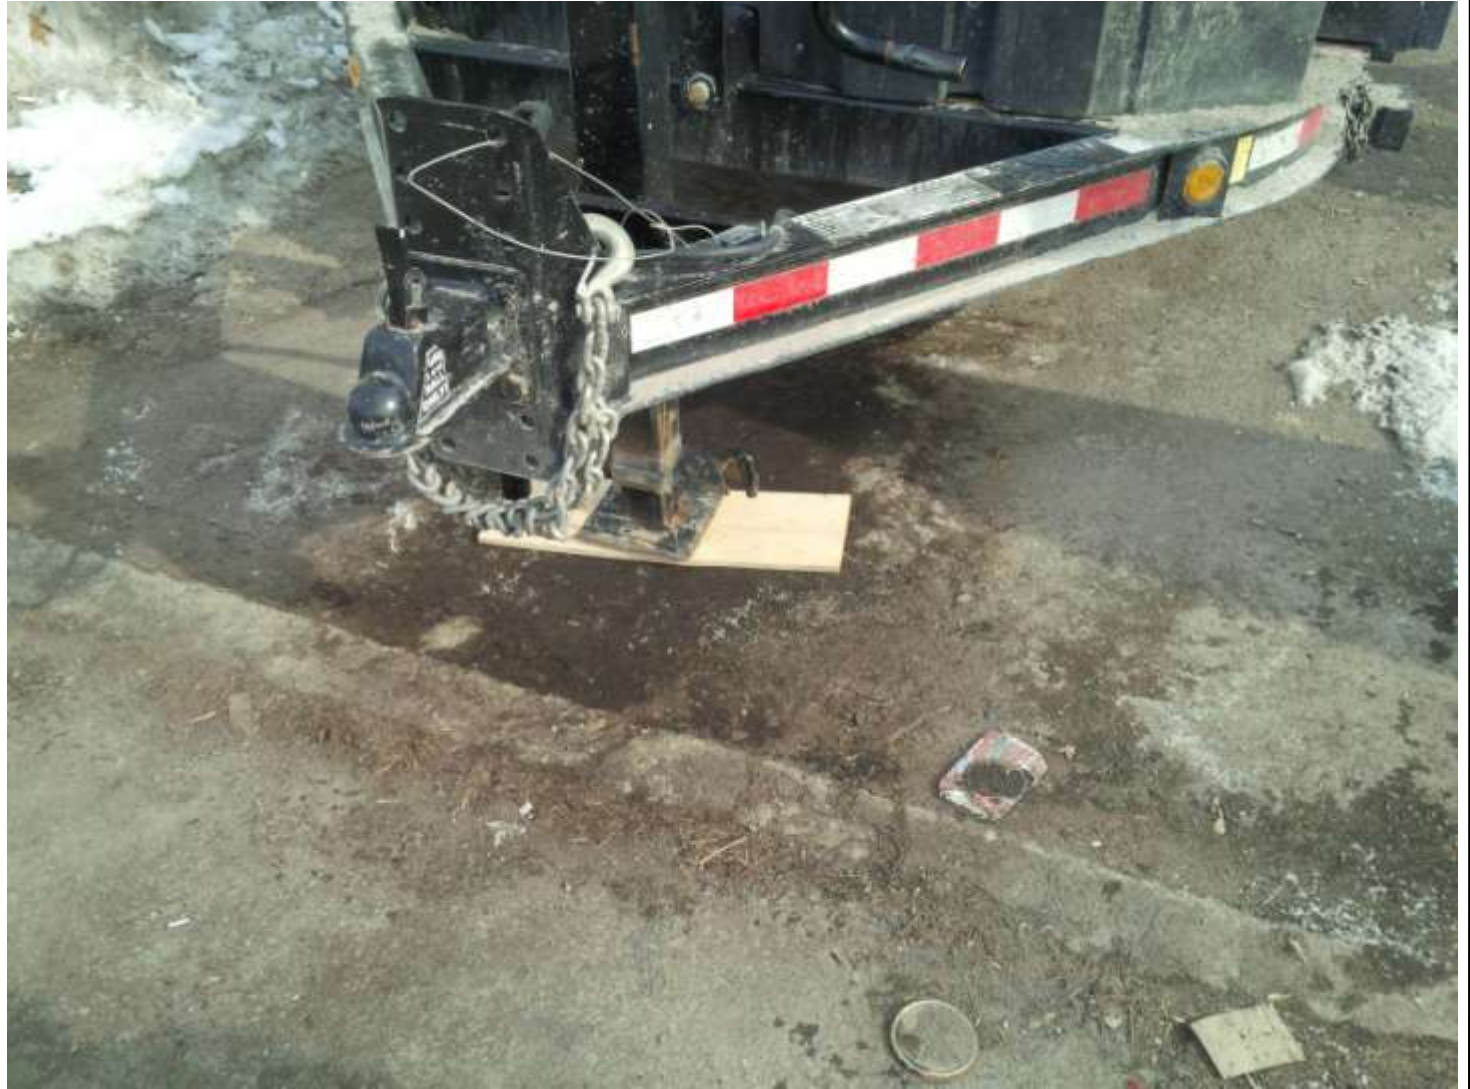
Site Photographs

Plate Number	Compass Orientation	Description
I1	North	Shed workshop located at the rear of 67 Marquette Avenue. Vehicle and other maintenance activities were performed in the vicinity.
I2	West	Waste containers and other products associated with vehicle and other maintenance activities.
I3	North	Crawl space in the basement of 67 Marquette Avenue. Fill material and other debris were present.
I4	North	Stained asphalt in front of the garage at 71 Marquette Avenue.

- Potential fill material was present in the crawl space basement;
- There was a distinct fuel and oil odour in the workshop shed located at the rear of the subject property;
- Potential waste oils and other products associated with vehicle maintenance were being stored on the exterior of the shed;
- Paints, lubricants, oil pan, and three (3) 5 gallon pails of oil were observed in the workshop shed.
- The residence is heated by natural gas and the shed is heated by propane.

- A stain was observed on the asphalt in front of the garage;
- A large amount of garbage was present on the site.
- The building is heated by natural gas.
