Phase I Environmental Site Assessment

Vacant Land
590 Rideau Street
Ottawa, Ontario

March 9, 2016

Report: PE2706-2

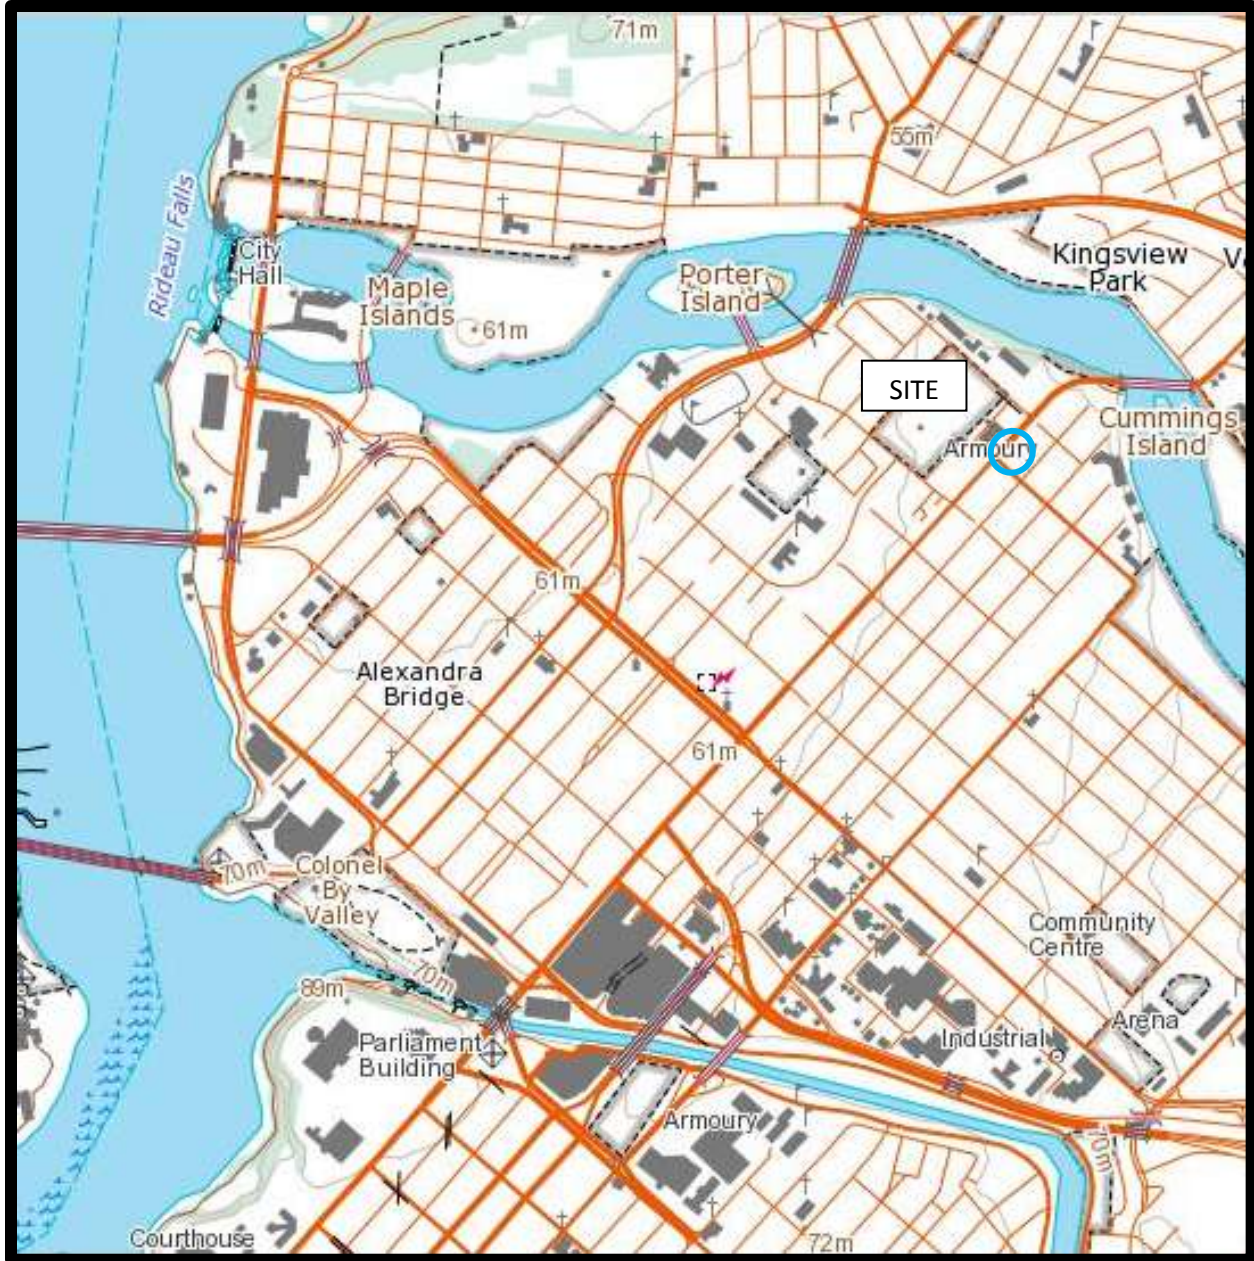
FIGURE 2
TOPOGRAPHIC MAP

Topographic maps were obtained from Natural Resources Canada – The Atlas of Canada website and from the City of Ottawa website. The topographic maps indicate that the regional topography in the general area of the site slopes downward towards the Rideau River to the east. According to the map, the nearest water body is the Rideau River located 250 m to the east. An illustration of the referenced topographic map is presented on Figure 2 – Topographic Map, appended to this report.

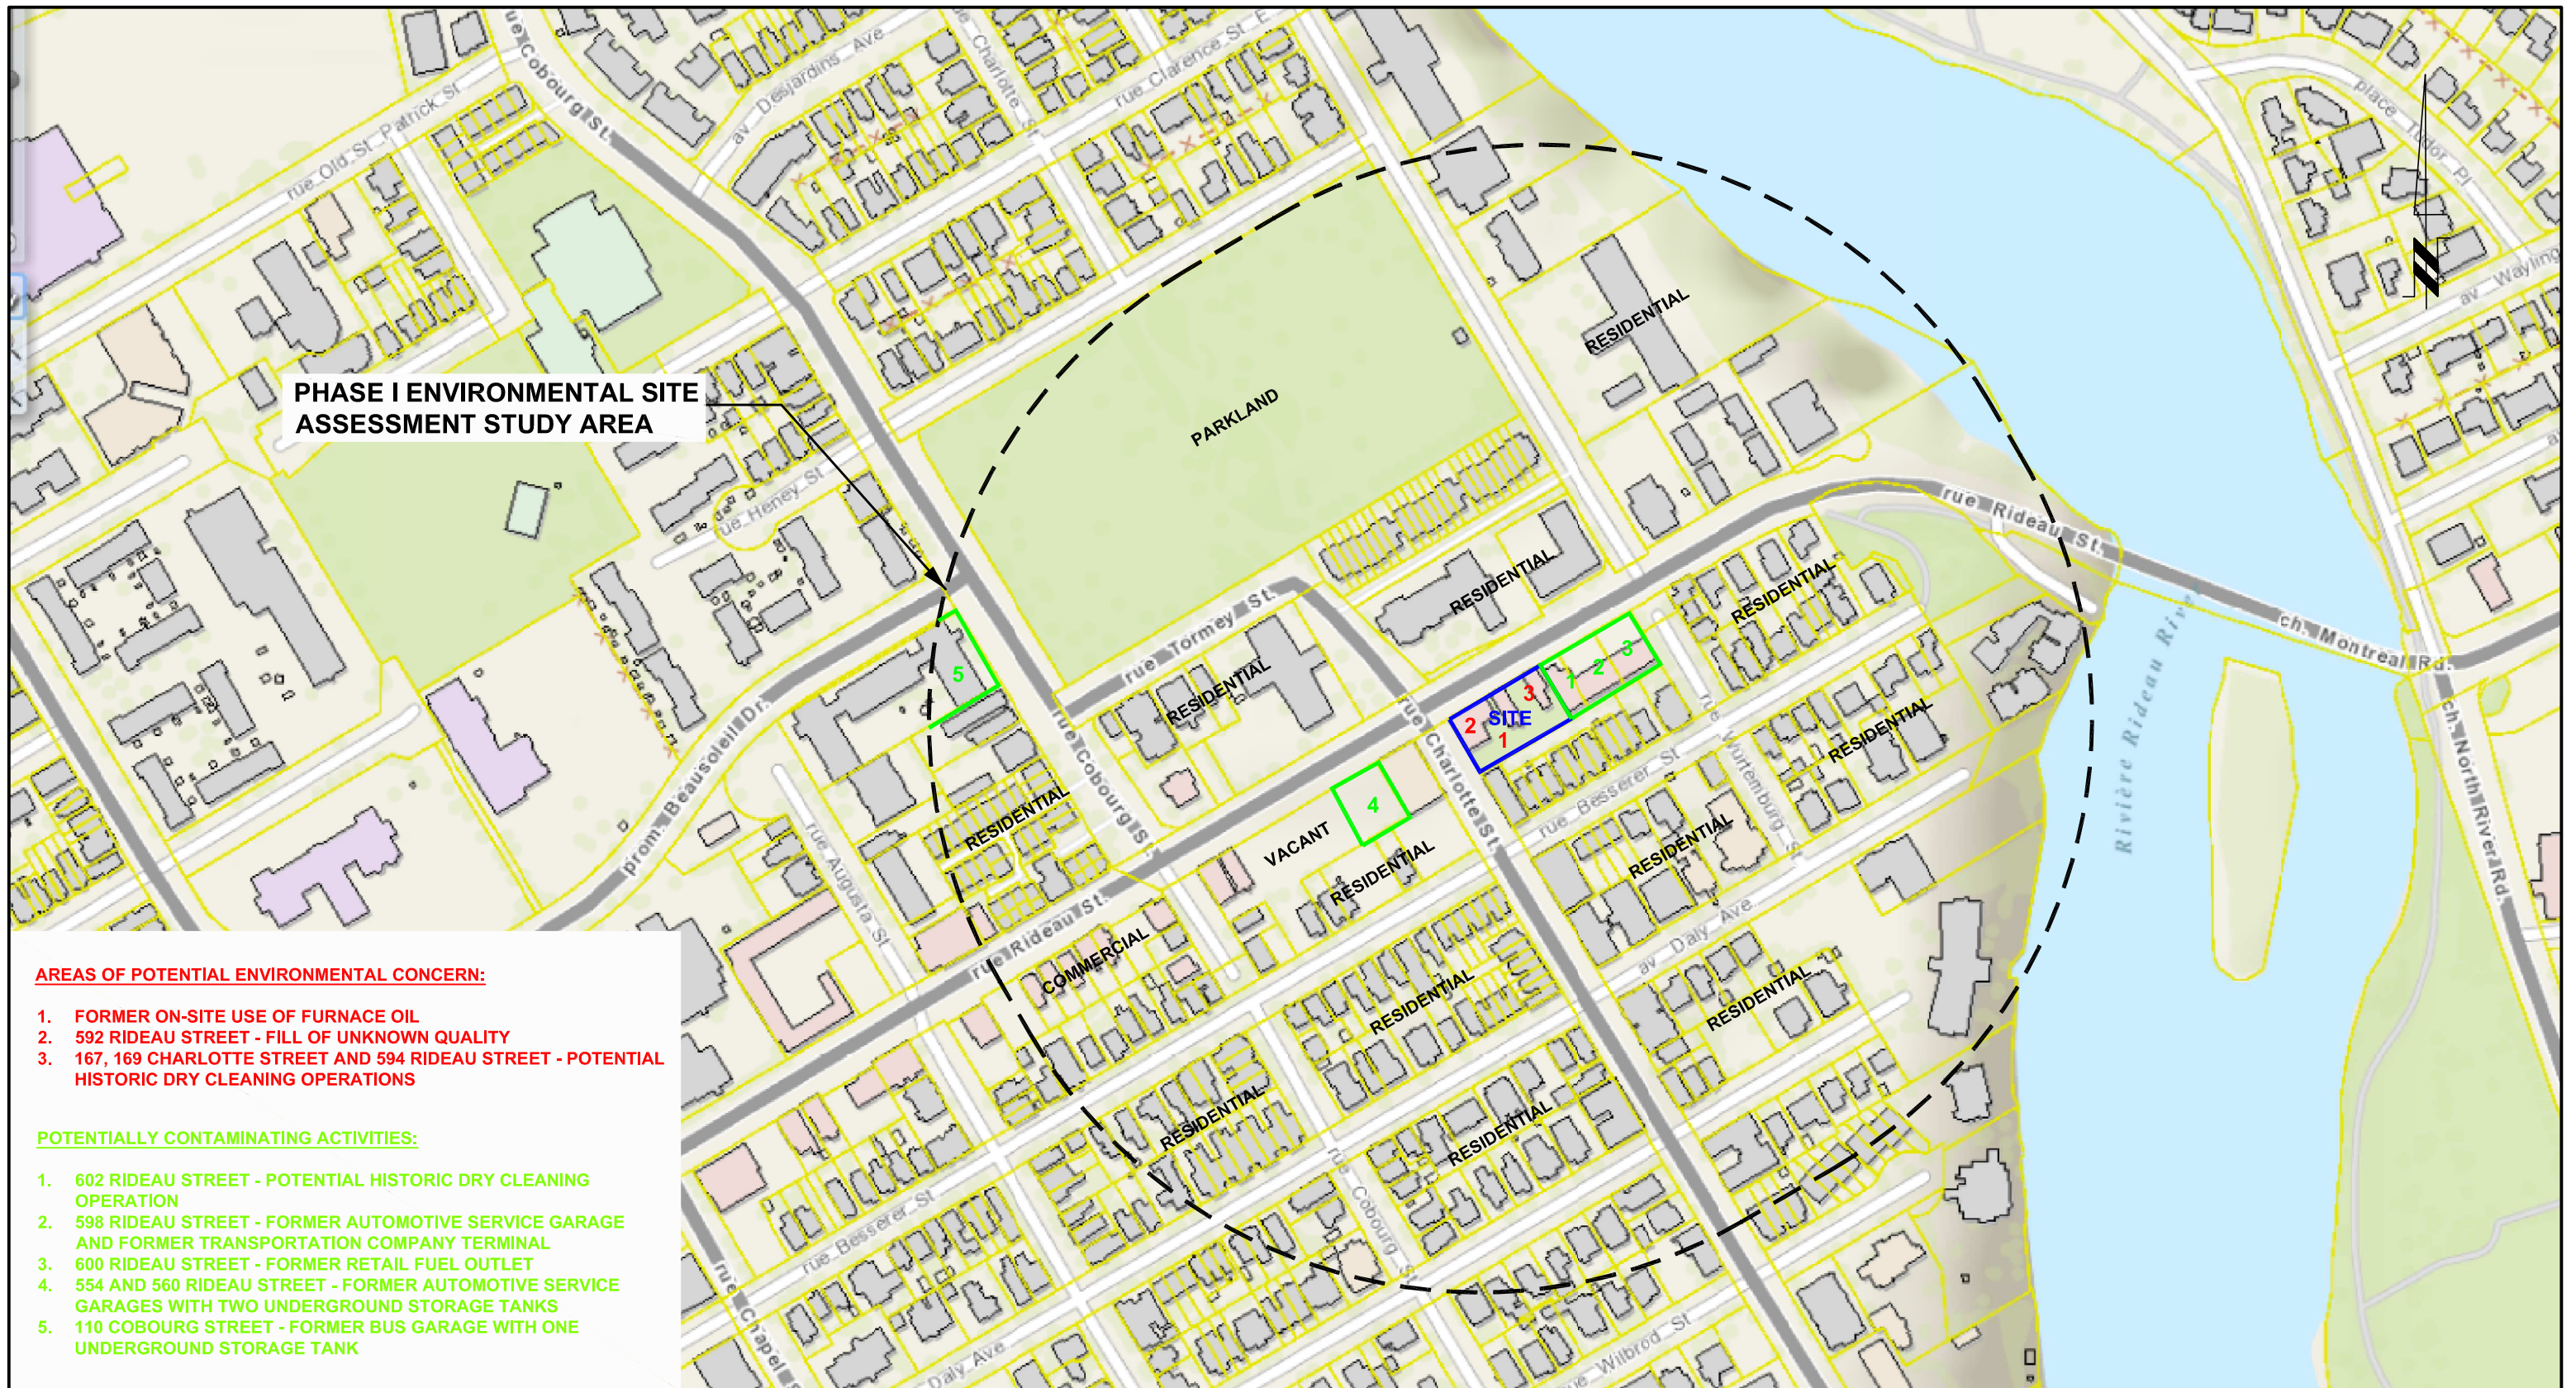
Drawing Title: **SITE PLAN**

AREAS OF POTENTIAL ENVIRONMENTAL CONCERN:

- 1. FORMER ON-SITE USE OF FURNACE OIL
- 2. 592 RIDEAU STREET - FILL OF UNKNOWN QUALITY
- 3. 167, 169 CHARLOTTE STREET AND 594 RIDEAU STREET - POTENTIAL HISTORIC DRY CLEANING OPERATIONS

As per Section 7.1 of this report, the historical presence of dry cleaners that may have used chemicals, the former on-site use of furnace oil and potential fill of questionable quality used to backfill a building foundation represent Areas of Potential Environmental Concern (APECs) on the subject site. Additionally, the former retail fuel outlet, automotive service garage and dry cleaner adjacent to the east also represent Areas of Potential Environmental Concern (APECs). Other off-site Potentially Contaminating Activities (PCAs) identified within the Phase I study area are not considered to represent APECs with respect to the subject site.

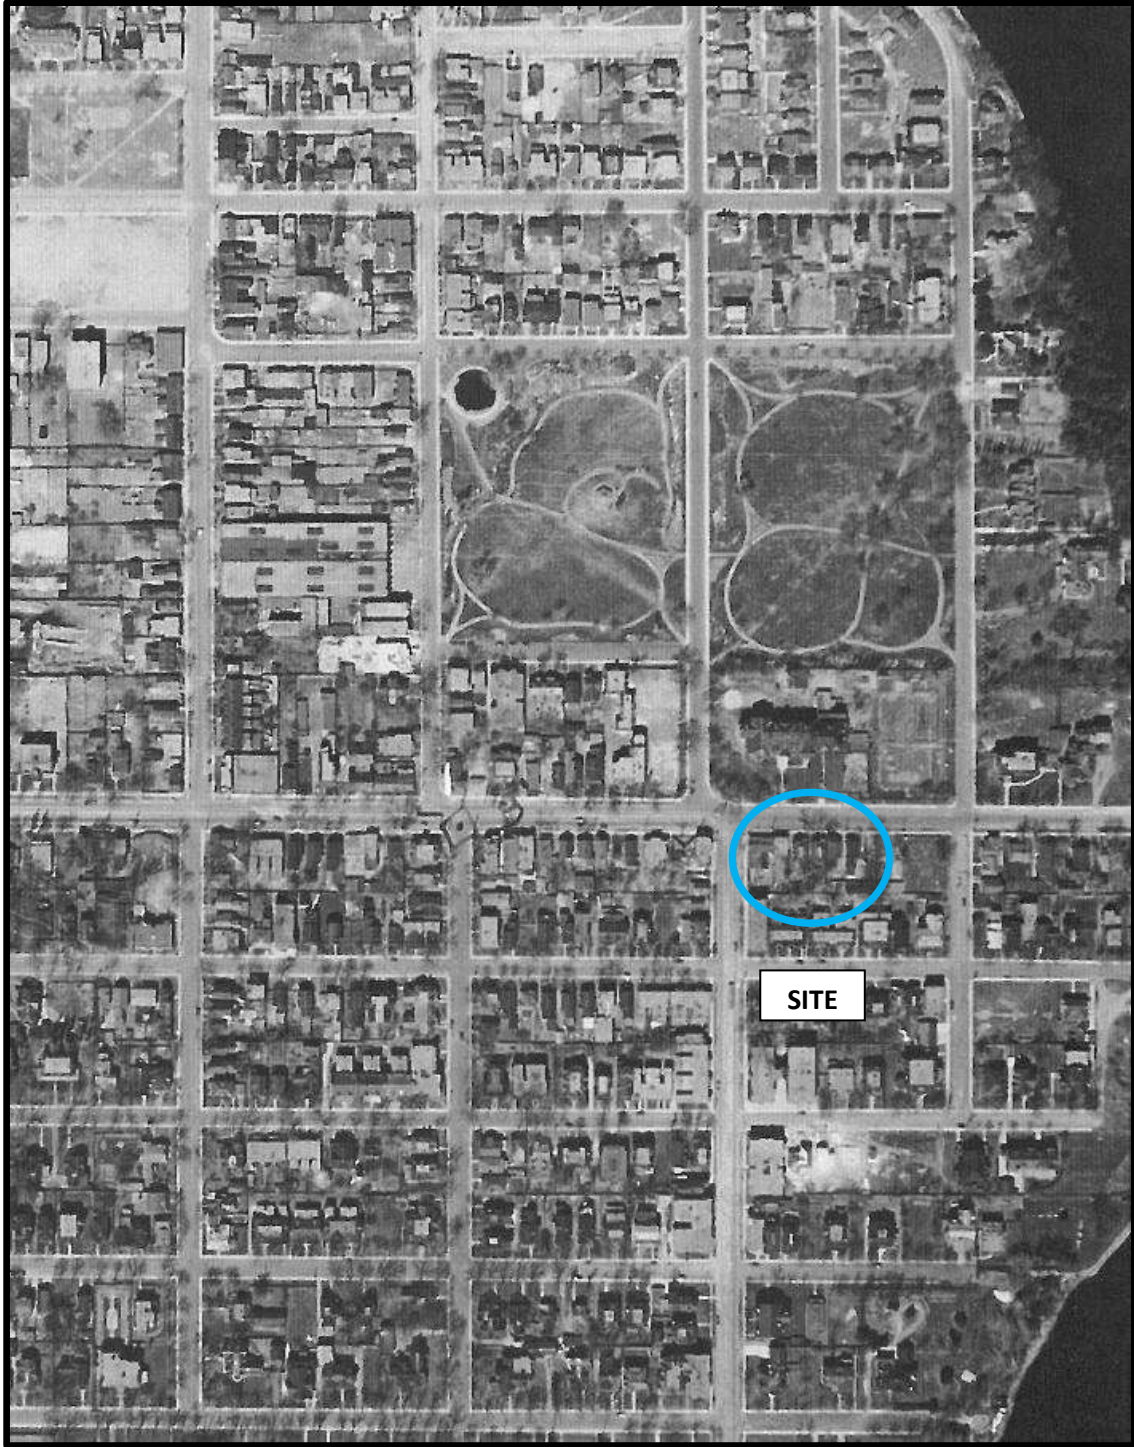
AERIAL PHOTOGRAPH
1928

| 1928 | The subject property is occupied by four (4) structures. Adjacent buildings to the south are occupied by residential buildings. The property to the north, across Rideau Street, is occupied by a residential or possibly institutional building. The adjacent property to the east is occupied by a residential dwelling. The property to the west, across Charlotte Street, is occupied by a residential or commercial building. |

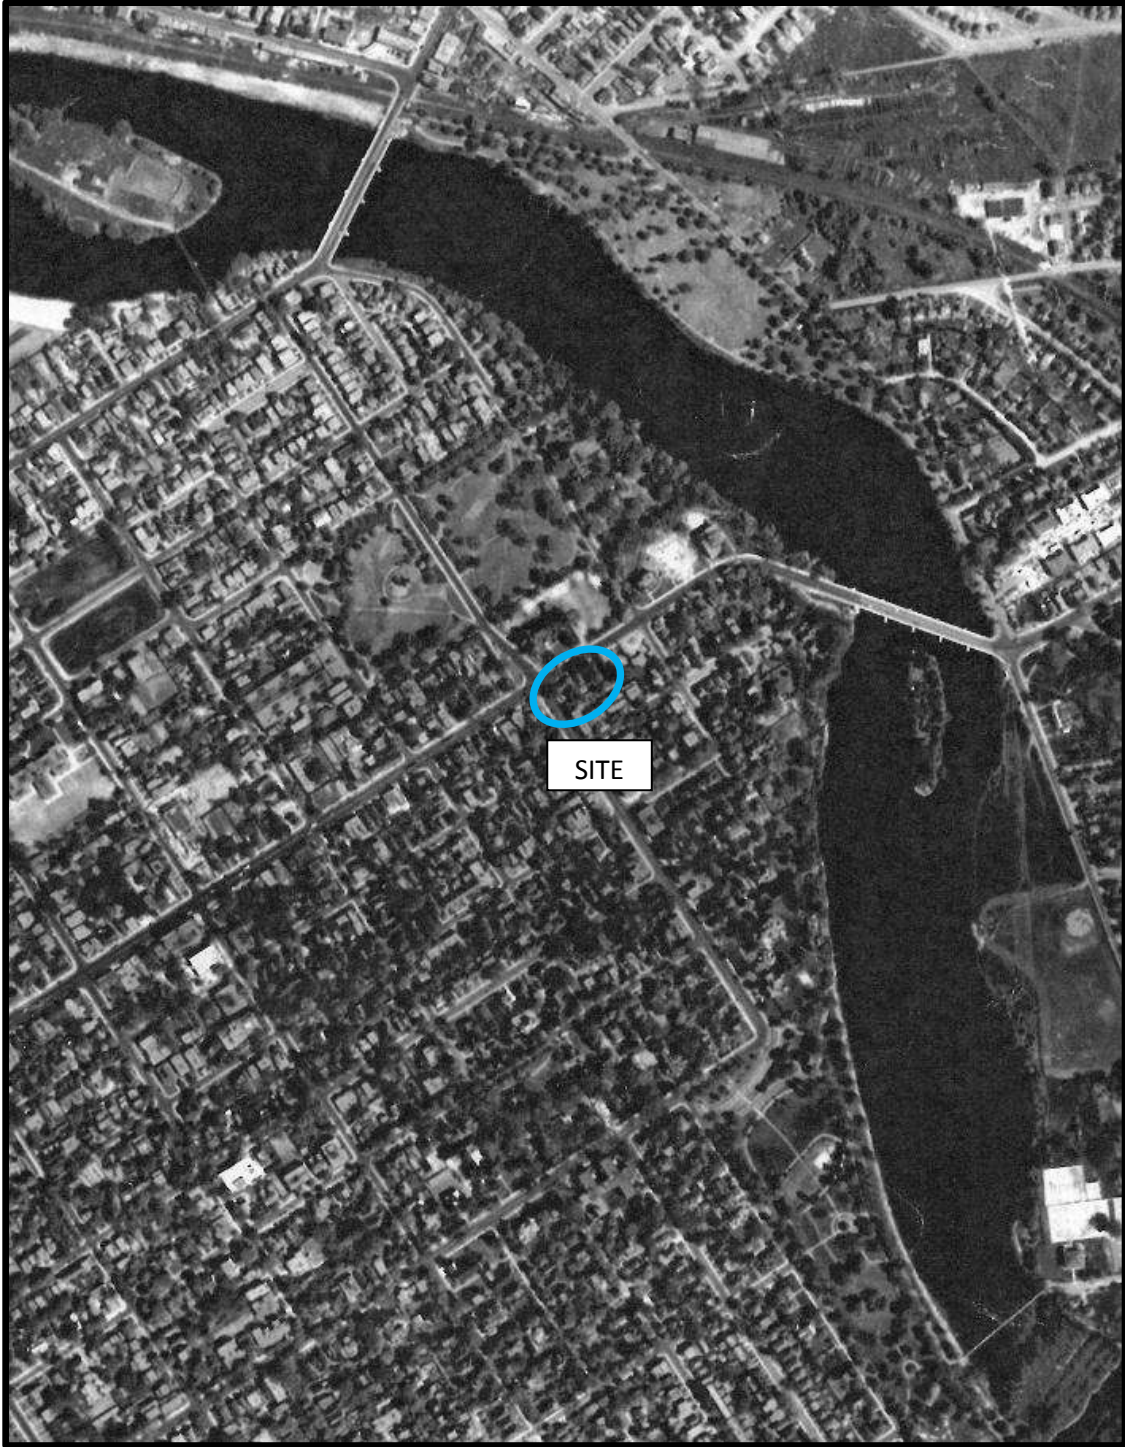
AERIAL PHOTOGRAPH
1950

| 1950 | No significant changes have been made to the subject site or neighbouring properties. Charlotte Street, north of Rideau Street, has been realigned. |

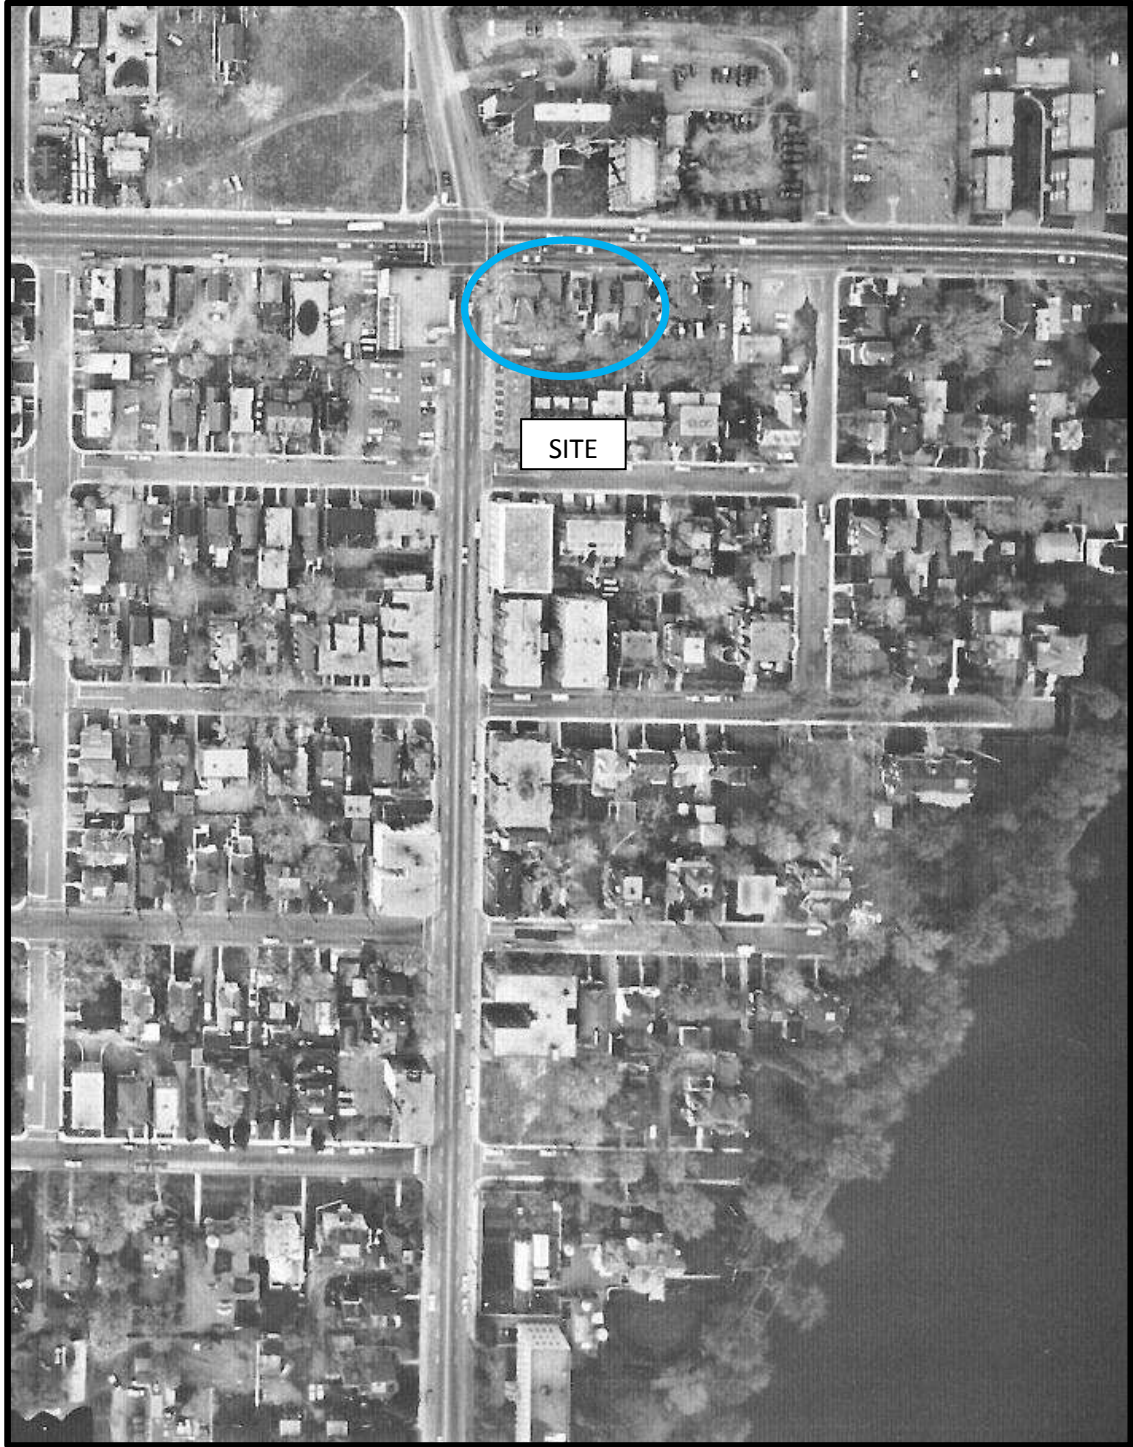
AERIAL PHOTOGRAPH
1968

- 1968 No significant changes have been made to the subject site. Structures on a neighbouring property to the northwest, across the Rideau Street and Charlotte Street intersection, have been demolished and the land is vacant.

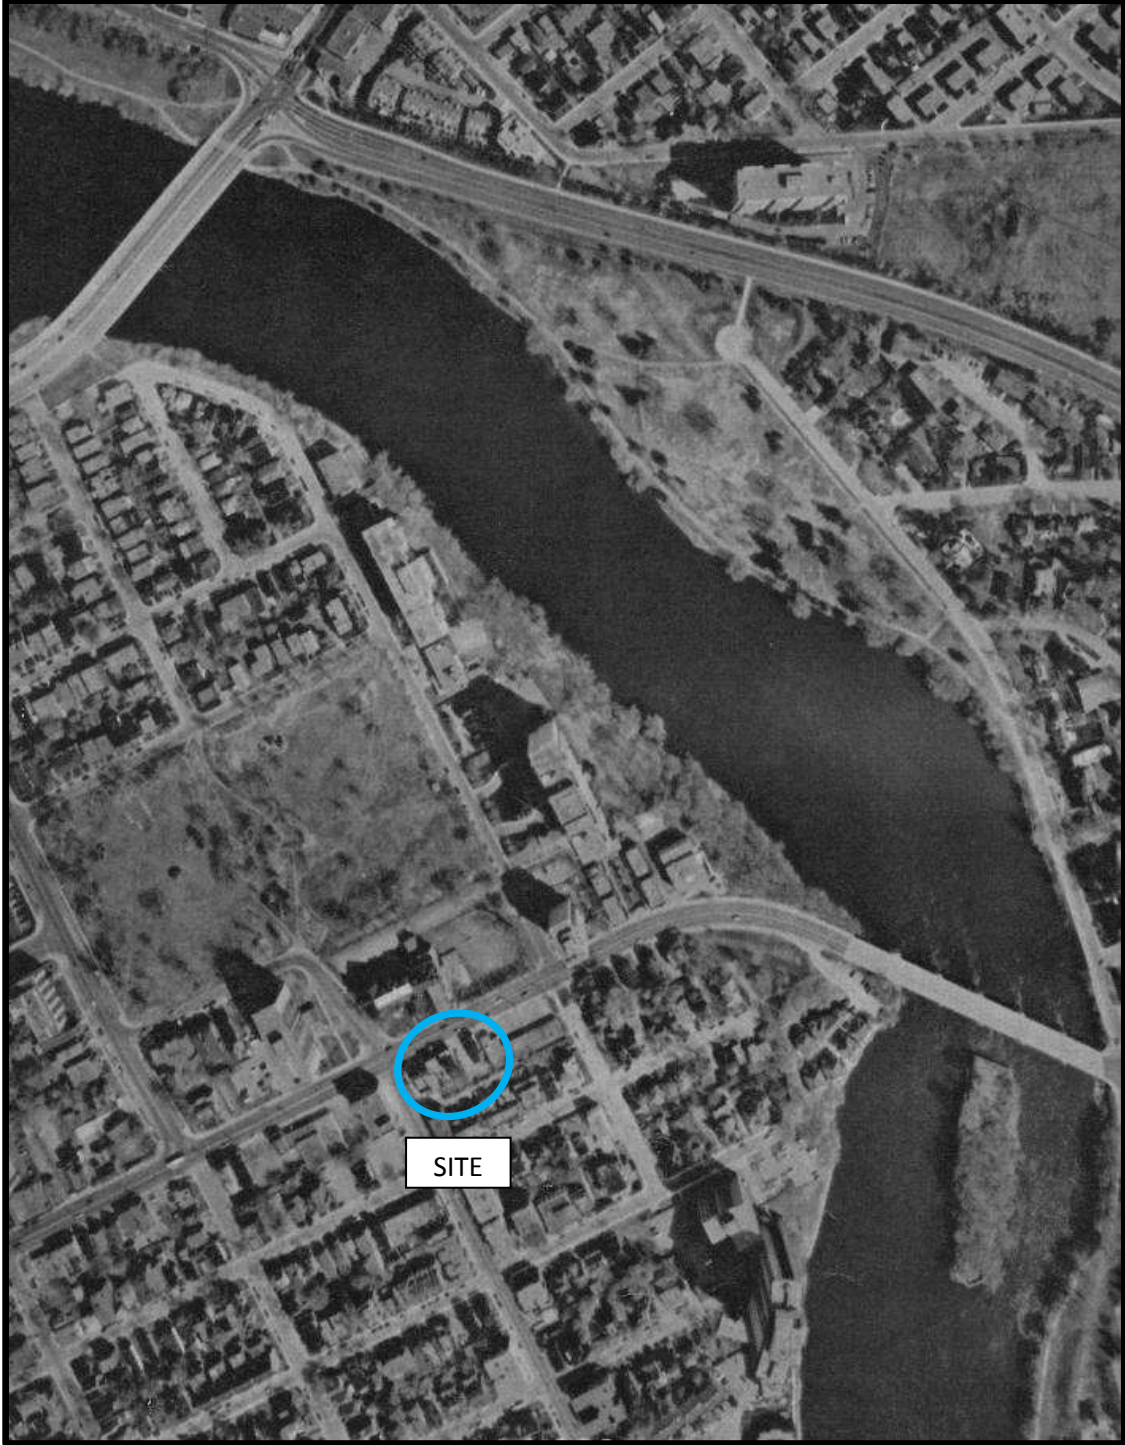
AERIAL PHOTOGRAPH
1993

- 1993 A structure on the subject site (592 Rideau Street) has been demolished. The adjacent property to the east has been redeveloped with a commercial plaza. The vacant property to the northwest, across the intersection, has been redeveloped with a multi-storey residential building. No other significant changes have been made to the subject site or neighbouring properties.

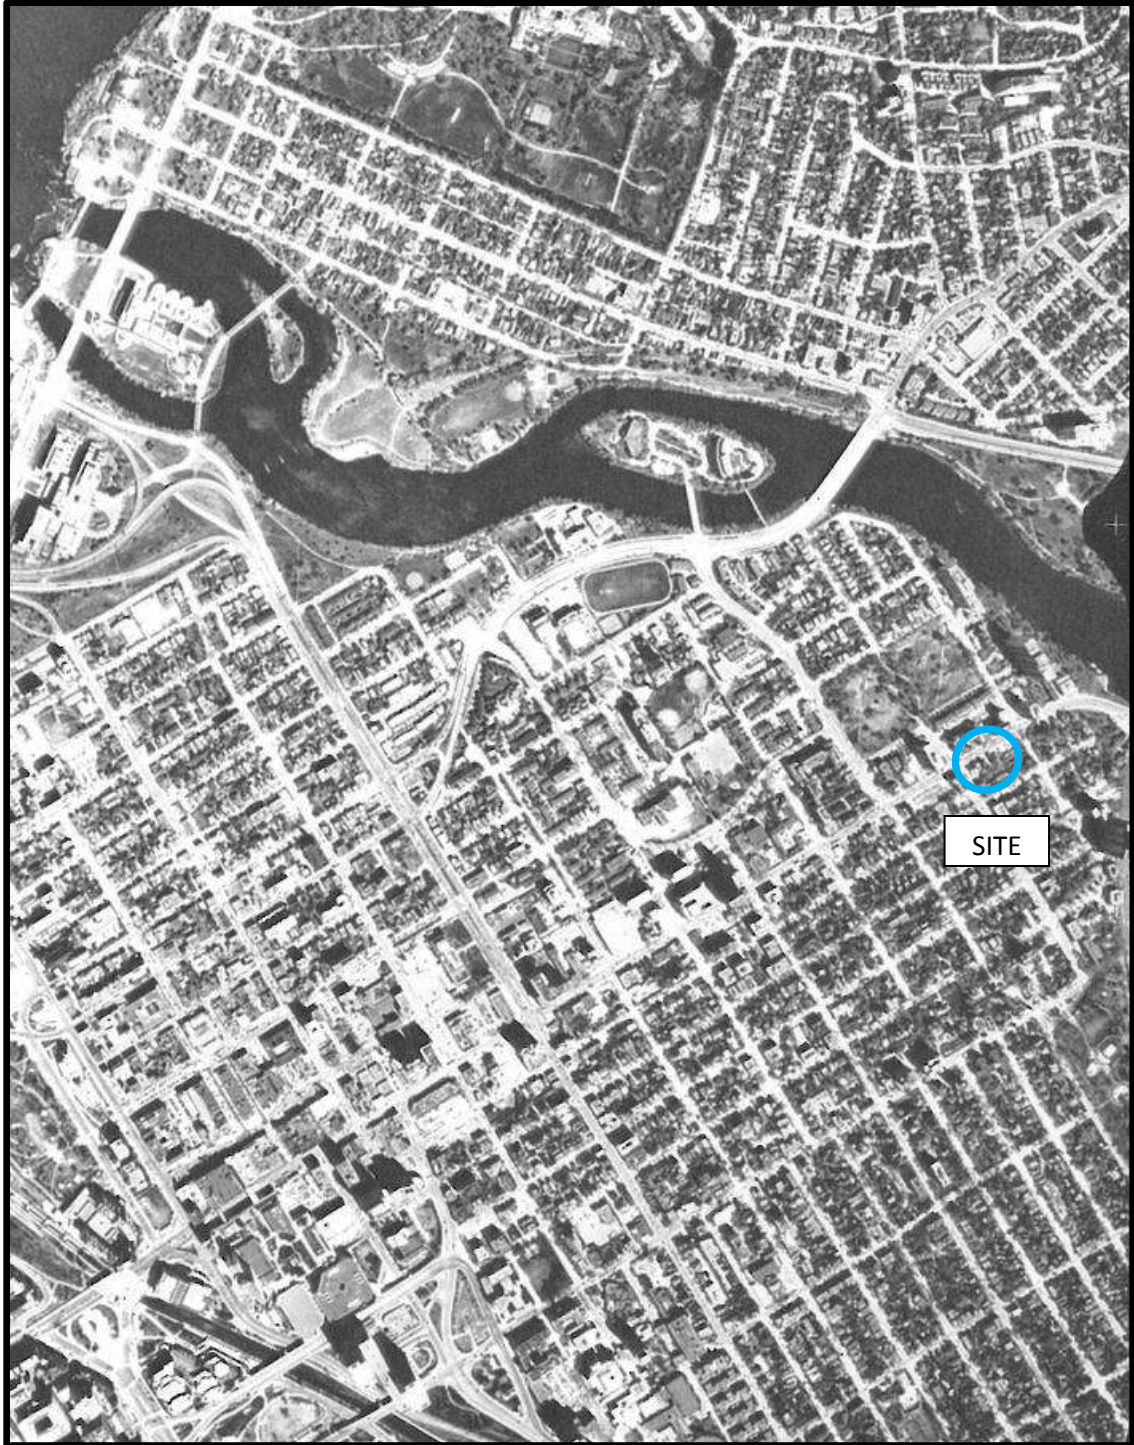
AERIAL PHOTOGRAPH
2001

- 2001 No significant change has been made to the subject property. A property northeast of the subject site has been developed with a multi-storey residential building. A building further to the west, along Rideau Street, has been demolished. No other apparent changes have been made to the neighbouring properties.

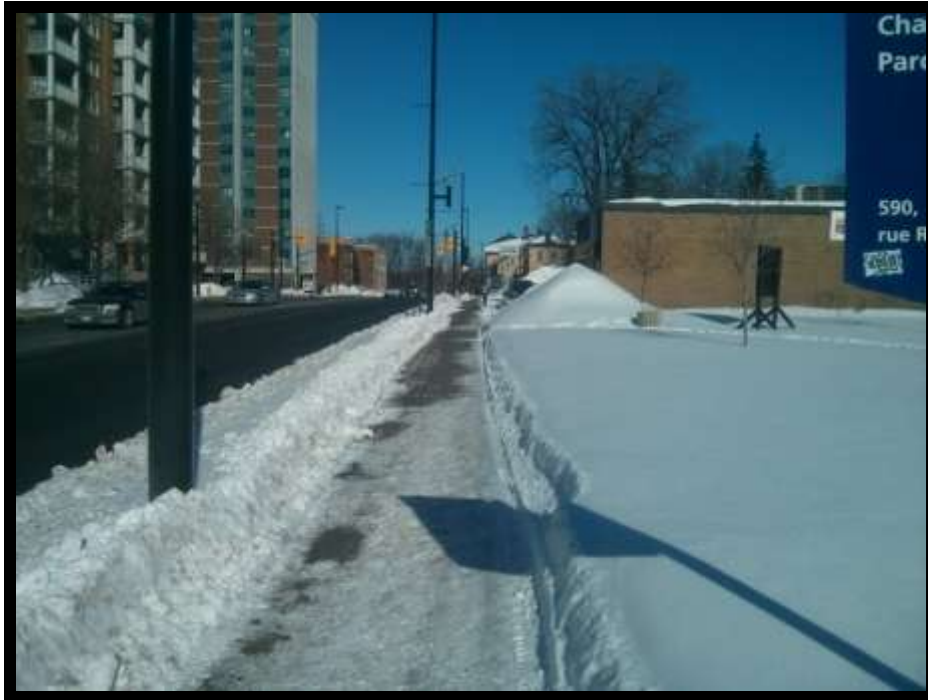
Photograph 1: Subject site, facing east along Rideau Street.

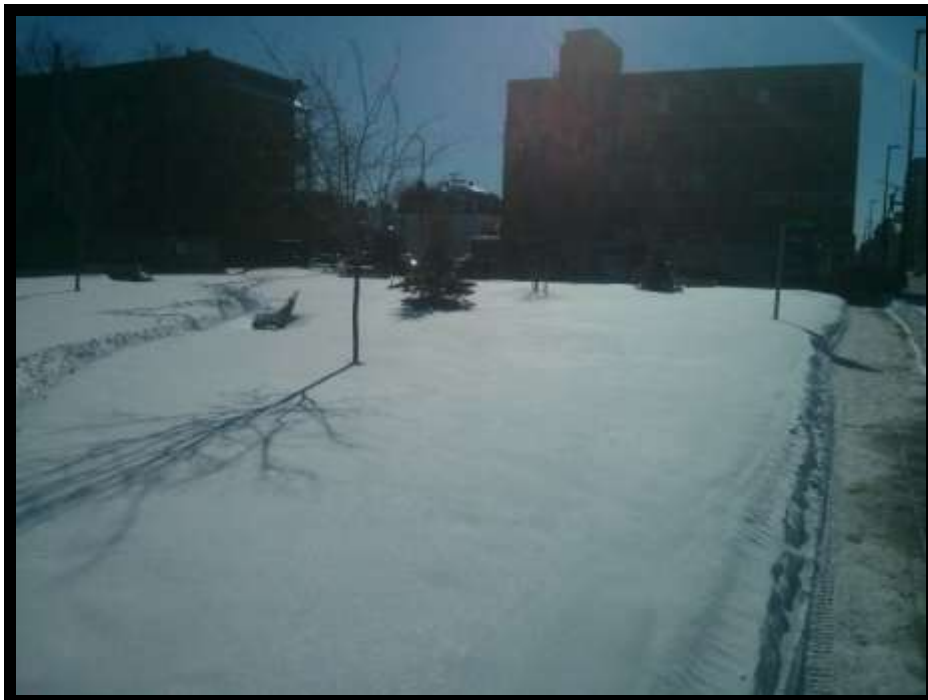
Photograph 2: Subject site, facing southwest towards Charlotte Street.
