Arborist Report  
&  
Tree Preservation Plan

231 Cobourg Street  
Ottawa, ON  
K1N 8J2

**February 15, 2017**

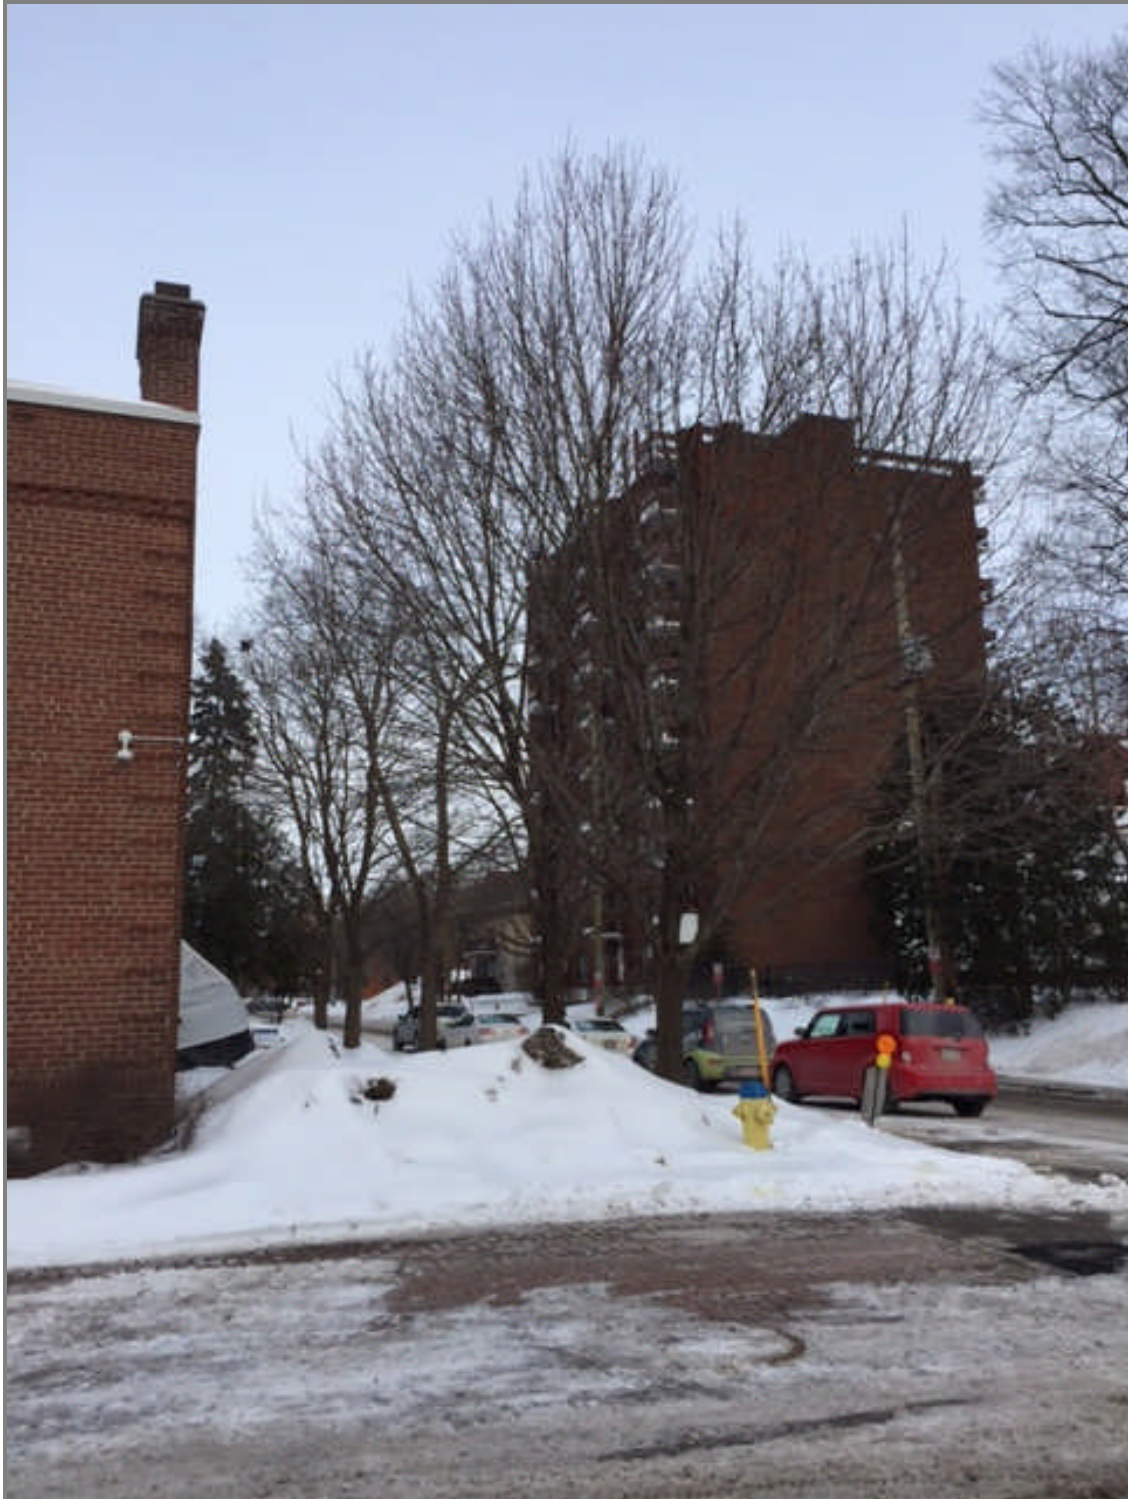
Photo #1: Trees no. 180, 181 and C1 looking east.

1. As listed above, there are nine regulated trees involved with this project, three of which are located within the City road allowance, being trees no. 180, 181 and C1. Tree no. C1 is clear of proposed development, shall retain its prescribed CRZ and as such, will not be disturbed during construction.

2. Tree no. 181 is situated adjacent to an existing structure, being the interlocking sidewalk. With the above in mind, proposed construction will not infringe on the existing root structure of this tree as the existing hard surface structures protect the roots from disturbance and if protected by hoarding, as outlined in the Tree Protection Plan, will not adversely affect the trees current condition.

3. Tree no. 180 is also situated adjacent to the existing sidewalk however it is encroached upon by proposed construction by <2%. Such encroachment is located on the outer edge of the critical root zone. Roots disturbed within this area are likely to be no larger than 1-3cm in diameter and can easily be ameliorated by retaining a qualified arborist to supervise excavation, root prune as required and fertilize to promote root regeneration. This tree is healthy and vigourous and has an excess of stored energy (carbohydrates) to easily recover from this minor disturbance. Written permission from forestry services must be obtained to injure any tree growing on City property.

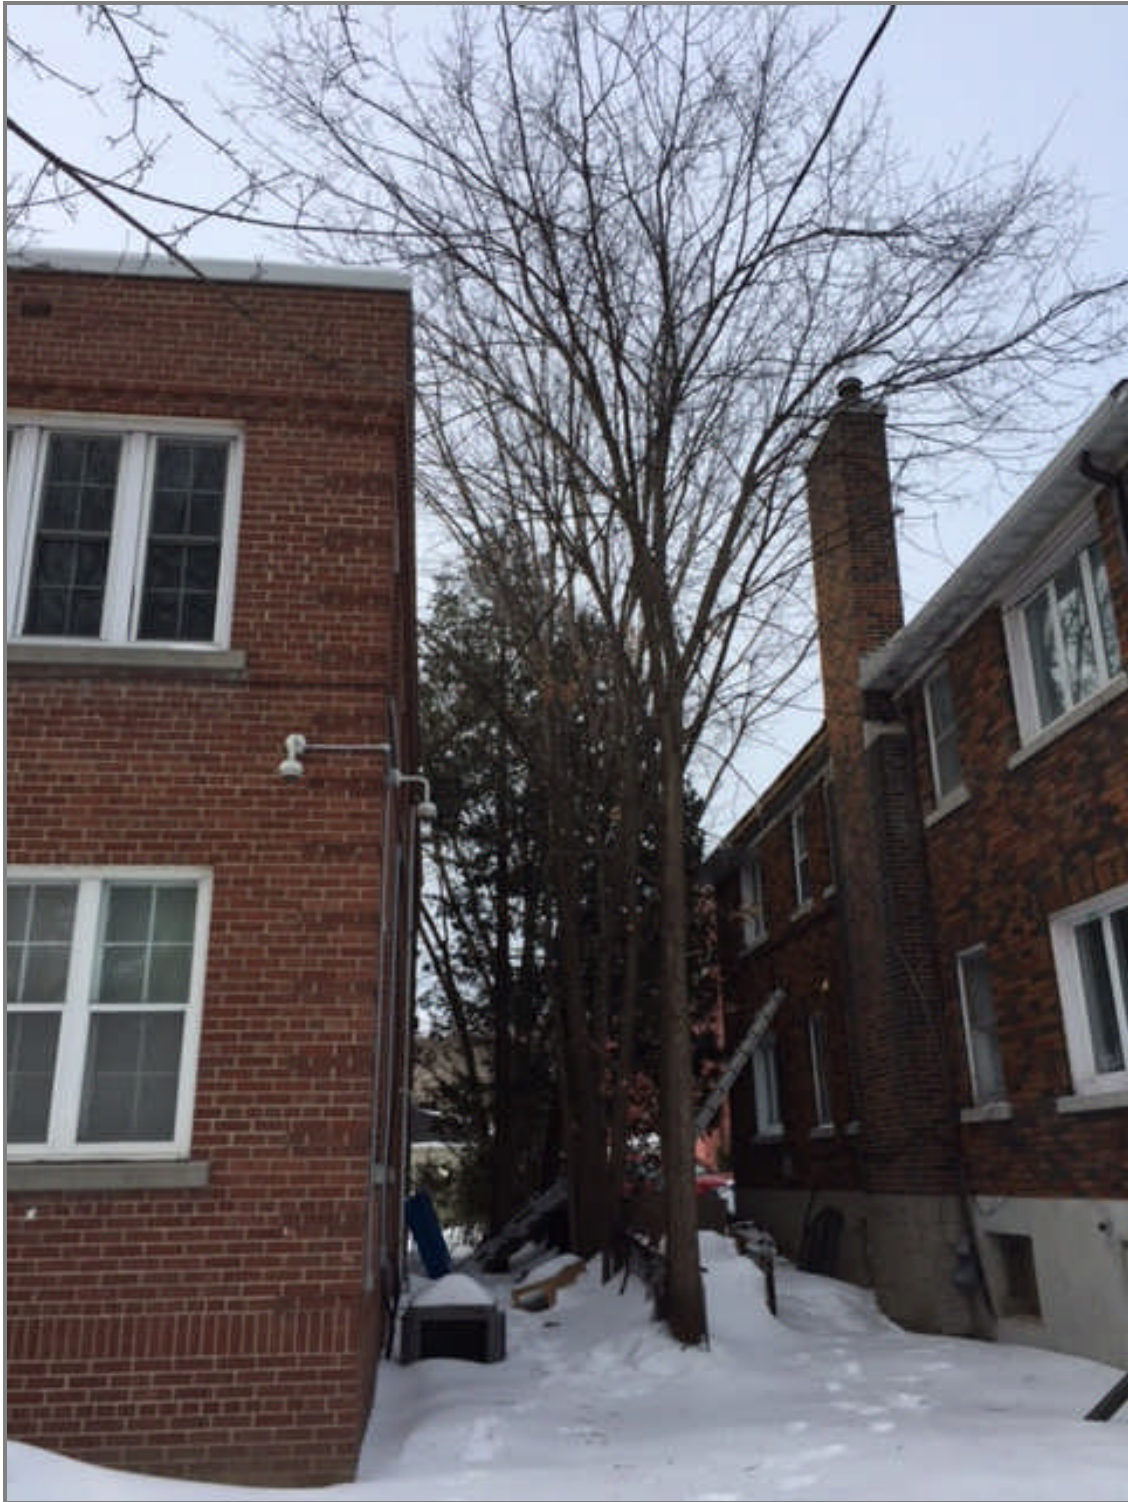
Photo #2: Trees no. 182-186 looking northwest.

1. There are six regulated trees located on the subject site, being trees no. 182-187. All six trees are either in conflict with or are heavily encroached upon by proposed construction and as such, are recommended for removal. A tree permit issued by Planning and Growth Management is required before any tree 10cm in diameter or larger can be removed.
2. All other trees located on or within 6.0m of the subject site have a DBH of less than 10cm, are non-regulated trees and as such, were not included in this report.
3. To further protect the trees scheduled for preservation from the potential of construction disturbance, I recommend implementing the below listed tree preservation recommendations. Details for each recommendation are listed in the *Tree Preservation Specification* schedule in Appendix III.

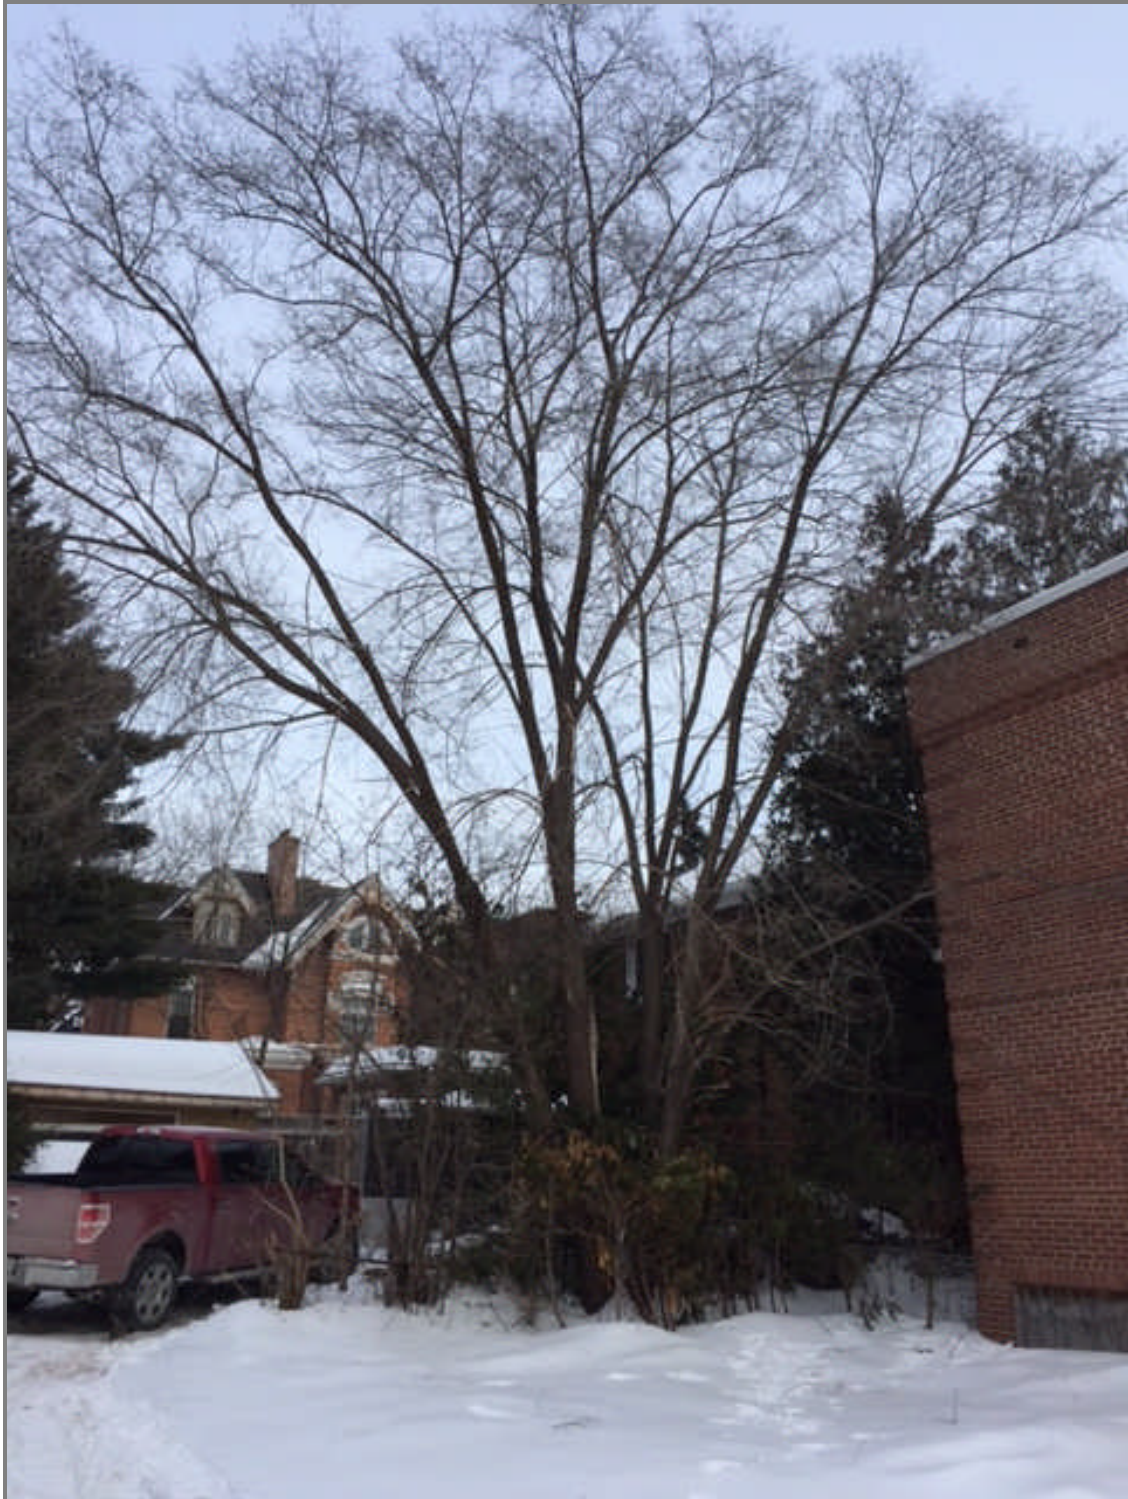
Photo #3: Tree no. 187 looking east.
