Muncaster Environmental Planning Inc.

RE: UHC Chancery Building 231 Cobourg Street, Ottawa Project ADMN/216/276/01 Scoped Environmental Impact Statement - Chimney Swift Surveys

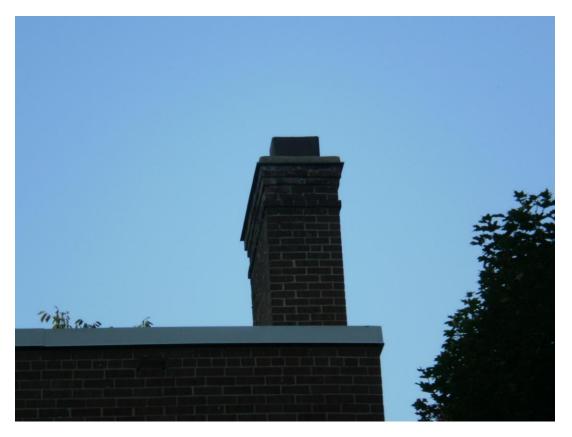
The Uganda High Commission Chancery building at 231 Cobourg Street in Ottawa has an open chimney (Photo 1). The open chimney could be habitat for chimney swift, which is designated a threatened Species at Risk under the provincial Endangered Species Act (2007). There is the potential for future work in proximity or otherwise cause a disturbance to the open chimney. Thus surveys before and at dusk were undertaken in July and early August, 2016 to determine if chimney swifts are utilizing the chimney for nesting.

Photo 1 – Open brick chimney on the top of the building at 231 Cobourg Street

As the open chimney was not used by chimney swifts it is not considered significant habitat for chimney swifts. It is recommended that the chimney be removed, capped or screened, with this work completed after October 31st and before April 15th, 2017.

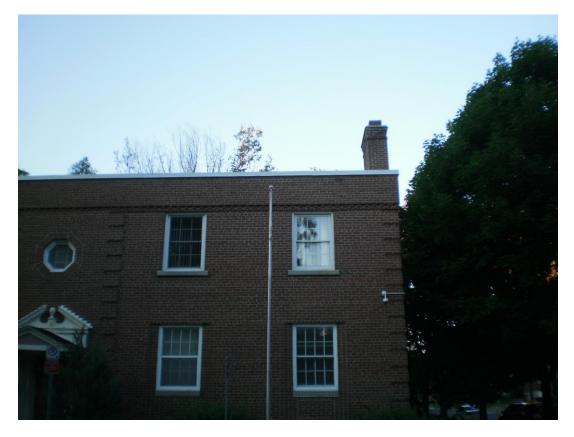
Photo 2 – South half of the building at 231 Cobourg Street with the chimney on south face of the building
