ENVIRONMENTAL IMPACT STATEMENT

210 & 220 MAPLE CREEK COURT, CITY OF OTTAWA, ONTARIO

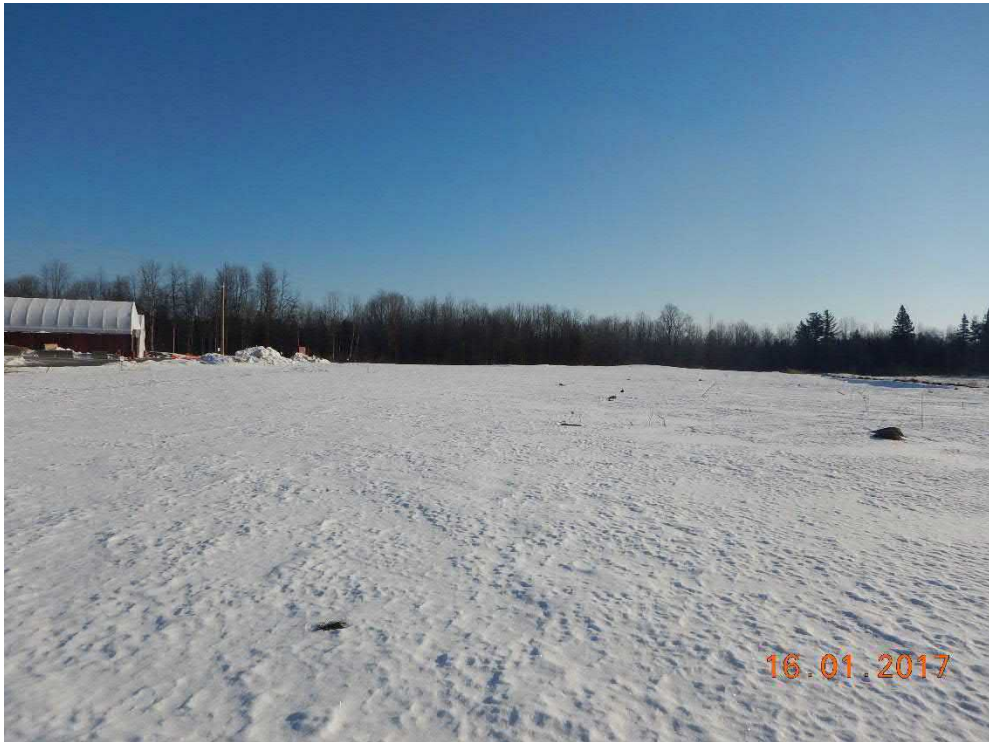
Photo 1: Subject property at 210 Maple Creek Court in winter conditions, facing east. 16 January 2017.

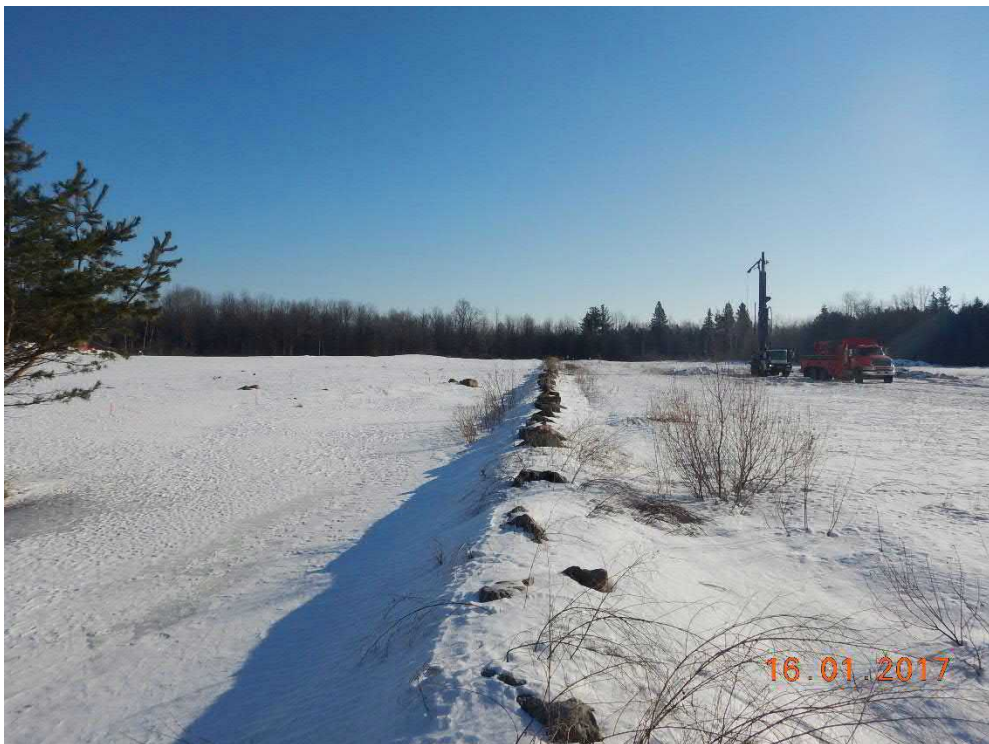
Photo 2: Subject properties at 210 and 220 Maple Creek Court in winter conditions, facing southeast. 16 January 2017.

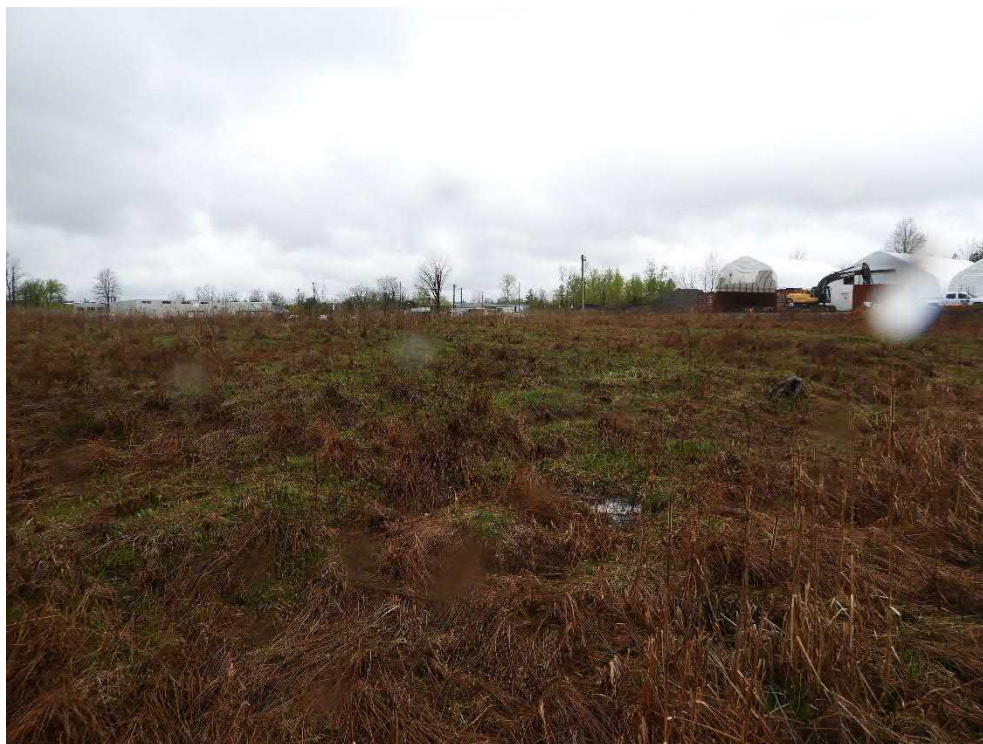
Photo 5: Subject property at 210 Maple Creek Court in spring conditions, facing west. 14 May 2019.

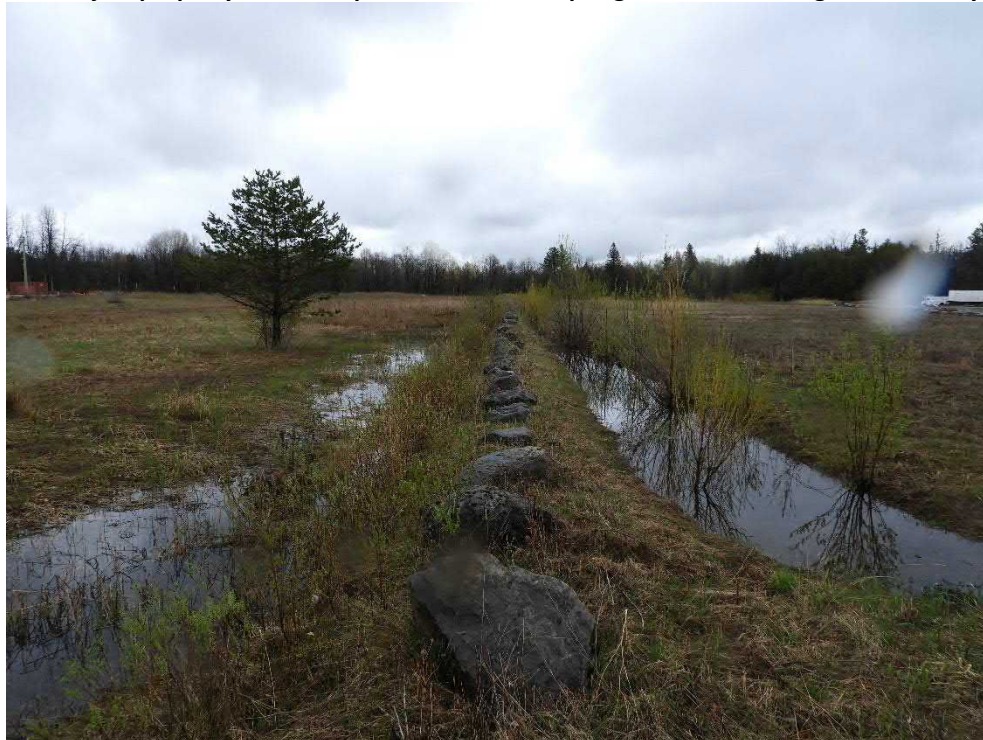
Photo 6: Subject property at 210 Maple Creek Court (left), subject property at 220 Maple Creek Court (right) and rock fence line (middle), facing east. 14 May 2019.

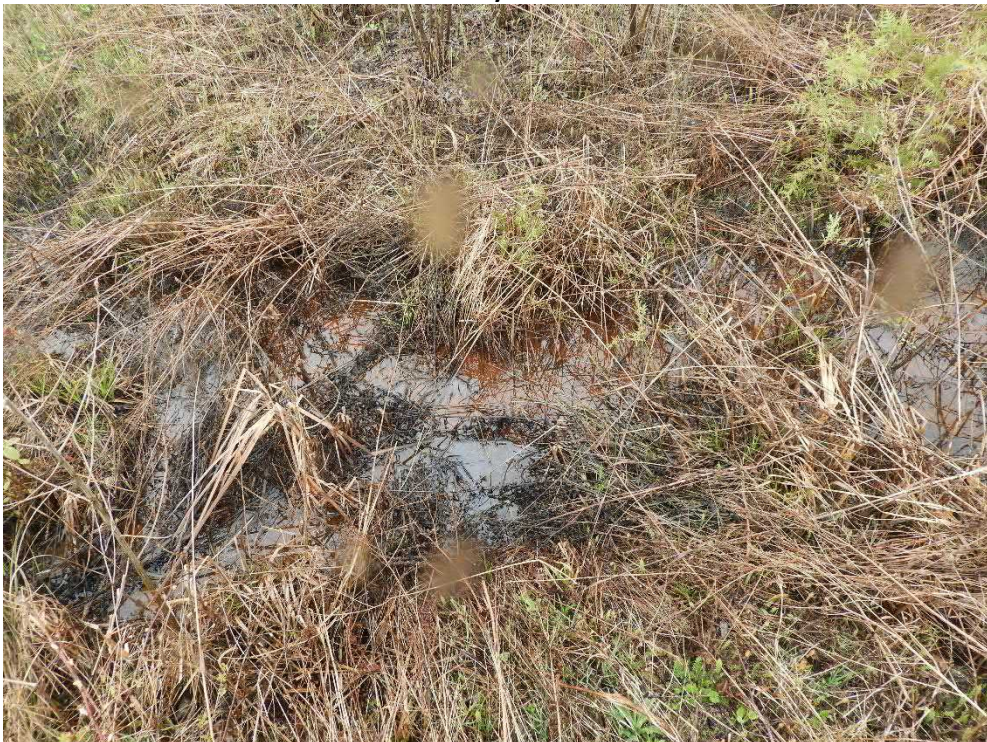
**Photo 8: Iron staining and film on standing water suggesting potential ground water on south side of rock fence line.
14 May 2019.**

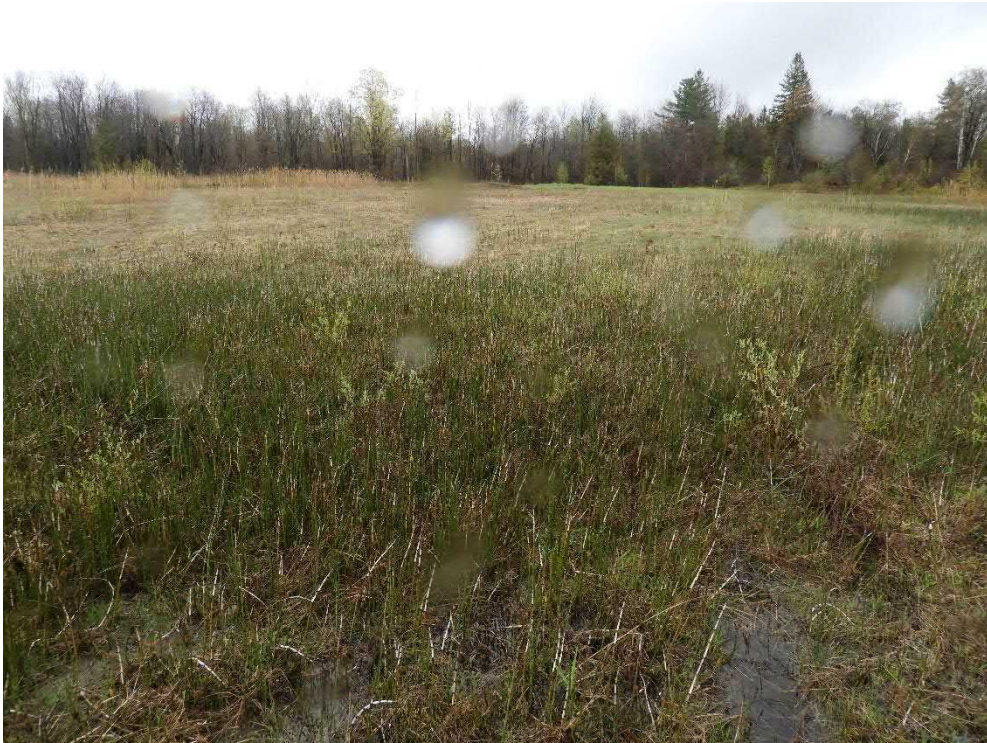
Photo 9: Wet horsetail area in southeast corner of study area, facing southeast. 14 May 2019.

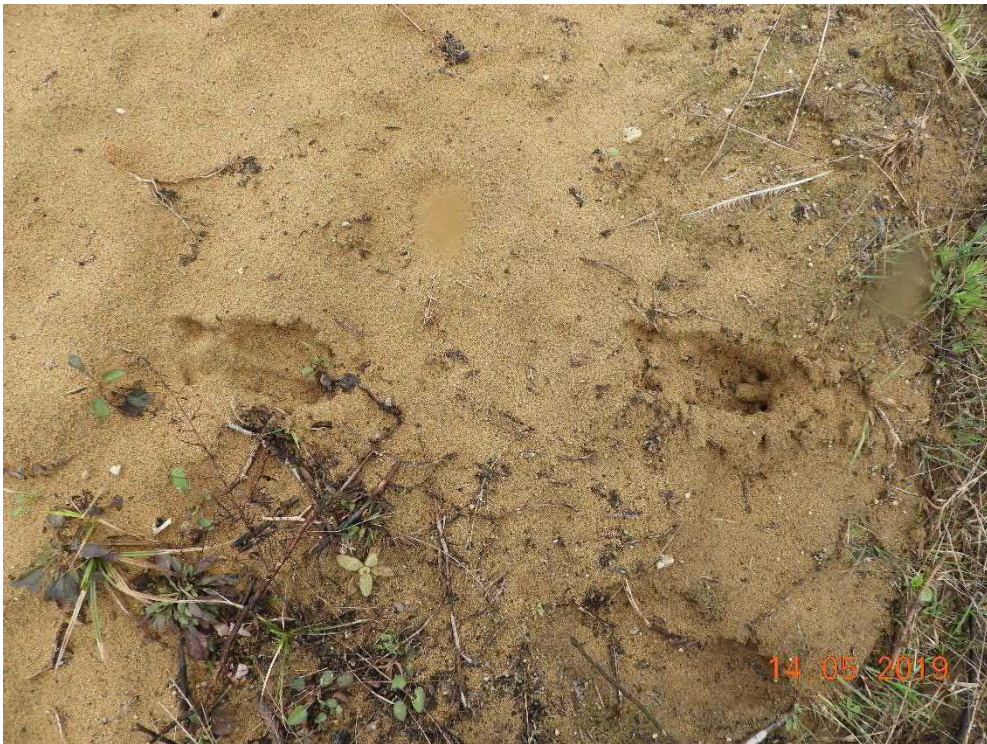
Photo 22: White-tailed deer (*Odocoileus virginianus*) tracks found in the study area. 14 May 2019.

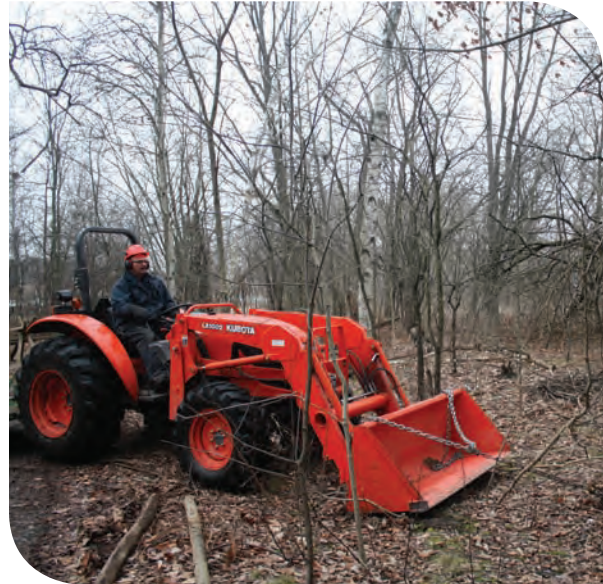
Buckthorn removal, Lynde Shores Conservation Area.
Photo by: Central Lake Ontario Conservation Authority

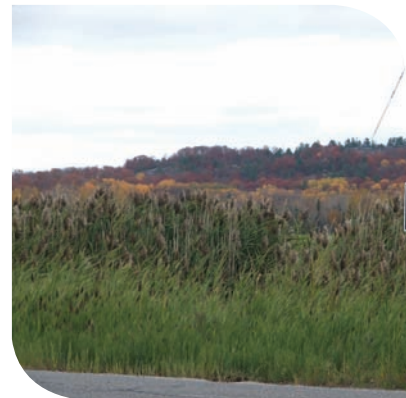
Phragmites
(*Phragmites australis* subsp. *Australis*)
Photo by: Michael Irvine

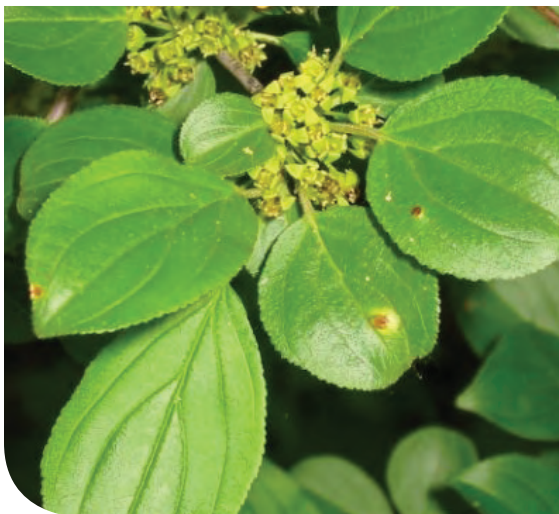
Similar native species: Native dogwoods, which lack the thorny “tip”. Native dogwoods are truly opposite in arrangement of twigs; only alternate leaved (pagoda) dogwood has alternate branching.

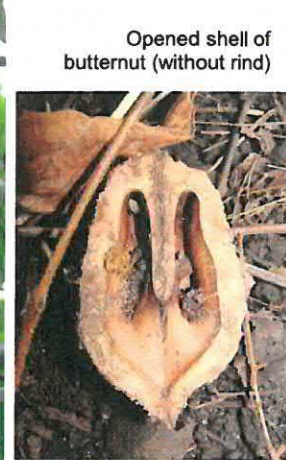
Opened shell of butternut (without rind)
