# ENVIRONMENTAL IMPACT STATEMENT

210 & 220 MAPLE CREEK COURT, CITY OF OTTAWA, ONTARIO

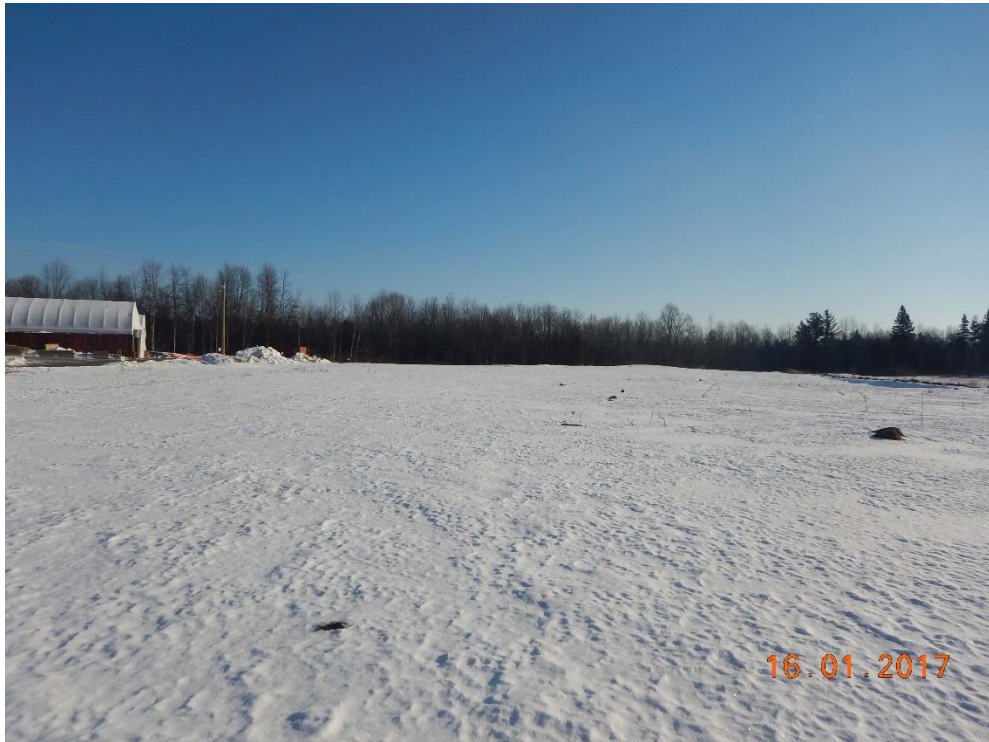
Photo 1: Subject property at 210 Maple Creek Court in winter conditions, facing east. 16 January 2017.

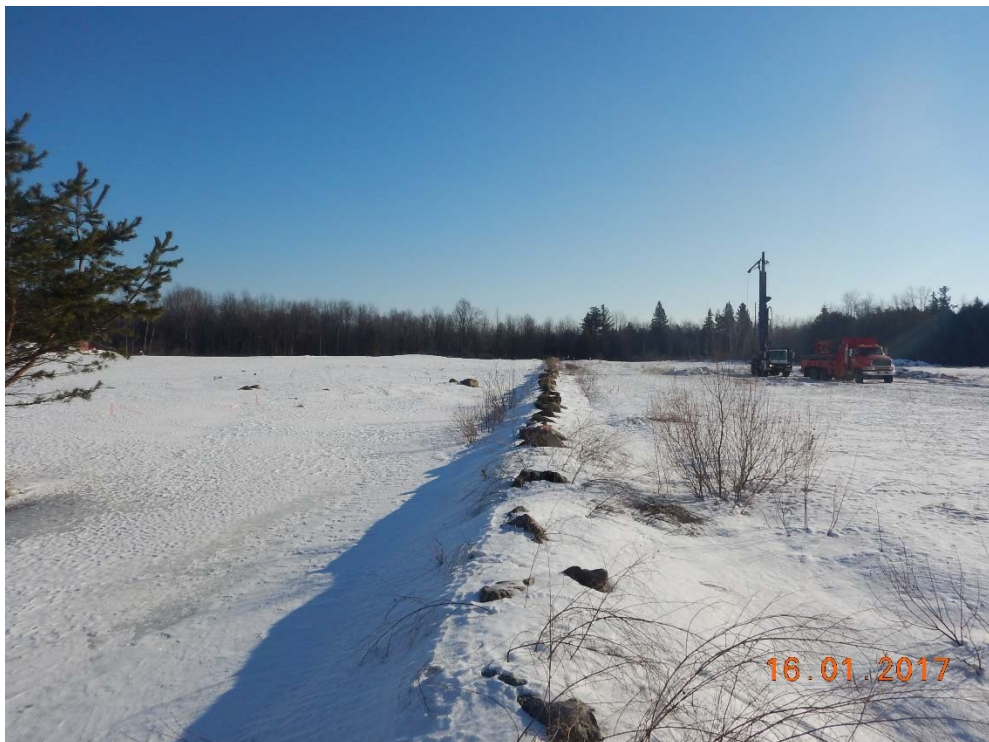
Photo 2: Subject properties at 210 and 220 Maple Creek Court in winter conditions, facing southeast. 16 January 2017.

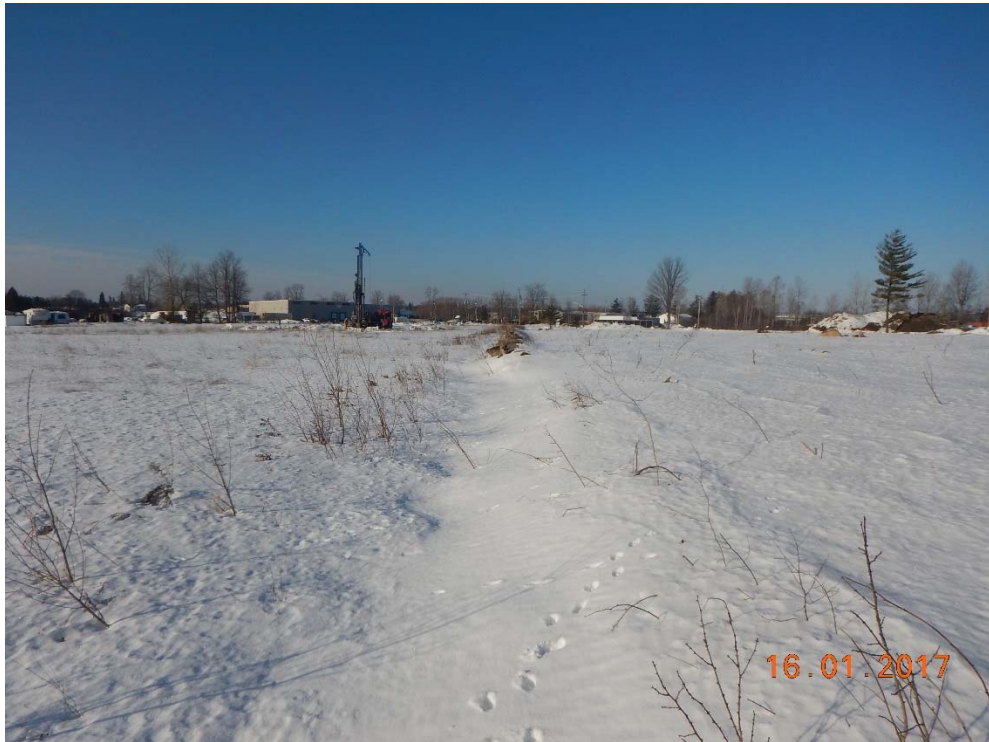
**Photo 3: Subject properties at 210 and 220 Maple Creek Court in winter conditions, facing west towards Maple Creek Court. 16 January 2017.**

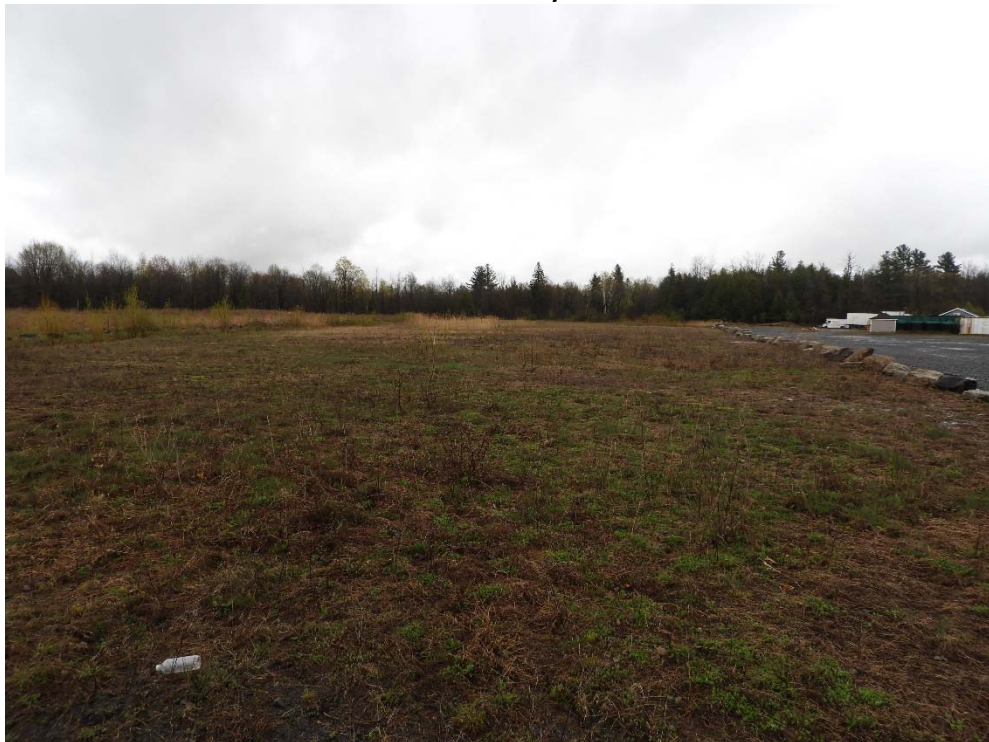
**Photo 4: Subject property at 220 Maple Creek Court in spring conditions, facing east. 14 May 2019.**

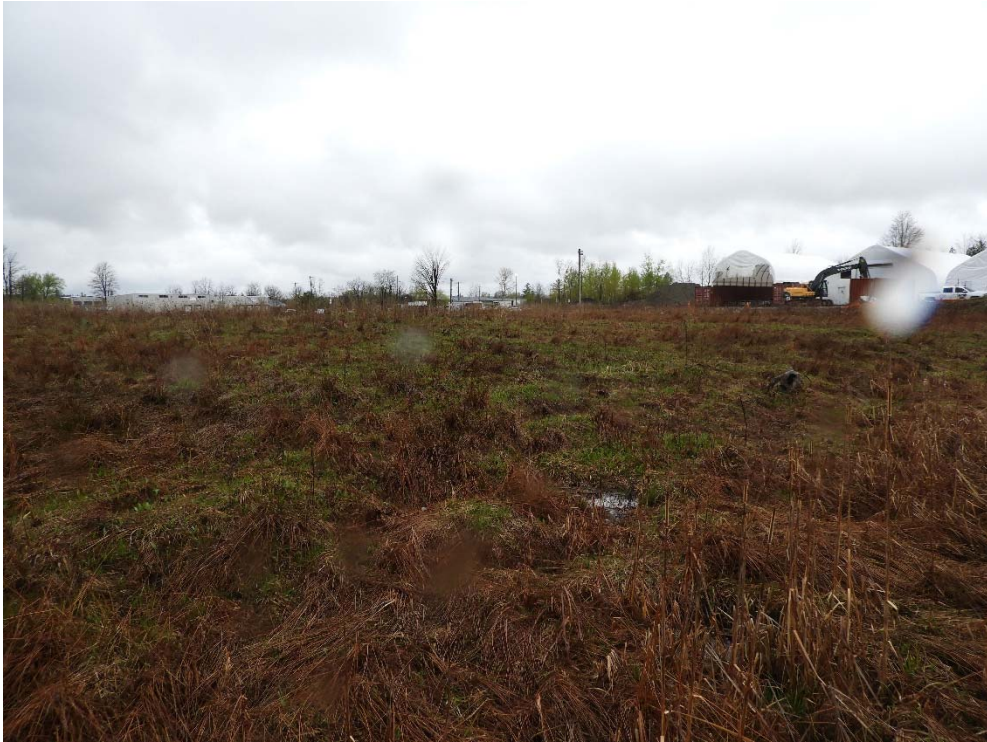
Photo 5: Subject property at 210 Maple Creek Court in spring conditions, facing west. 14 May 2019.

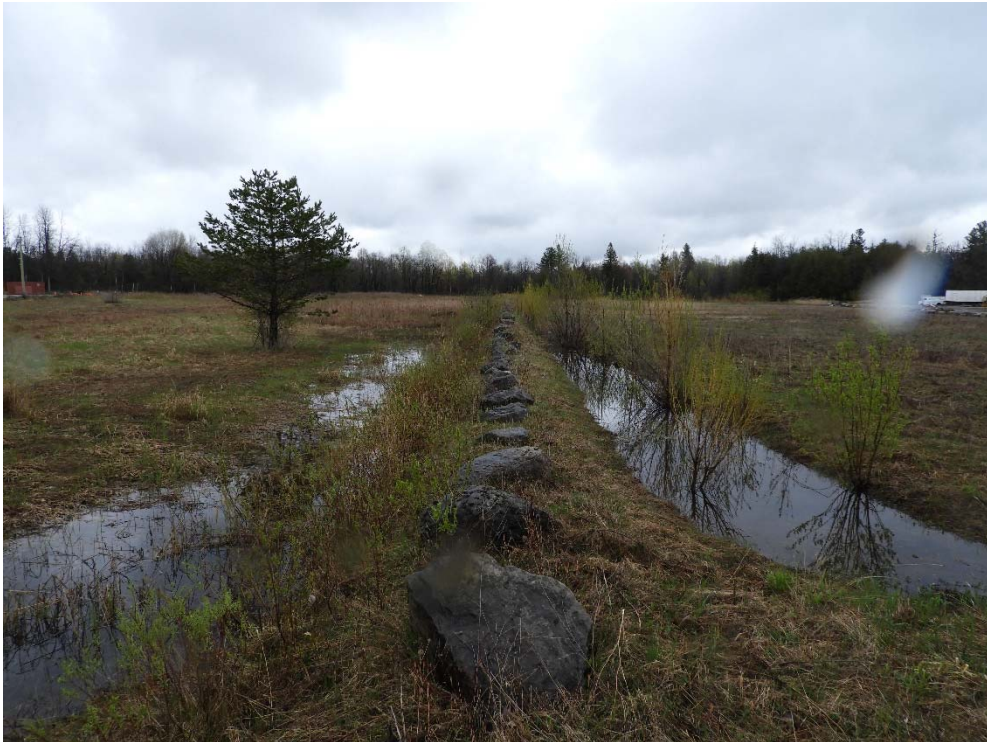
Photo 6: Subject property at 210 Maple Creek Court (left), subject property at 220 Maple Creek Court (right) and rock fence line (middle), facing east. 14 May 2019.

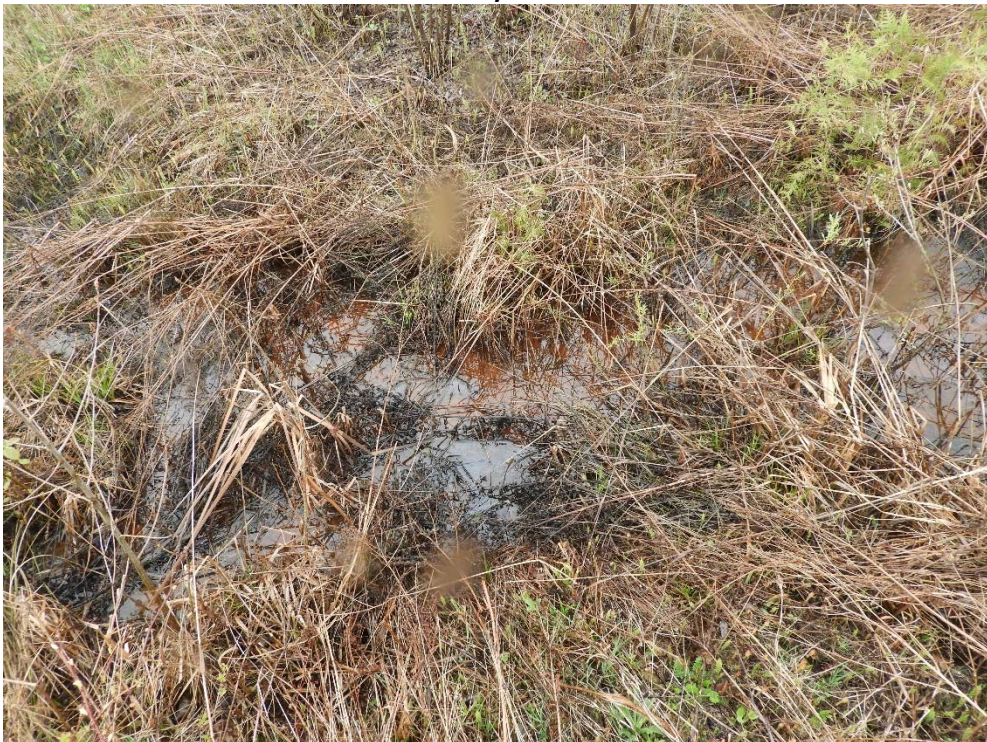
**Photo 8: Iron staining and film on standing water suggesting potential ground water on south side of rock fence line.  
14 May 2019.**

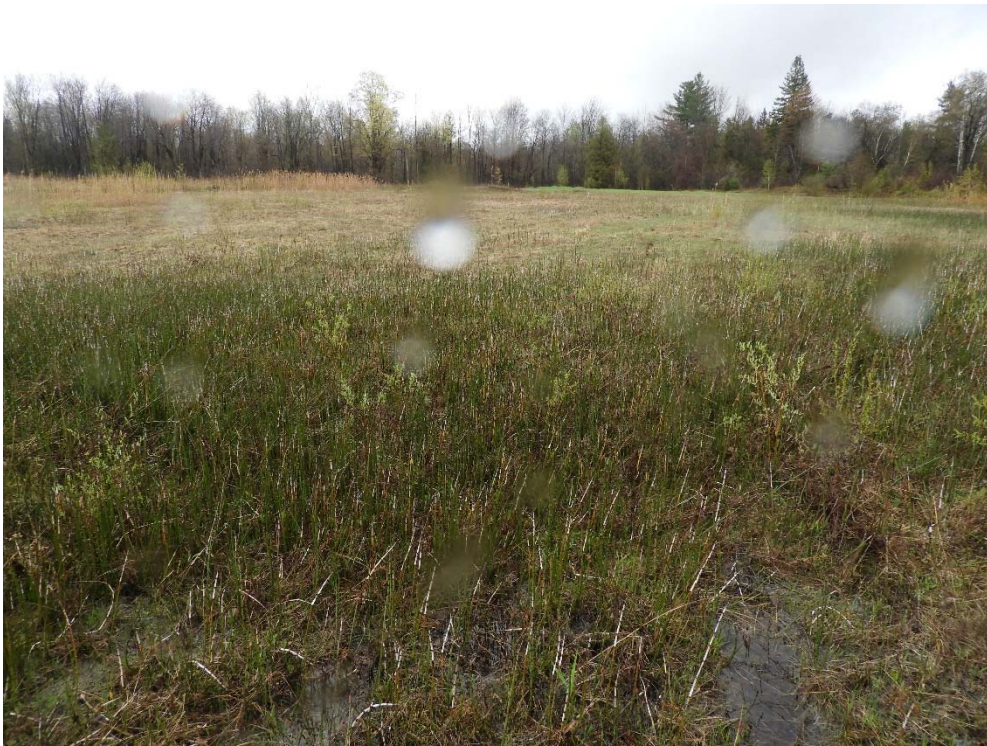
**Photo 9: Wet horsetail area in southeast corner of study area, facing southeast. 14 May 2019.**

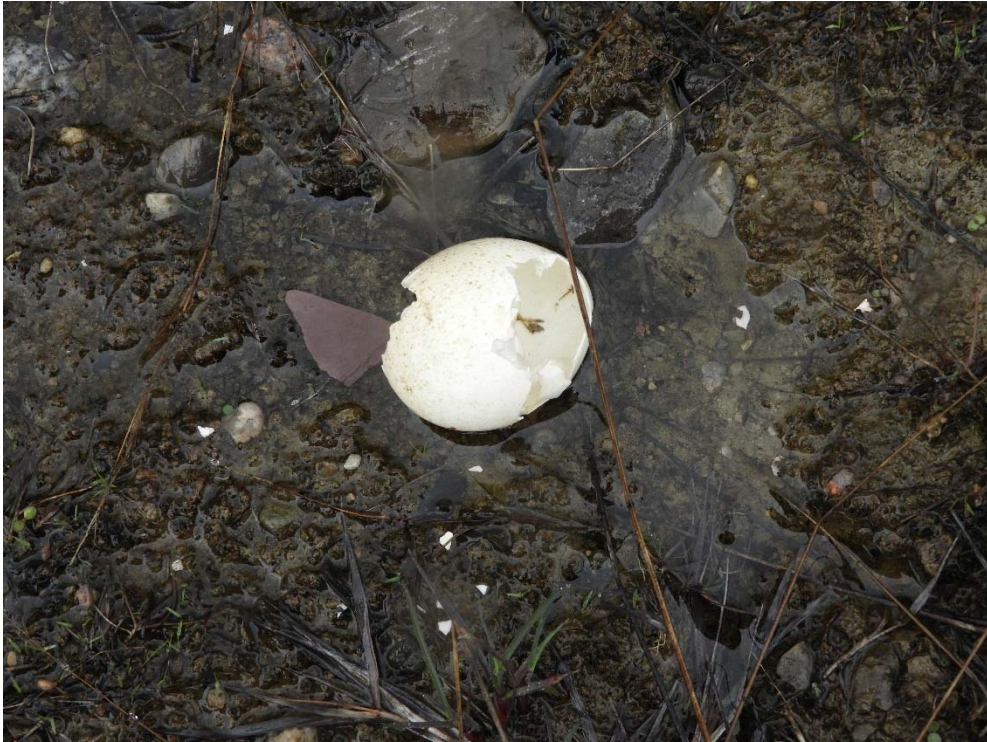
Photo 21: One of two Wild Turkey (*Meleagris gallopavo*) eggs found on the ground within the study area. 14 May 2019.

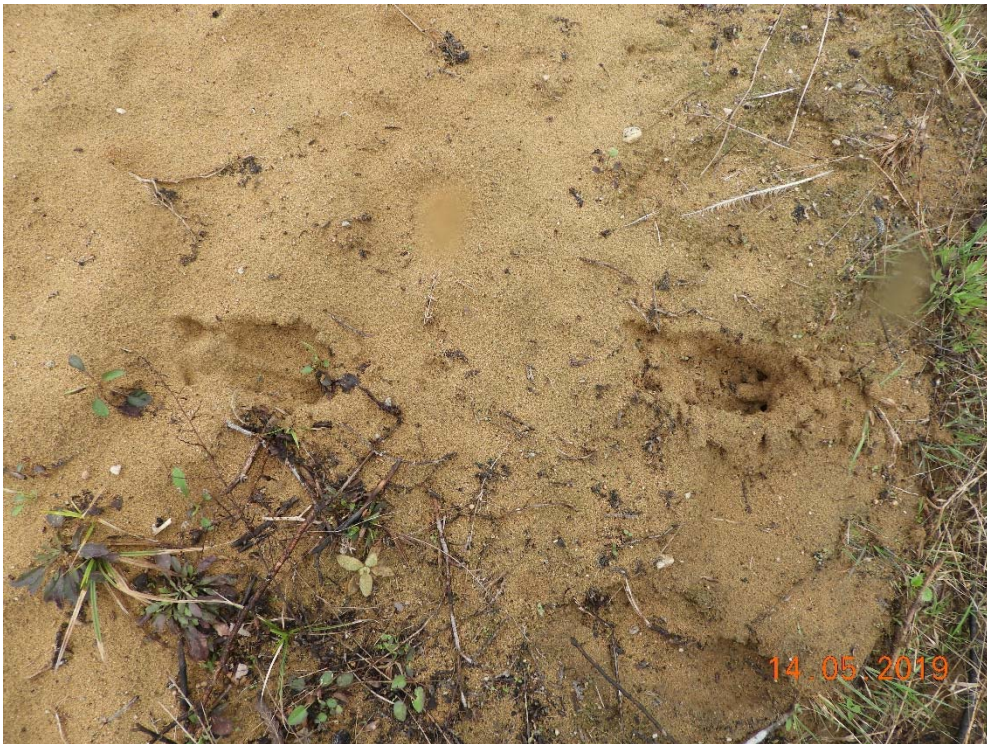
Photo 22: White-tailed deer (*Odocoileus virginianus*) tracks found in the study area. 14 May 2019.

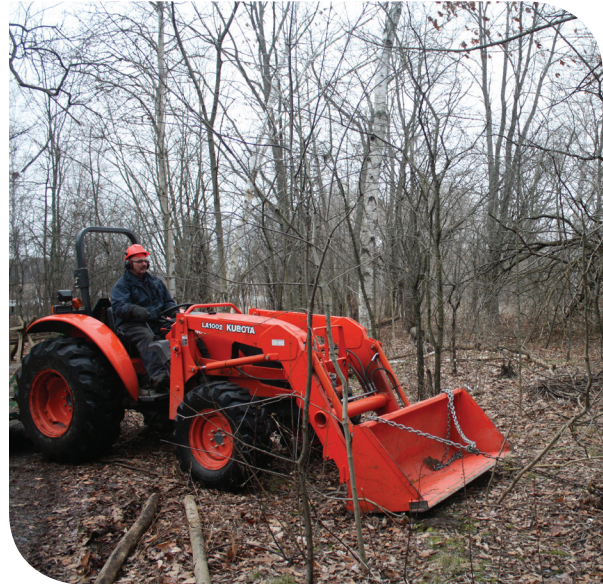
**Buckthorn removal, Lynde Shores Conservation Area.**  
Photo by: Central Lake Ontario Conservation Authority

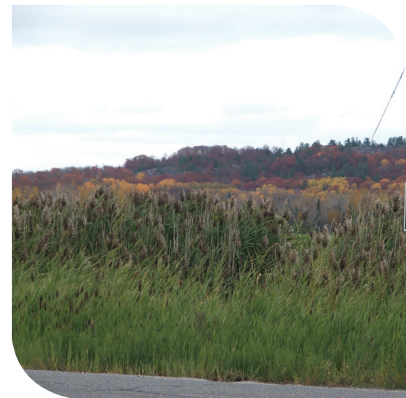
**Phragmites**  
(*Phragmites australis* subsp. *Australis*)  
Photo by: Michael Irvine

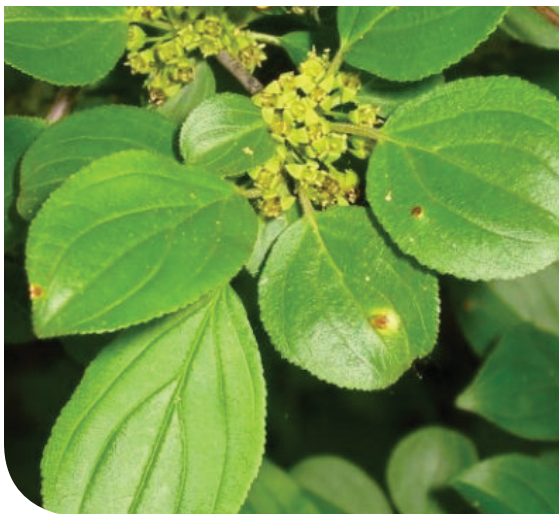
## dog-strangling vine

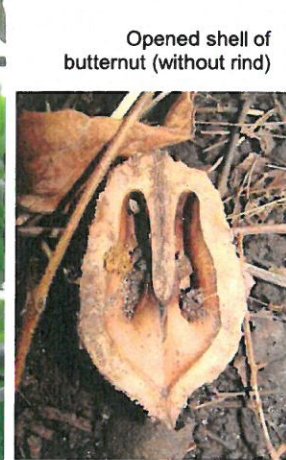
Opened shell of butternut (without rind)
