## **Phase I Environmental Site Assessment**

Vacant Property - Oak Ridge Gate Subdivision Chinon Place at Breezewood Street Ottawa, Ontario

Report: PE2326-2

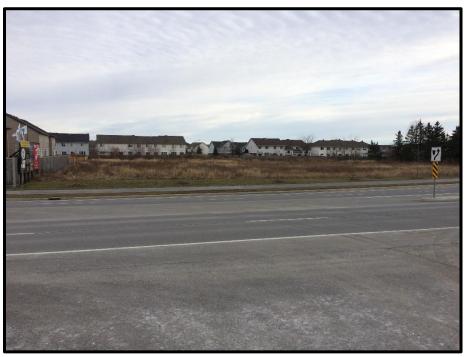
Photograph 1: View of the subject site, facing east. Trim Road is present in the foreground. The subject site is currently vacant grassed land.

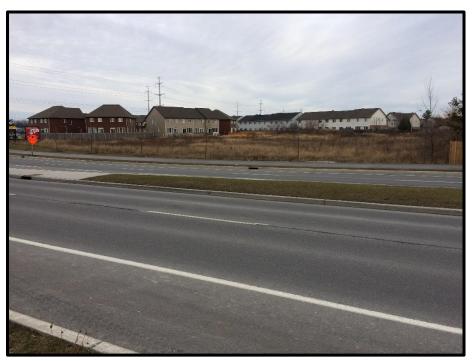
Photograph 2: View of the subject site, facing northeast. The subject site is flanked to the north and east by newer residential properties.

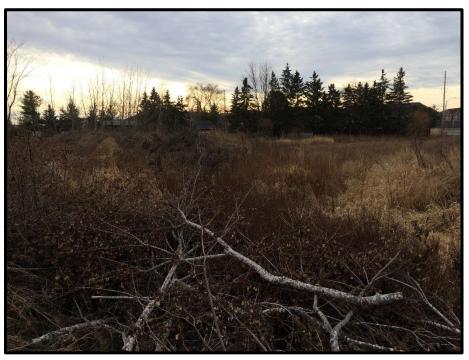
Minor amounts of non-hazardous municipal solid waste and compostable material was present on the subject site at the time of the site visit. These items are not considered an environmental concern.

Photograph 3: View of the subject site, facing southwest. The east portion of the subject site was observed to have some tree clippings and minor amount of non-hazardous solid waste present.
