## Phase I Environmental Site Assessment

83 Hinton Avenue North  
Ottawa, Ontario

February 27, 2018

Report: PE4241-1

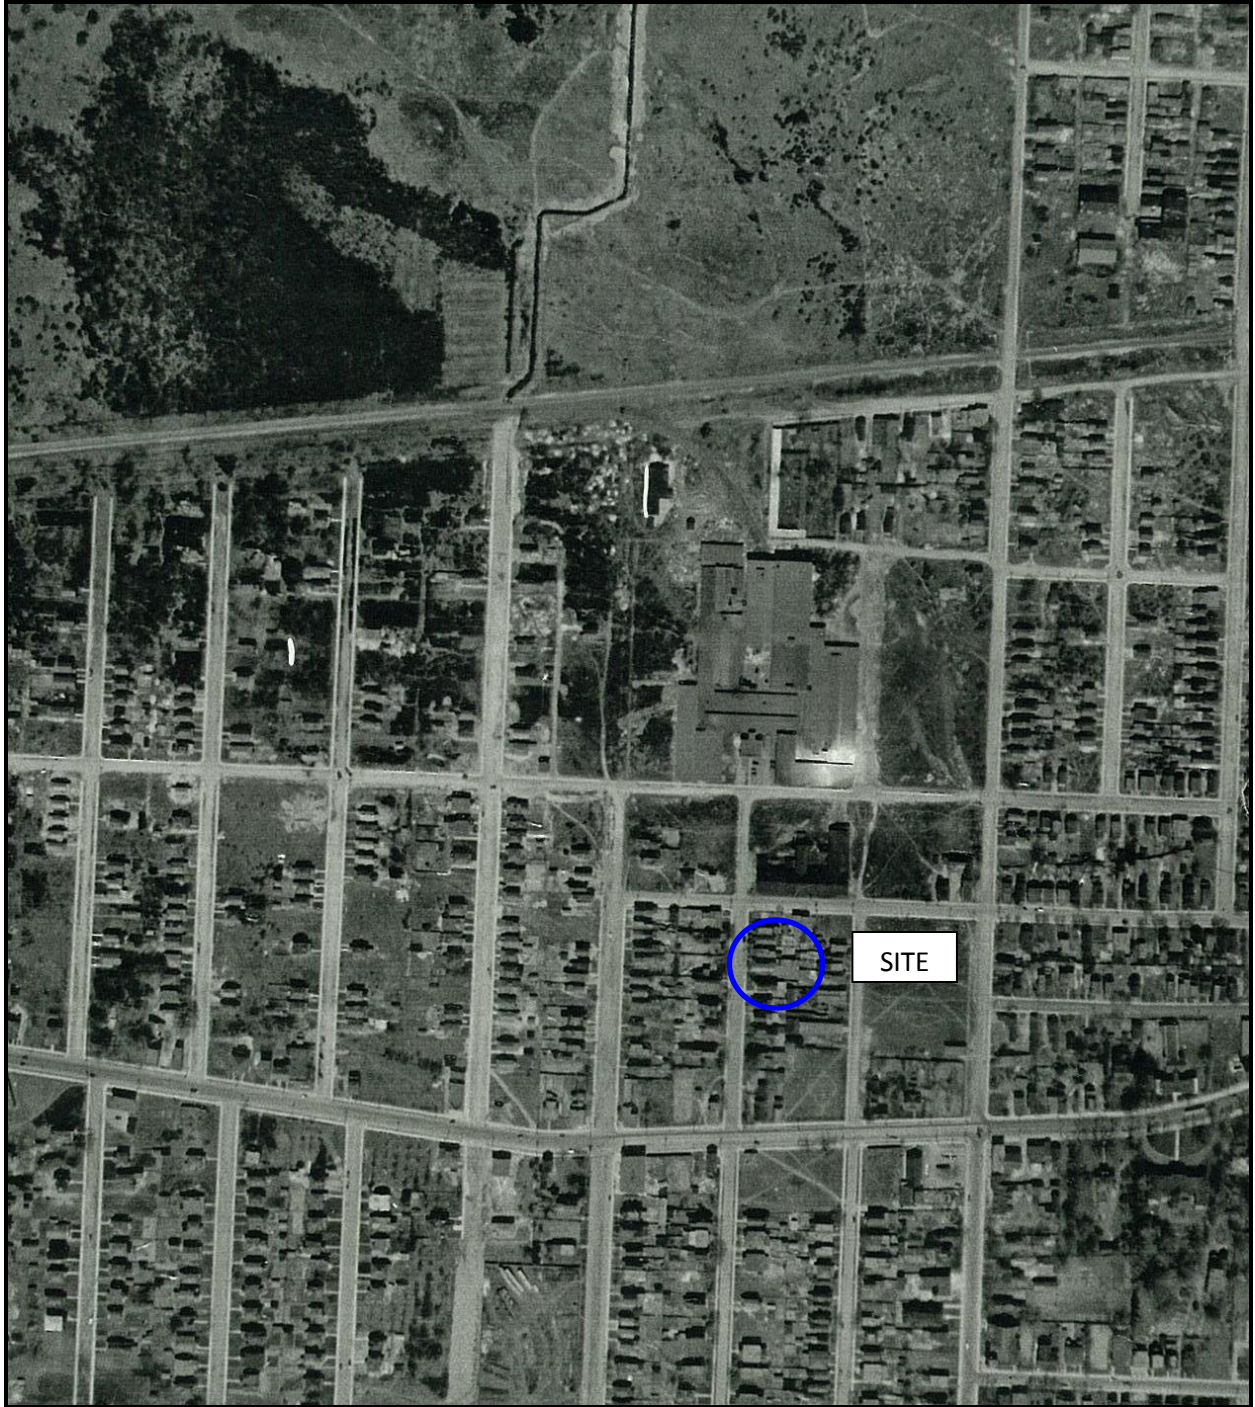
AERIAL PHOTOGRAPH  
1928

- 1928      The subject site is occupied by a residential dwelling similar to the one present on-site today. Adjacent properties appear to be used for residential purposes as well, with the exception of an industrial structure (foundry) to the southeast. An industrial building can also be seen further to north, and a much larger industrial building beyond that.

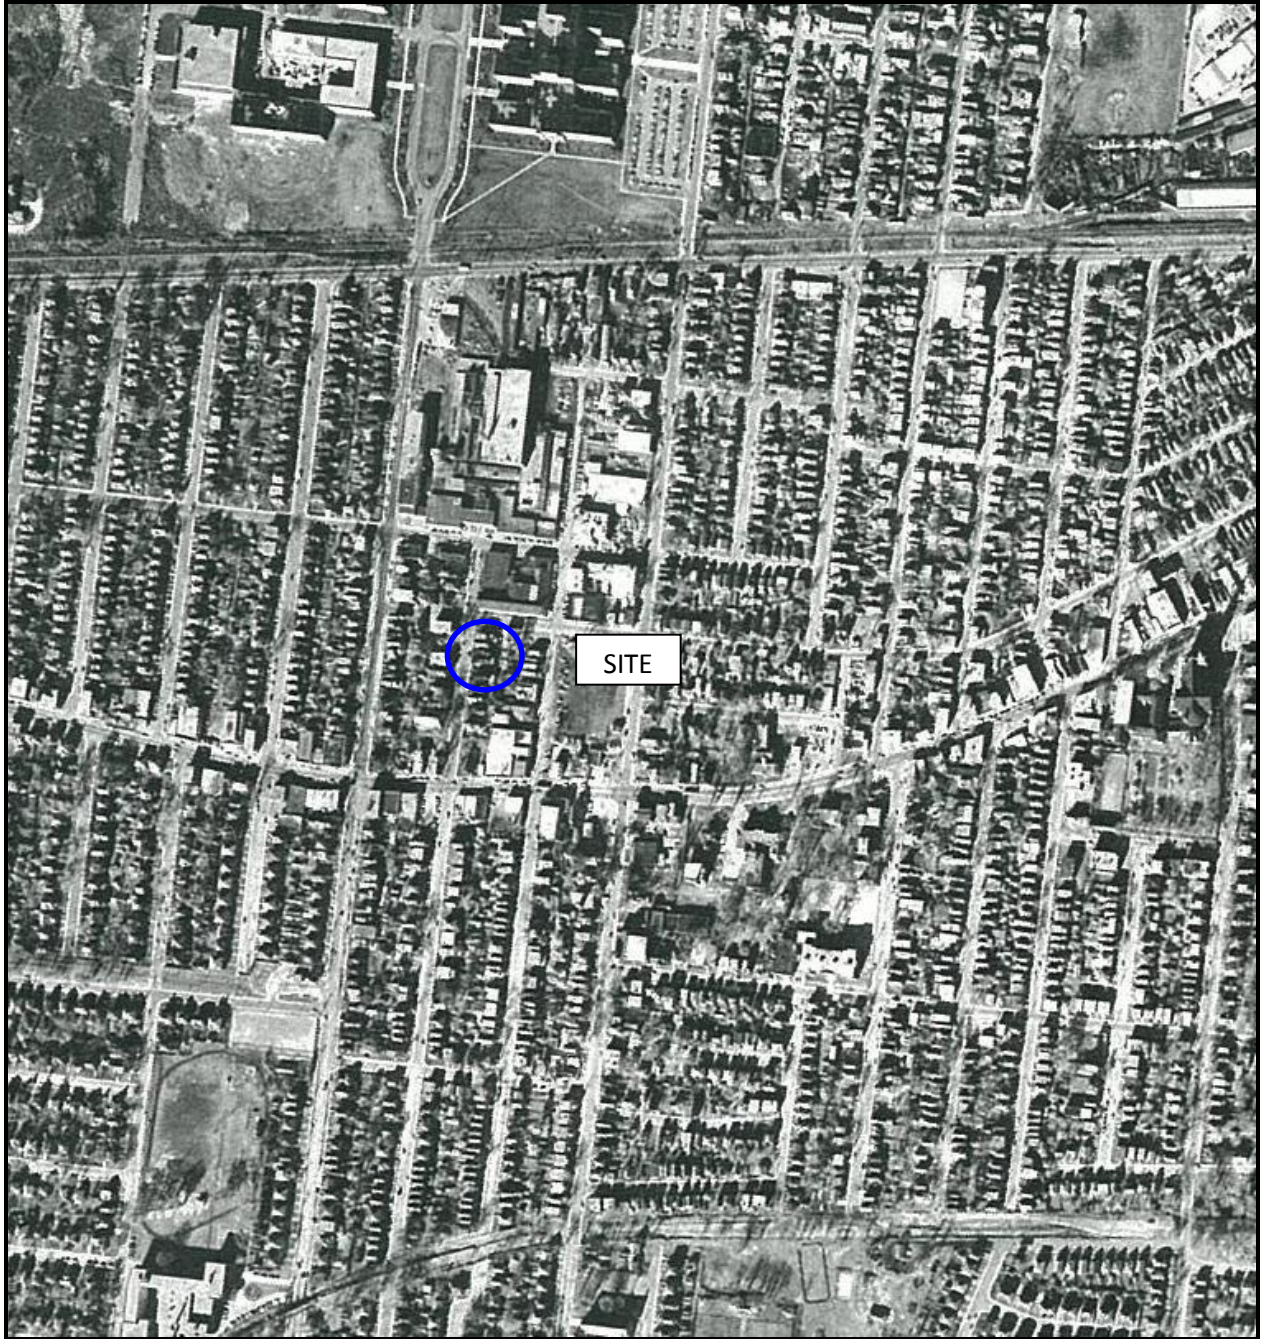
AERIAL PHOTOGRAPH  
1958

- 1958      No significant changes appear to have been made to the subject site.
- 1976      No significant changes appear to have been made to the subject site. The property to the southeast, formerly occupied by a foundry, now appears to be vacant.

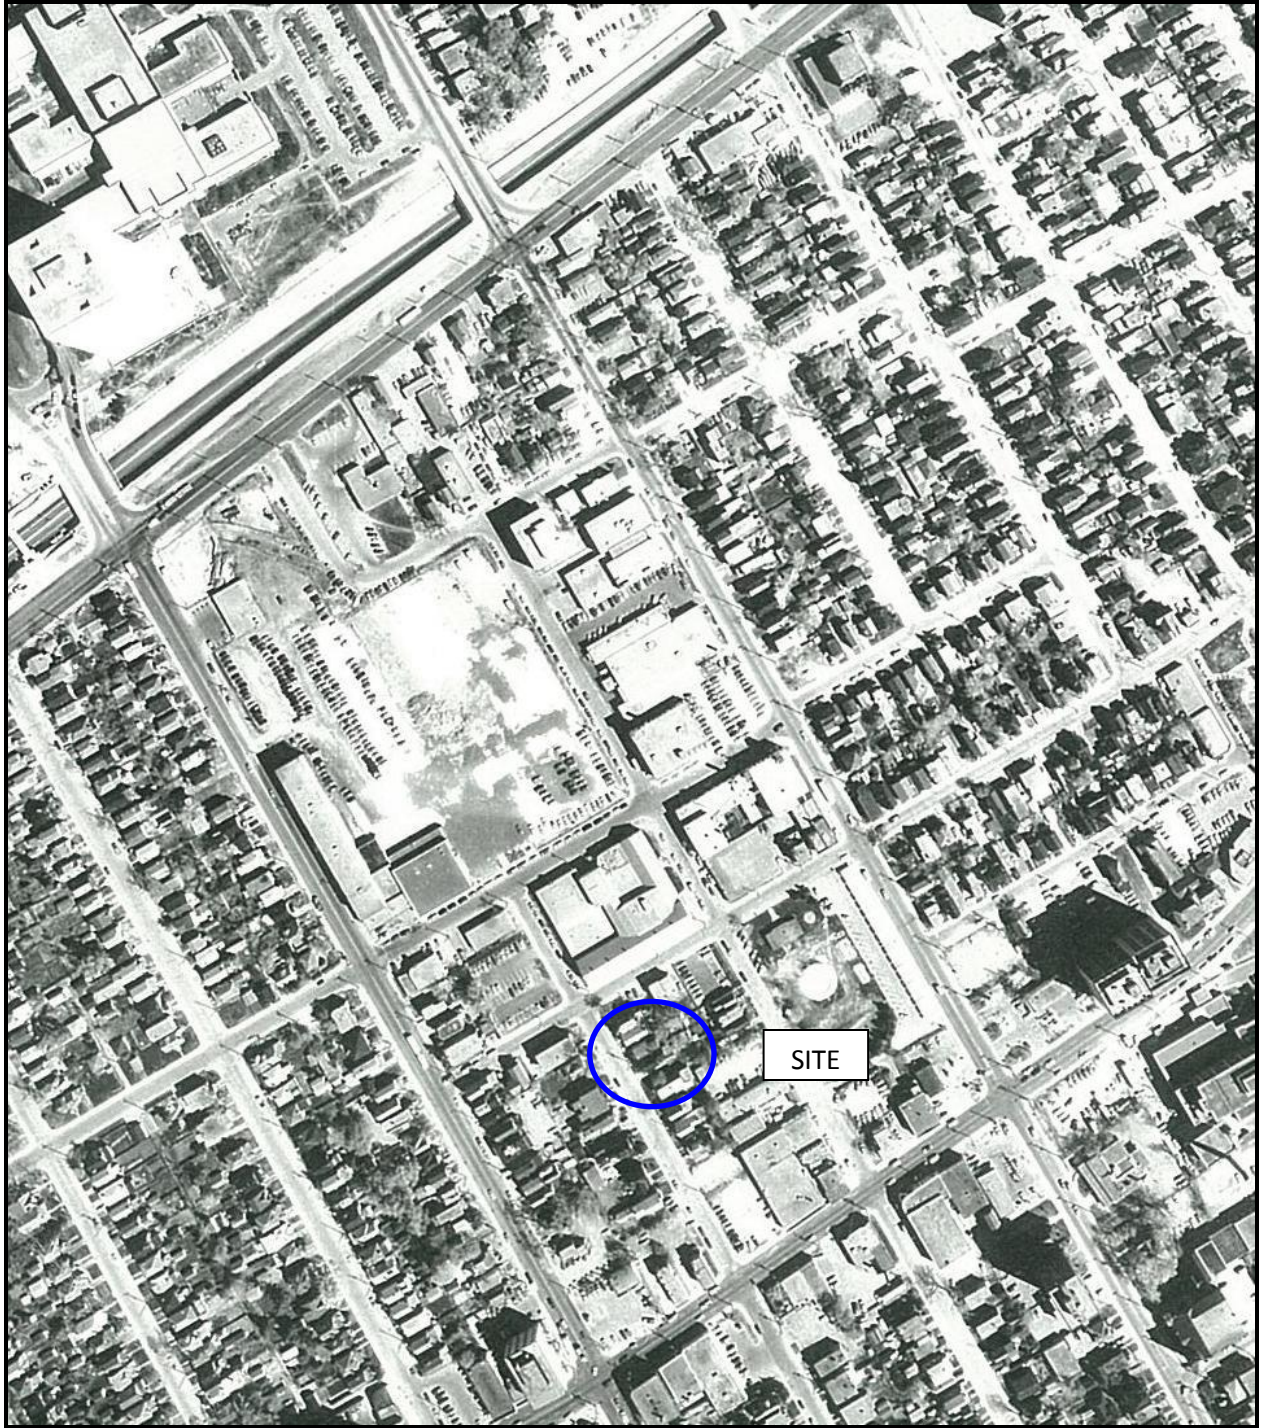
AERIAL PHOTOGRAPH  
1986

- 1986      No significant changes appear to have been made to the subject site. No significant changes appear to have been made to adjacent properties, however, further to the north, the large foundry has been demolished, and the property is not largely vacant.

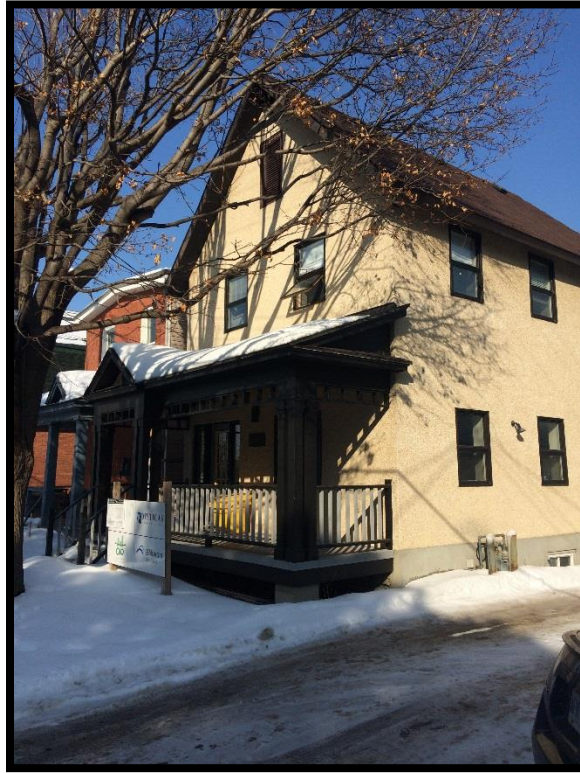
Photograph 1: View of the west building face.

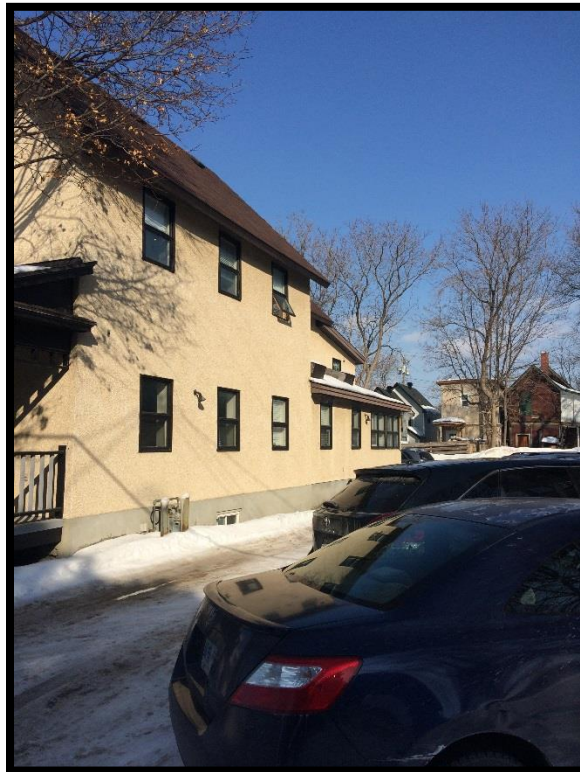
Photograph 2: View of the south building face, and parking lot.
