# HYDROGEOLOGICAL ASSESSMENT

## 6688 FRANKTOWN ROAD, OTTAWA ON

Project No: CCO-25-1134 (previously CP-17-0503)

Original: July, 2018  
Addendum 1: February 13, 2025  
Revision 1: June 6, 2025

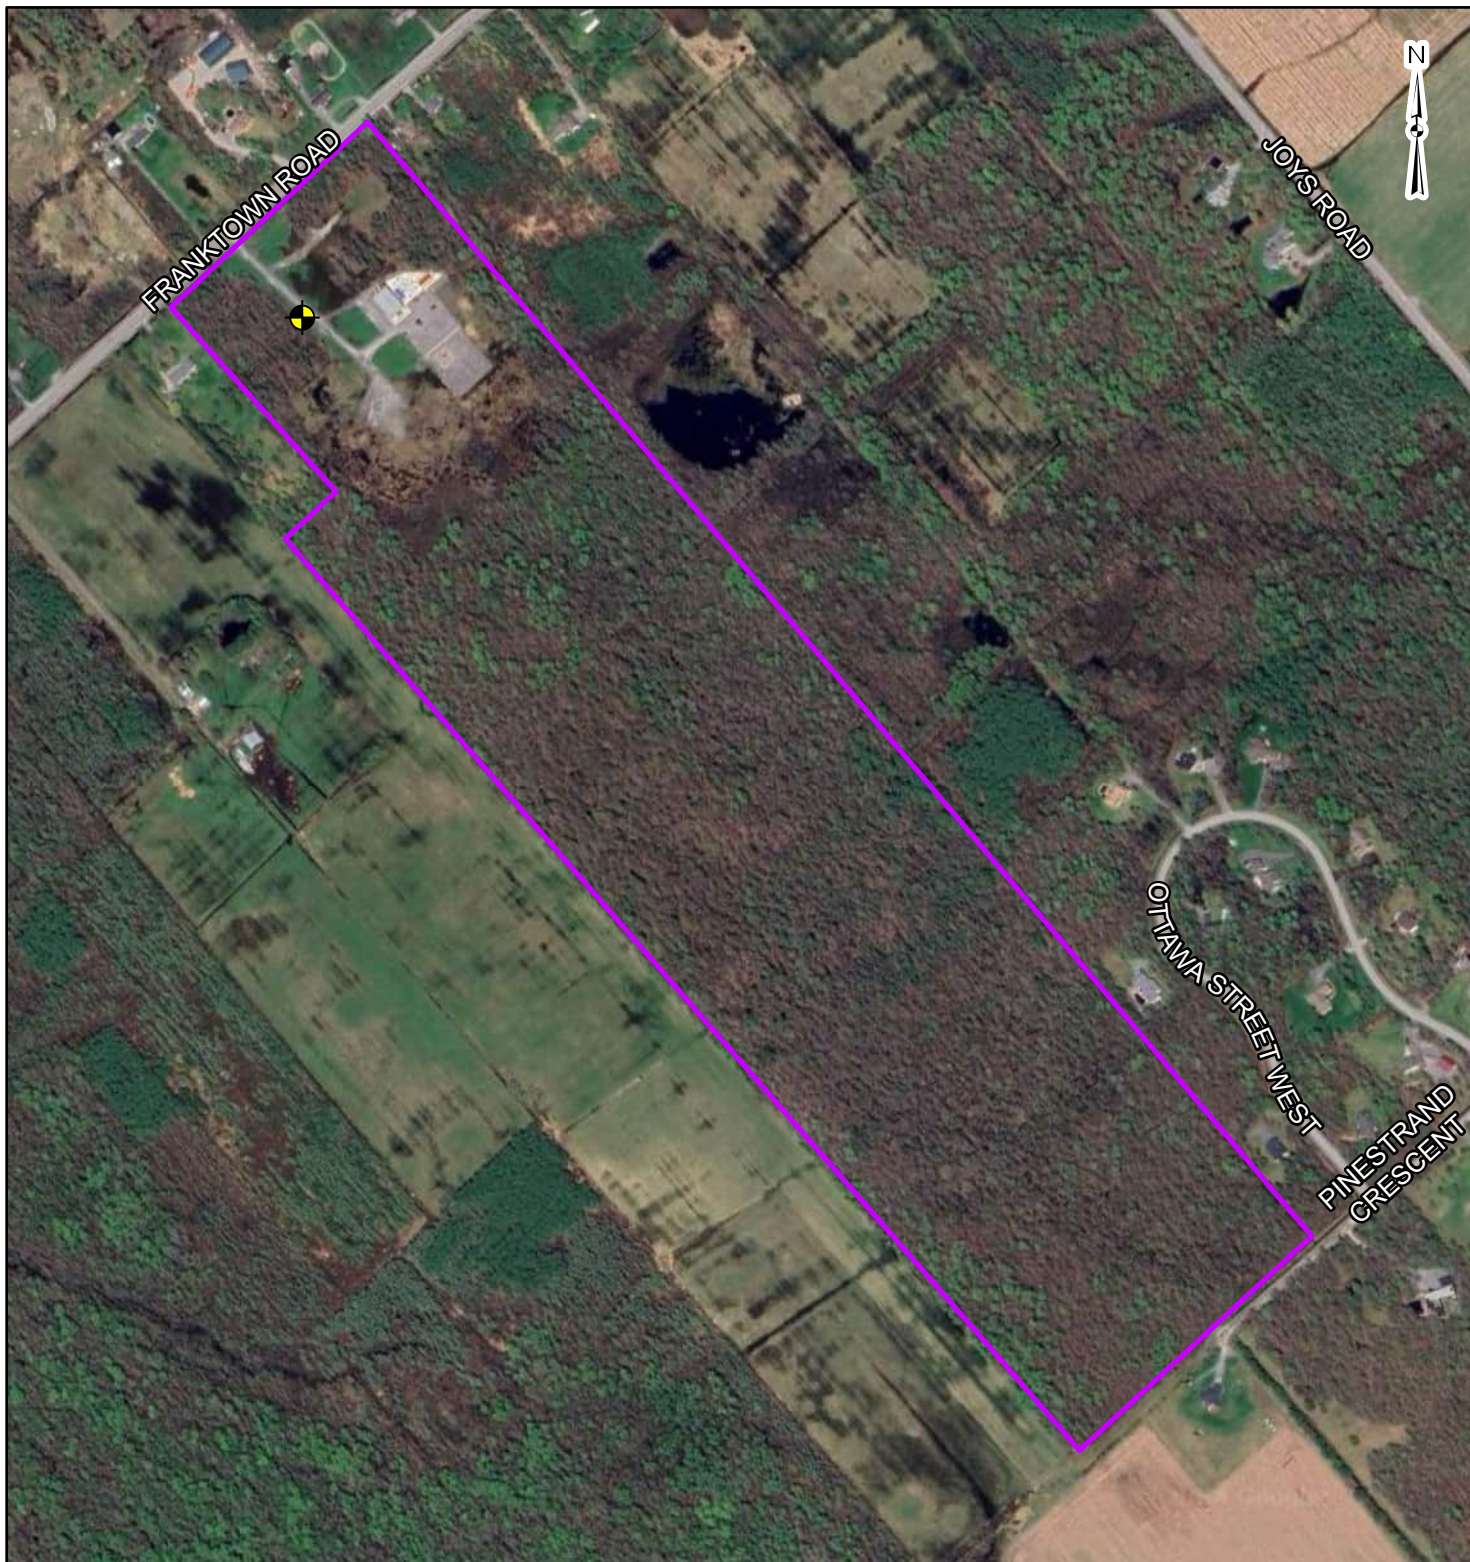
**2**

- Approximate Property Boundary
- ⬮ TW1 (A252856)

The Site location is shown on Figure 1 (Site Location) and an outline of the Site showing the neighbouring properties and an aerial photograph with the proposed development is presented on Figure 2 (Site Layout). A Site Plan of the proposed development has been included in Appendix A.

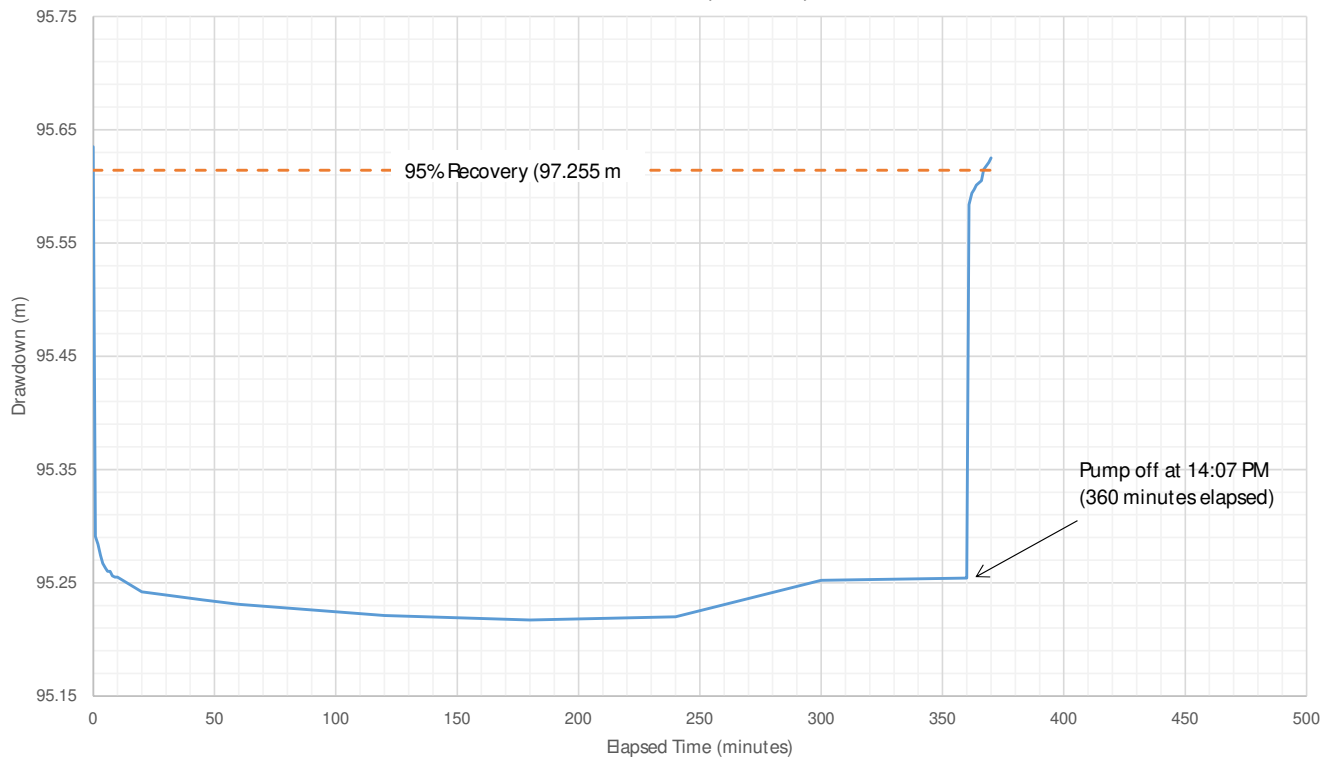
Drawdown vs Time  
TW1 Pumping Test (Drawdown), July 13, 2018  
6688 Franktown Road, Ottawa, ON

The water level ranged between 95.217 m to 95.625 m local (4.375 to 4.783 m btoc), with a maximum drawdown of 0.418 m observed. 100% recovery was achieved in the well within 10 minutes of pump shut down.

At 8:07 AM, the pump was turned on and the flow rate was recorded to be approximately 92 L/min. It is noted that pumping continued for a full 6 hours at a consistent pumping rate (92 L/min). The groundwater level ranged between 4.365 – 4.773 m btoc, with a maximum drawdown of 0.418 m observed.
