HYDROGEOLOGICAL STUDY 6688 FRANKTOWN ROAD

Project No.: CP-17-0503

July 2018

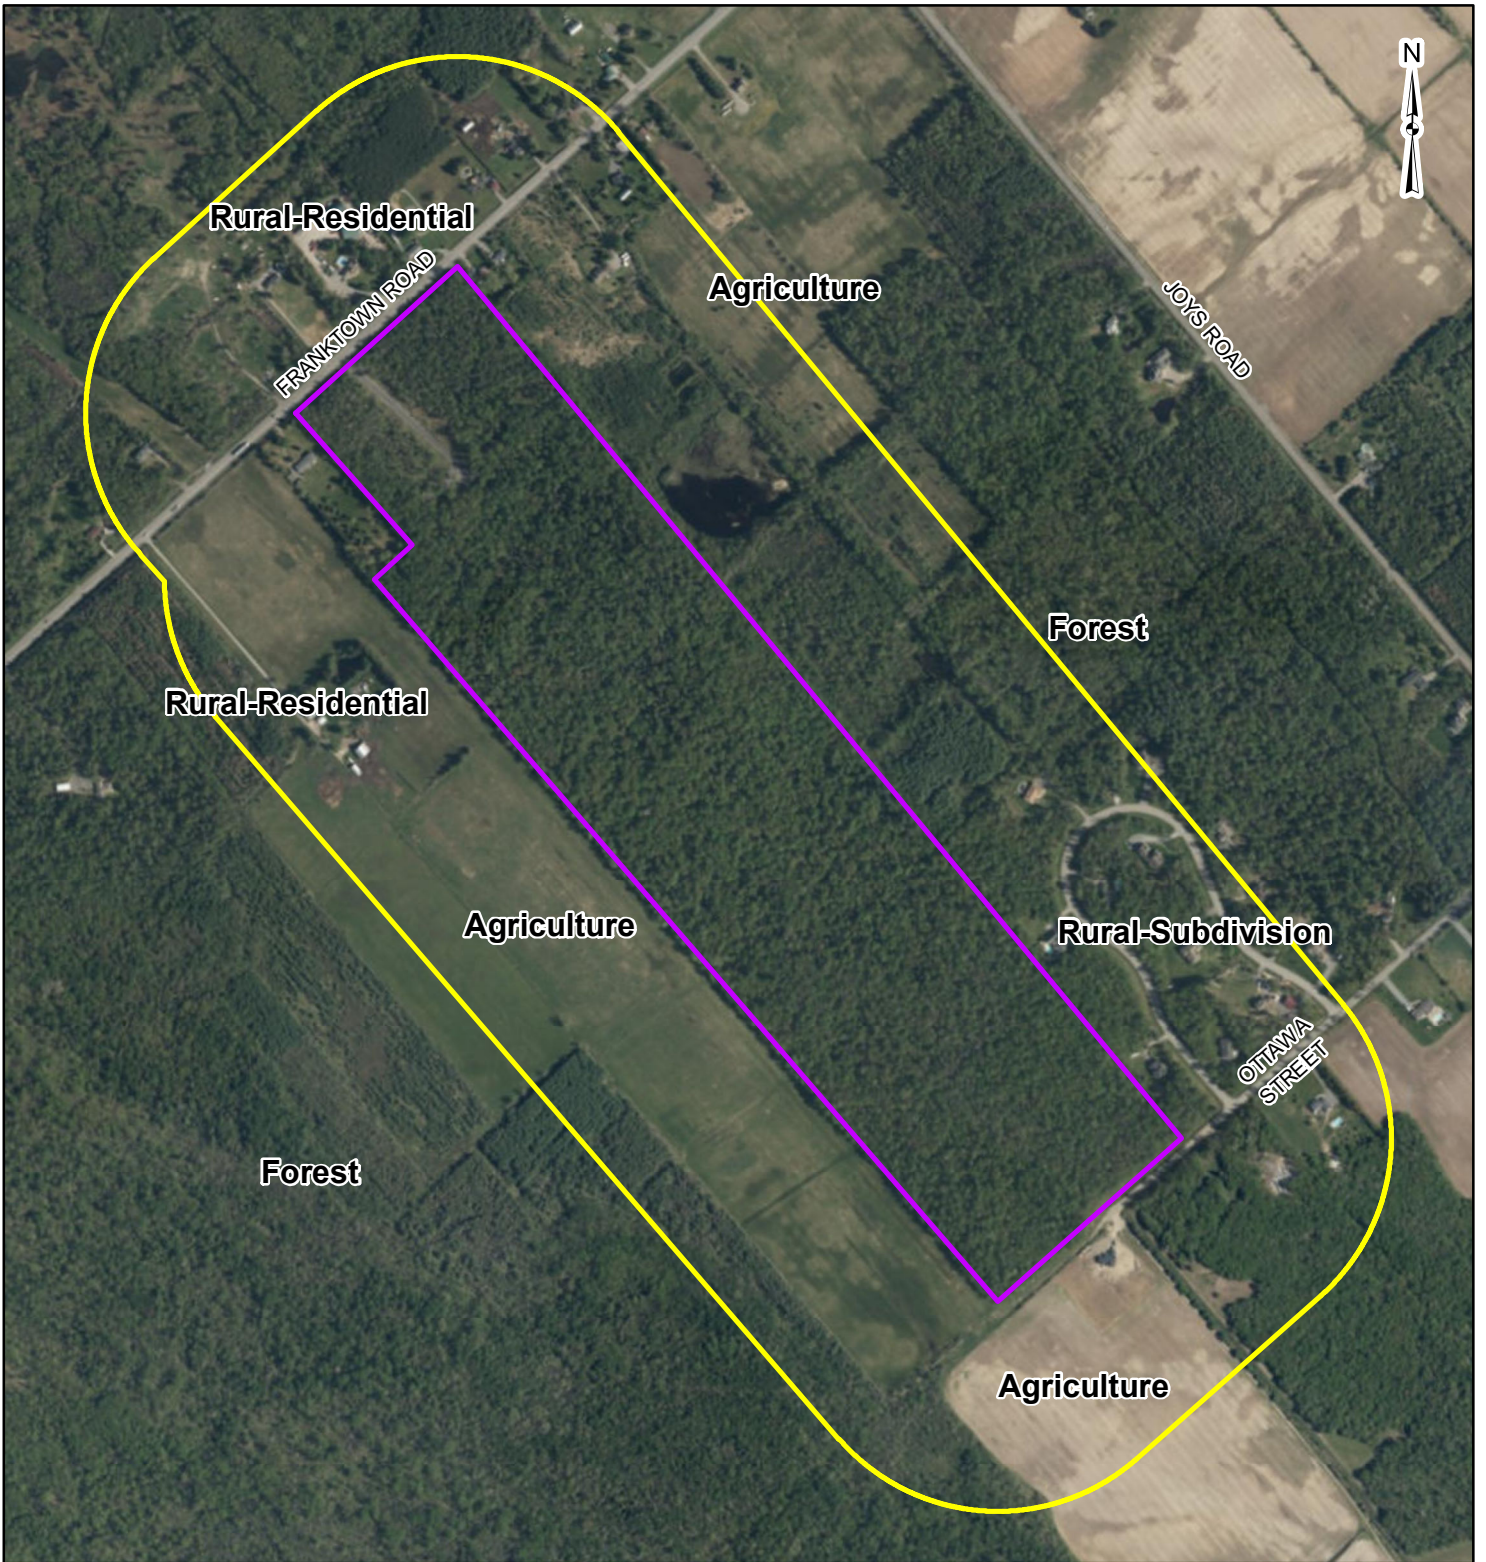
The Site is bound by forested land and low-density residential rural development to north and east, by agricultural fields to the south, and by a buried service corridor to the west (see Figure 3).

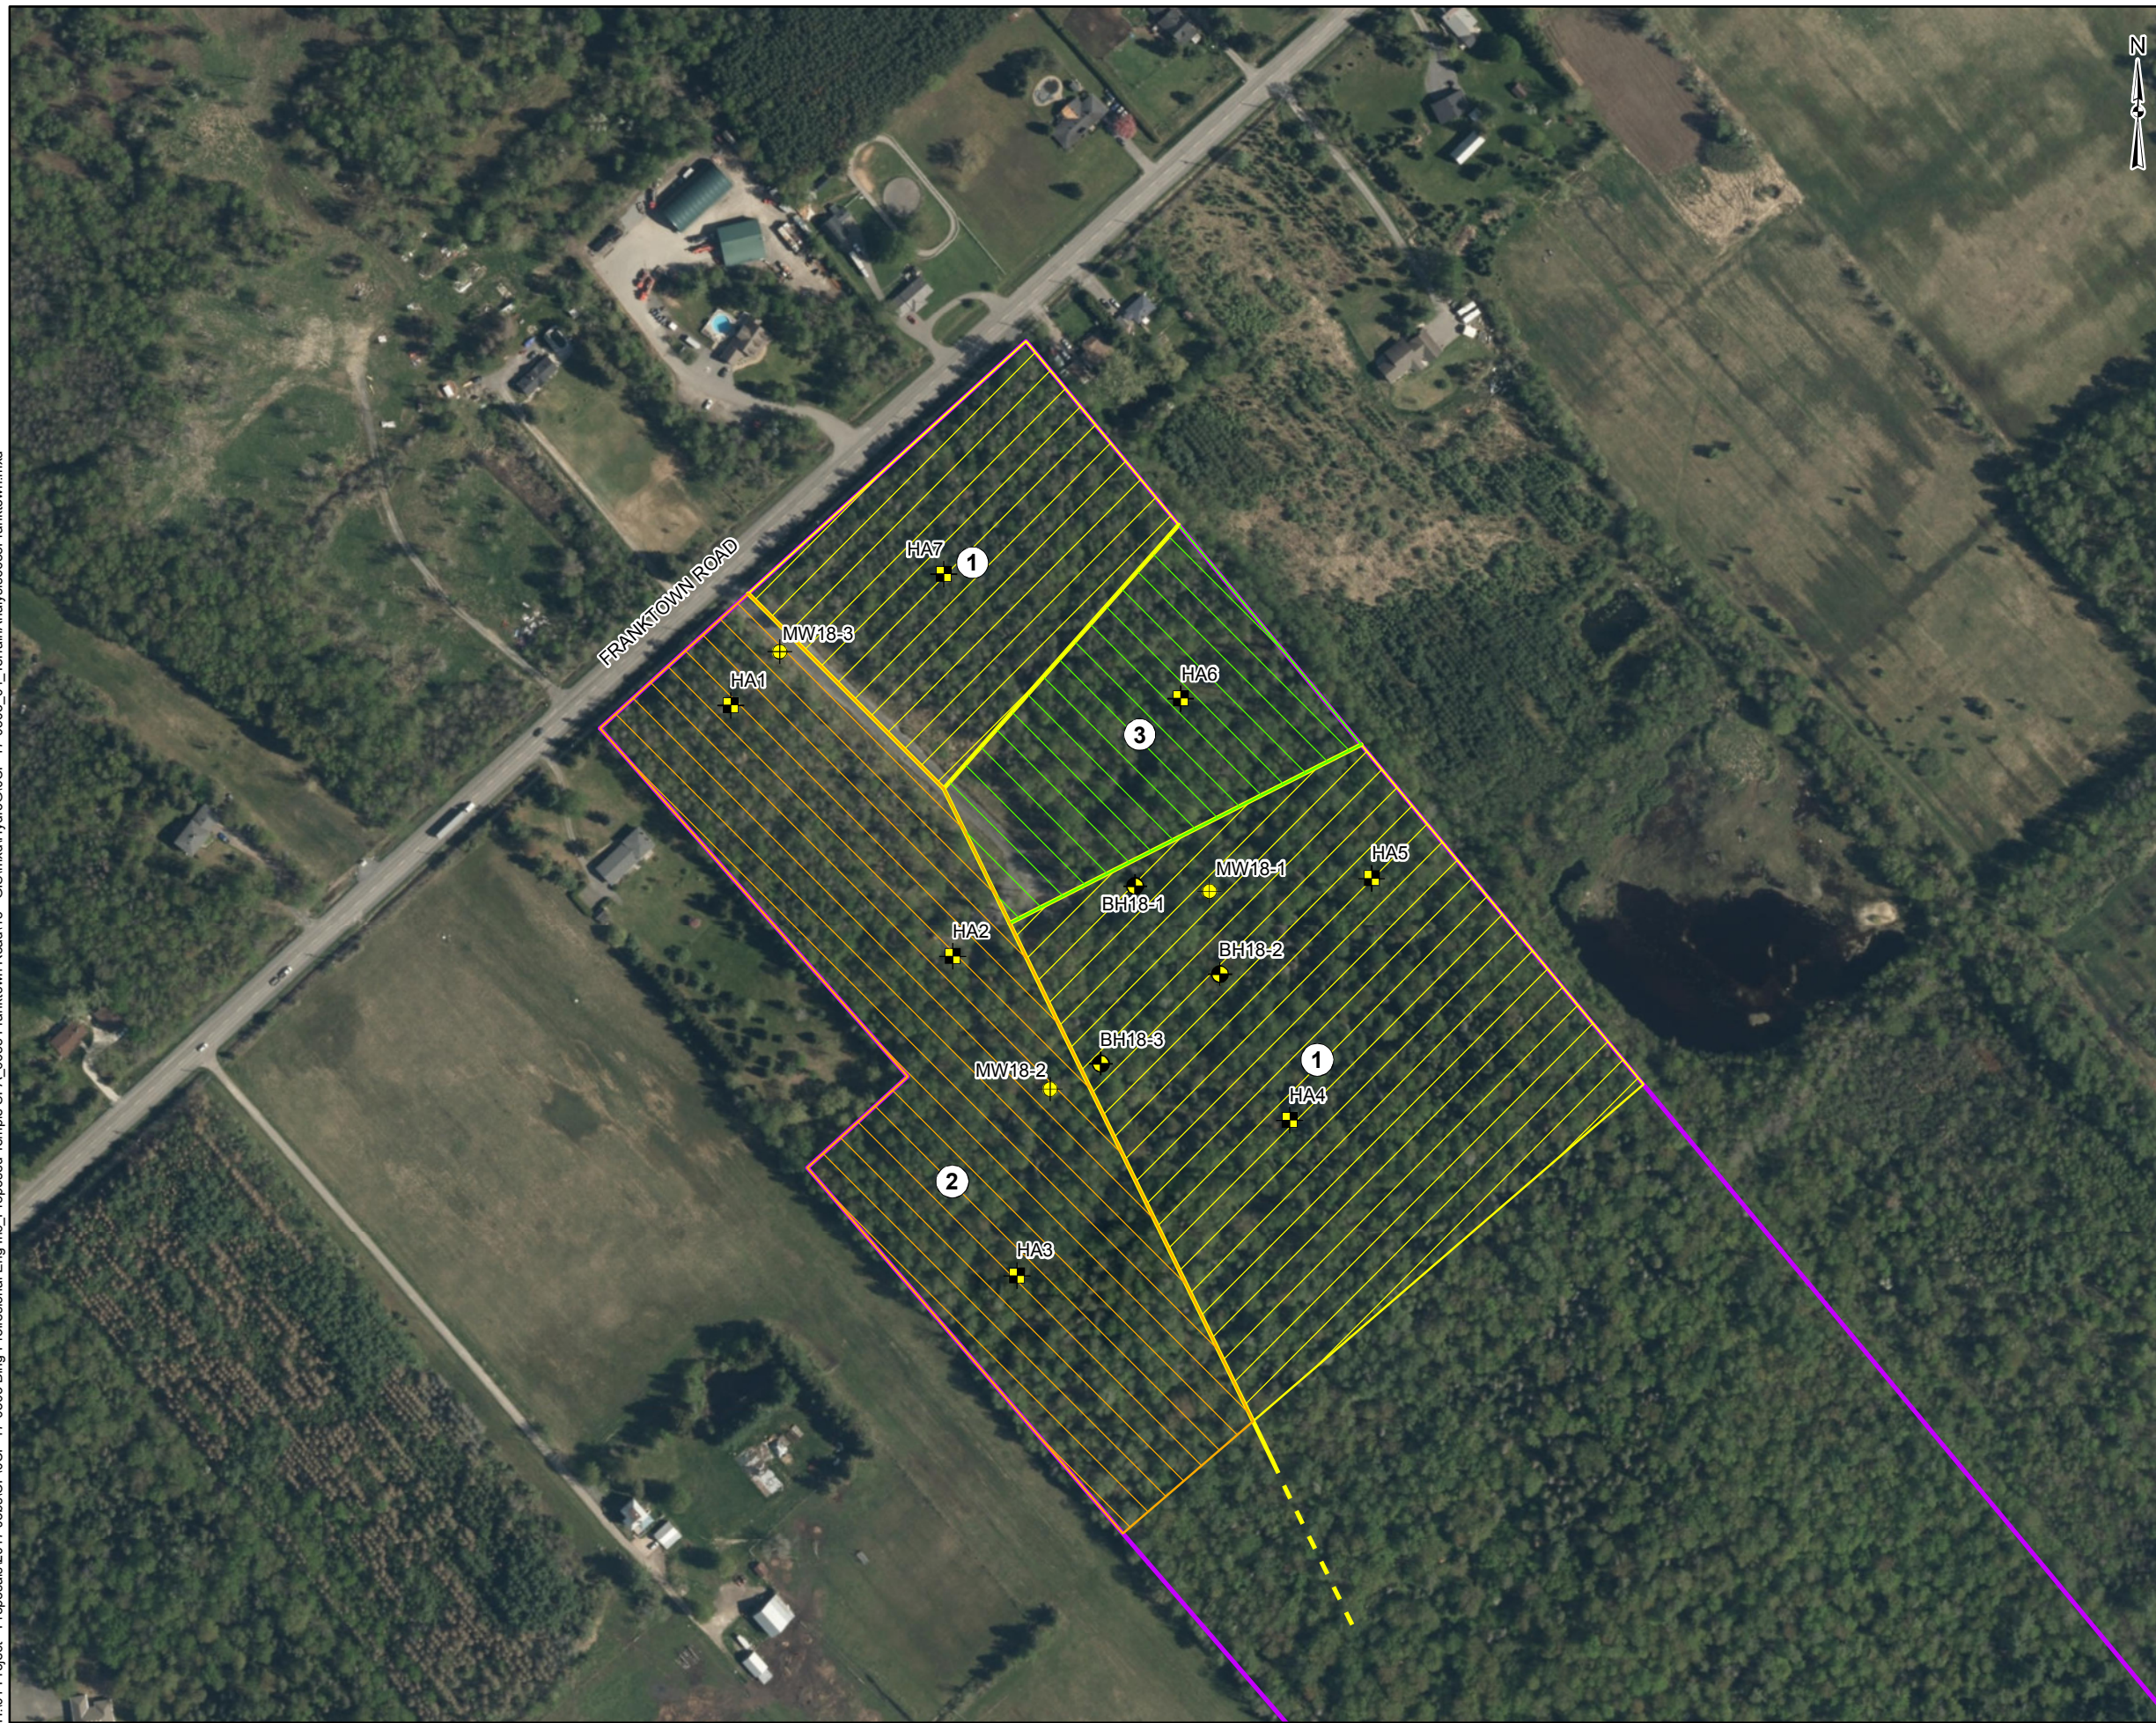
Based on a hand auger program carried out by McIntosh Perry personnel on May 2, 2018, shallow on-site soils can be generally described as coarse grained sand, with areas of silt and clay. From a surficial geology perspective, the Site can be delineated into three main zones (see Figure 4):

Zone 1: Medium brown sand, some to trace fines.

Zone 2: Silt and clay, trace sand.

Zone 3: Silty fine sand.

In addition to hand auger holes, McIntosh Perry personnel advanced three geotechnical boreholes (BH18-1, BH18-2, BH18-3) and three monitoring wells (MW18-1, MW18-2, MW18-3) at the Site on May 23-24, 2018 (see Figure 4).

- Hand Auger
- Borehole
- Monitoring Well
- Site Boundary
- Zone 1 - MEDIUM SAND, some to trace fines
- Zone 2 - SILT and CLAY, trace sand
- Zone 3 - Silty FINE SAND

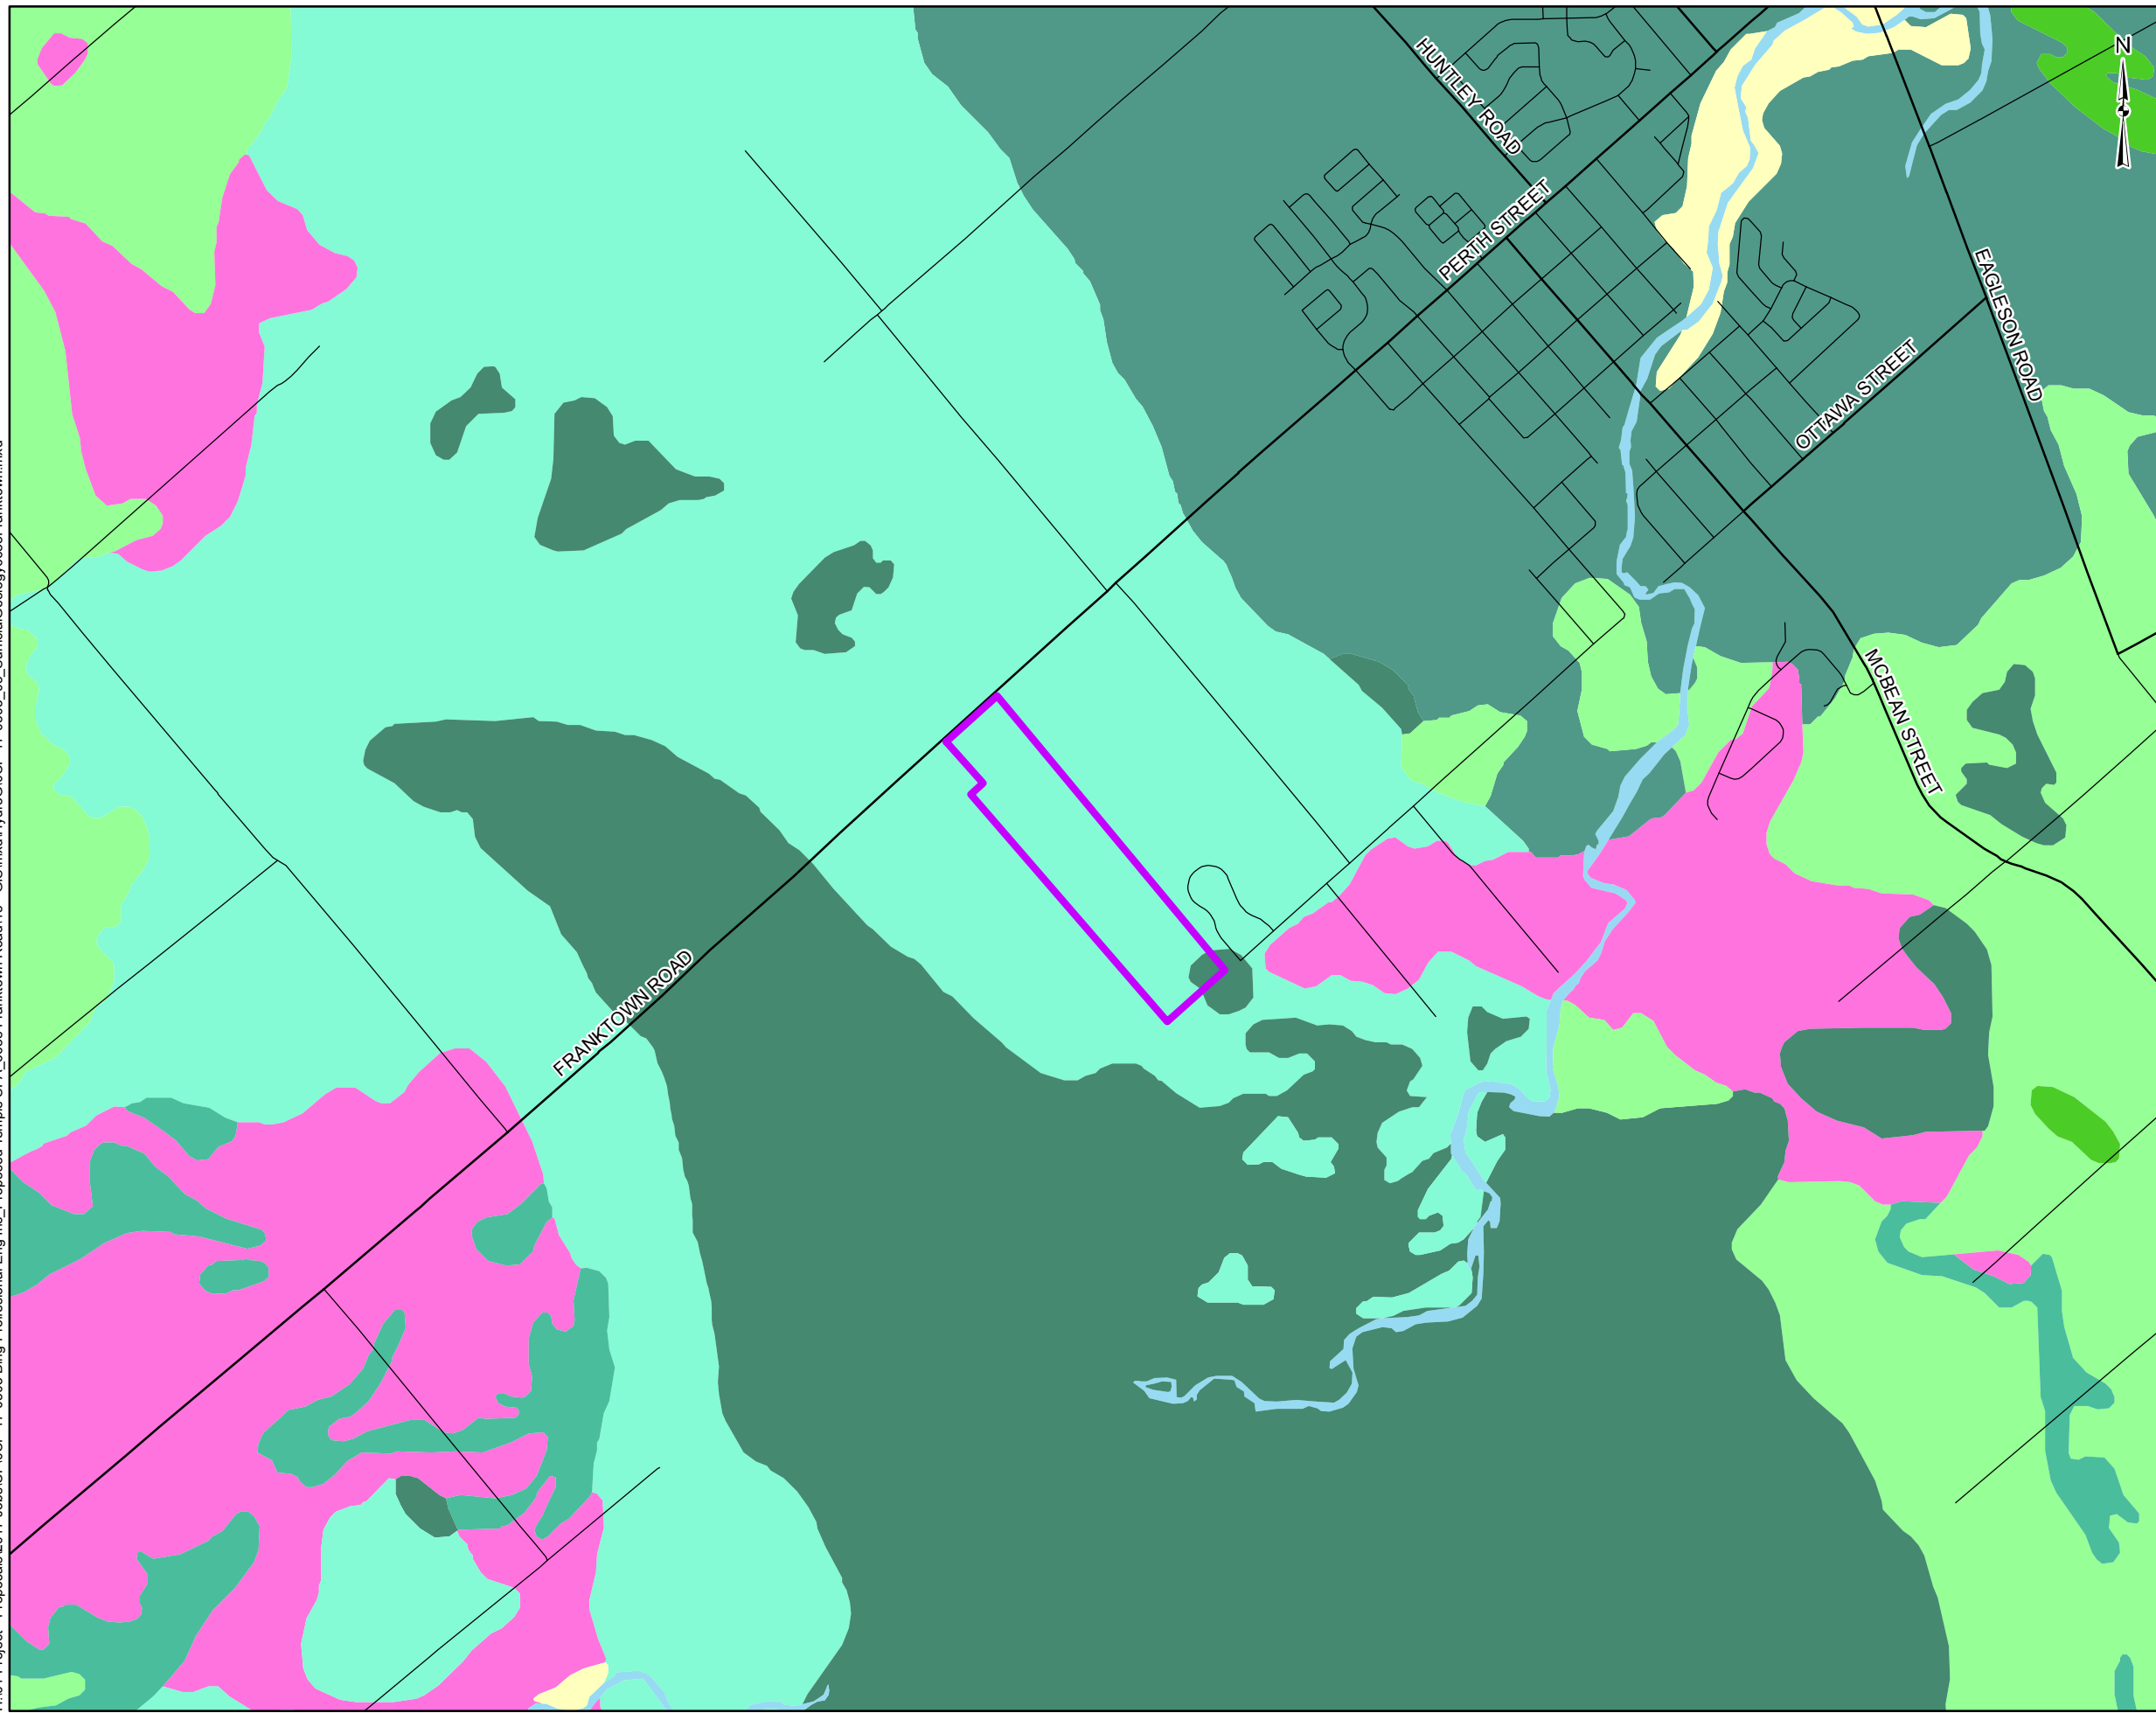
Data taken from the OGS GIS Downloads website are generally consistent with on-site observations. Geological maps of the area classify the overburden at the Site as coarse-textured glaciomarine deposits, including sand, gravel, and minor silt and clay (see Figure 5). (OGS, 2018)

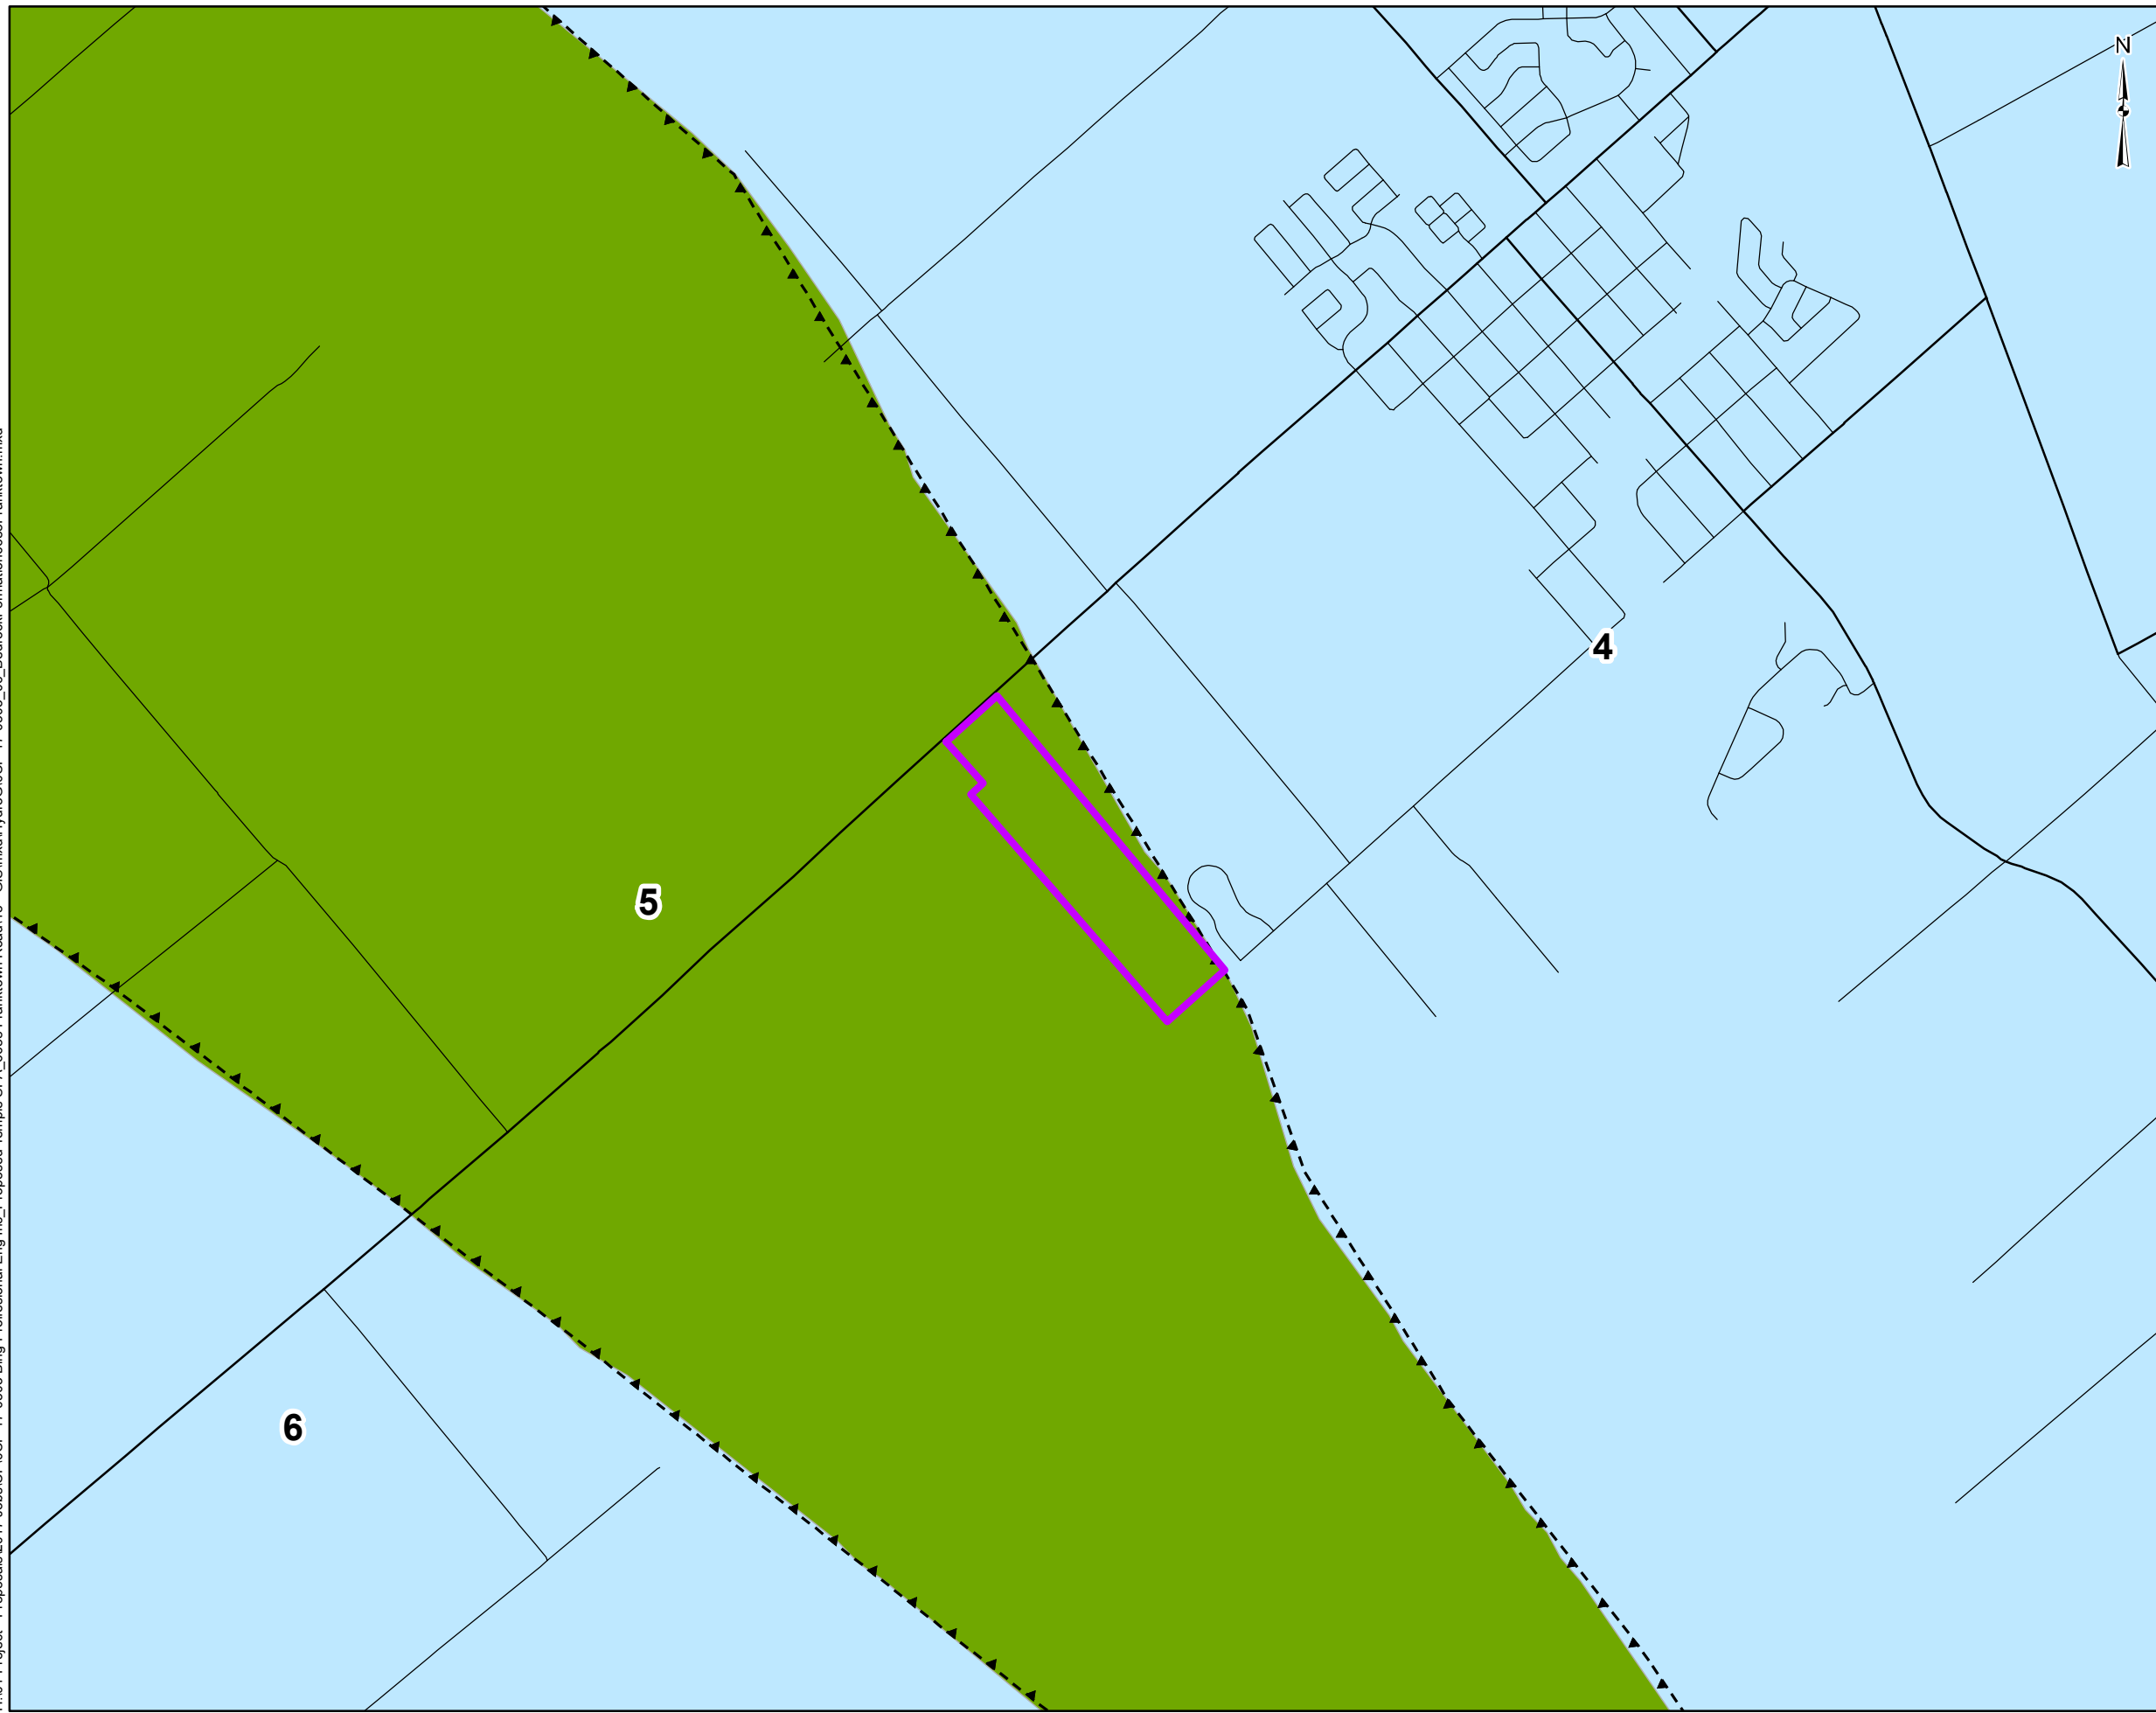
Geological maps of the area classify the bedrock under the Site as limestone, dolostone, shale, arkose, and sandstone of the Ottawa Group, Simcoe Group, and/or of the Shadow Lake Formation (see Figure 6). (OGS, 2018)

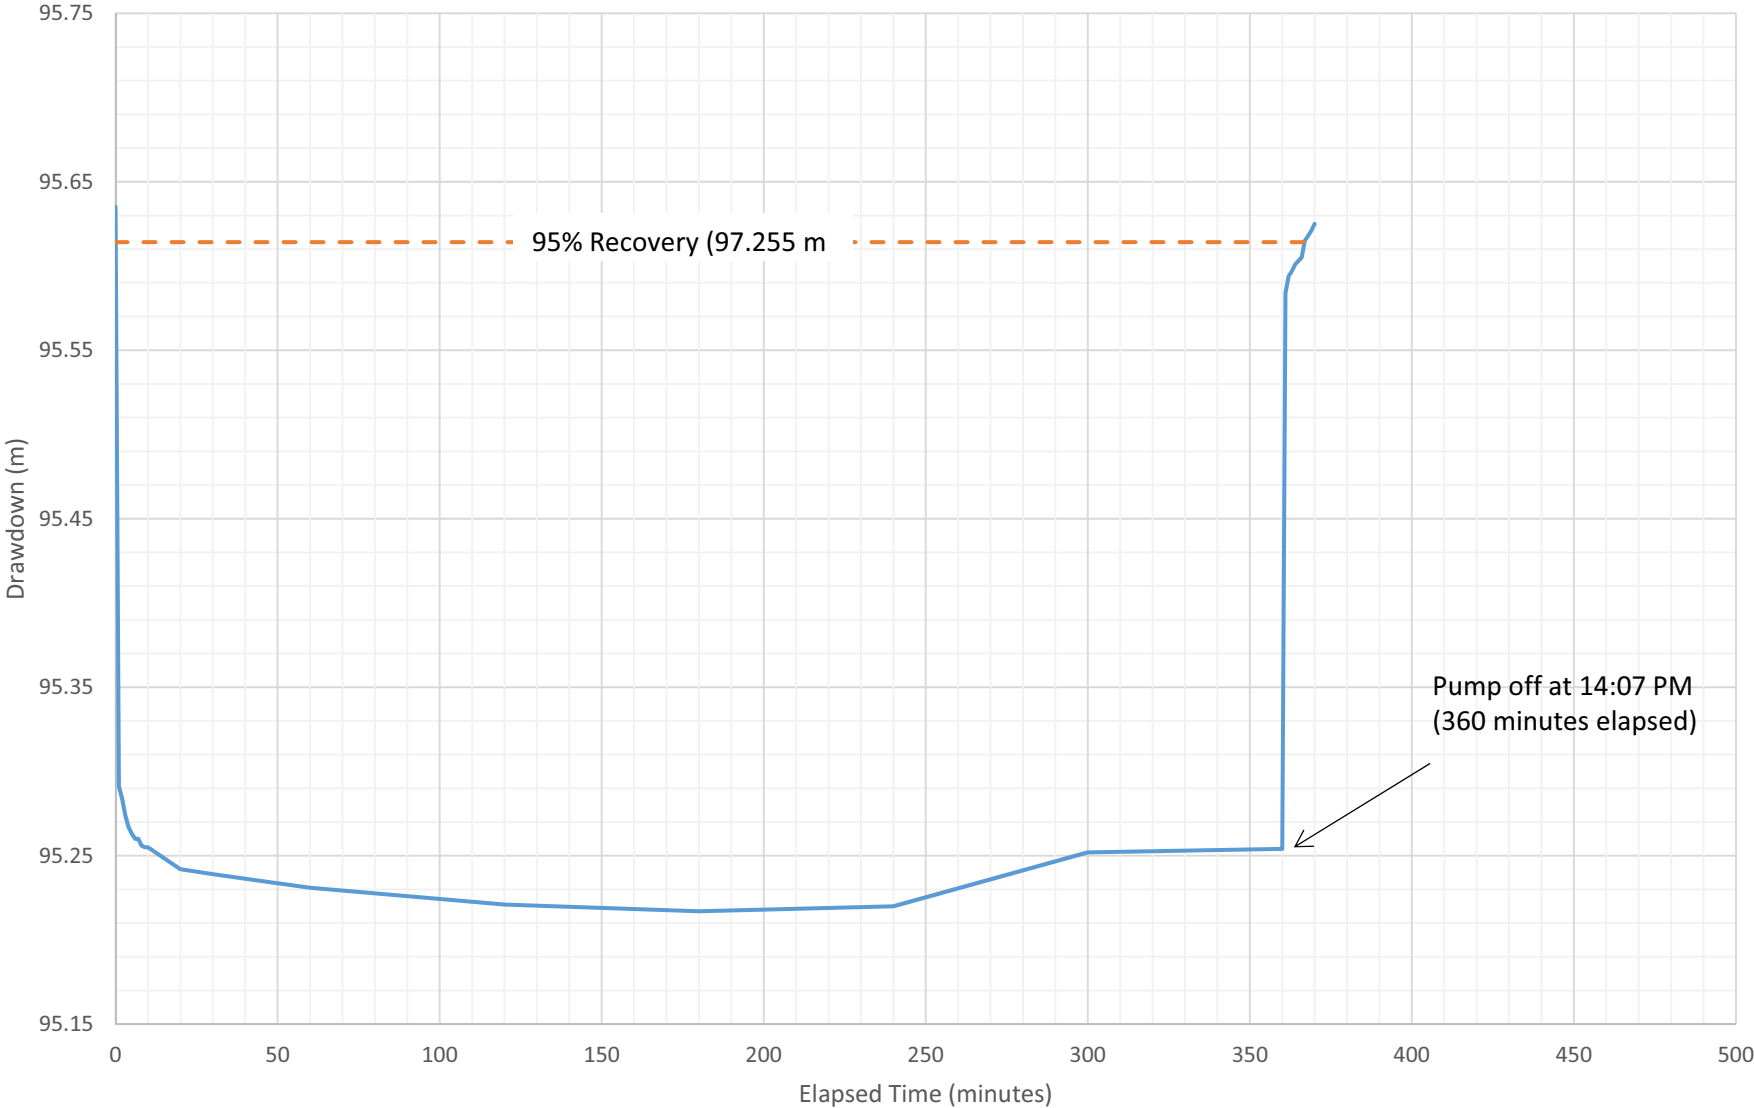
Drawdown vs Time
TW1 Pumping Test (Drawdown), July 13, 2018
6688 Franktown Road, Ottawa, ON

The water level ranged between 95.217 m to 95.625 m local (4.375 to 4.783 m btoc), with a maximum drawdown of 0.418 m observed. 100% recovery was achieved in the well within 10 minutes of pump shut down.

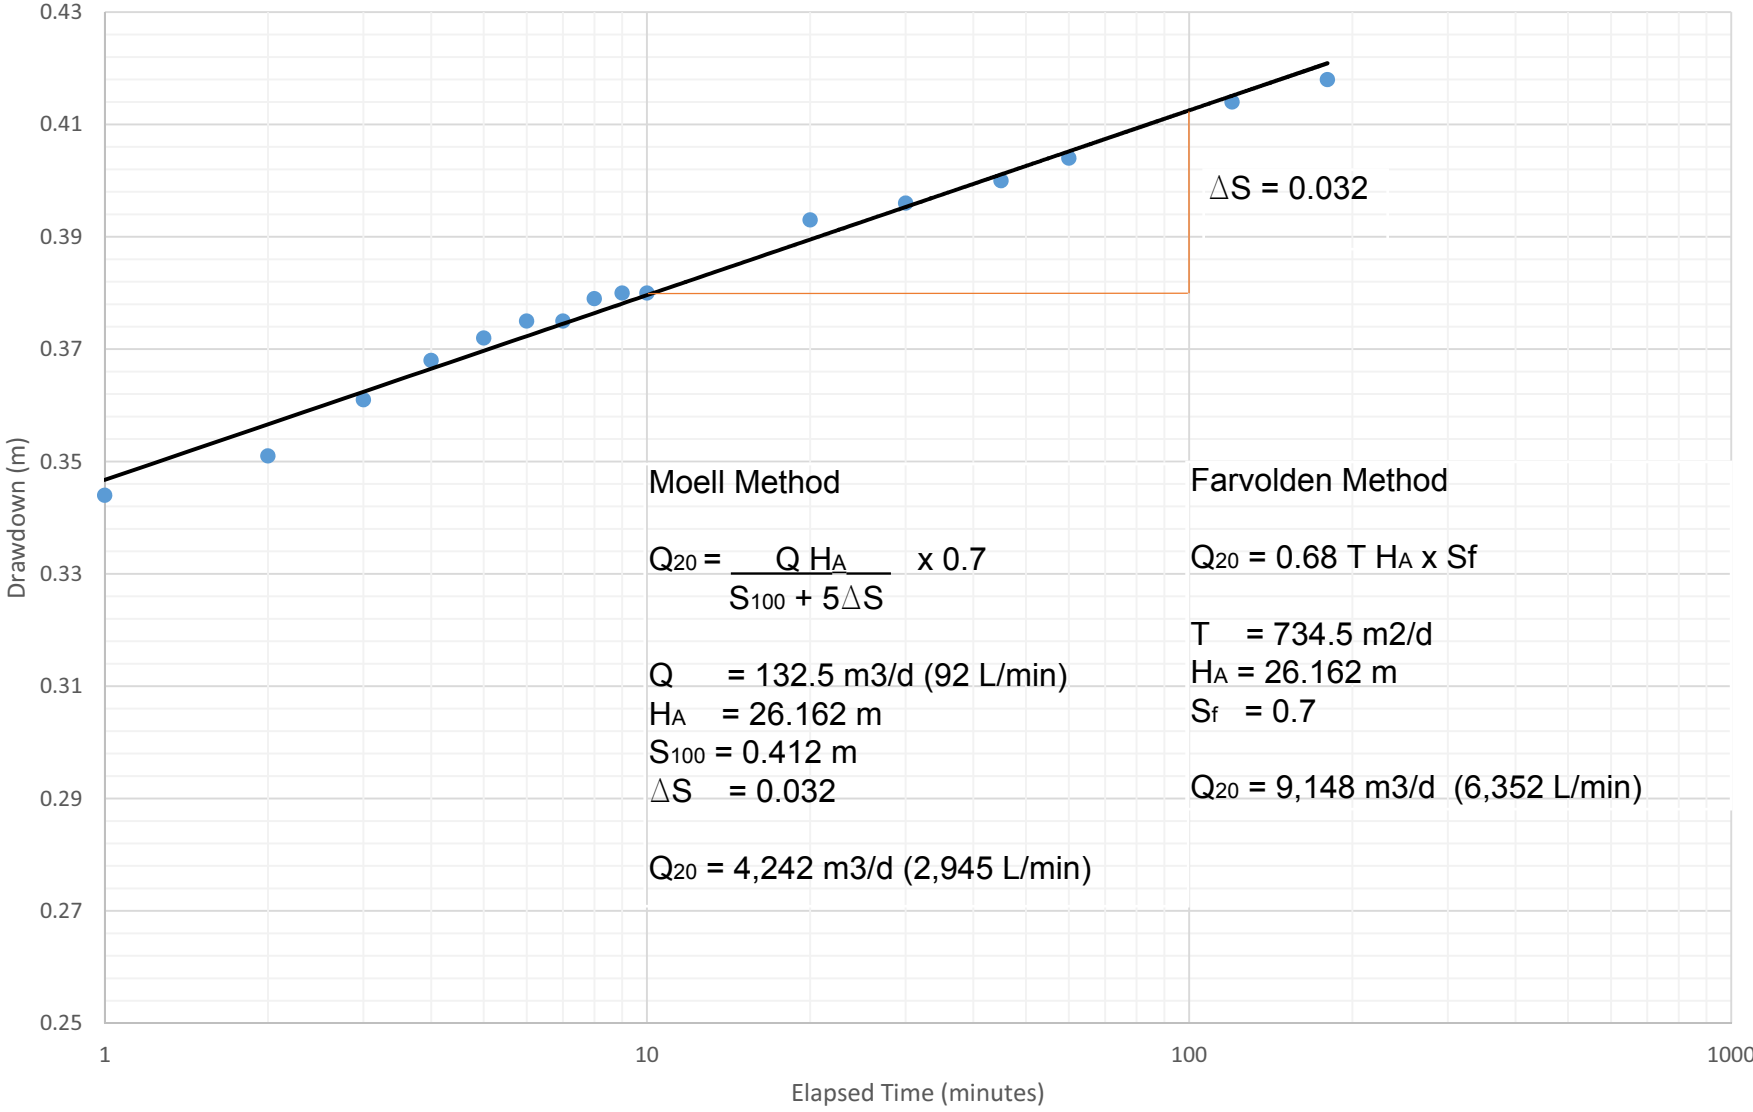
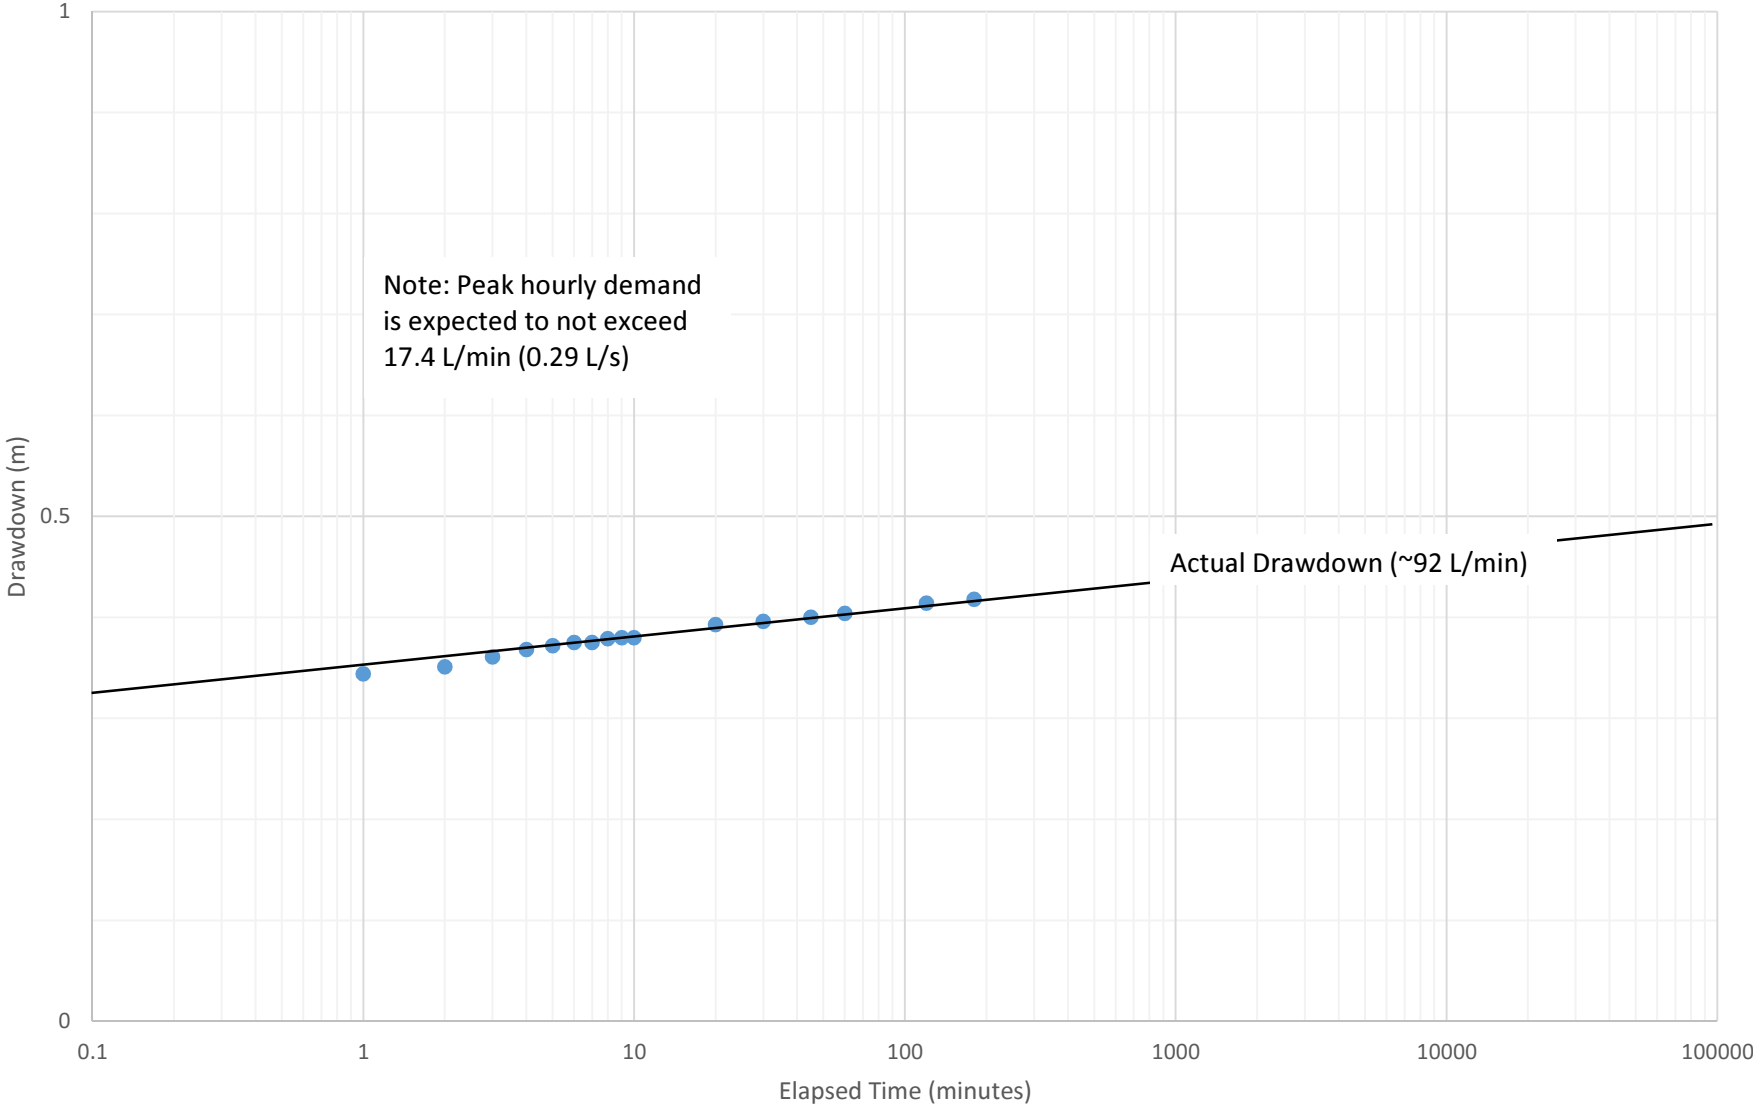
Drawdown vs Log Time
TW1 Pumping Test (Drawdown), July 13, 2018
6688 Franktown Road, Ottawa, ON

By extrapolating the drawdown data on a semi-logarithmic scale, it is estimated that a conservatively maximum pumping rate of 92 L/min could be sustained for over 100,000 minutes (69 days) of continuous pumping with a maximum drawdown of under 1 m (see Appendix E). It is noted that this situation is inherently conservative, as the pump will cycle on and off on a much shorter time scale, allowing the well to recharge.
