**PHASE I - ENVIRONMENTAL SITE ASSESSMENT
VACANT PROPERTY
BANK STREET AT PARKWAY ROAD
CITY OF OTTAWA (GREELY), ONTARIO**

Sunset Lakes Development Corporation

December 17, 2003

Report No. E2834-1

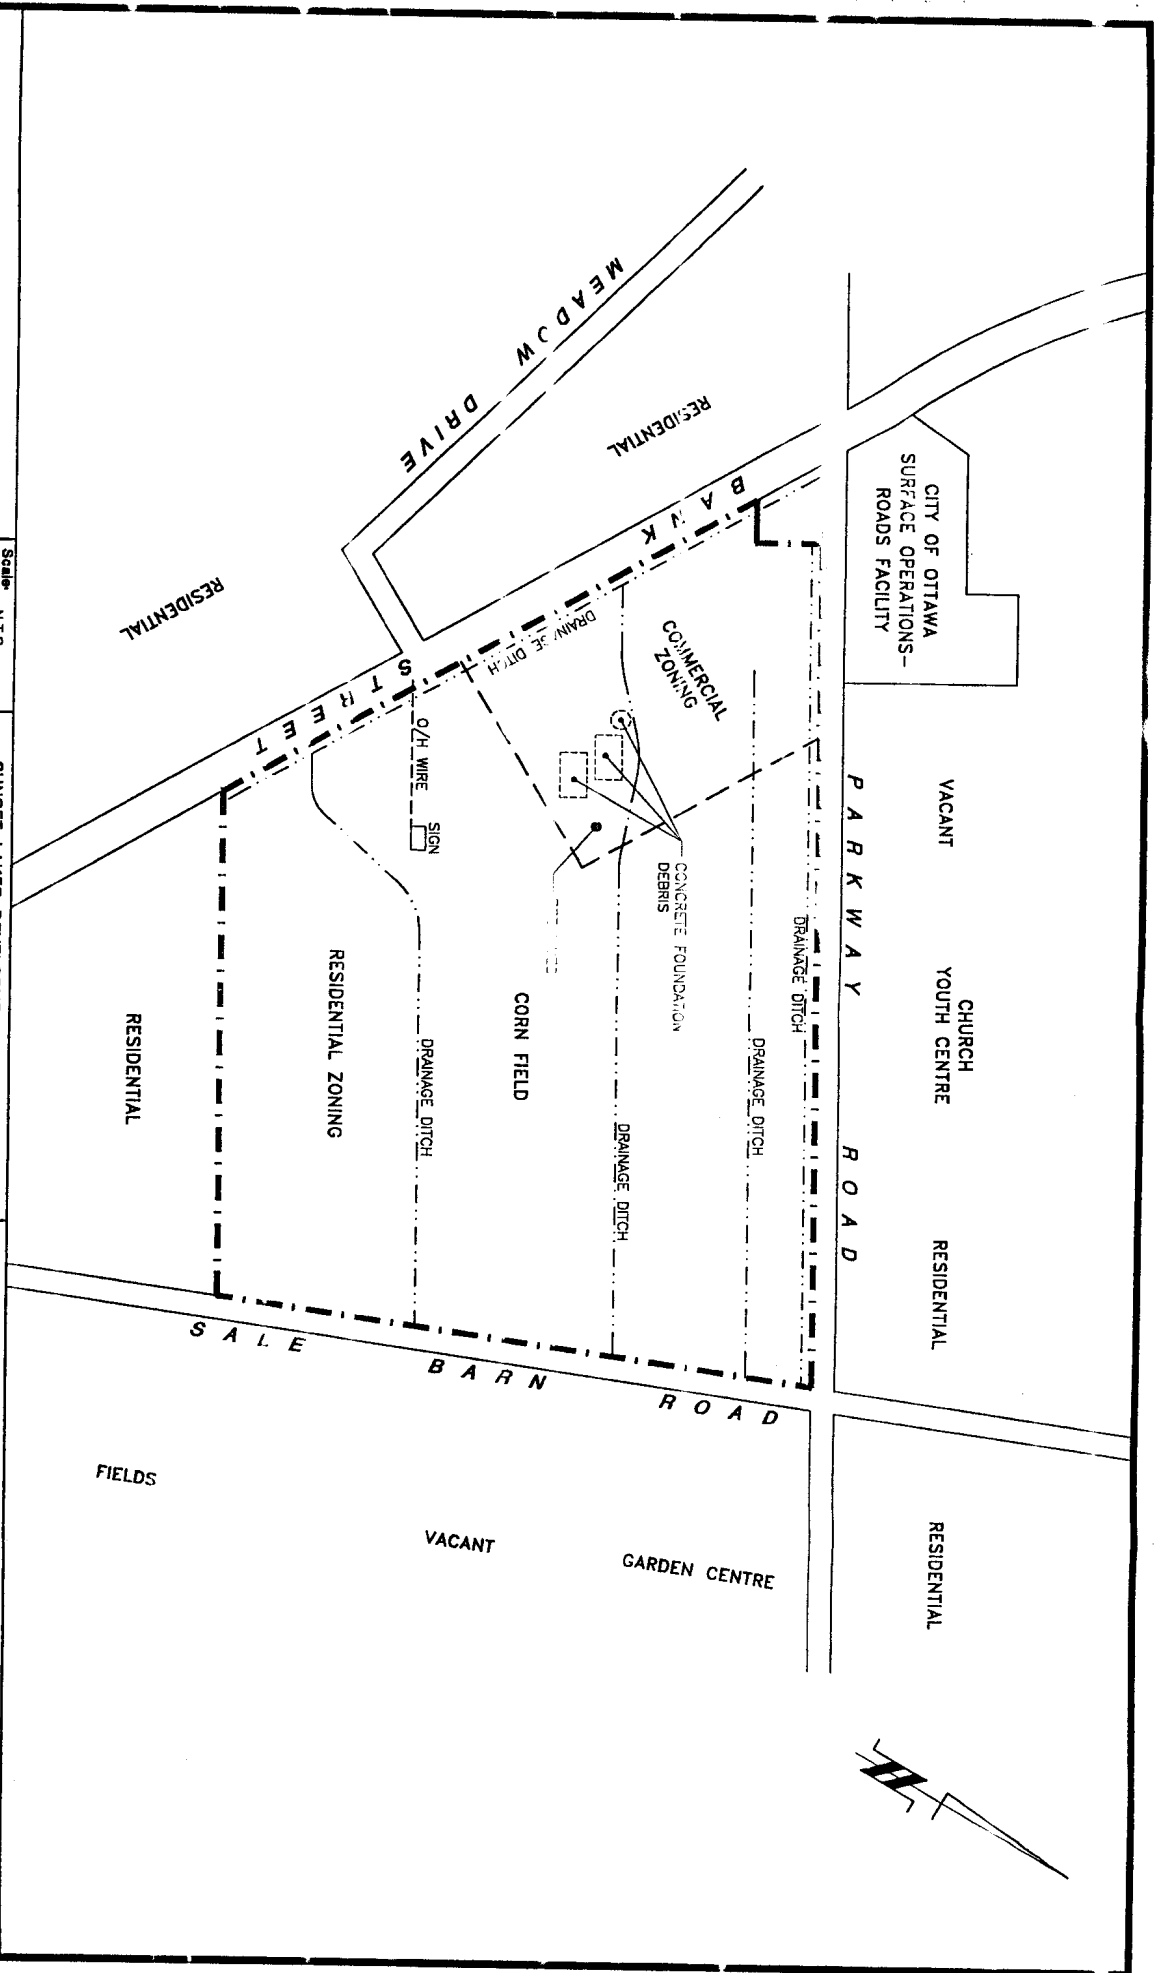
SITE PLAN

- North - *Parkway Road, commercial (City yard), church and residential;*
- South - *Residential;*
- East - *Sale Barn Road followed by commercial farm and vacant fields;*
- West - *Bank Street followed by residential.*

The environmental impact of the neighbouring properties upon the subject site was considered to be low with the possible exception of the road maintenance facility located across Parkway Road. Based on interviews with MTO personnel, it was determined that the storage and handling of salt on has impacted the shallow groundwater aquifer beneath the former MTO site, although no information was available for the deeper groundwater aquifer. The potential for impacted groundwater, in the shallow aquifer to have migrated onto the subject property is difficult to assess, since the nature and depth of the overburden materials, the bedrock formation and the groundwater flow direction are not well known. However, it is our opinion that the potential for the deeper aquifer to have been significantly impacted is low. Furthermore, road salt impacted groundwater can be readily treated and it is not considered to represent a significant liability to the subject land.

Land use adjacent to the subject site is illustrated on Drawing No. E2834-1 - Site Plan in Appendix 2 of this report.

It is our understanding that a hydrogeological study will be required prior to the development of the site. As part of this study, it is recommended that one of the test well be installed in relatively close proximity to the road maintenance facility in order to assess the groundwater quality in the bedrock aquifer.
