Phase II-Environmental Site Assessment

70 Beech Street and 75 Norman Street
Ottawa, Ontario

Prepared For
Beech Holdings Ltd.

August 22, 2018
Report: PE2746-2

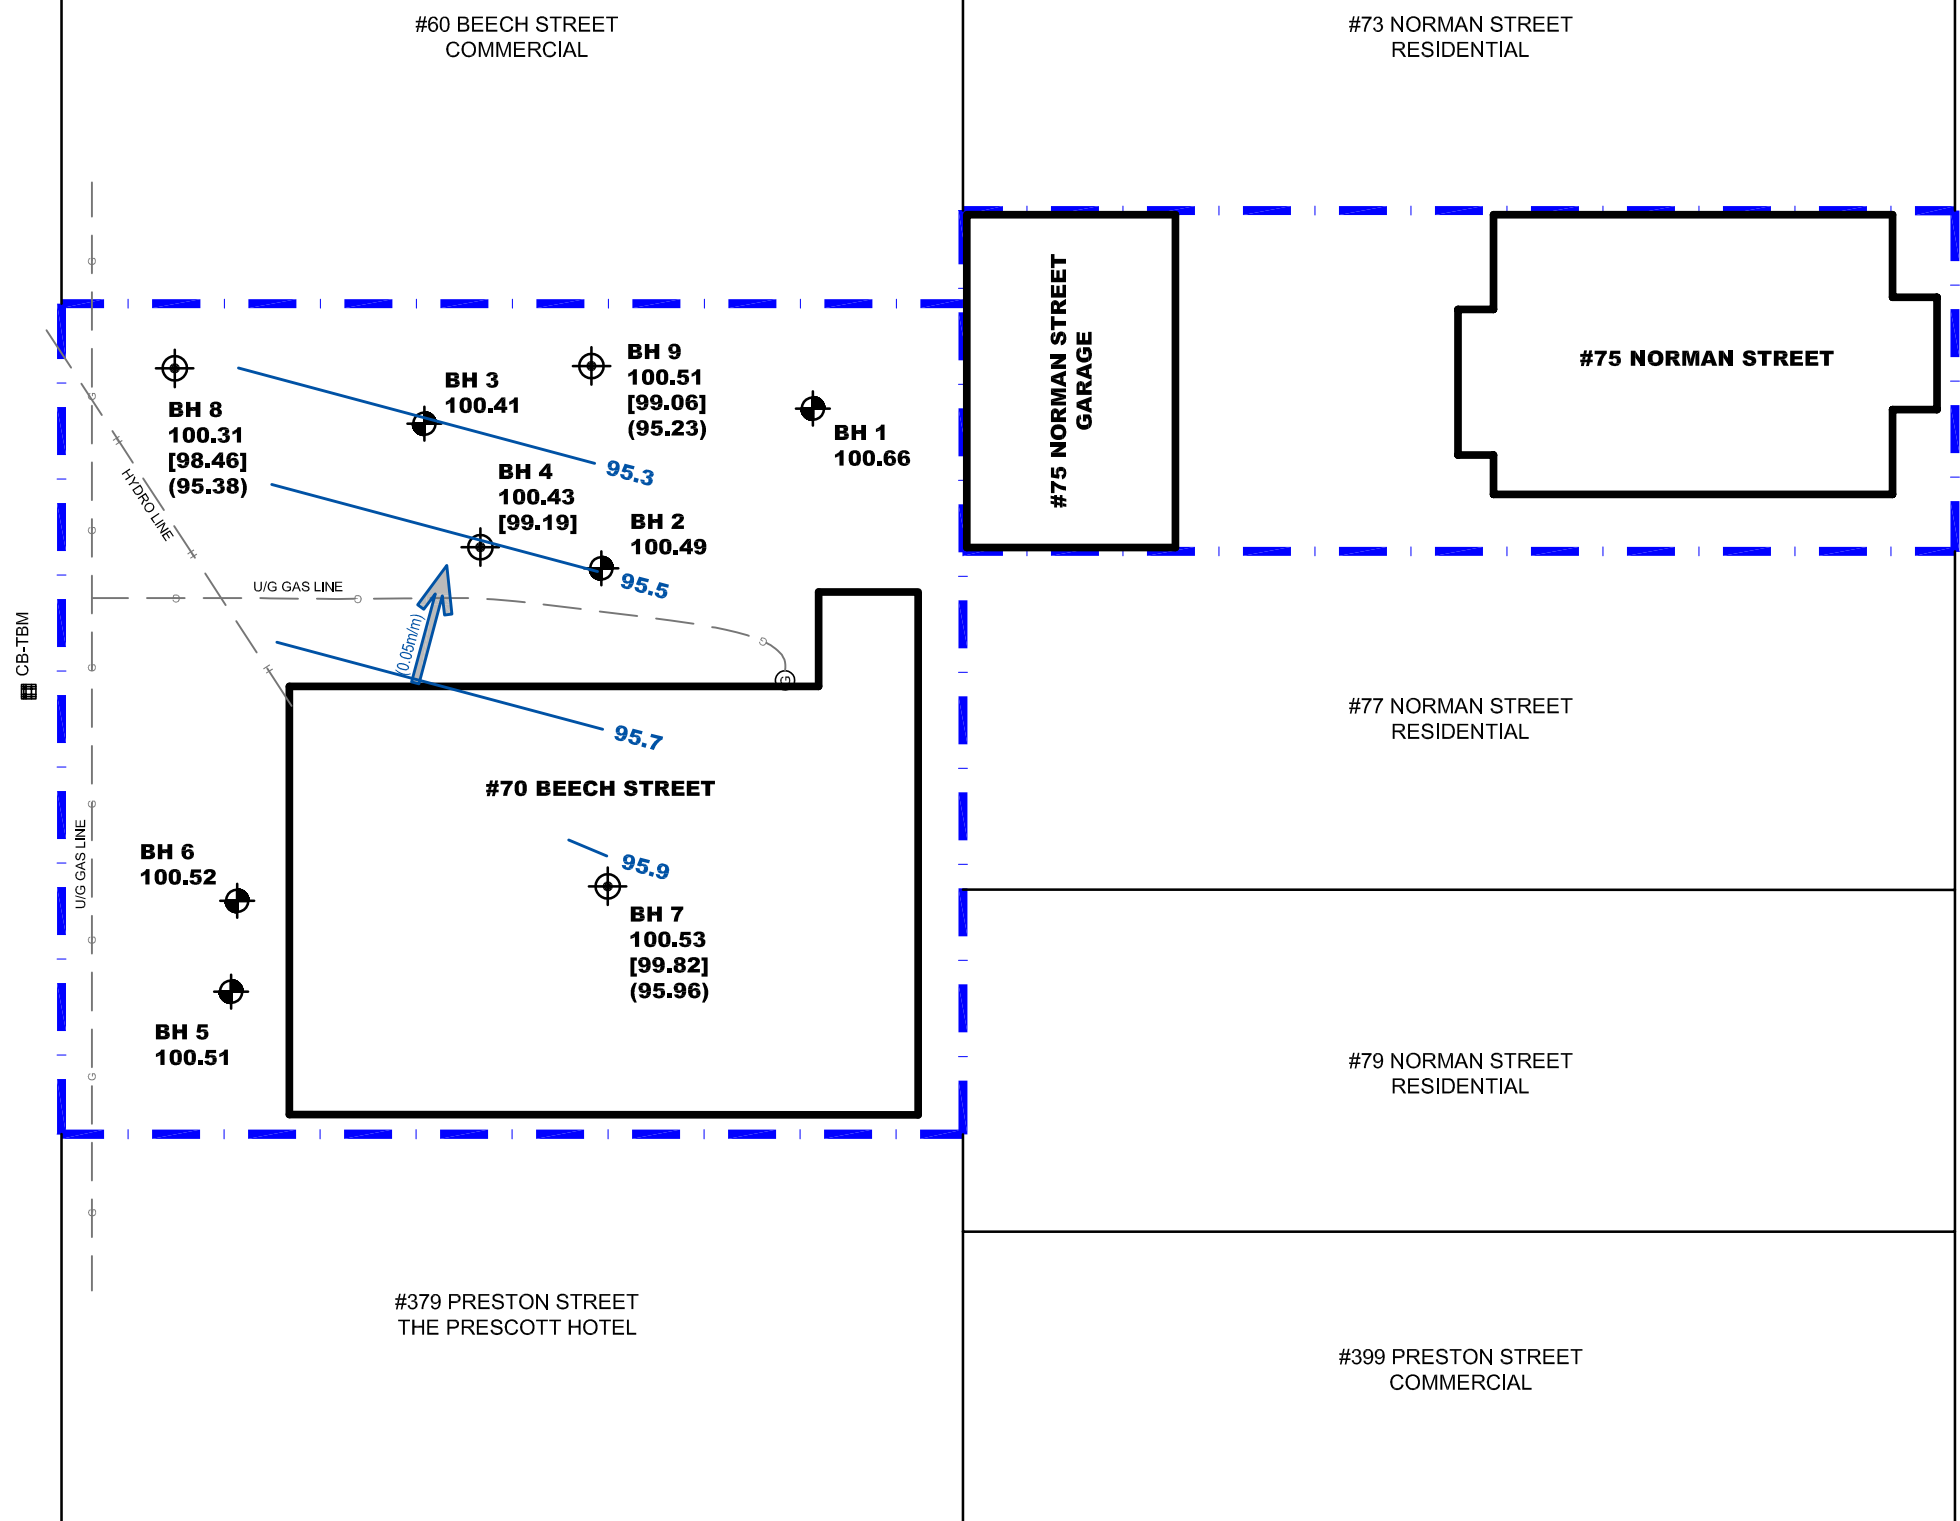
Based on the groundwater elevations from the most recent sampling event (June 2018), groundwater contour mapping was completed for the bedrock aquifer unit. Groundwater contours are shown on Drawing PE2746-5 - Groundwater Contour Plan. Based on the contour mapping, groundwater flow at the subject site appears to be in a eastern direction. A horizontal hydraulic gradient of approximately 0.05 m/m was calculated. No free product was observed in the monitoring wells at the subject site. No visual or olfactory indications of contamination were noted during the groundwater monitoring events.

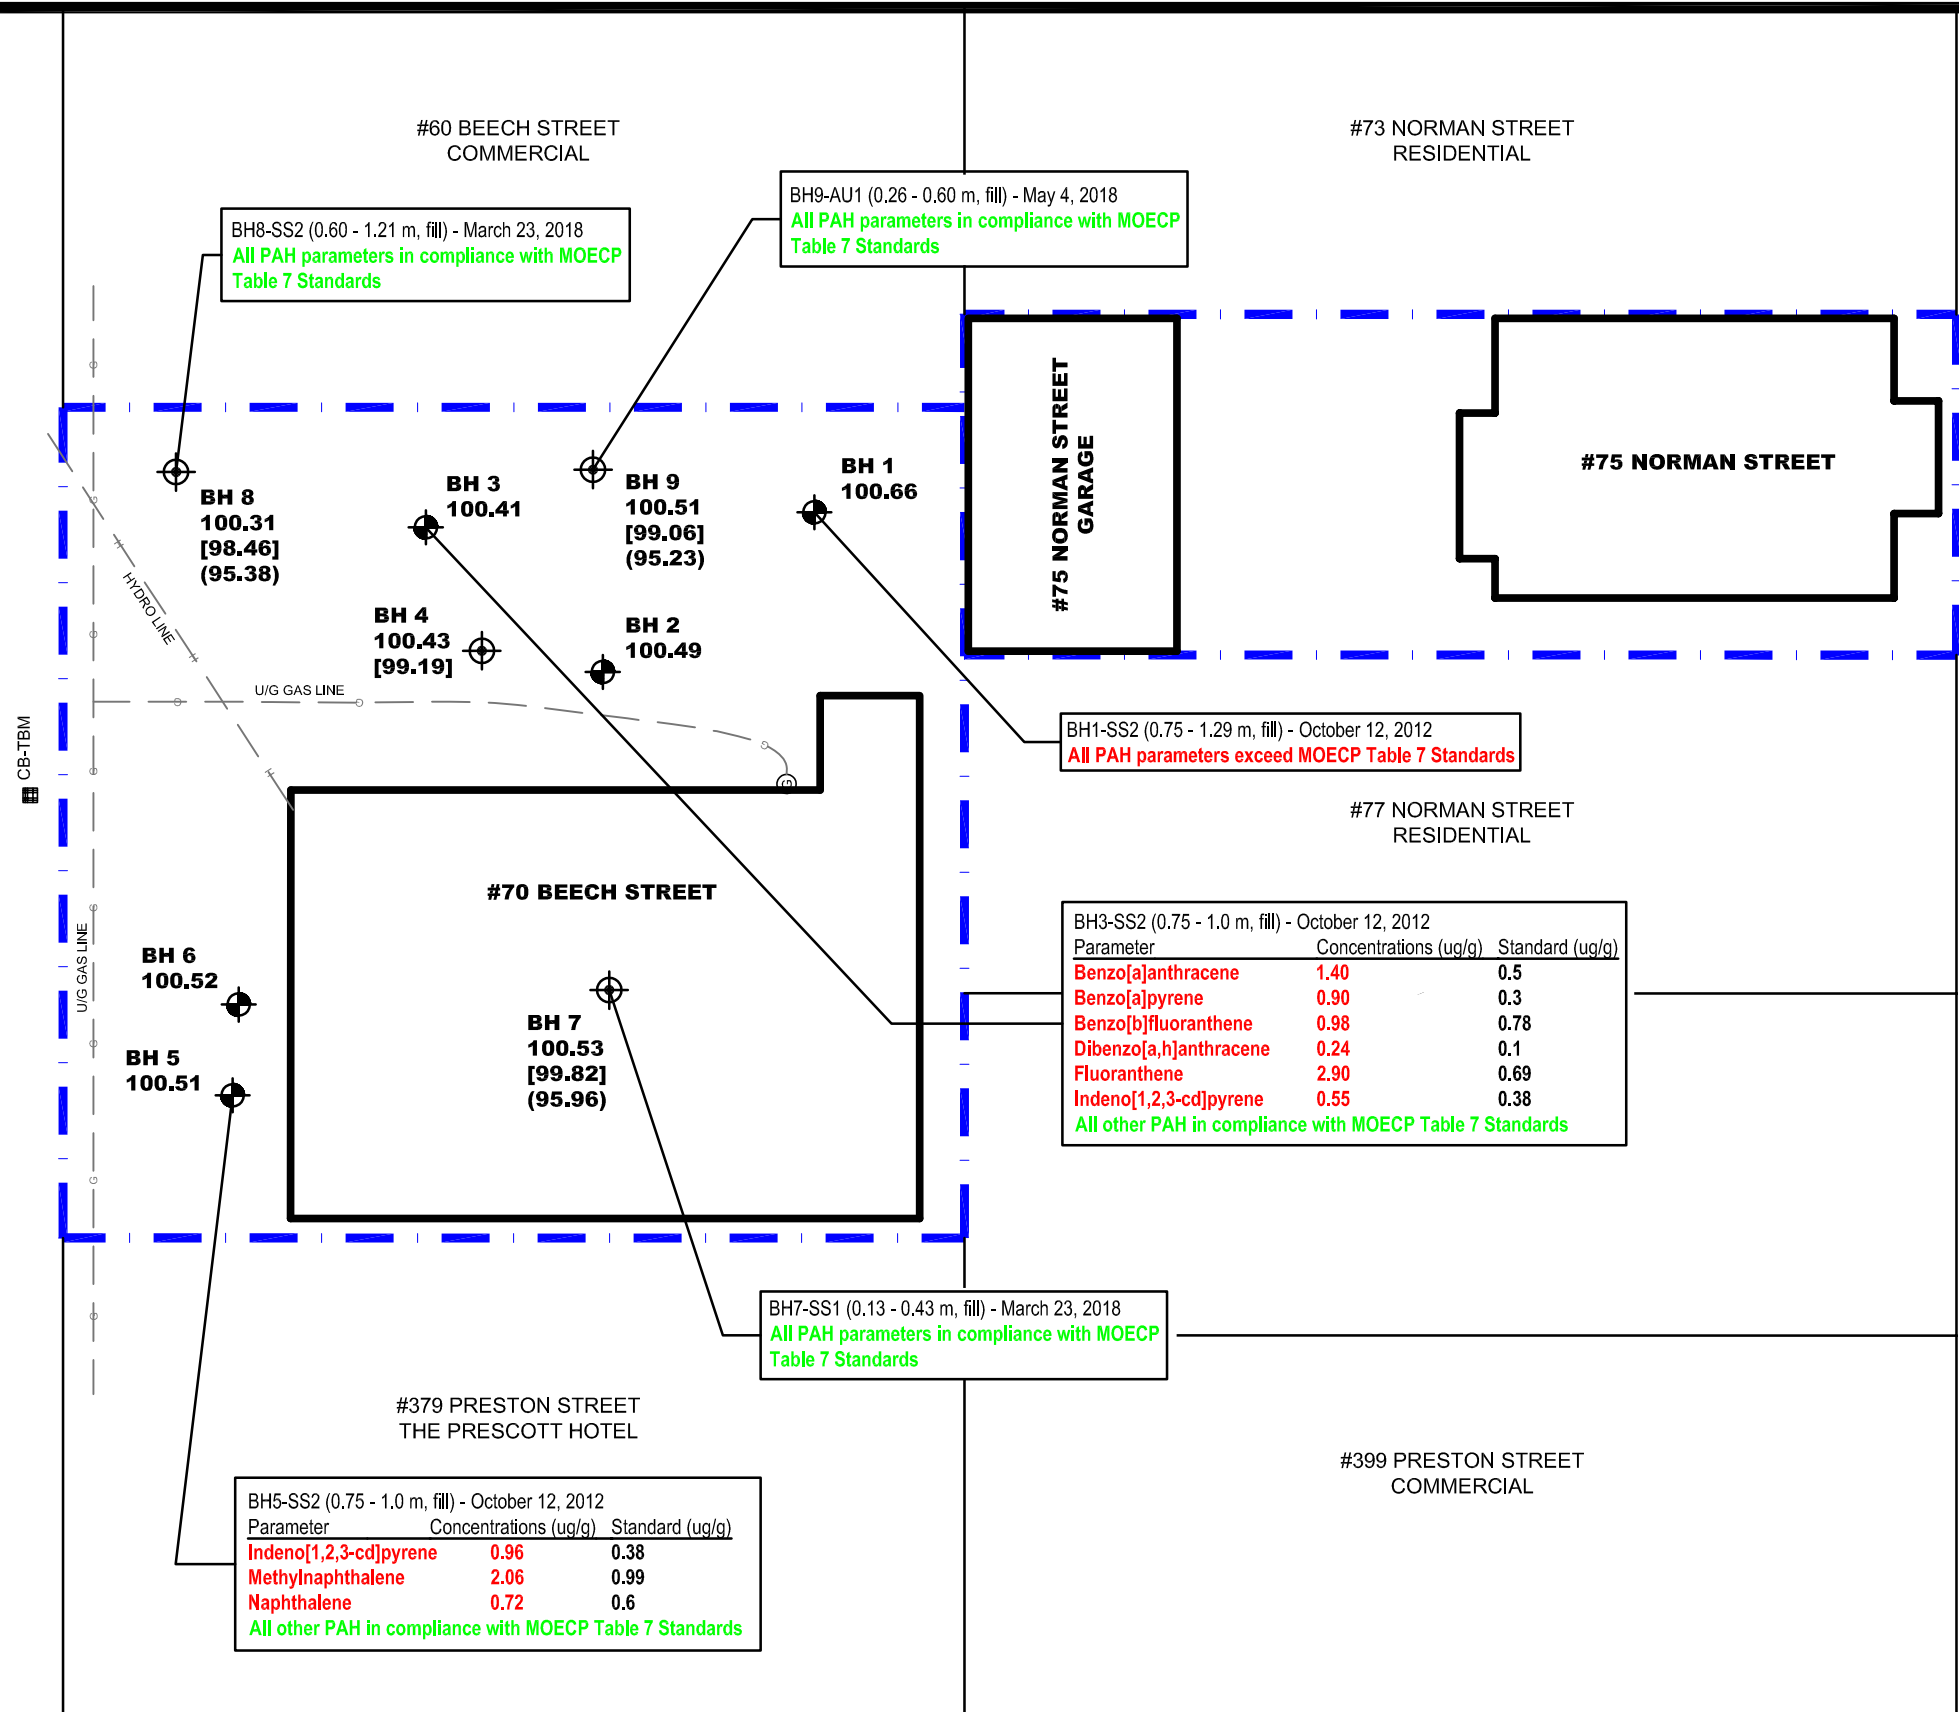
All PAH parameters were found to be in compliance with the MOECC Table 7 standards.

BH8-SS2 (0.60 - 1.21 m, fill) - March 23, 2018
All PAH parameters in compliance with MOECP Table 7 Standards

BH9-AU1 (0.26 - 0.60 m, fill) - May 4, 2018
All PAH parameters in compliance with MOECP Table 7 Standards

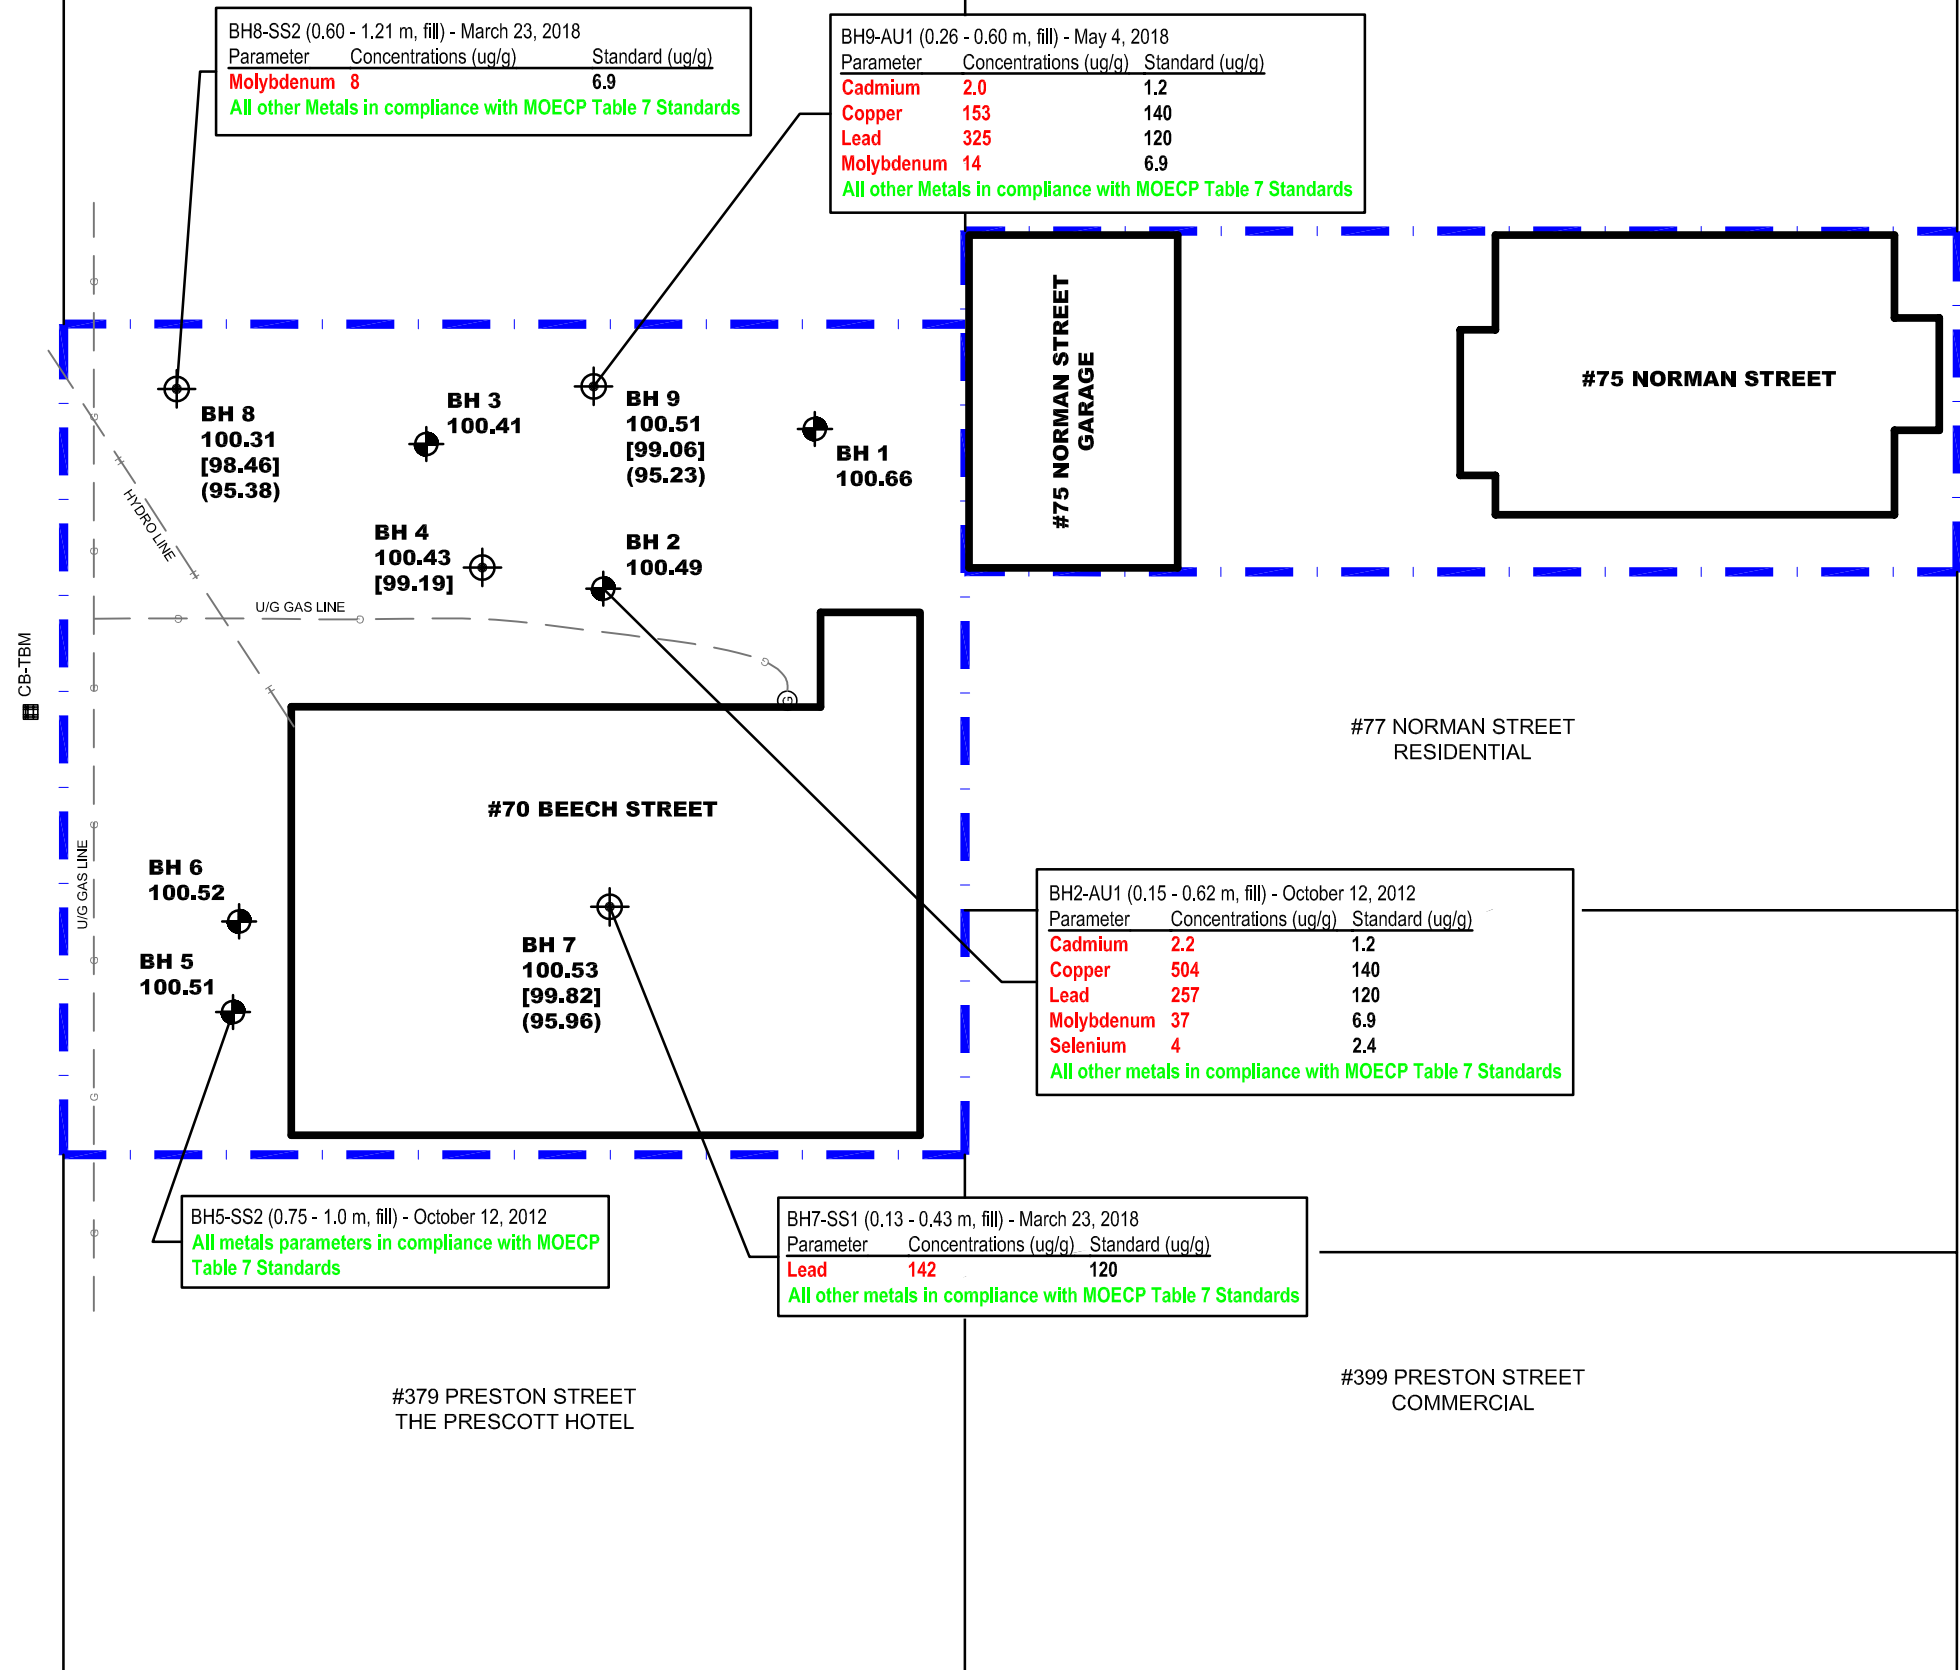
BH8-SS2 (0.60 - 1.21 m, fill) - March 23, 2018

Parameter	Concentrations (ug/g)	Standard (ug/g)
Molybdenum	8	6.9
All other Metals in compliance with MOECP Table 7 Standards

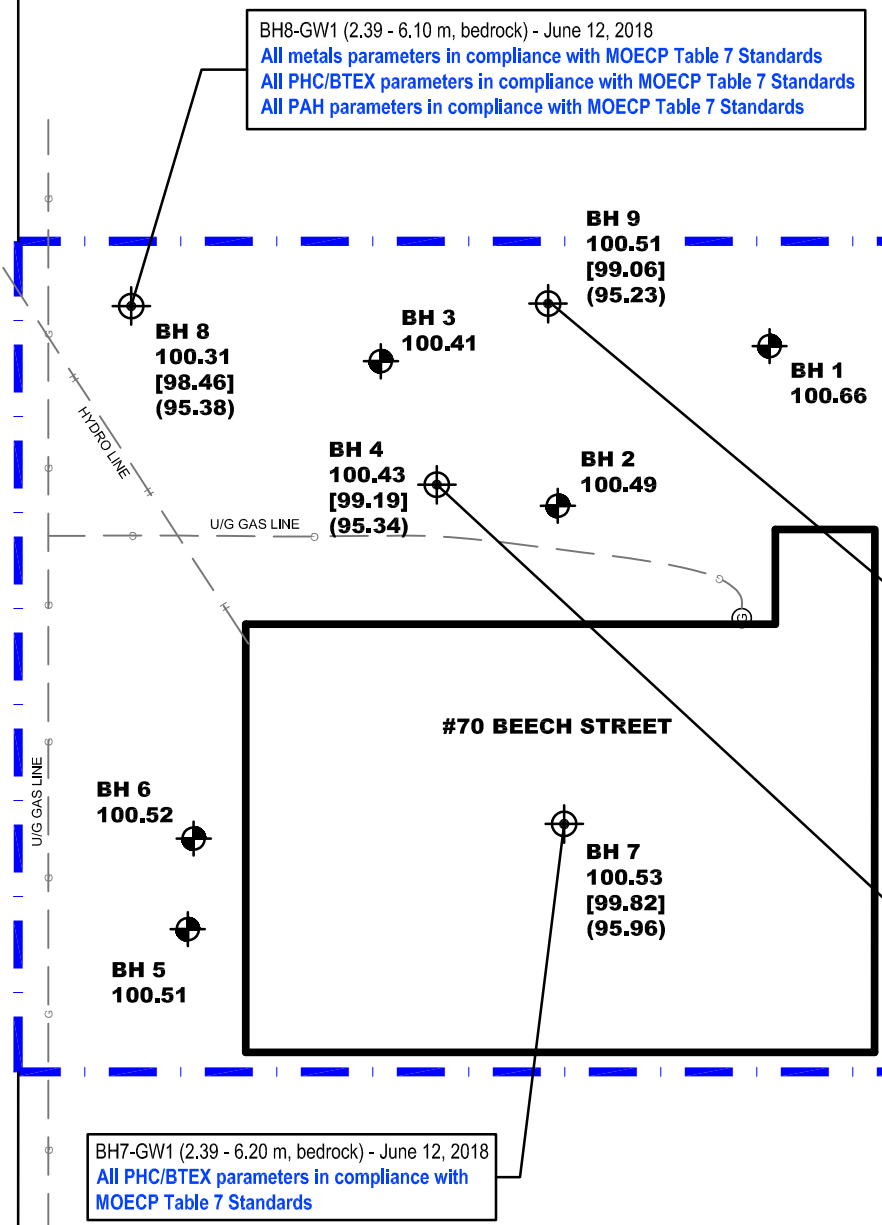
BEECH HOLDINGS LIMITED
 PHASE II - ENVIRONMENTAL SITE ASSESSMENT
 70 BEECH STREET AND 75 NORMAN STREET
 OTTAWA, ONTARIO
 Title: **ANALYTICAL TESTING PLAN - GROUNDWATER**

None of the analytical test parameters were detected in Samples BH4-GW2, BH7-GW1 and BH8-GW1, all were in compliance with the MOECC Table 7 standards. The F1 PHC fraction, benzene and xylenes were detected above the site standard in Samples BH9-GW1. It should be noted that this monitoring well produced relatively little water, and the water sample contained some suspended sediment which could have influenced the analytical testing results.

BH8-GW1 (2.39 - 6.10 m, bedrock) - June 12, 2018
 All metals parameters in compliance with MOECP Table 7 Standards
 All PHC/BTEX parameters in compliance with MOECP Table 7 Standards
 All PAH parameters in compliance with MOECP Table 7 Standards

BH9-GW1 (3.50 - 6.68 m, bedrock) - June 12, 2018
 All metals parameters in compliance with MOECP Table 7 Standards
 All PAH parameters in compliance with MOECP Table 7 Standards

The groundwater monitoring wells should be kept in good condition until site redevelopment. The groundwater at Borehole BH9 should be re-sampled in the near future (ideally before winter), in order to confirm the groundwater quality at that time.

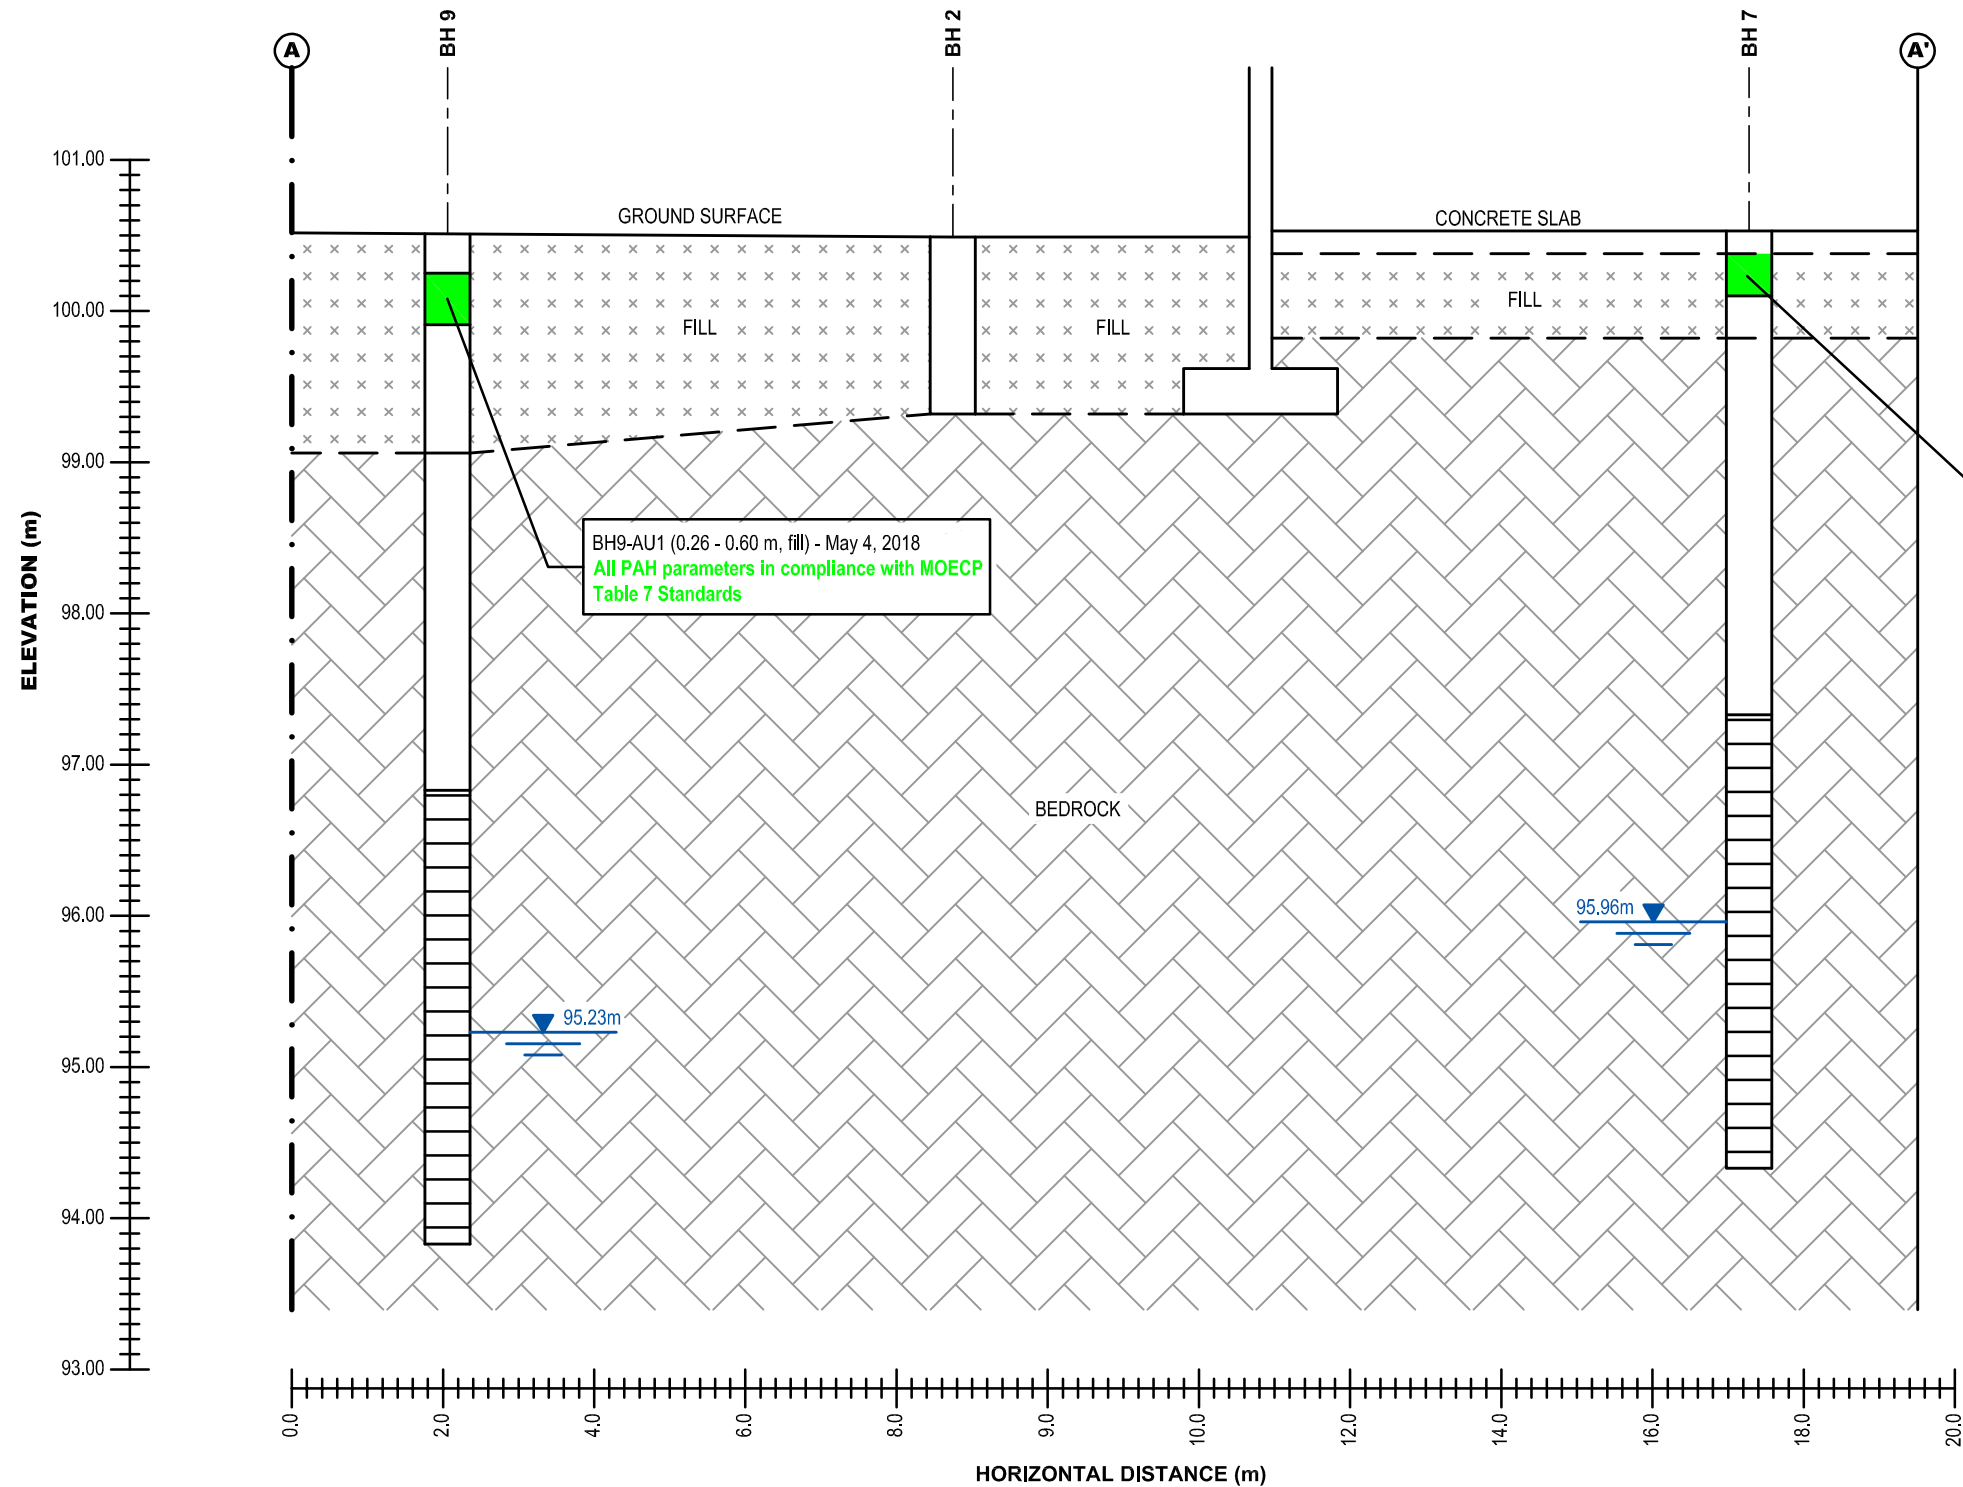
Title: CROSS-SECTION A-A' - SOIL (PAH)

BH7-SS1 (0.13 - 0.43 m, fill) - March 23, 2018
 All PAH parameters in compliance with MOECP Table 7 Standards

BH9-AU1 (0.26 - 0.60 m, fill) - May 4, 2018
 All PAH parameters in compliance with MOECP Table 7 Standards

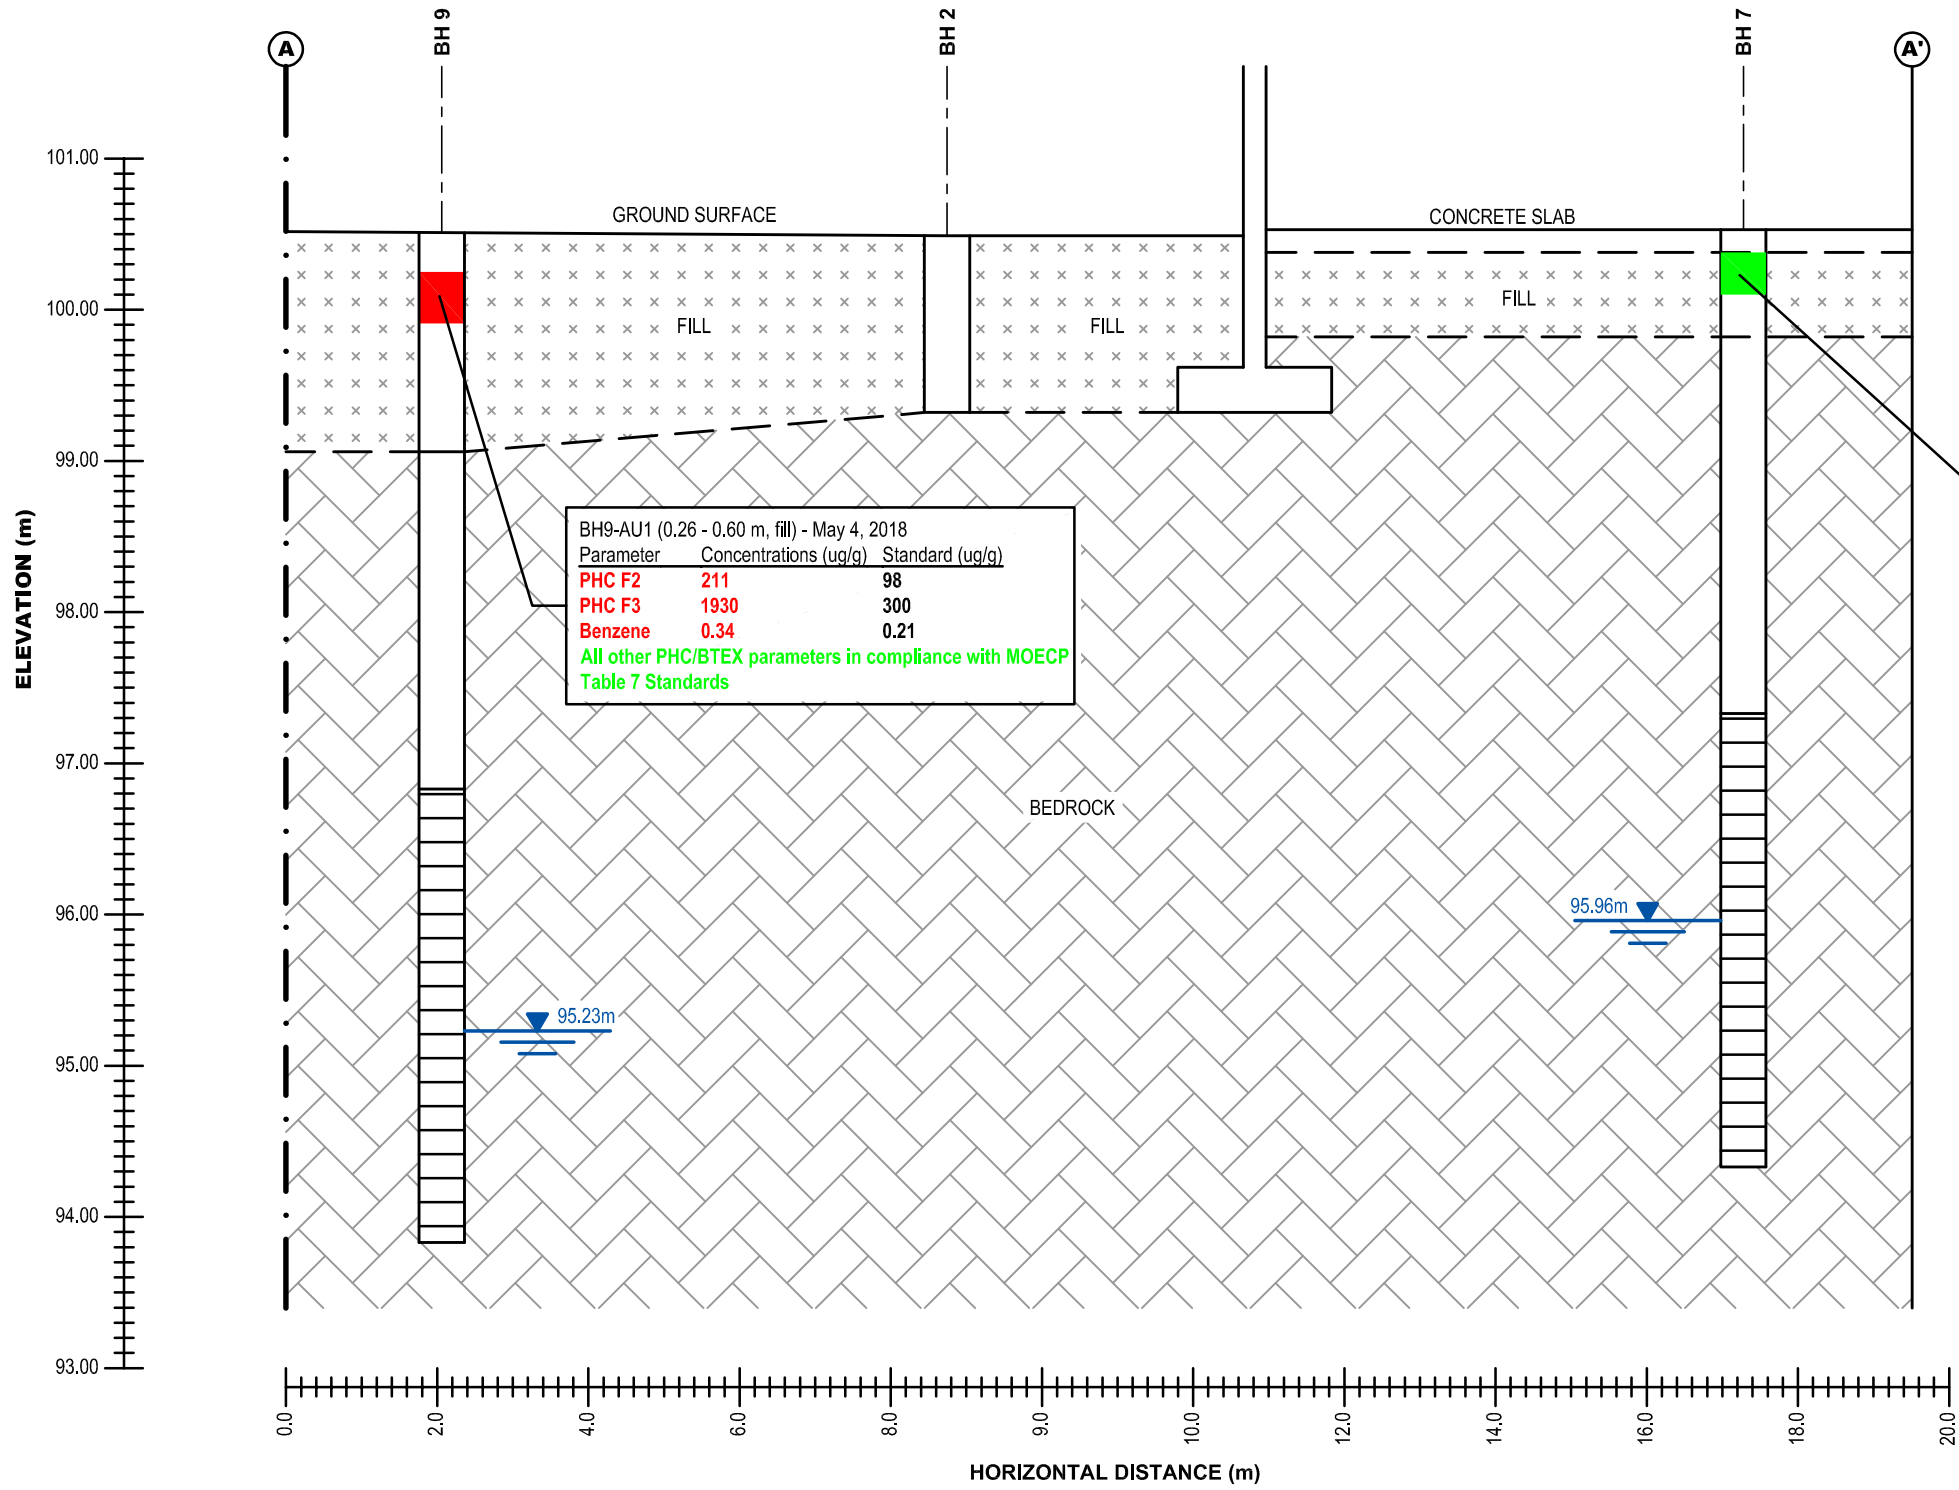
Title: **CROSS-SECTION A-A' - SOIL (PHC/BTEX)**

All PHC and BTEX parameters in Samples BH7-SS1 and BH8-SS2 were in compliance with the MOECC Table 7 standards. The PHC F2 and F3 parameters in Samples BH9-AU1, as well as benzene, were found to exceed the site standards.

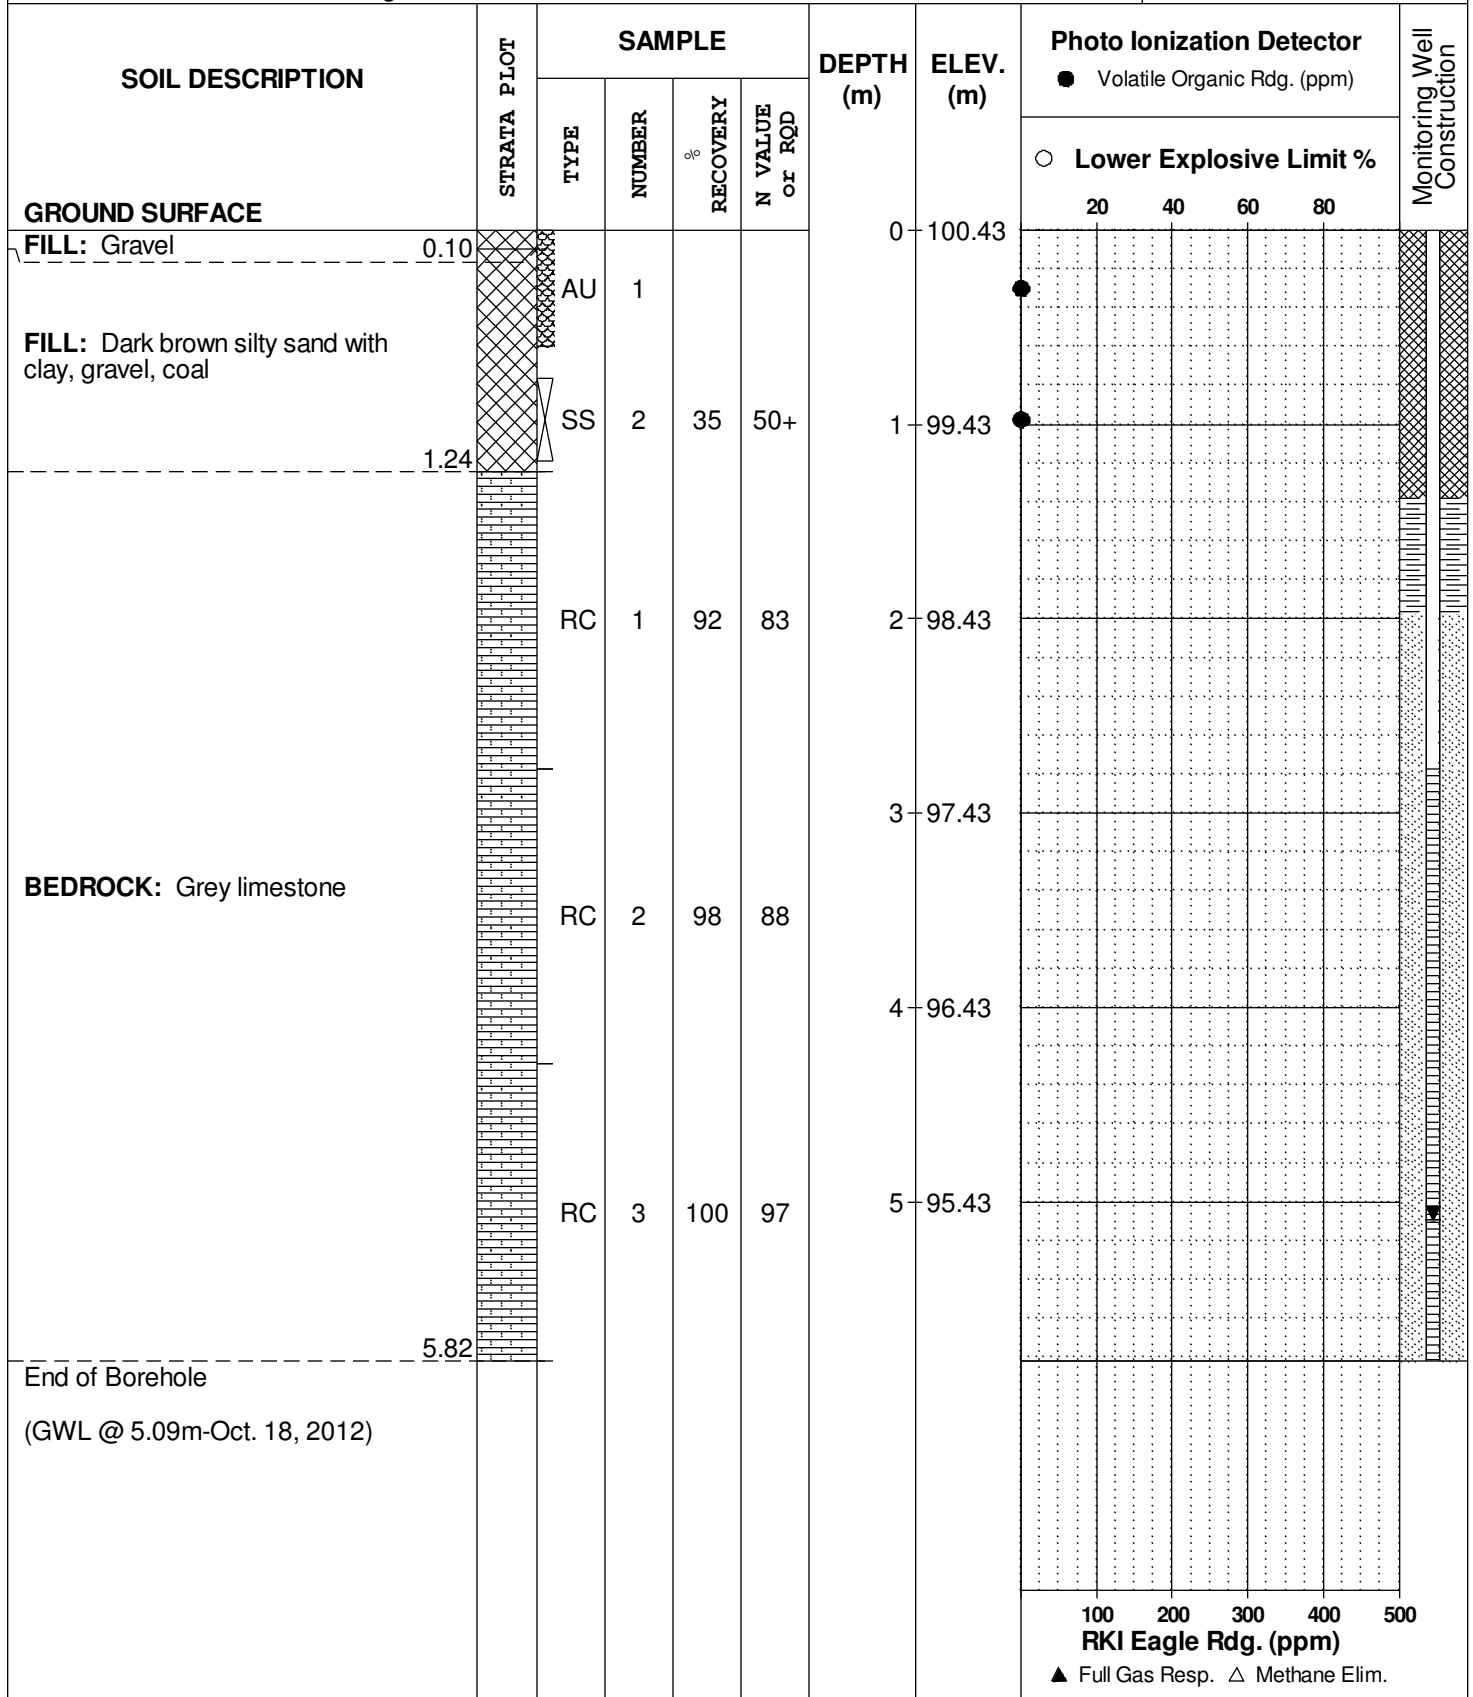
HOLE NO. BH 4

SOIL PROFILE AND TEST DATA
