**RE: 1164/1166 Highcroft Drive, Manotick**  
**Tree Conservation Report and Environmental Impact Statement**

**1164/1166 HIGHCROFT DRIVE, MANOTICK  
TREE CONSERVATION REPORT and ENVIRONMENTAL IMPACT STATEMENT**

**ENVIRONMENTAL IMPACT STATEMENT/  
TREE CONSERVATION REPORT**

**PROPOSED CONSERVED VEGETATION  
TREE CONSERVATION REPORT**

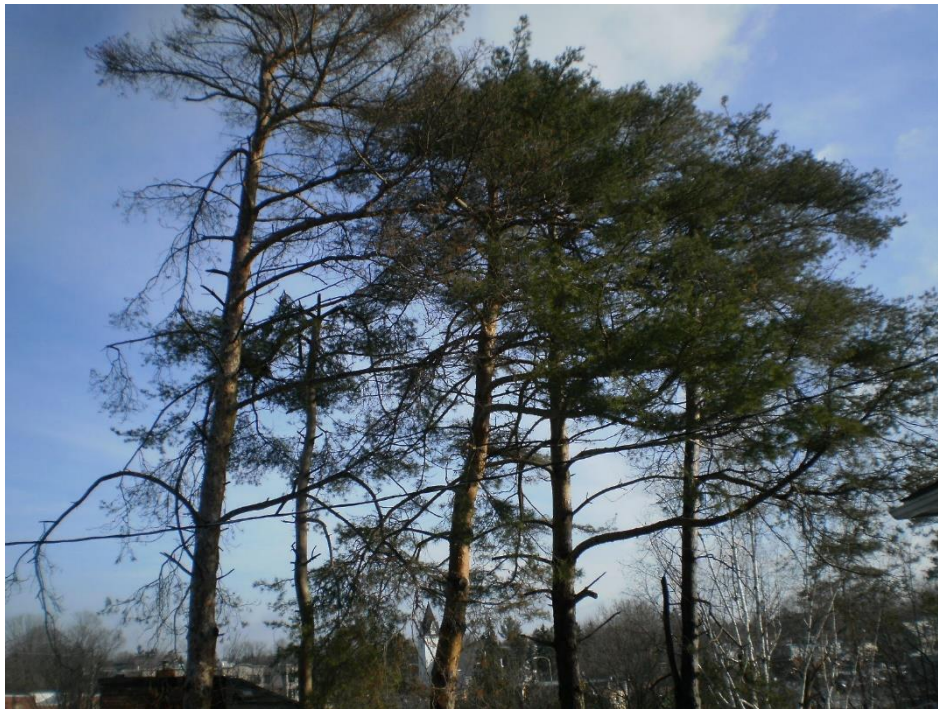
Woody vegetation on the site included a north-south row of five Scot's pine south of Highcroft Drive just east of the lot line between 1164 and 1166 Highcroft Drive (Photo 2). The Scot's pine ranged in size between 25cm and 37cm diameter at breast height (dbh) and appeared to be in average condition with some trunk damage. A 42cm dbh white spruce in apparently good condition was to the north of the existing residence at 1166 Highcroft Drive (Photo 1). A 100cm dbh black locust cultivar was to the west of the residence at 1166, approximately 1.5 metres east of the west property line (Photo 3). The tree appeared to be in average condition with some branch damage. A twin-stem white birch up to 30cm dbh was to the south of the existing residence at 1164 Highcroft Drive, with crabapples up to 18cm dbh and highbush cranberry and common lilac shrubs scattered in the rear yard of 1164.

*Photo 2 – Scot's pines between 1164 and 1166 Highcroft Drive, south of Highcroft Drive.  
View looking east*

A few scattered trees are on the site, including five Scot's pine in a north-south hedgerow and larger trees in the front and northwest corner of the rear yard of 1166 Highcroft Drive. The potential for tree retention was reviewed in conjunction with the Grading Plan prepared by D.B. Gray Engineering Inc. (Drawing C-2, revised August 9<sup>th</sup>, 2019). Grade raises between one and three metres throughout the site in combination with the location of the trees in areas proposed for the north-south road or the townhome will generally preclude tree retention on the site. One potential exception is the trees in the northwest portion of 1166 Highcroft Drive. The grade raises are minimal in this area and a small area of potential tree retention is shown on Map 2 for this portion of the site.

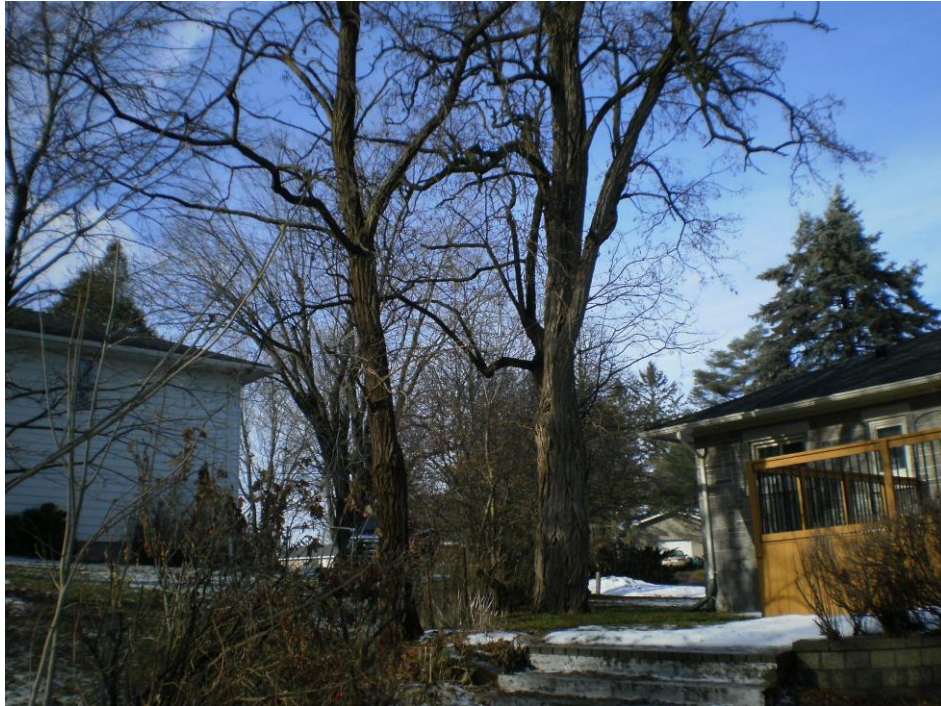
*Photo 3 – Mature locust in the west portion of 1166 Highcroft Drive, with smaller locust along the west property line to the left. View looking northwest*

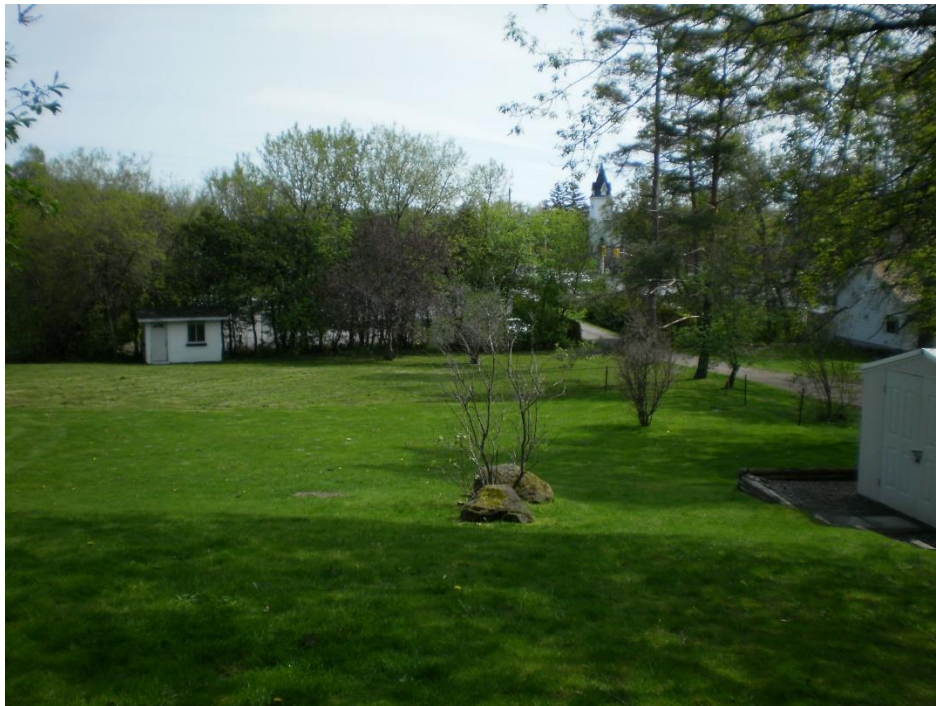
The site is dominated by two existing residences and associated large manicured grassed lands (Photos 4 and 5) to the north and south of the residences. In addition to the dominant bluegrass, common dandelion, ground ivy, common burdock, and goldenrod were observed.

*Photo 4 –South portion of the site. View looking east from west site edge*

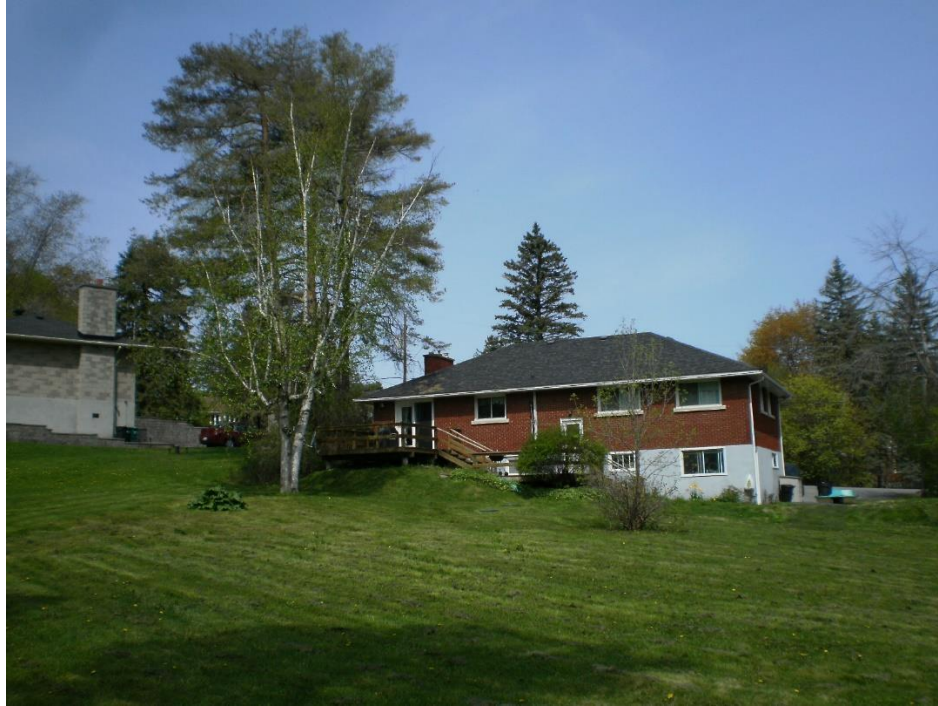
*Photo 5 – South portion of 1164 Highcroft Drive.  
From southeast corner of the site view looking north to residence to be removed*

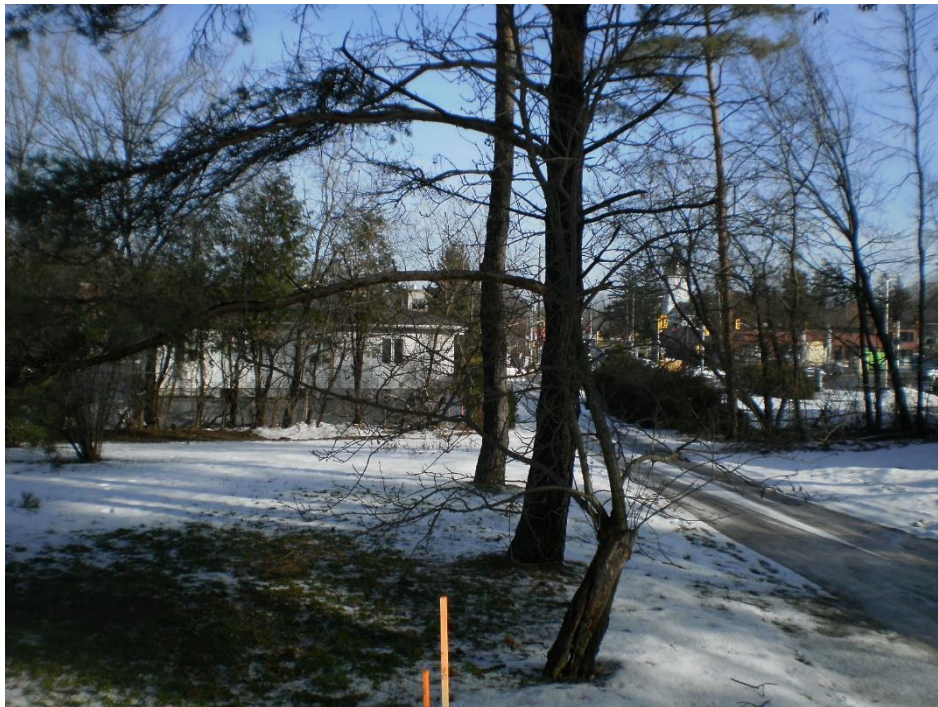
Scot's pine up to 40cm dbh were just to the south of the south property line, with the trunks within 0.5 metres of the property line based on property line stakes (Photo 6). The lower branches of many of the pines extended well onto the site. A reduced number of needles in good condition were observed on many of the Scot's pine. A 28cm dbh sugar maple with major trunk decay, very little leaf-out, and extensive vine growth was also along the south property line in the southwest corner, along with common lilac and European mountain ash.

*Photo 6 – Scot's pines immediately to the south of the site. View looking east*

The Grading Plan also shows retaining walls along much of the site periphery not fronting onto Highcroft Drive. This will preclude retention of trees along the site peripheries other than the northwest area as shown on Map 2. The Scot's pine just to the south of the site will also likely need to be removed as a large portion of their critical root zone will likely be impacted by the retaining wall construction and on-site grade raises. Discussions are required with the adjacent landowners to identify the need for tree removal and to develop a planting plan to replace the removed trees with new plantings post-construction.

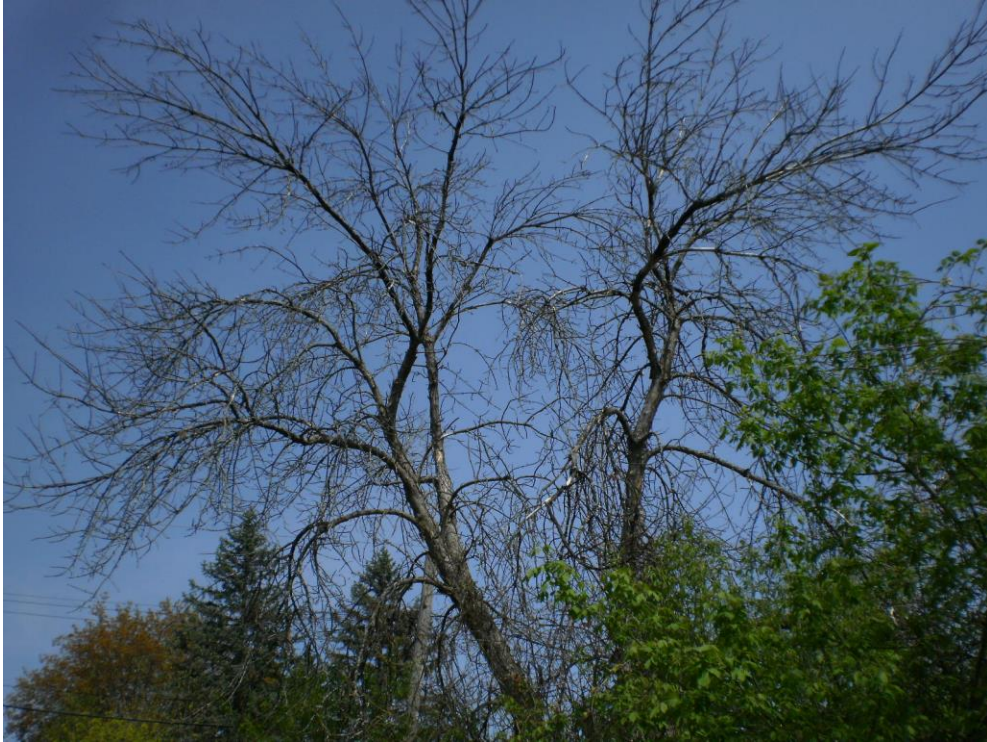
Along the east site boundary, a 44cm dbh white ash is about one metre to the east of the property line approximately 20 metres south of Highcroft Drive (Photo 7). Vine growth was extensive on the ash and very few live buds were observed. Many regenerating Manitoba maple and white elm stems up to 15cm dbh are also along the property line in this area. Further south, a hedgerow of white cedars up to 12cm dbh are along the property line and west of a commercial parking lot. Several of the smaller cedar stems appeared dead. Manitoba maples up to 30cm dbh and common lilac shrubs were among the cedars. Many of the Manitoba maples had badly bent trunks.

*Photo 7 – White ash with no live buds of note, smaller Manitoba maple, and vines along the east property line south of Highcroft Drive. View looking north to Highcroft*
