Phase I - Environmental Site Assessment

Future Commercial Development
Hazeldean Road at Huntmar Drive
Ottawa, Ontario

April 30, 2012

Report: PE2142-1

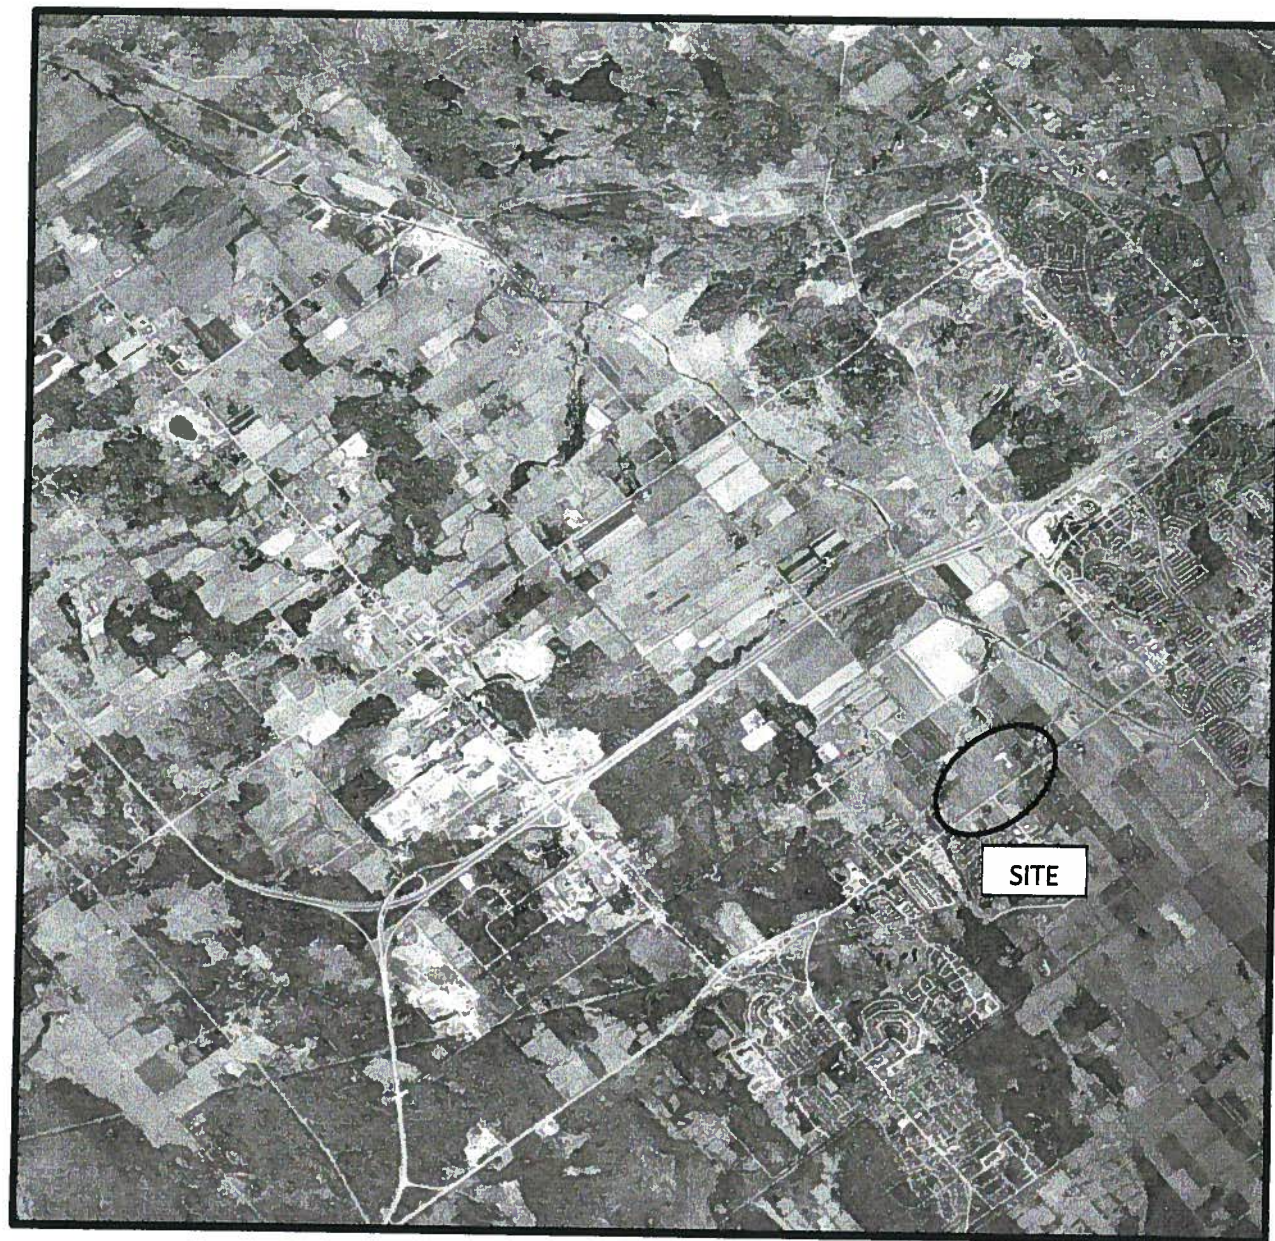
AERIAL PHOTOGRAPH
1988

- 1988 A small area on the eastern portion of the site appears to be under development. The western portion of the site remains vacant and used for agricultural purposes. No significant changes appear to have been made to the adjacent properties.

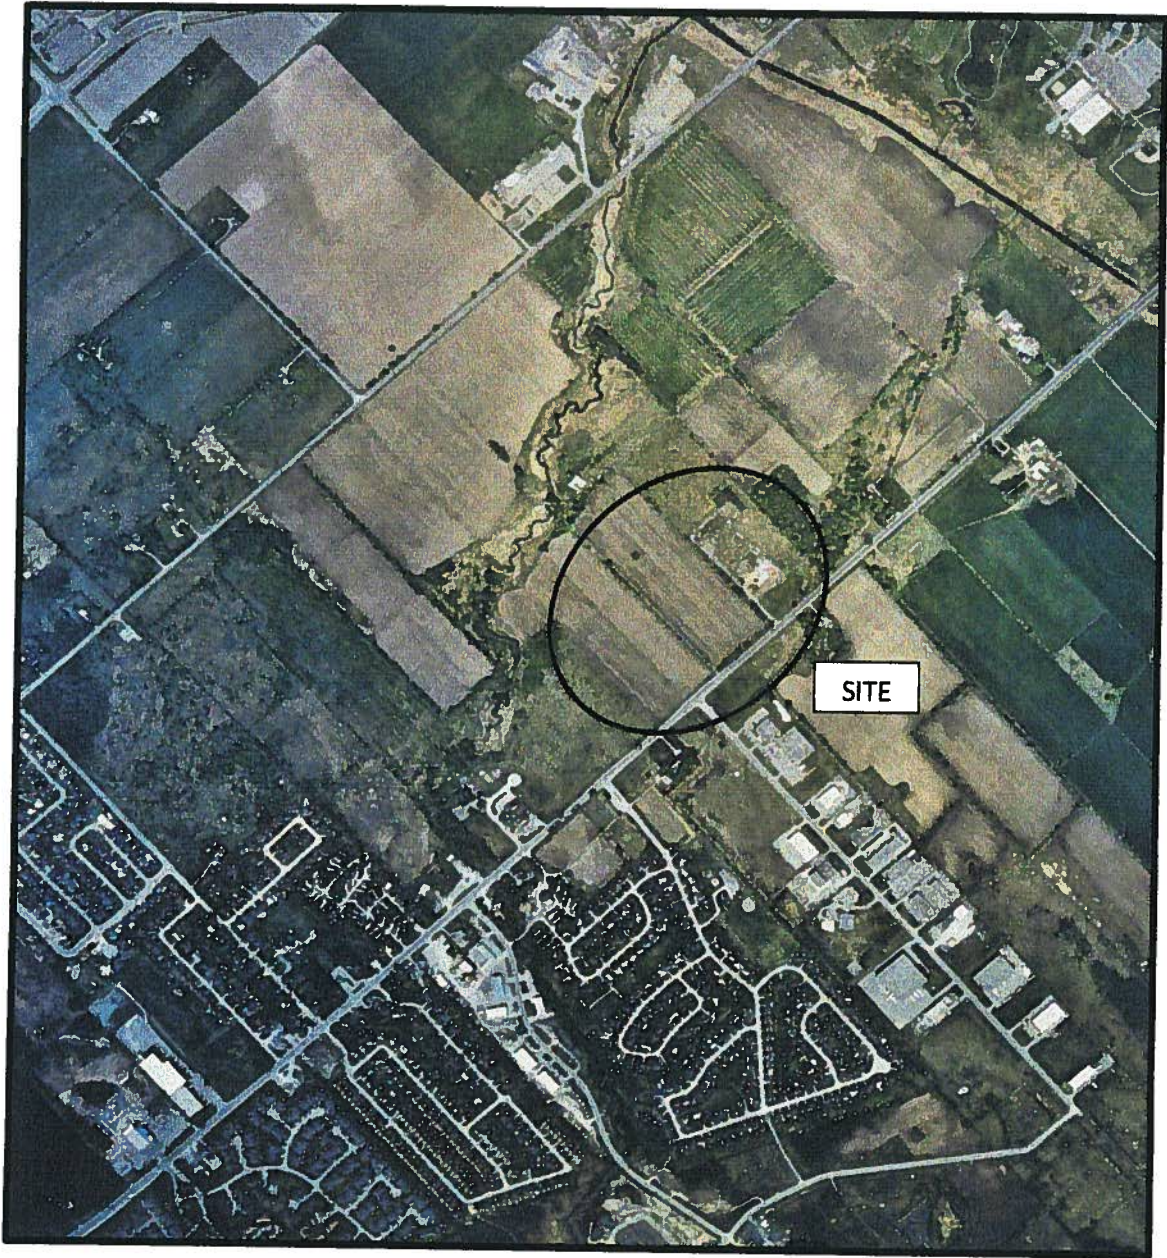
AERIAL PHOTOGRAPH
1999

- 1999 The eastern portion of the site has been developed and it is clear that a commercial business is present on site. What appears to be a structure, is present closer to Hazeldean Road, while stockpiles of soil or other materials appear to be present along the northern property boundary. An L-shaped section of the land along the northern property boundary appears to have been stripped of topsoil. No apparent changes have been made to the adjacent properties.
