Muncaster
Environmental
Planning Inc.

December 31, 2019

RE: 2707 Solandt Drive
Tree Conservation Report and Environmental Impact Statement - Revised

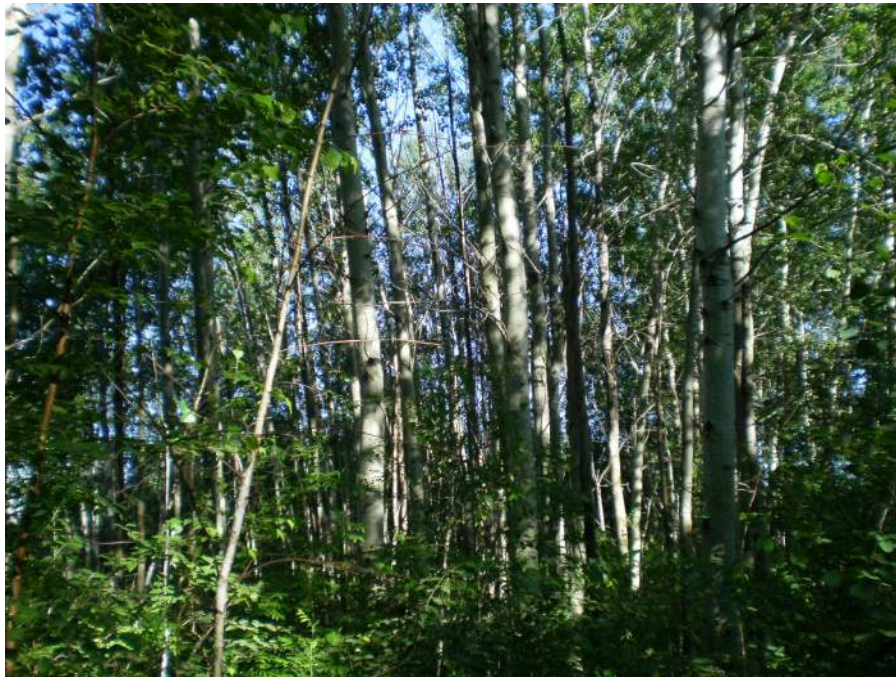
*Photo 1 – Typical poplar trees in the centre portion of the upland deciduous forest.
View looking northwest*

The site is dominated by a young upland poplar-birch deciduous forest (Map 1, Photos 1, 2 and 3) dominated by trembling aspen and large-toothed aspen up to 36cm dbh, with white birch, grey birch, red maple, and white spruce in the 20cm to 23cm dbh and Scot's pine up to 30cm dbh. Young birch trees were more dominant in the west portion of the site (Photo 3). Windthrow was extensive in areas, especially in the west portion of the forest. Fungus and bark damage were common on many of the poplar and birch trees. A twin-stem white pine, with the larger stem 38cm dbh, in the west portion appeared to be in good condition, but similar sized white pines in the southeast corner showed bark damage and had poor form (Photo 4). The conifer component, including white spruce, white pine, and Scot's pine, was greater in the south portion. Many trails were throughout the small forest (Photo 2). The east edge of the forest, west of the stormwater channel described below, is dominated by regenerating poplar and birch stems.

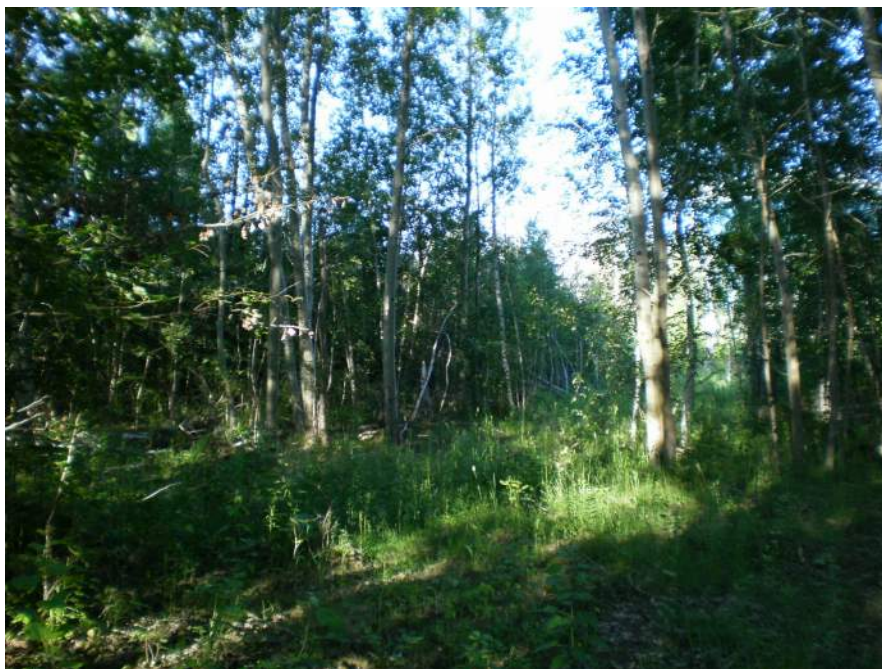
*Photo 2 – There are many open areas in the upland deciduous forest.
This example is in the central portion of the forest, with view looking west*

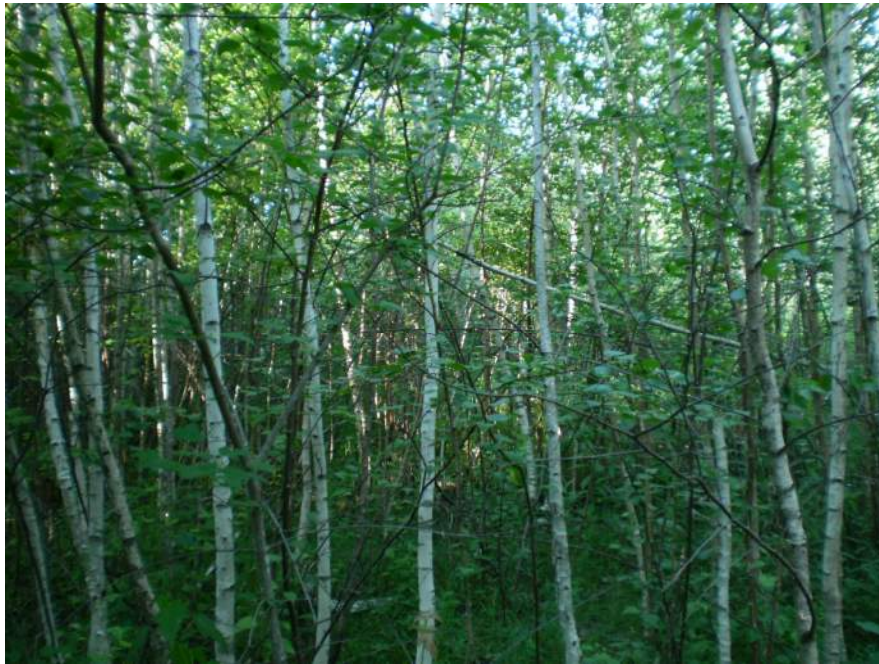
Photo 3 – Young birch were dominant in the west portion of the upland deciduous forest. View looking southwest

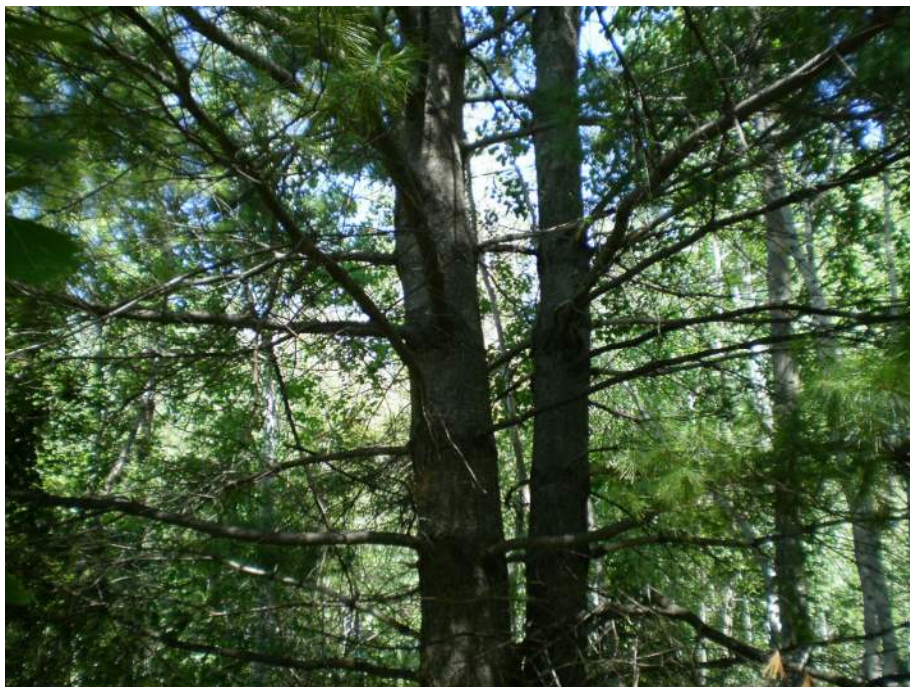
Photo 4 – The largest trees on-site were a couple of white pines in the south portion of the upland forest. This example is in the southwest corner of the site. View looking north

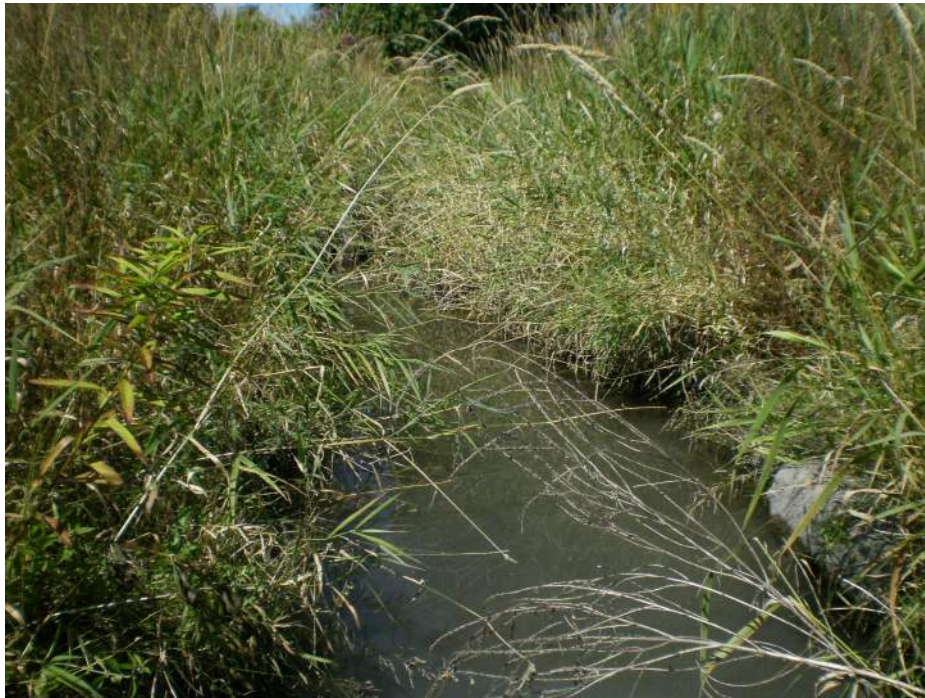
Photo 5 – Shirley's Brook is the northwest edge of the site. View looking north

The retention of the Category 2 Blanding's turtle habitat, will also provide suitable protection for the aquatic habitat of Shirley's Brook. There will be no site disturbances within 30 metres of Shirley's Brook.

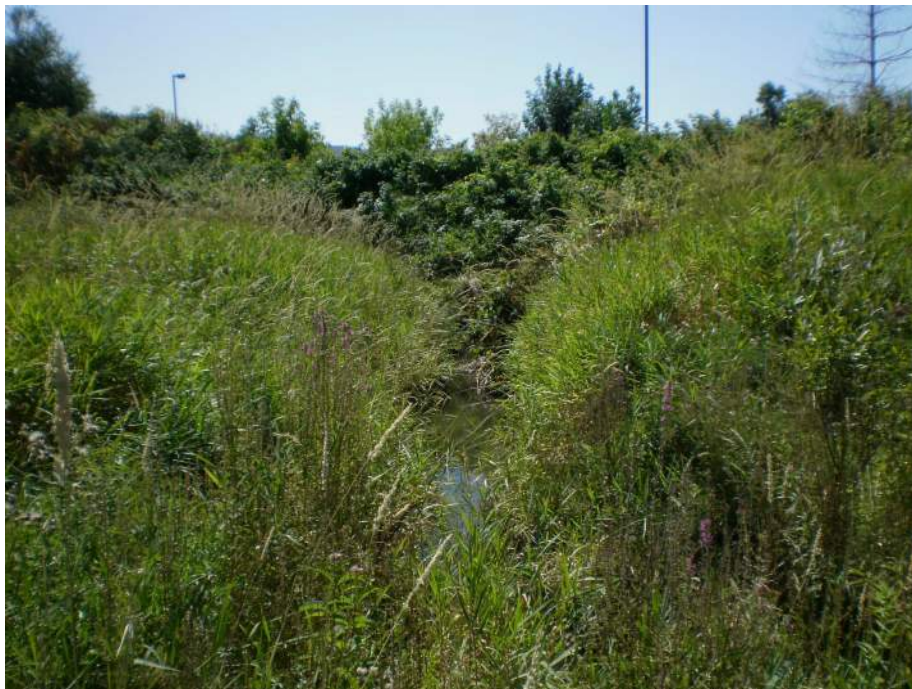
Photo 6 – Meadow habitat on-site to the east of Shirley's Brook. View looking west

No wetland habitat was present adjacent to Shirley's Brook in the northwest corner of the site, as there is a clear rise in elevation to the east of the channel, and off-site to the west. Small areas of culture meadow upland habitat along the Shirley's Brook corridor were dominated by June meadow grass, orchard grass, reed canary grass, cow vetch, crown vetch, thicket creeper, wild grape, bird's-foot trefoil, black swallowwort, ox-eye daisy, purple loosestrife, Canada goldenrod, and Canada thistle, along with tartarian honeysuckle and red raspberry shrubs (Photo 6).

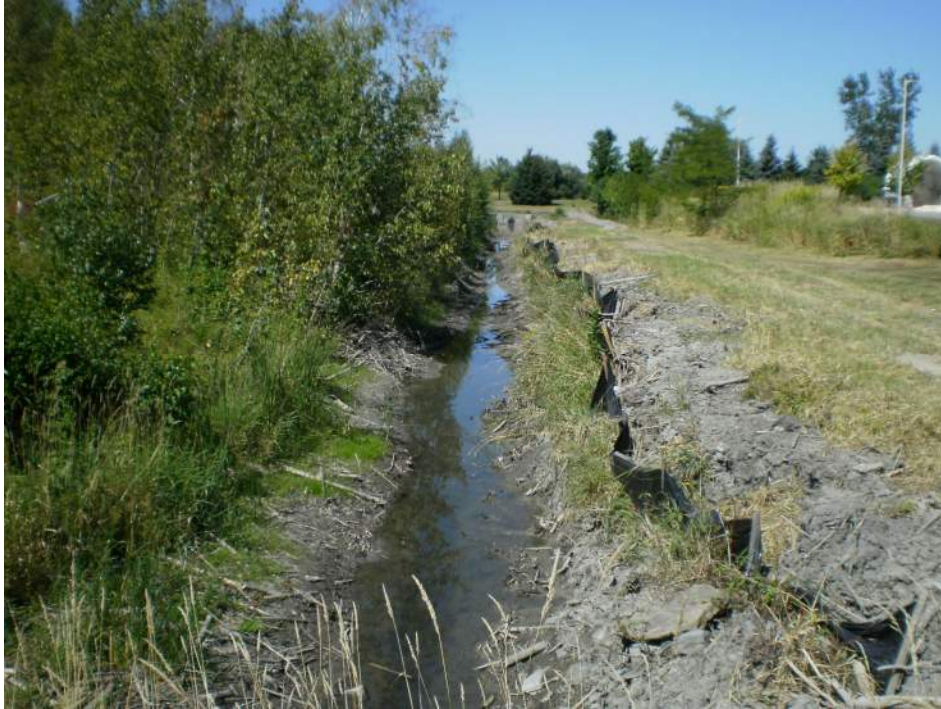
Photo 7 – North-south stormwater channel in the stormwater easement in the east edge of the site. View looking north from Solandt Road

The City's north-south stormwater easement on the east edge includes an open channel dug in the late 1990s and modified in the 2000s with construction south of Solandt Dive (Photo 7). The City's infrastructure mapping shows the channel is the outlet for all stormwater off Solandt Drive east of March Road. It is a channel dug and maintained to provide a connection between two concrete headwalls. There was no natural channel in this area before the stormwater infrastructure was dug. The stormwater channel is open for approximately 125 metres between concrete headwalls. The water depth was generally less than 5cm, with some ponding south of the north headwall. Evidence of former beaver dams were noted adjacent to the channel and as indicated below beaver cuttings were common in the east portion of the upland forest. Reed canary grass, soft-stem bulrush and broad-leaved cattail were common vegetation along the channel, with a small area of cattails adjacent to the west side of the north portion of the channel.

Although the north-south stormwater channel in the east portion of the site is not fish habitat by definition and no fish were observed in the stormwater channel during the field surveys, there is the potential for forage fish to be in the channel. The channel will be retained in its existing location but a culvert will be installed to provide access to the existing surface parking to the east at 2705 Solandt Drive. The following additional mitigation measures are recommended for the culvert installation:

- The summer period is recommended for the culvert installation due to the generally reduced flow, decreased potential for sediment input, and the greater growing season afforded for re-vegetation of disturbed areas. If the proposed timing of the work is to take place between October 15th and April 15th, it may be necessary to have any exposed areas covered with erosion control blankets to keep the soil in place and prevent erosion from occurring during the spring freshet time period;

- As required, rock protection is to be installed at the culvert ends to stabilize the channel and culvert. All material placed in the channel must be washed and clean of fines;

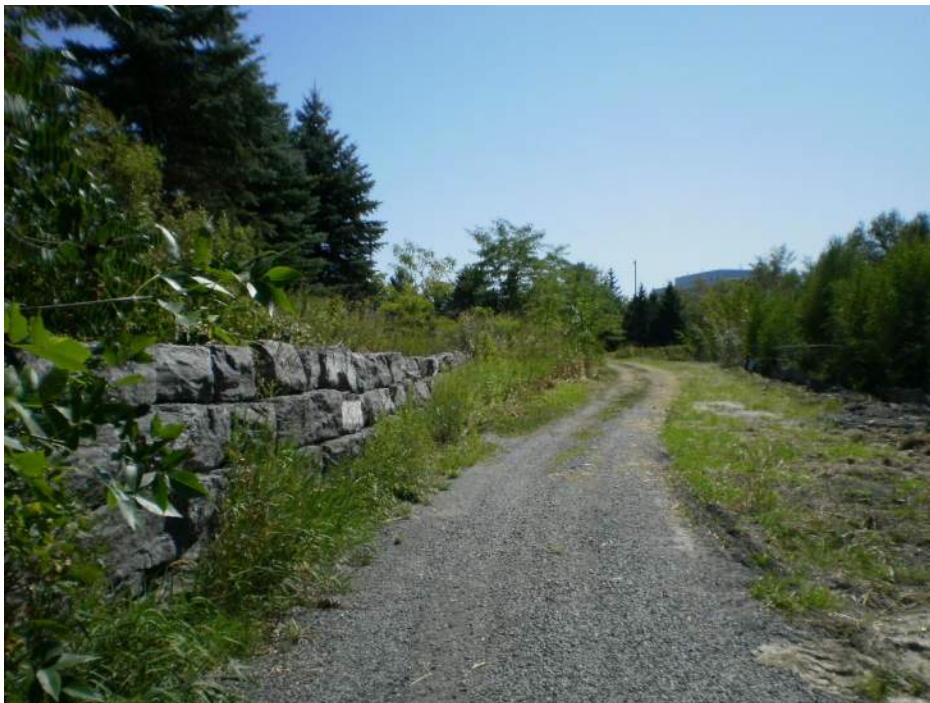
Photo 8 – Access trail, retaining, wall, berm and coniferous plantings on and adjacent to the east edge of the site. View looking south from the north property line

Another cultural meadow is along the east edge of the site and includes an access trail from Solandt Drive to the golf course north of the site and a sanitary sewer (Photo 8). Common ground flora in the meadow habitat included June meadow grass, timothy, common brome grass, common burdock, cow vetch, bladder campion, field horsetail, thicket creeper, tall goldenrod, white clover, wild carrot, common yarrow, ox-eye daisy, and black swallowwort.

A retaining wall and berm separate the site from the surface parking lot to the east. Conifer plantings up to 25cm dbh are to the east of the retaining wall on the berm. The critical root zones of these plantings would not extend onto the site. Along the north property line, white pine plantings up to 30cm dbh are common, with smaller white spruce. The critical root zone of these trees would extend onto the north edge of the site by up to three metres. There is a sidewalk north of Solandt Drive and thus no trees are to the south of the site. Meadow habitat is common to the west of the site, with poplar and birch trees up to 20cm dbh adjacent to the site further north of Solandt Drive. The critical root zone of these trees would extend onto the west edge of the site by up to one metre.

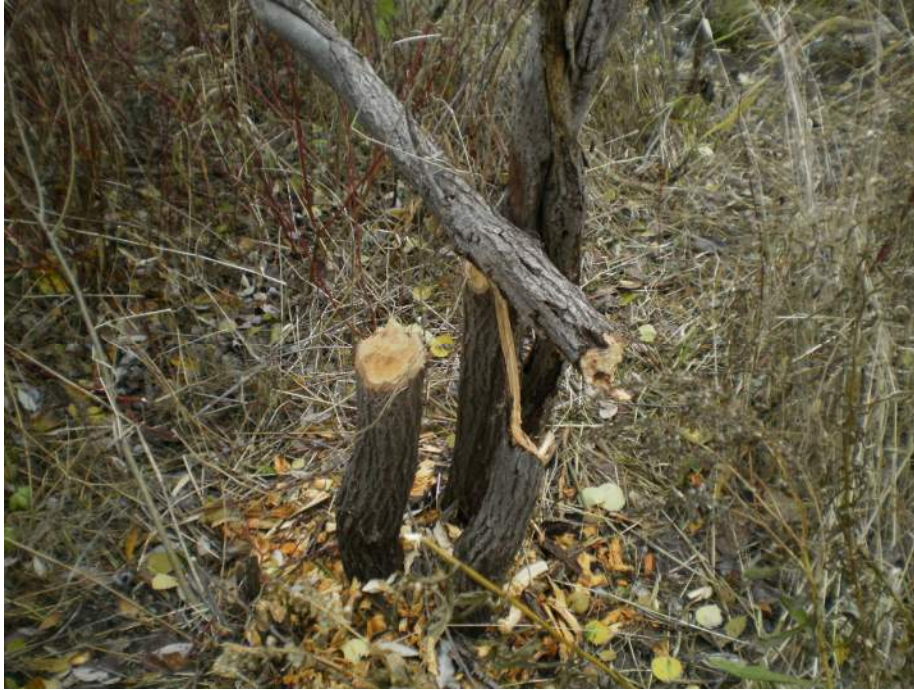
Photo 9 – Beaver cutting in the east edge of the site, west of the stormwater channel

The only Species at Risk observed on or adjacent to the site during the field surveys were barn swallows flying over the golf course to the north. No structures are present on the site that may be used for barn swallow nesting. Other wildlife observed included American crow, Canada goose, European starling, black-capped chickadee, American woodcock, great-crested flycatcher, yellow warbler, common yellowthroat, American robin, northern cardinal, common grackle, red-winged blackbird, gray catbird, barn swallow, cedar waxwing, song sparrow, American goldfinch, red squirrel, grey squirrel, woodchuck, green frog, and many beaver cuttings in the

east portion of the forest (Photo 9). No cavity trees, stick nests, or other evidence of raptor use were observed on or adjacent to the site.

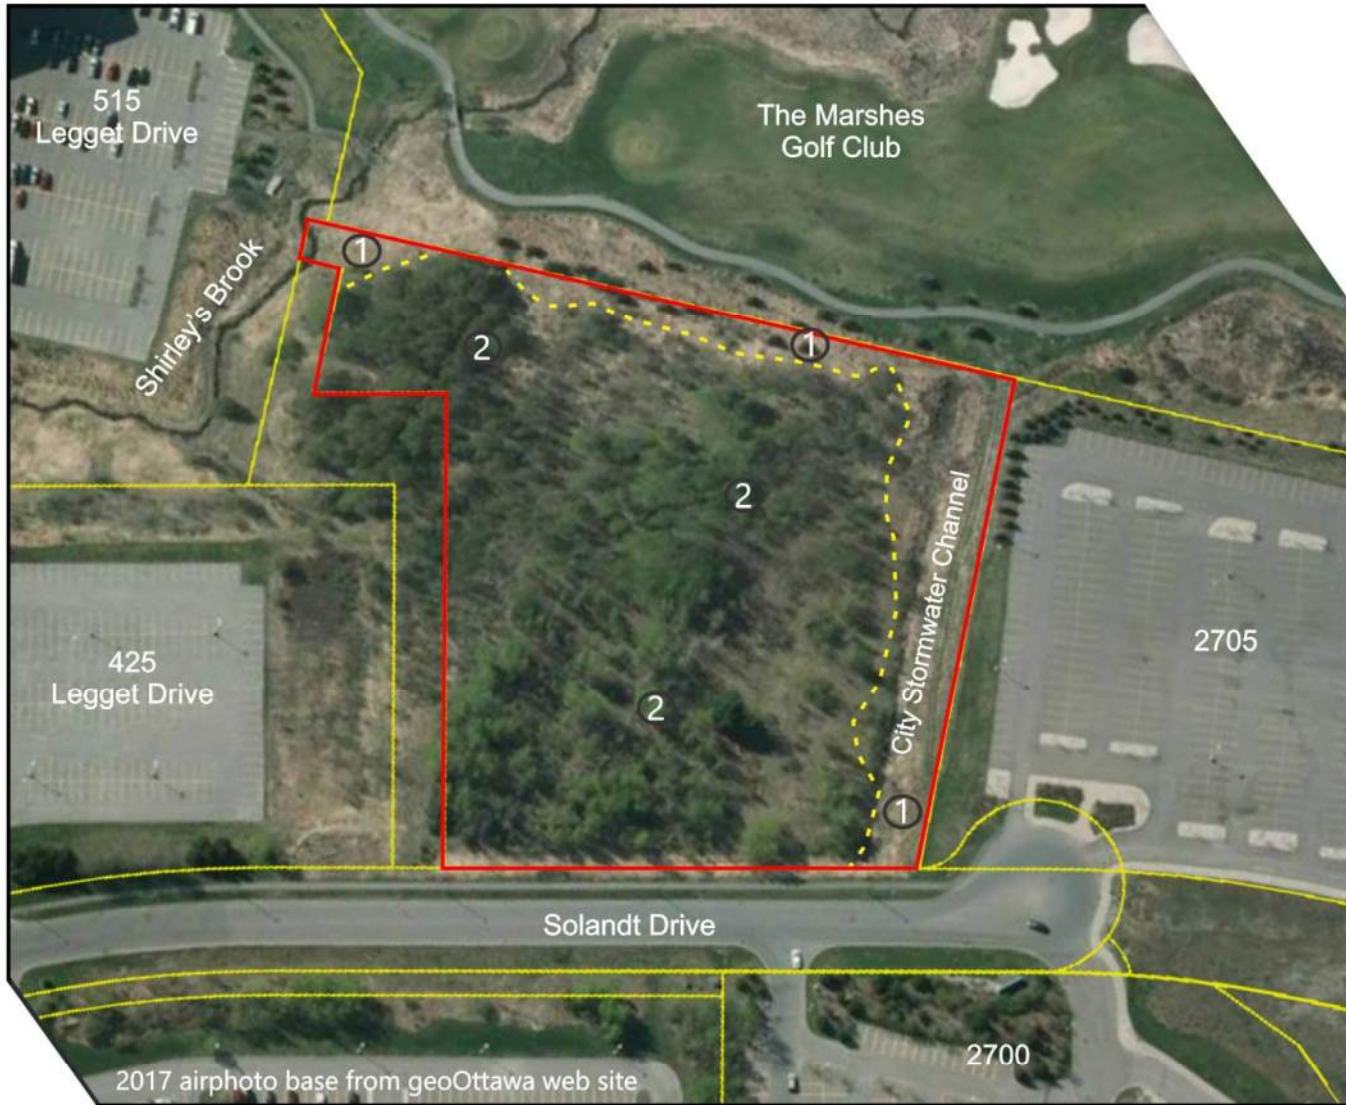
Map 1

**ENVIRONMENTAL IMPACT STATEMENT/TCR
CURRENT CONDITIONS**

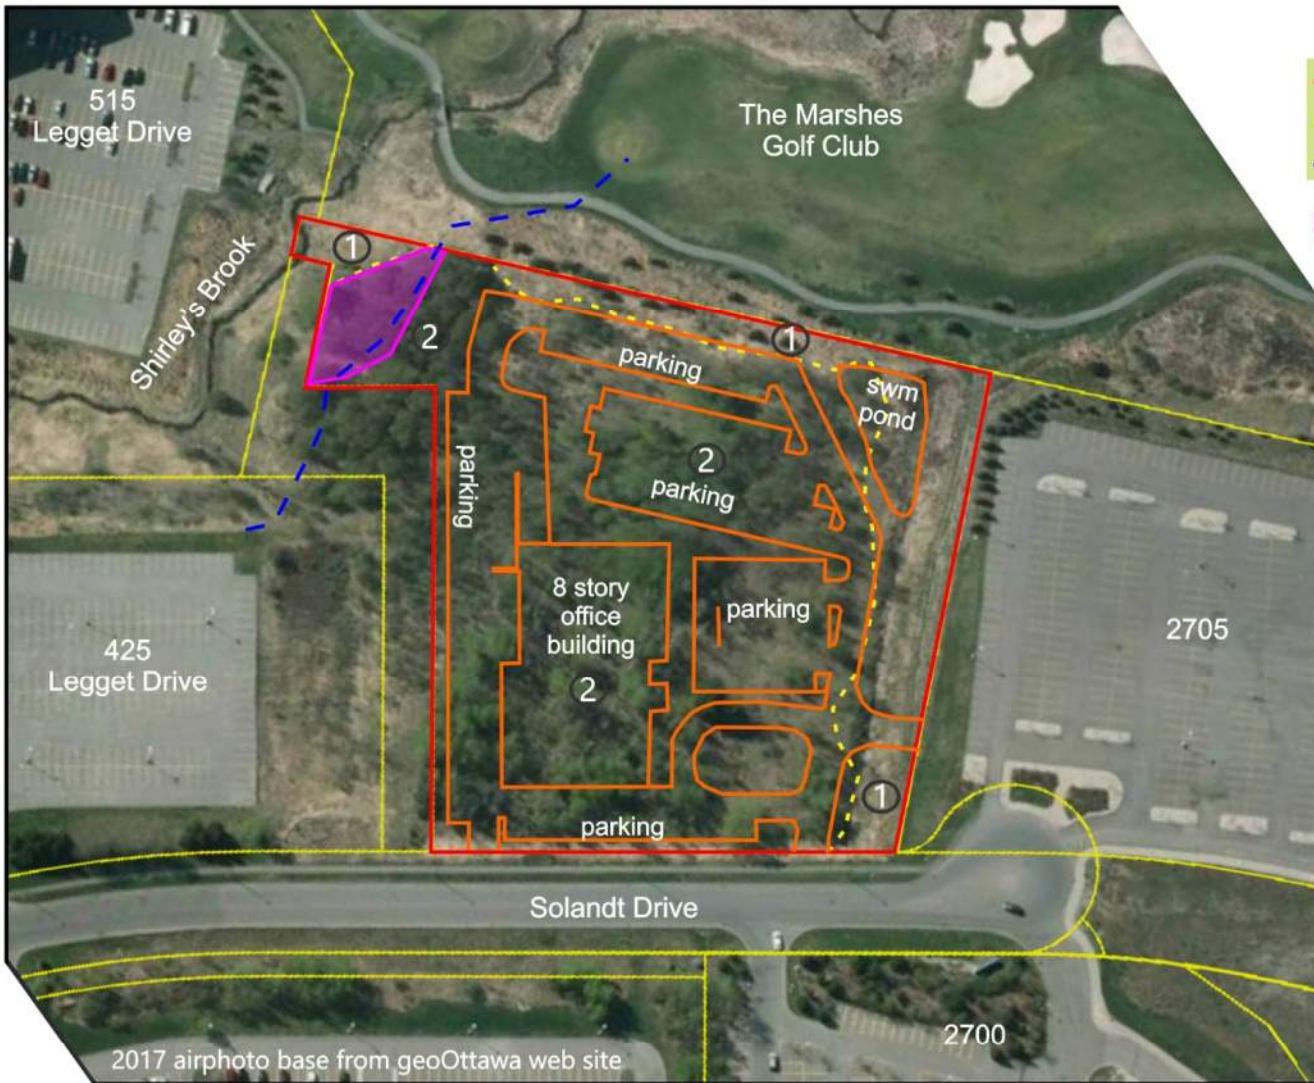
**ENVIRONMENTAL IMPACT STATEMENT/TCR
PROPOSED CONSERVED VEGETATION**

1. No tree removal or other site disturbances within 30 metres of Shirley's Brook as shown on Map 2 and described above;
2. To protect breeding birds, no tree removal should occur between April 15th and August 15th, unless a breeding bird survey conducted by a qualified biologist within five days of the woody vegetation removal identifies no active nests in the vegetation to be removed. Tree removal should begin in the south portion of the site and extend north, allowing any wildlife to relocate to the golf course to the north;
