**PHASE ONE  
ENVIRONMENTAL SITE ASSESSMENT  
975 GLADSTONE AVENUE,  
OTTAWA, ONTARIO**

**Canadian Bank Note Company, Limited**  
145 Richmond Road  
Ottawa, ON K1Z 1A1

**BluMetric Environmental Inc.**  
3108 Carp Road, Box 430  
Ottawa, ON K0A 1L0

Project Number: 190402  
10 July 2019

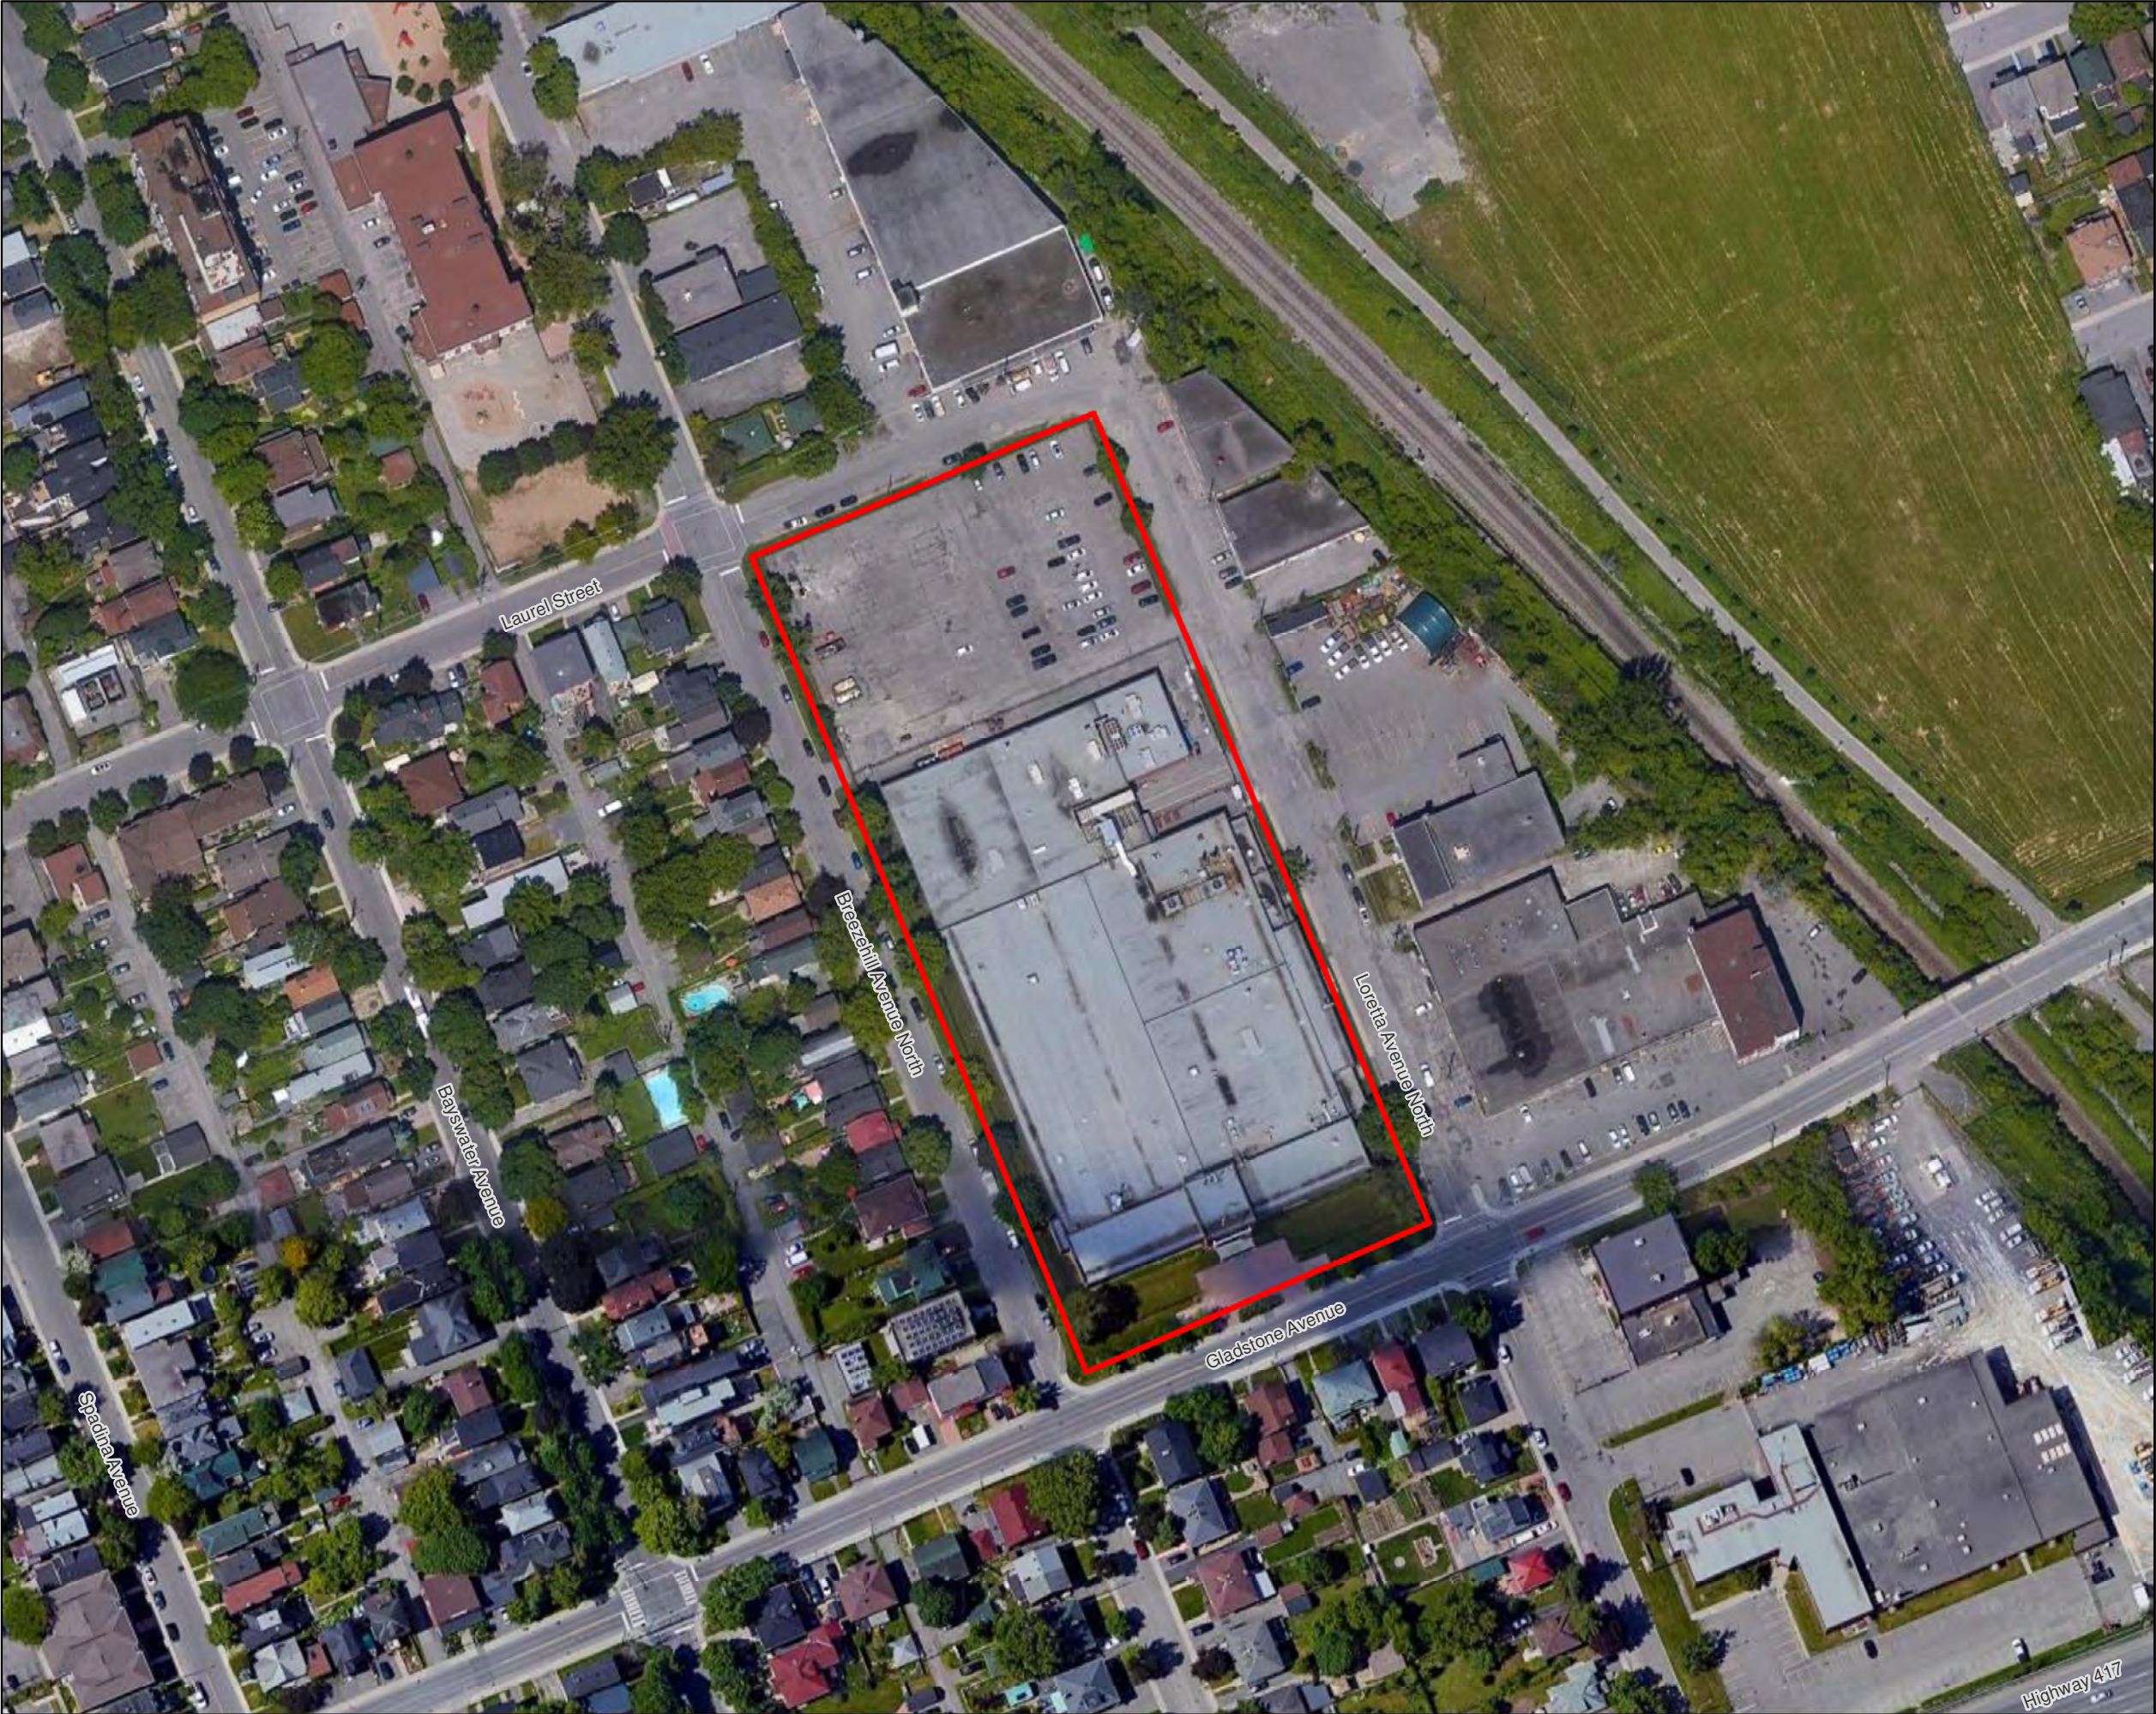
| DRAWN<br>KH | CHECKED<br>MKB | FIG NO.<br>03 | REV<br>0 |

The qualified person, Robert Hiller, QP<sub>ESA</sub> (subsequently referred to as the QP), determined that the conventional distance of 250 m from the Phase One Property boundary was adequate for defining the Phase One Study Area for all records reviewed, with the exception that a distance of 2 km was appropriate for reviewing records that pertain to active or former waste disposal sites, coal gasification plants, and coal tar sites, given that such sources can cause impacts that extend for distances of more than 250 m. The Phase One Property and Phase One Study Area are illustrated in Figure 3.

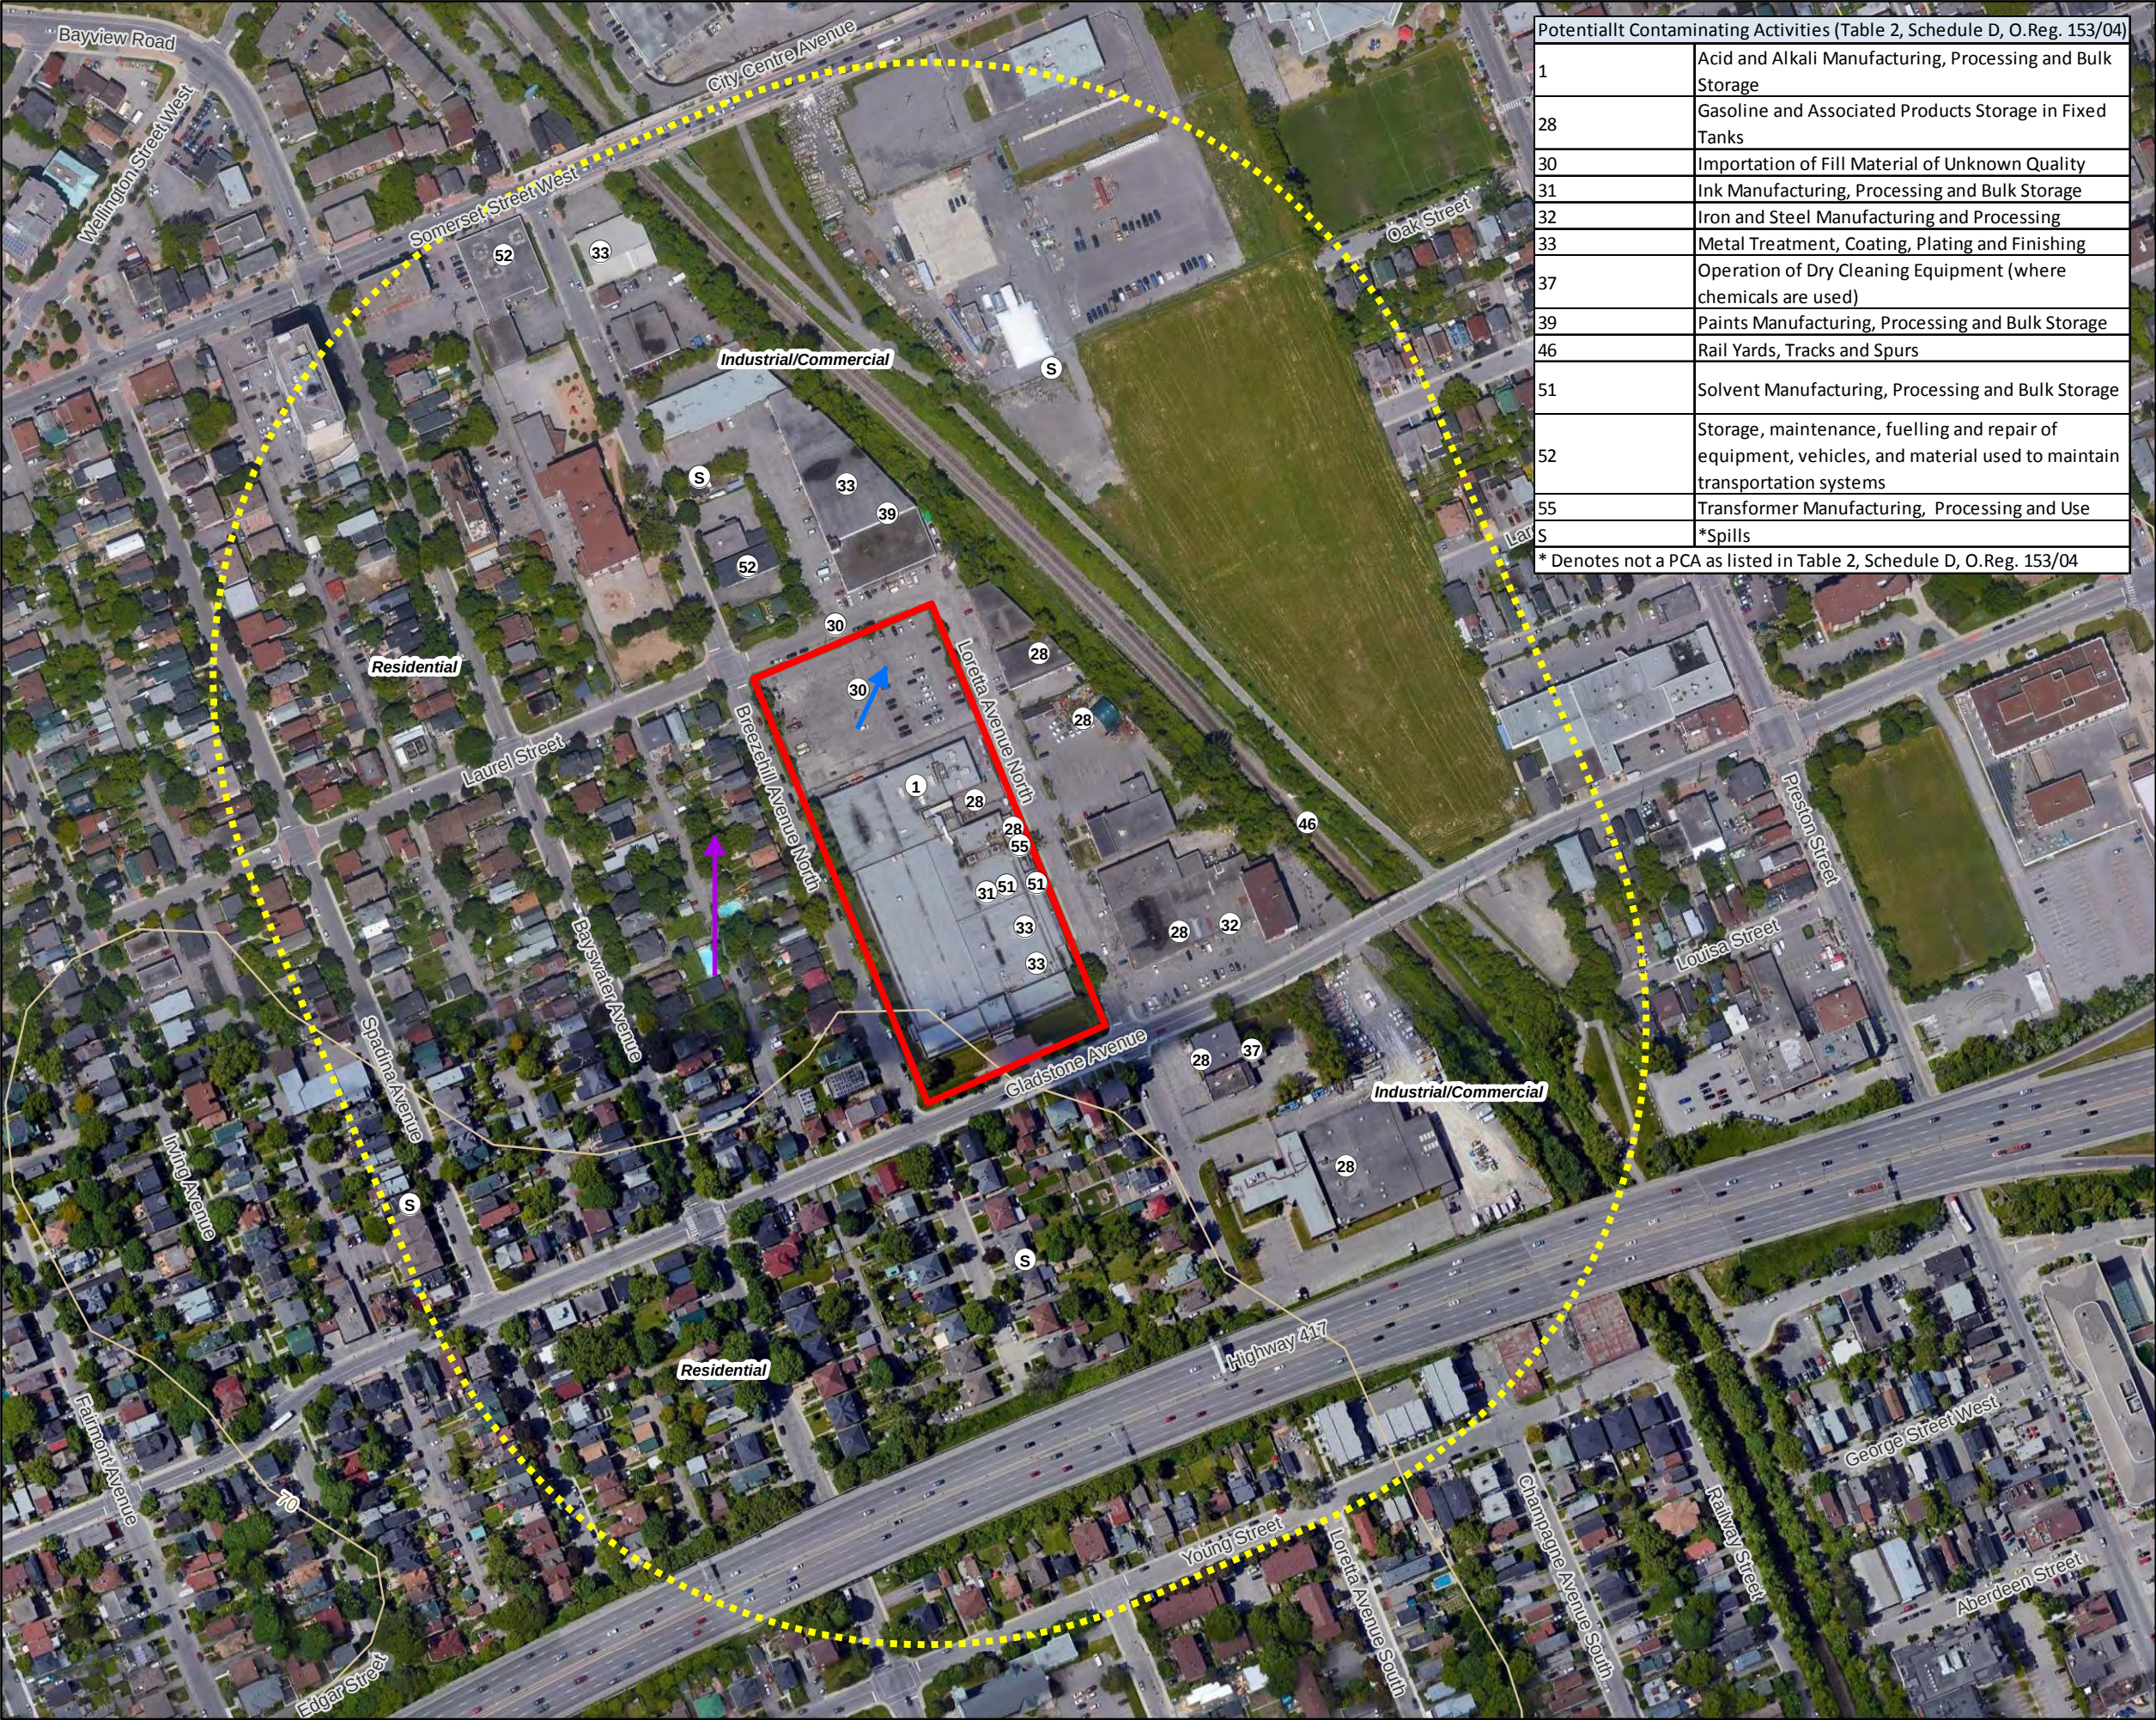
| Potentiallt Contaminating Activities (Table 2, Schedule D, O.Reg. 153/04) | |

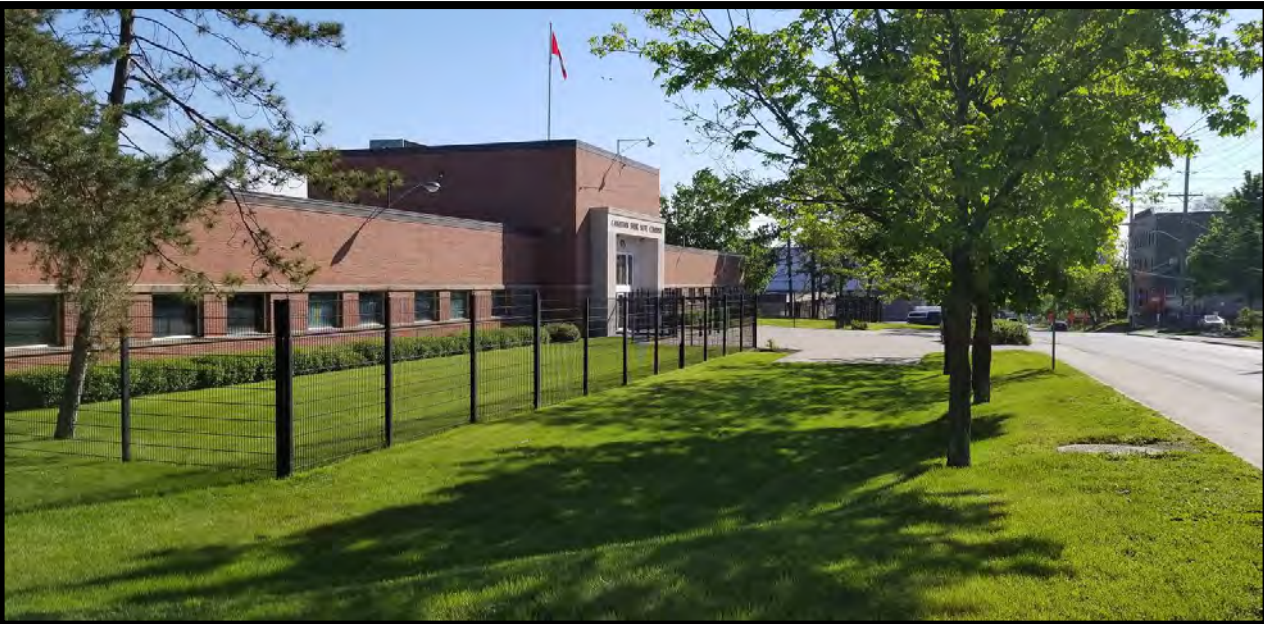
Looking northeast at the southern portion of the Phase One Property, as seen from southwestern corner of the Phase One Property.

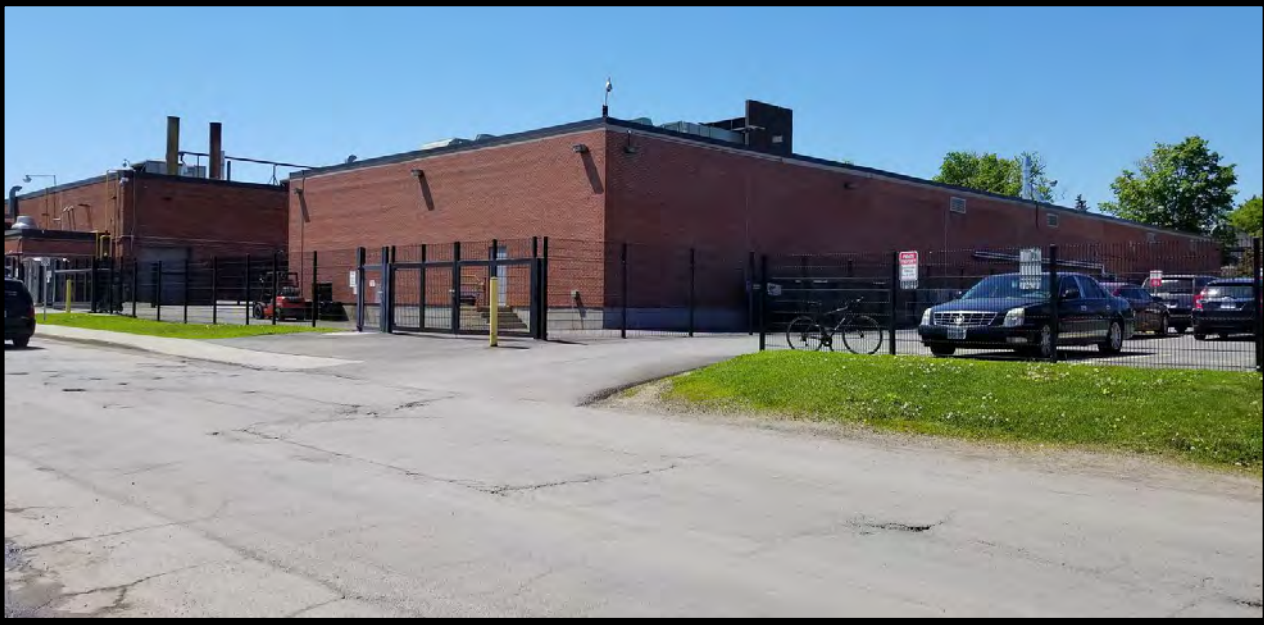
Looking southwest at the northern portion of the Phase One Property, as seen from Loretta Avenue North in the northeastern portion of the Phase One Study Area.

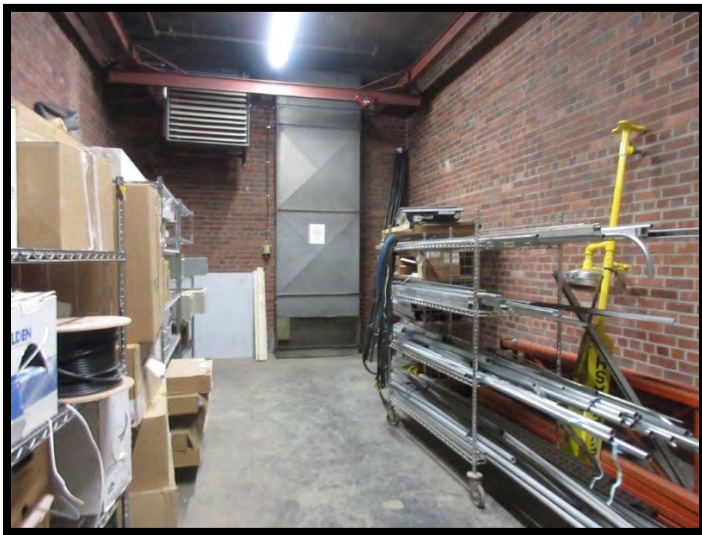
Left: Storage room in the northeastern portion of the CBN building.

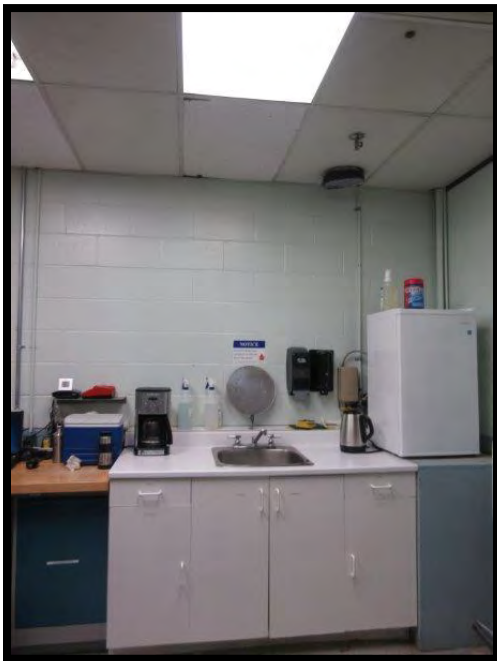
Left: Kitchen area of the electrician shop in the southeastern portion of the CBN building. The shop was formerly a lab with a fume hood (remnants of the fume hood can be seen in the ceiling).

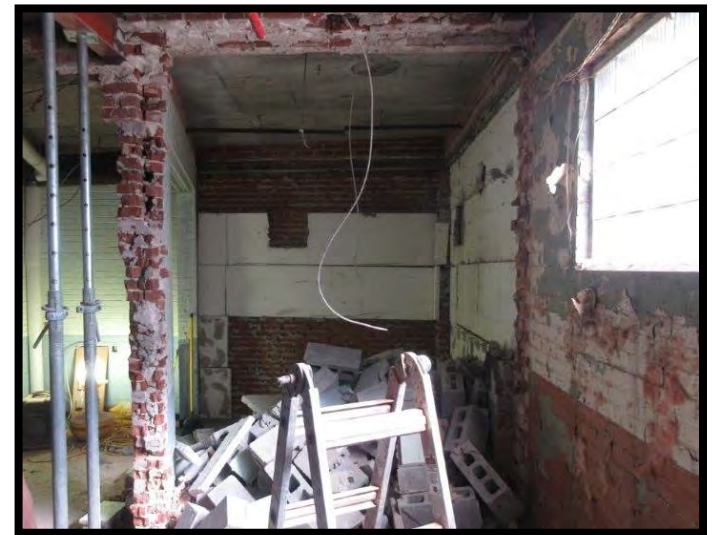
Right: Former upper floor building entrance at the southeast end of the CBN building.

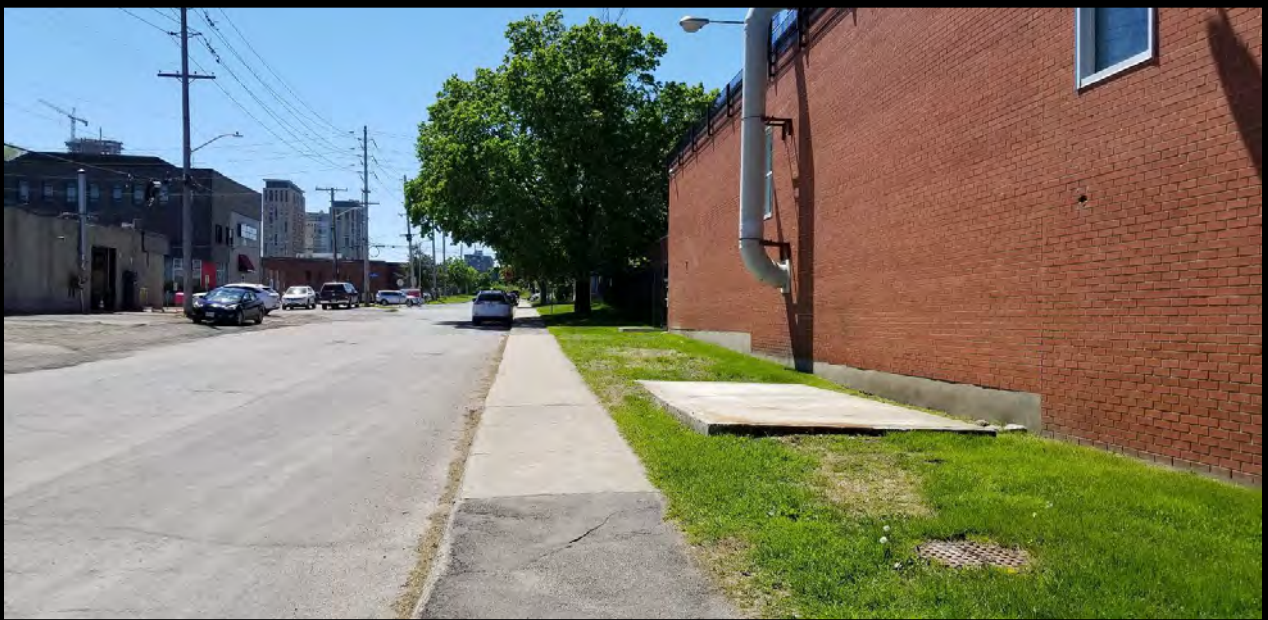
Looking south along Loretta Avenue North, as seen from the eastern boundary of the Phase One Property. The CBN building is located on the right side of the photo. The rectangular, concrete pad previously supported a small shed forming part of the former dual phase extraction remediation system.
