**PHASE TWO  
ENVIRONMENTAL SITE ASSESSMENT  
975 GLADSTONE AVENUE  
OTTAWA, ONTARIO**

**Canadian Bank Note Company, Limited**  
145 Richmond Road  
Ottawa, ON K1Z 1A1

**BluMetric Environmental Inc.**  
3108 Carp Road, Box 430  
Ottawa, ON K0A 1L0

Project Number: 190625  
31 October 2019

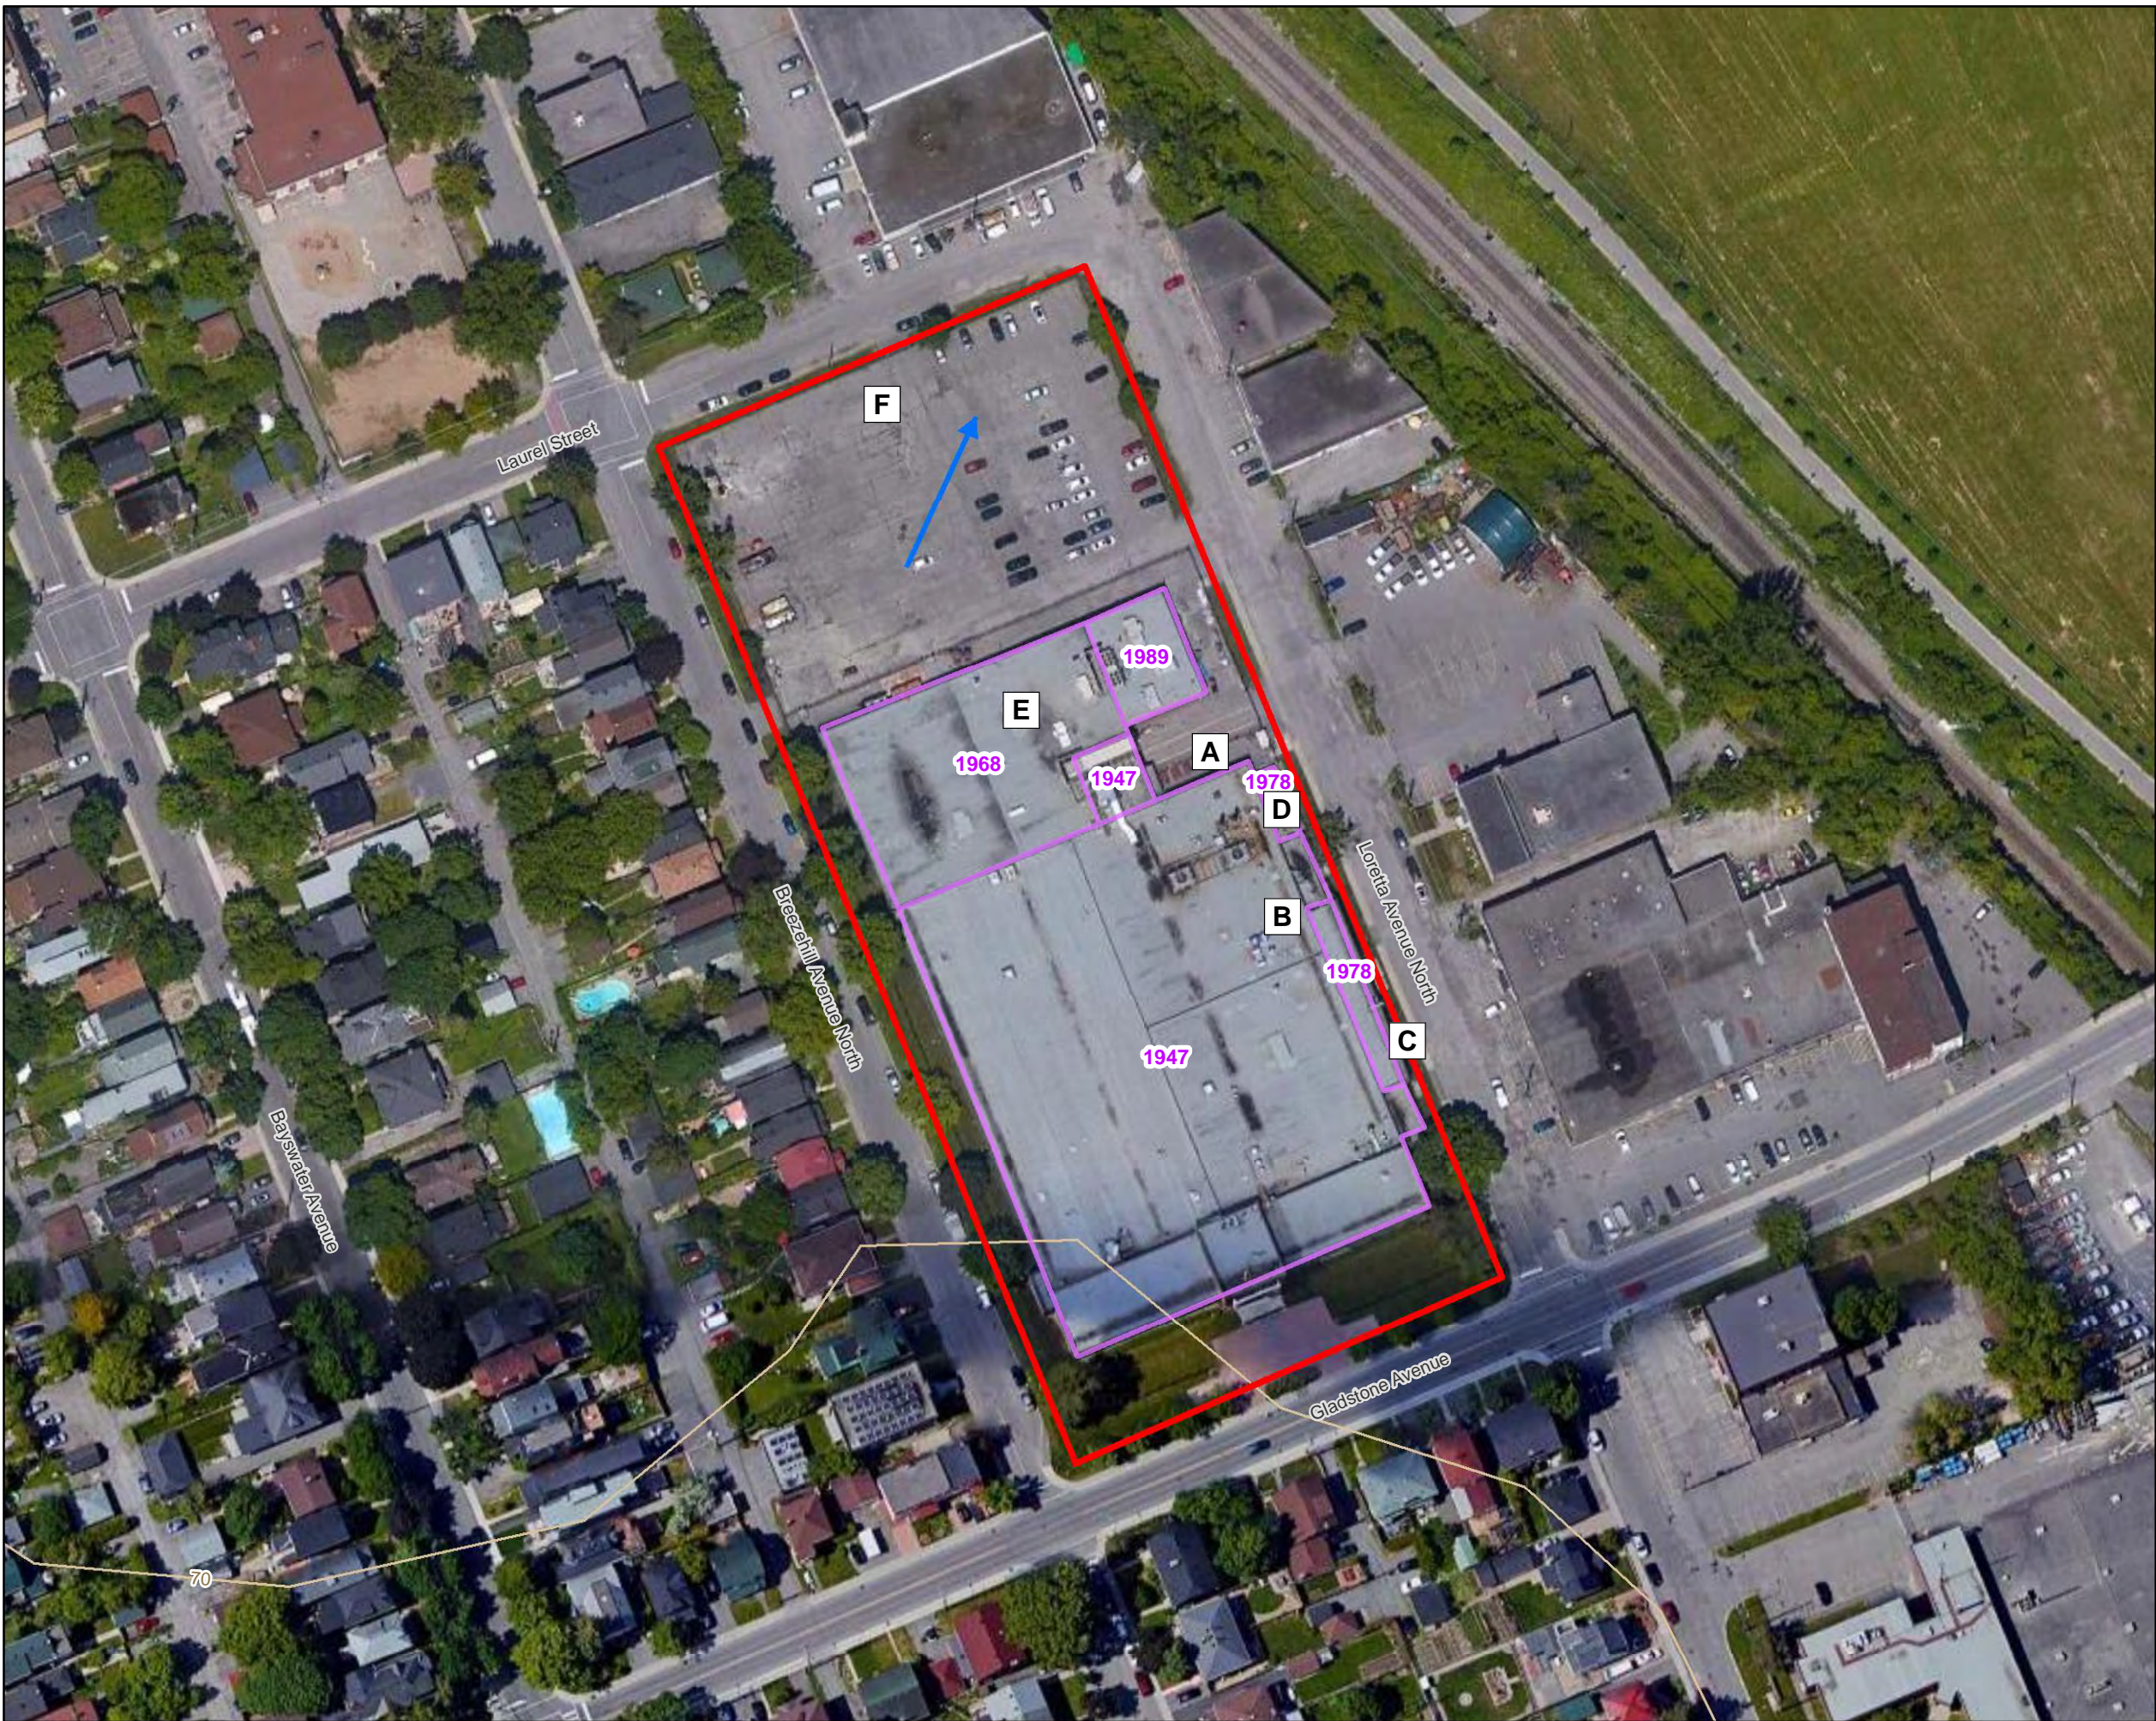
<b>PROJECT #</b> 190625		<b>DATE</b> October 03, 2019	
<b>DRAWN</b> KH	<b>CHECKED</b> MKB	<b>FIG NO.</b> 03a	<b>REV</b> 0

- Phase One Property
- 1947 Date of Construction
- Inferred Direction of Groundwater Flow

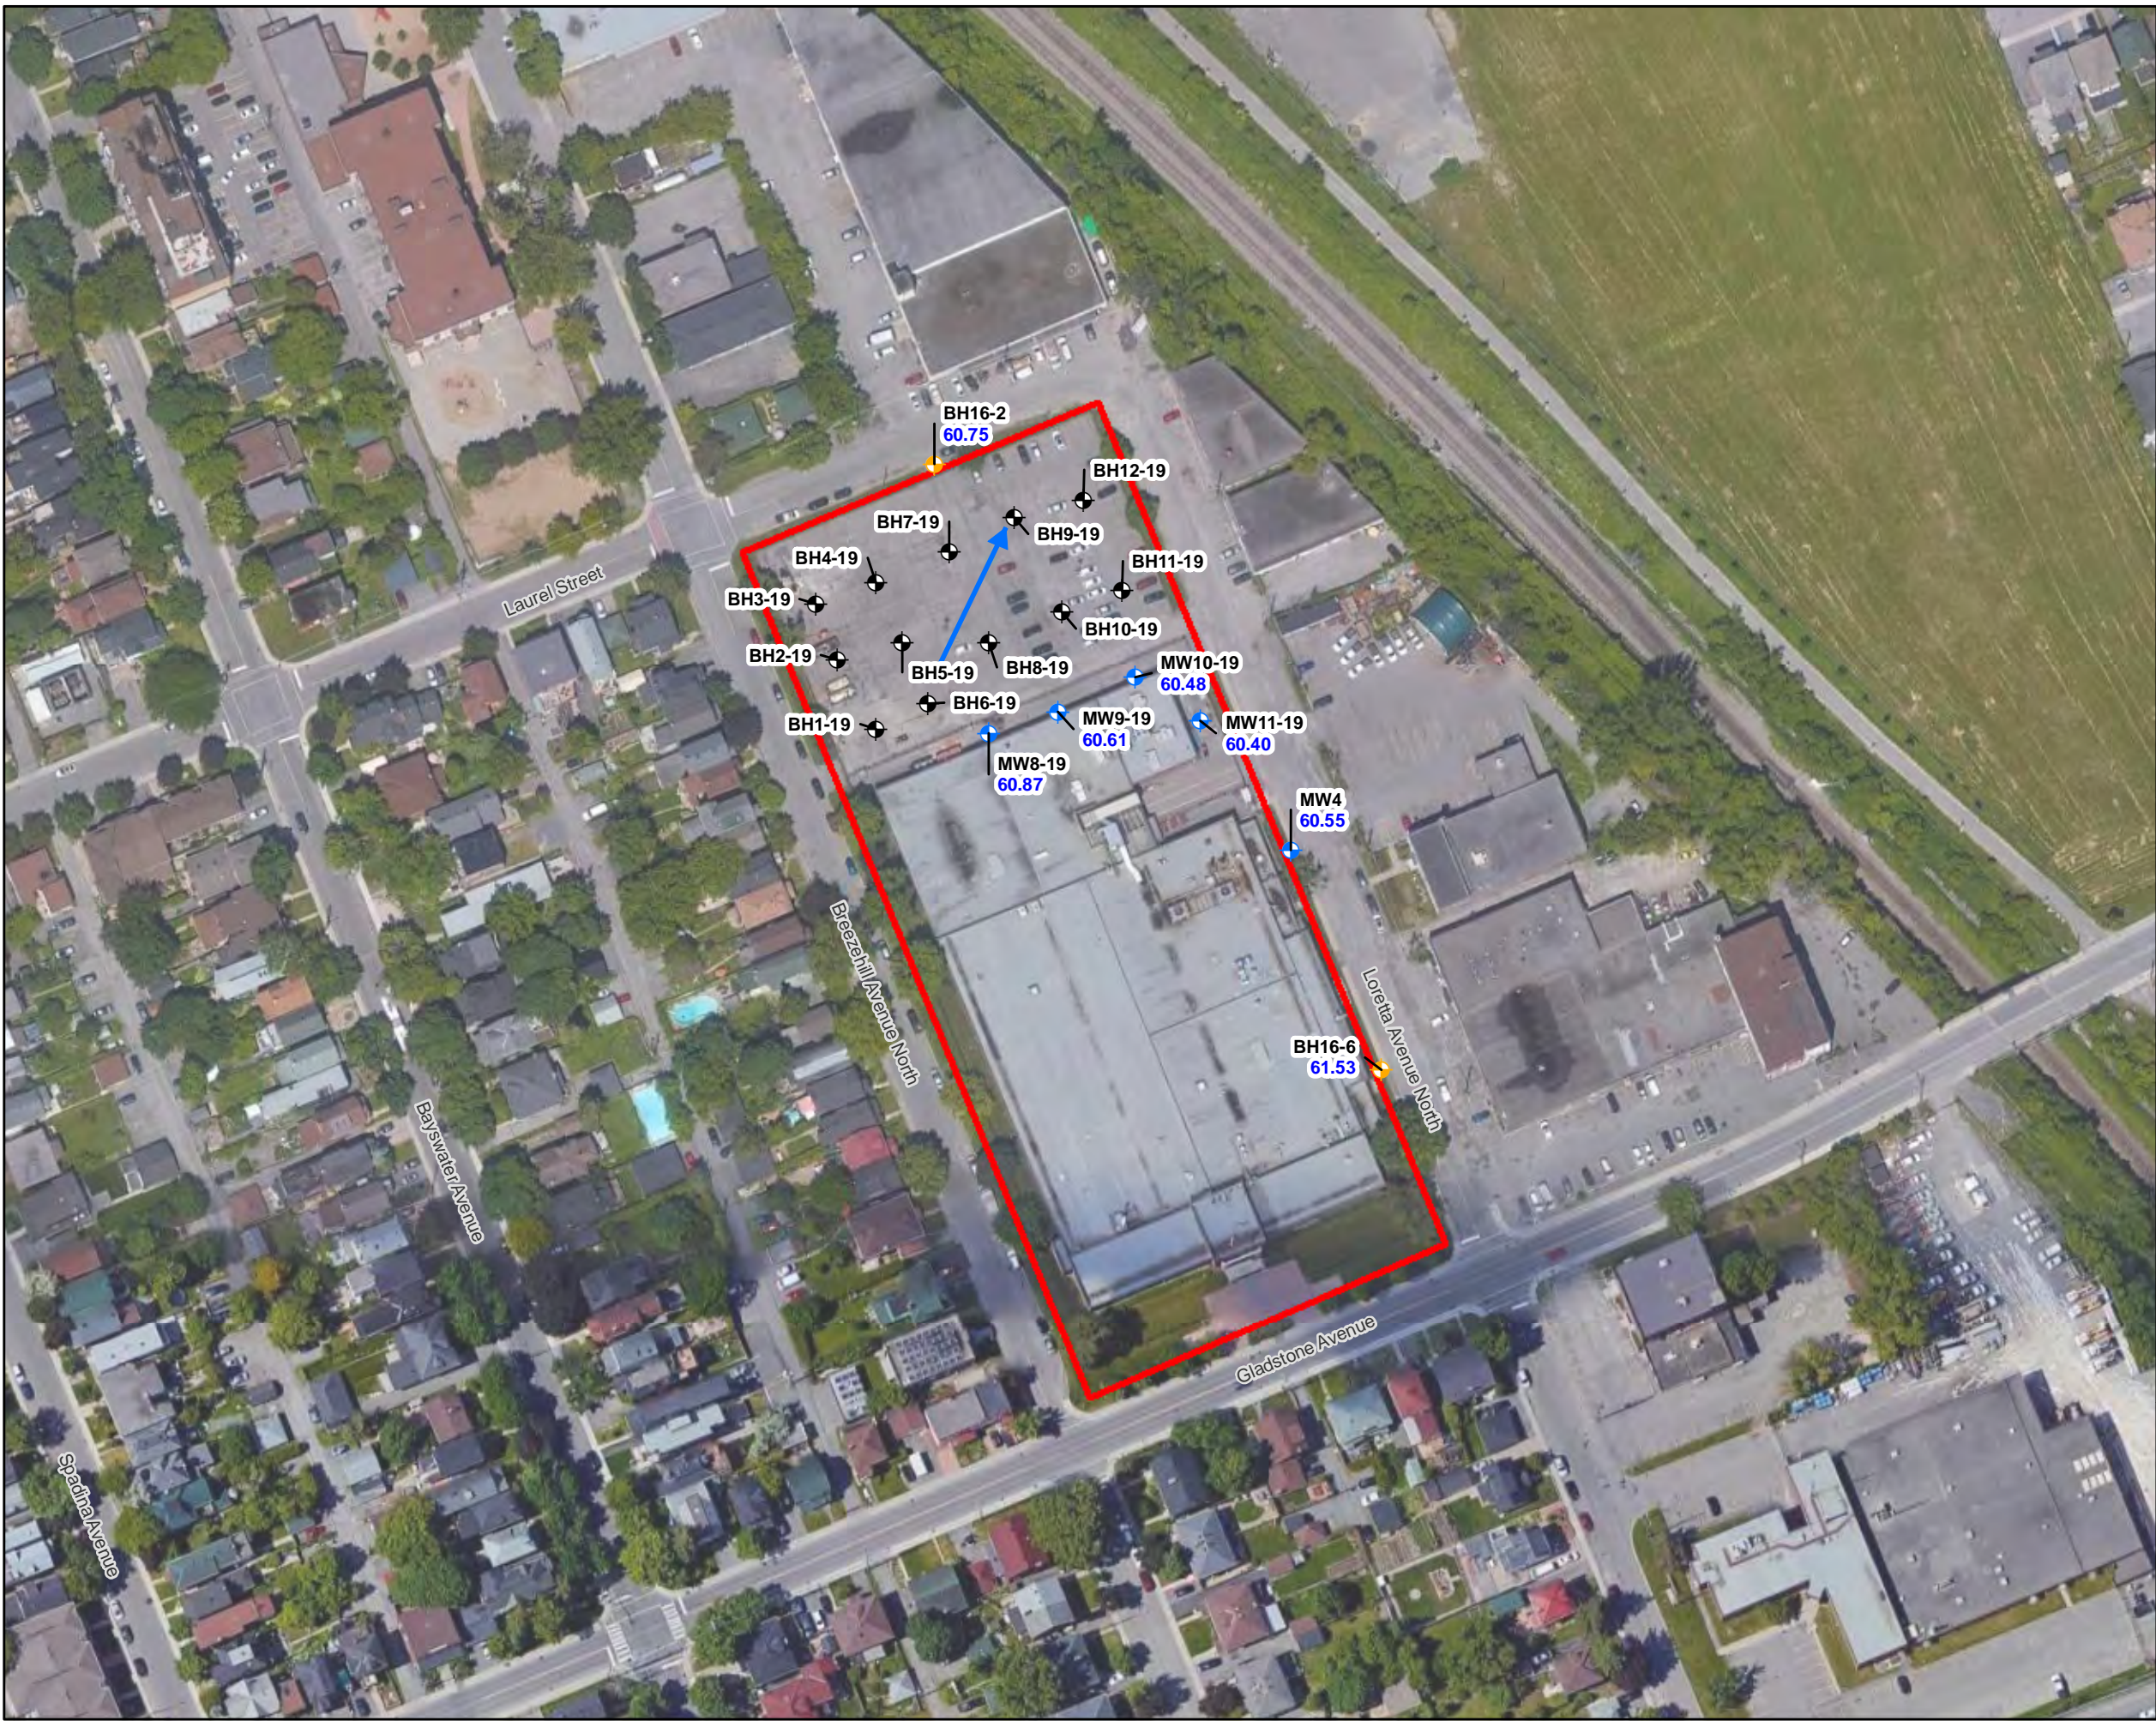
<b>PROJECT #</b> 190625-00		<b>DATE</b> October 18, 2019	
<b>DRAWN</b> KH	<b>CHECKED</b> RH	<b>FIG NO.</b> 04	<b>REV</b> 0

- Borehole
- City Well
- Monitoring Well
- 6055 Static Groundwater Elevation - October 7, 2019
- Inferred Groundwater Flow Direction
- Phase Two Property

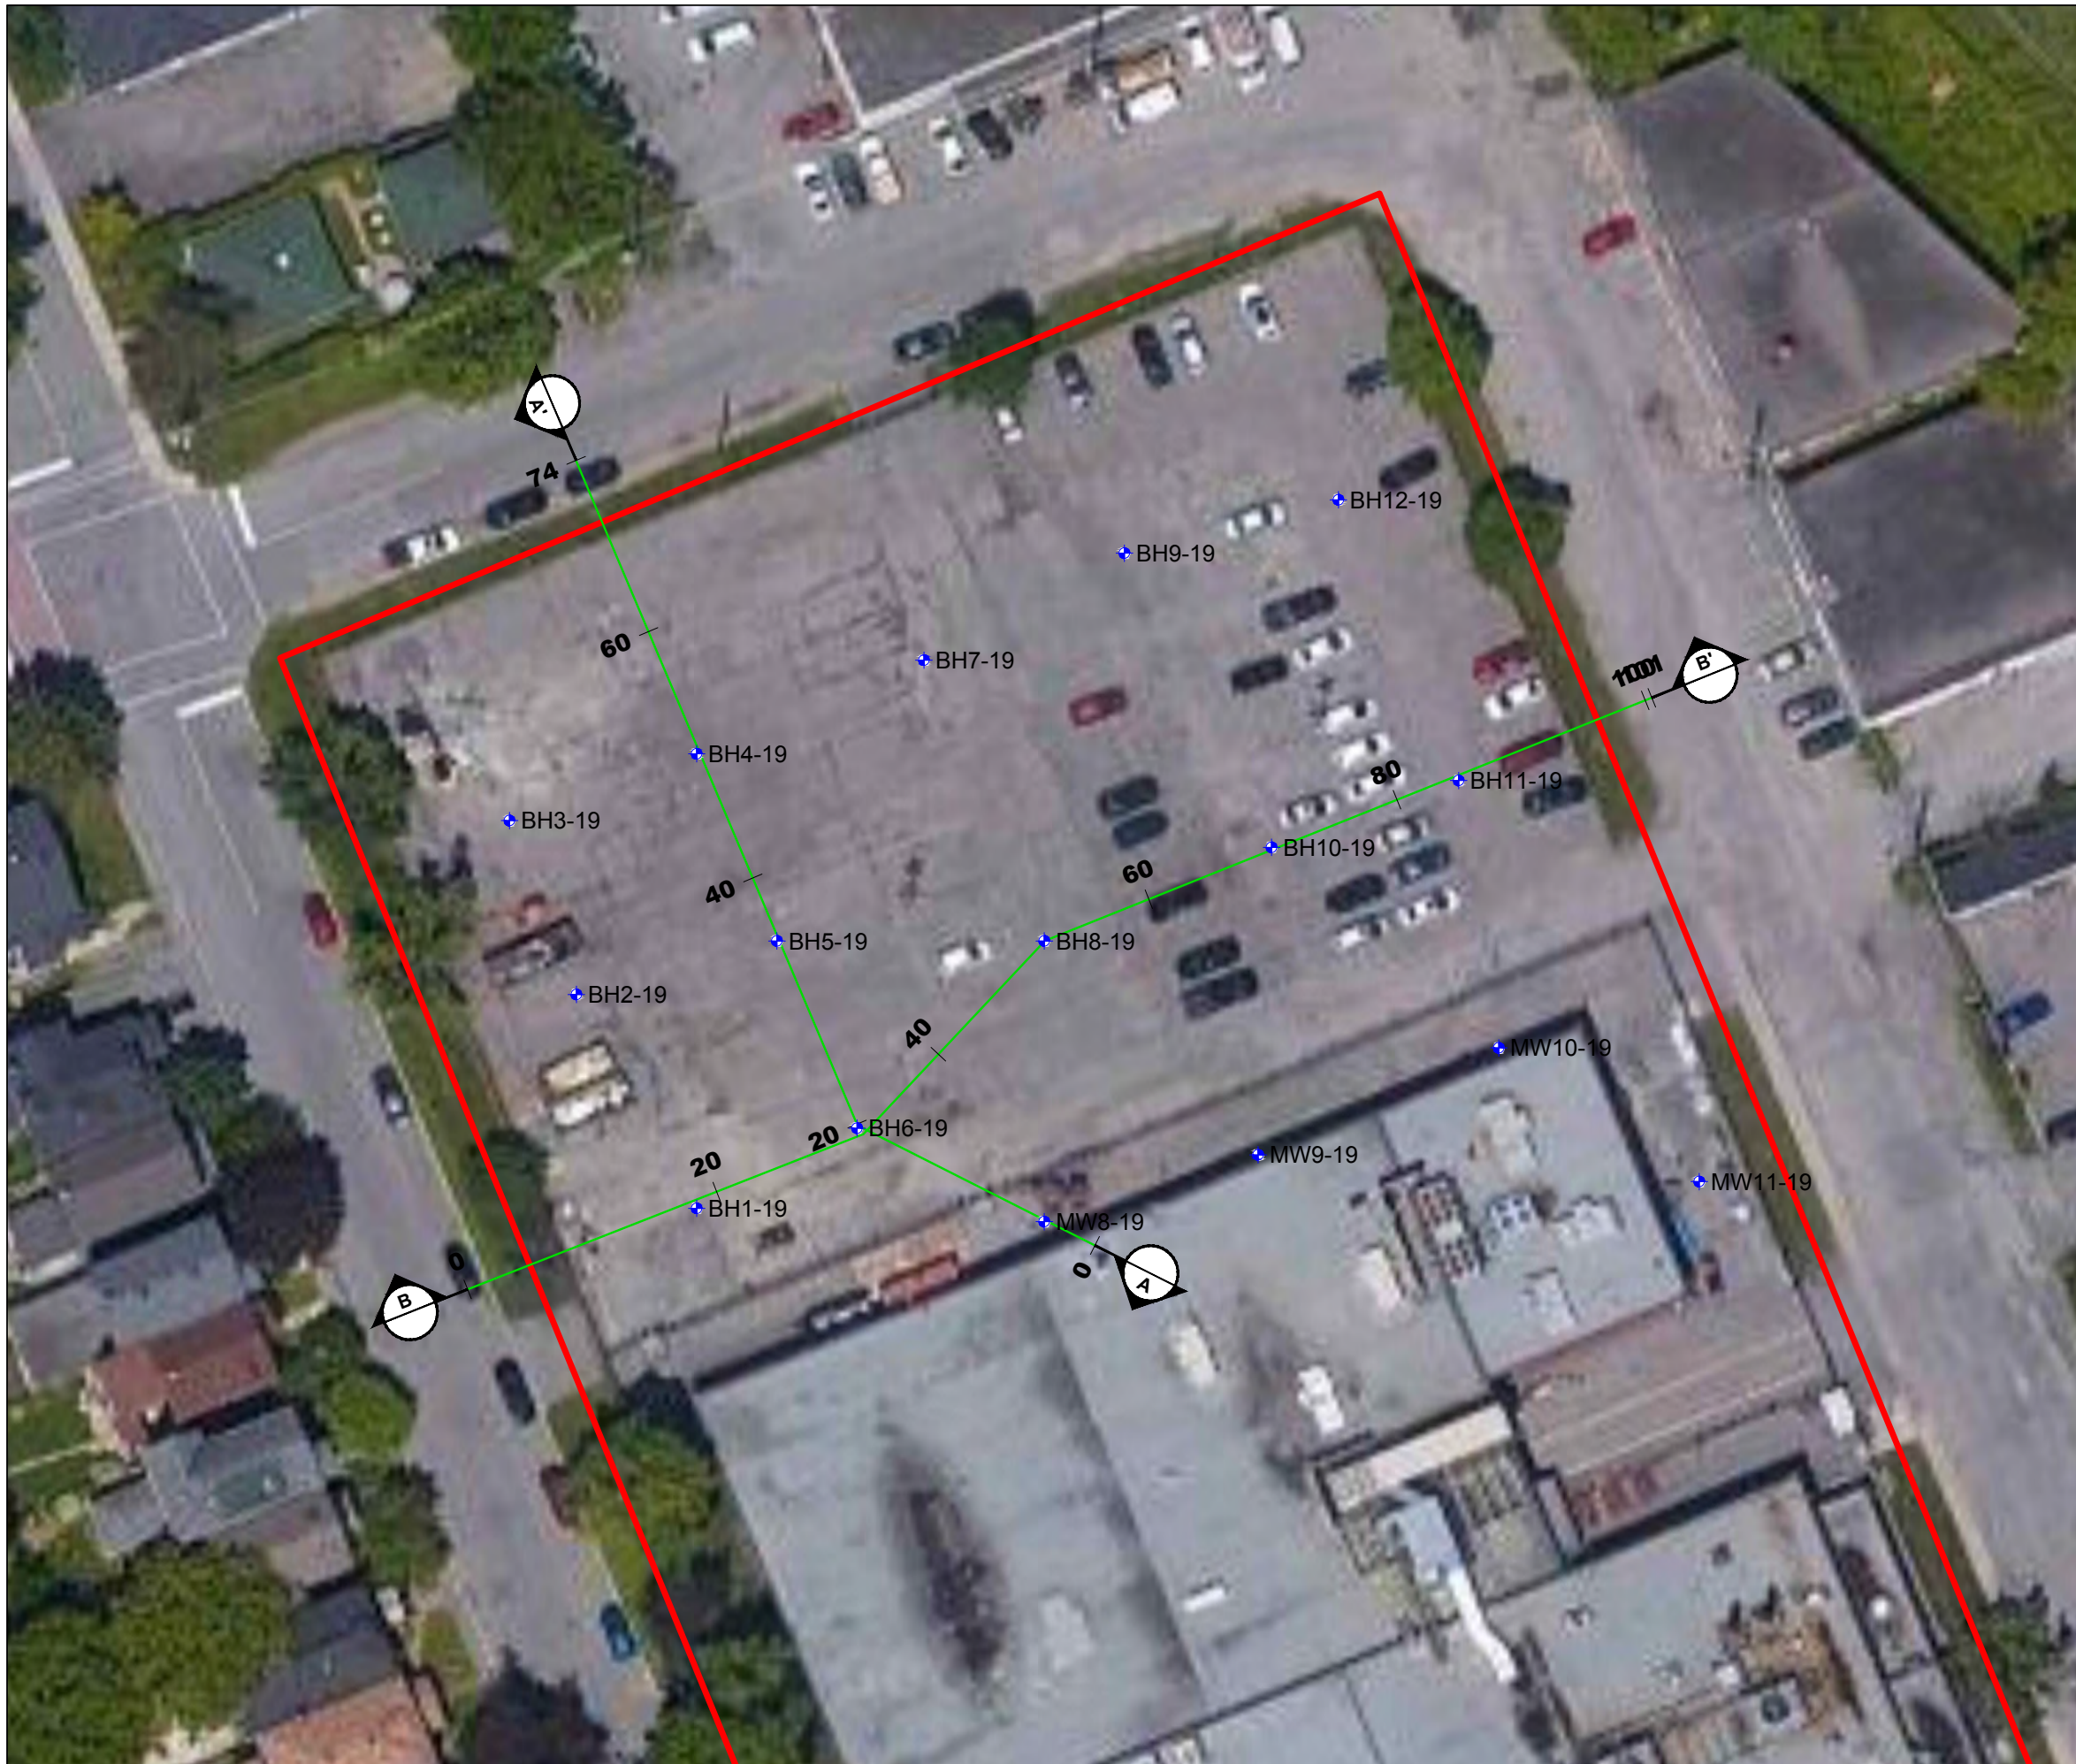
PROJECT # 190625-00	DATE October 18, 2019
DRAWN KH	CHECKED RH
FIG NO. 05	REV 0

- Monitoring Well / Borehole
- Line of Cross Section
- Property Line
