**Phase I-Environmental Site Assessment**

1050 and 1060 Bank Street  
Ottawa, Ontario

December 10, 2019

Report: PE4783-1

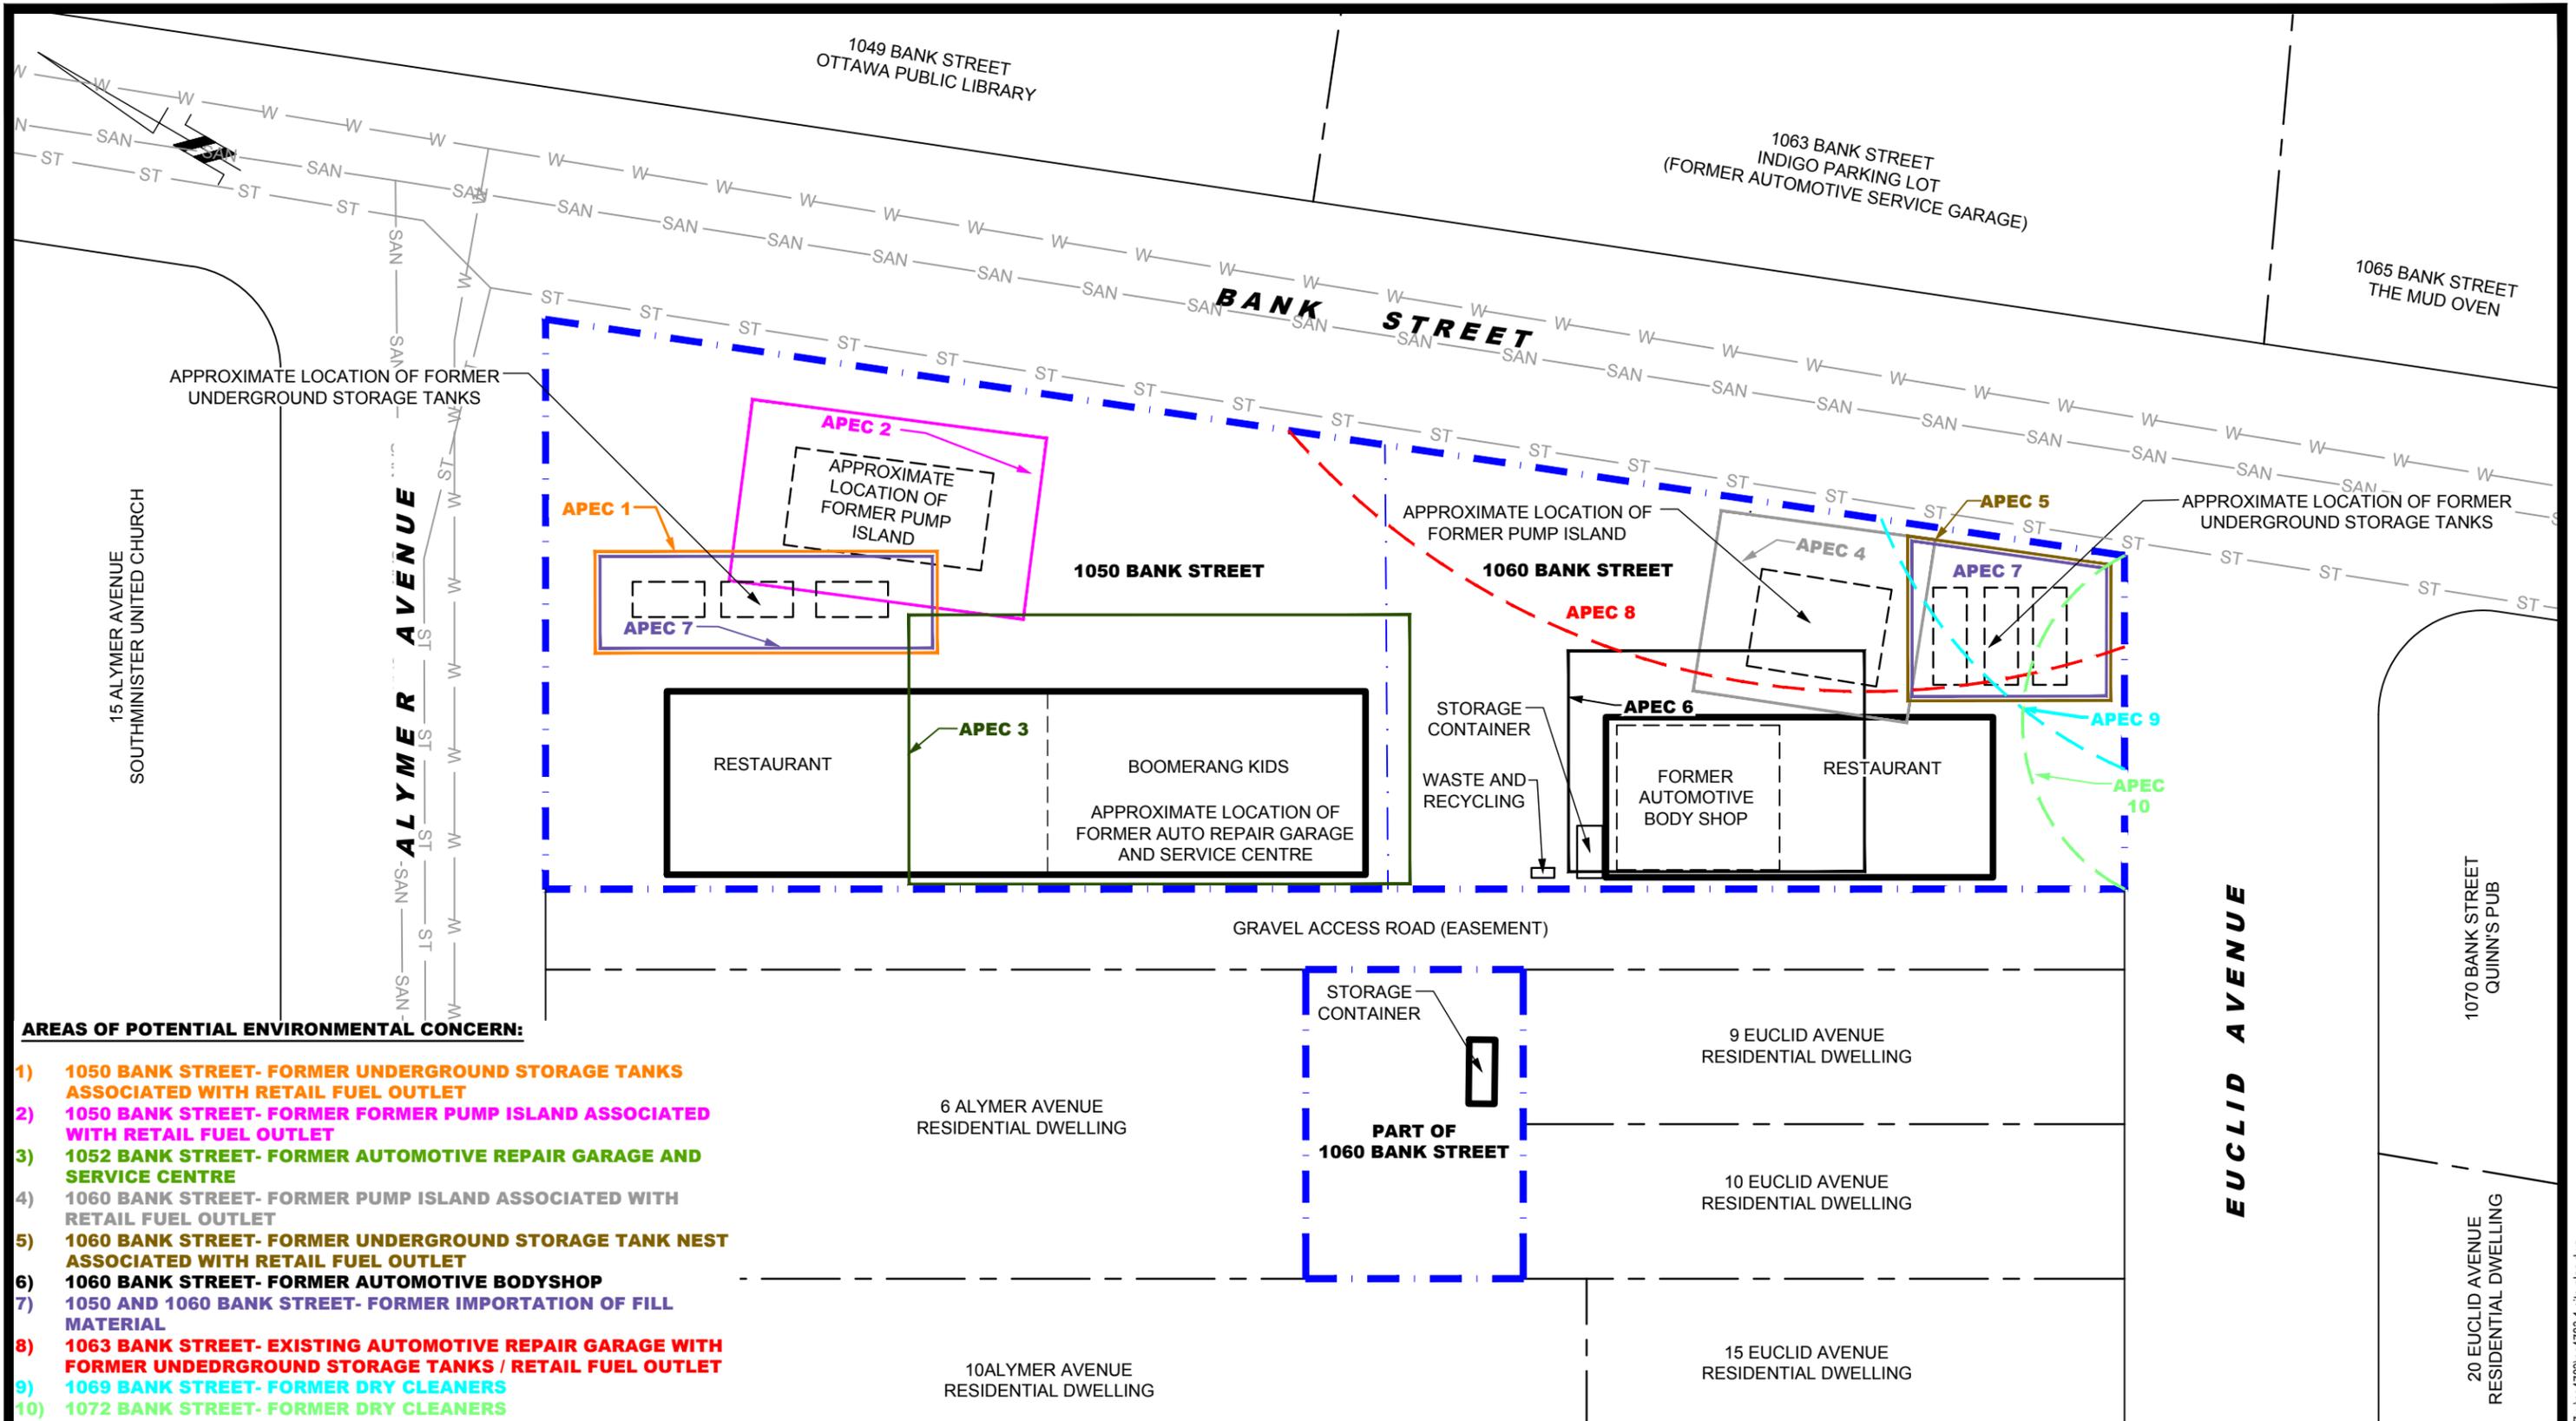
**DRAWING PE4783-1 – SITE PLAN**

**AREAS OF POTENTIAL ENVIRONMENTAL CONCERN:**

- 1) 1050 BANK STREET- FORMER UNDERGROUND STORAGE TANKS ASSOCIATED WITH RETAIL FUEL OUTLET
- 2) 1050 BANK STREET- FORMER FORMER PUMP ISLAND ASSOCIATED WITH RETAIL FUEL OUTLET
- 3) 1052 BANK STREET- FORMER AUTOMOTIVE REPAIR GARAGE AND SERVICE CENTRE
- 4) 1060 BANK STREET- FORMER PUMP ISLAND ASSOCIATED WITH RETAIL FUEL OUTLET
- 5) 1060 BANK STREET- FORMER UNDERGROUND STORAGE TANK NEST ASSOCIATED WITH RETAIL FUEL OUTLET
- 6) 1060 BANK STREET- FORMER AUTOMOTIVE BODYSHOP
- 7) 1050 AND 1060 BANK STREET- FORMER IMPORTATION OF FILL MATERIAL
- 8) 1063 BANK STREET- EXISTING AUTOMOTIVE REPAIR GARAGE WITH FORMER UNDEDRGROUND STORAGE TANKS / RETAIL FUEL OUTLET
- 9) 1069 BANK STREET- FORMER DRY CLEANERS
- 10) 1072 BANK STREET- FORMER DRY CLEANERS

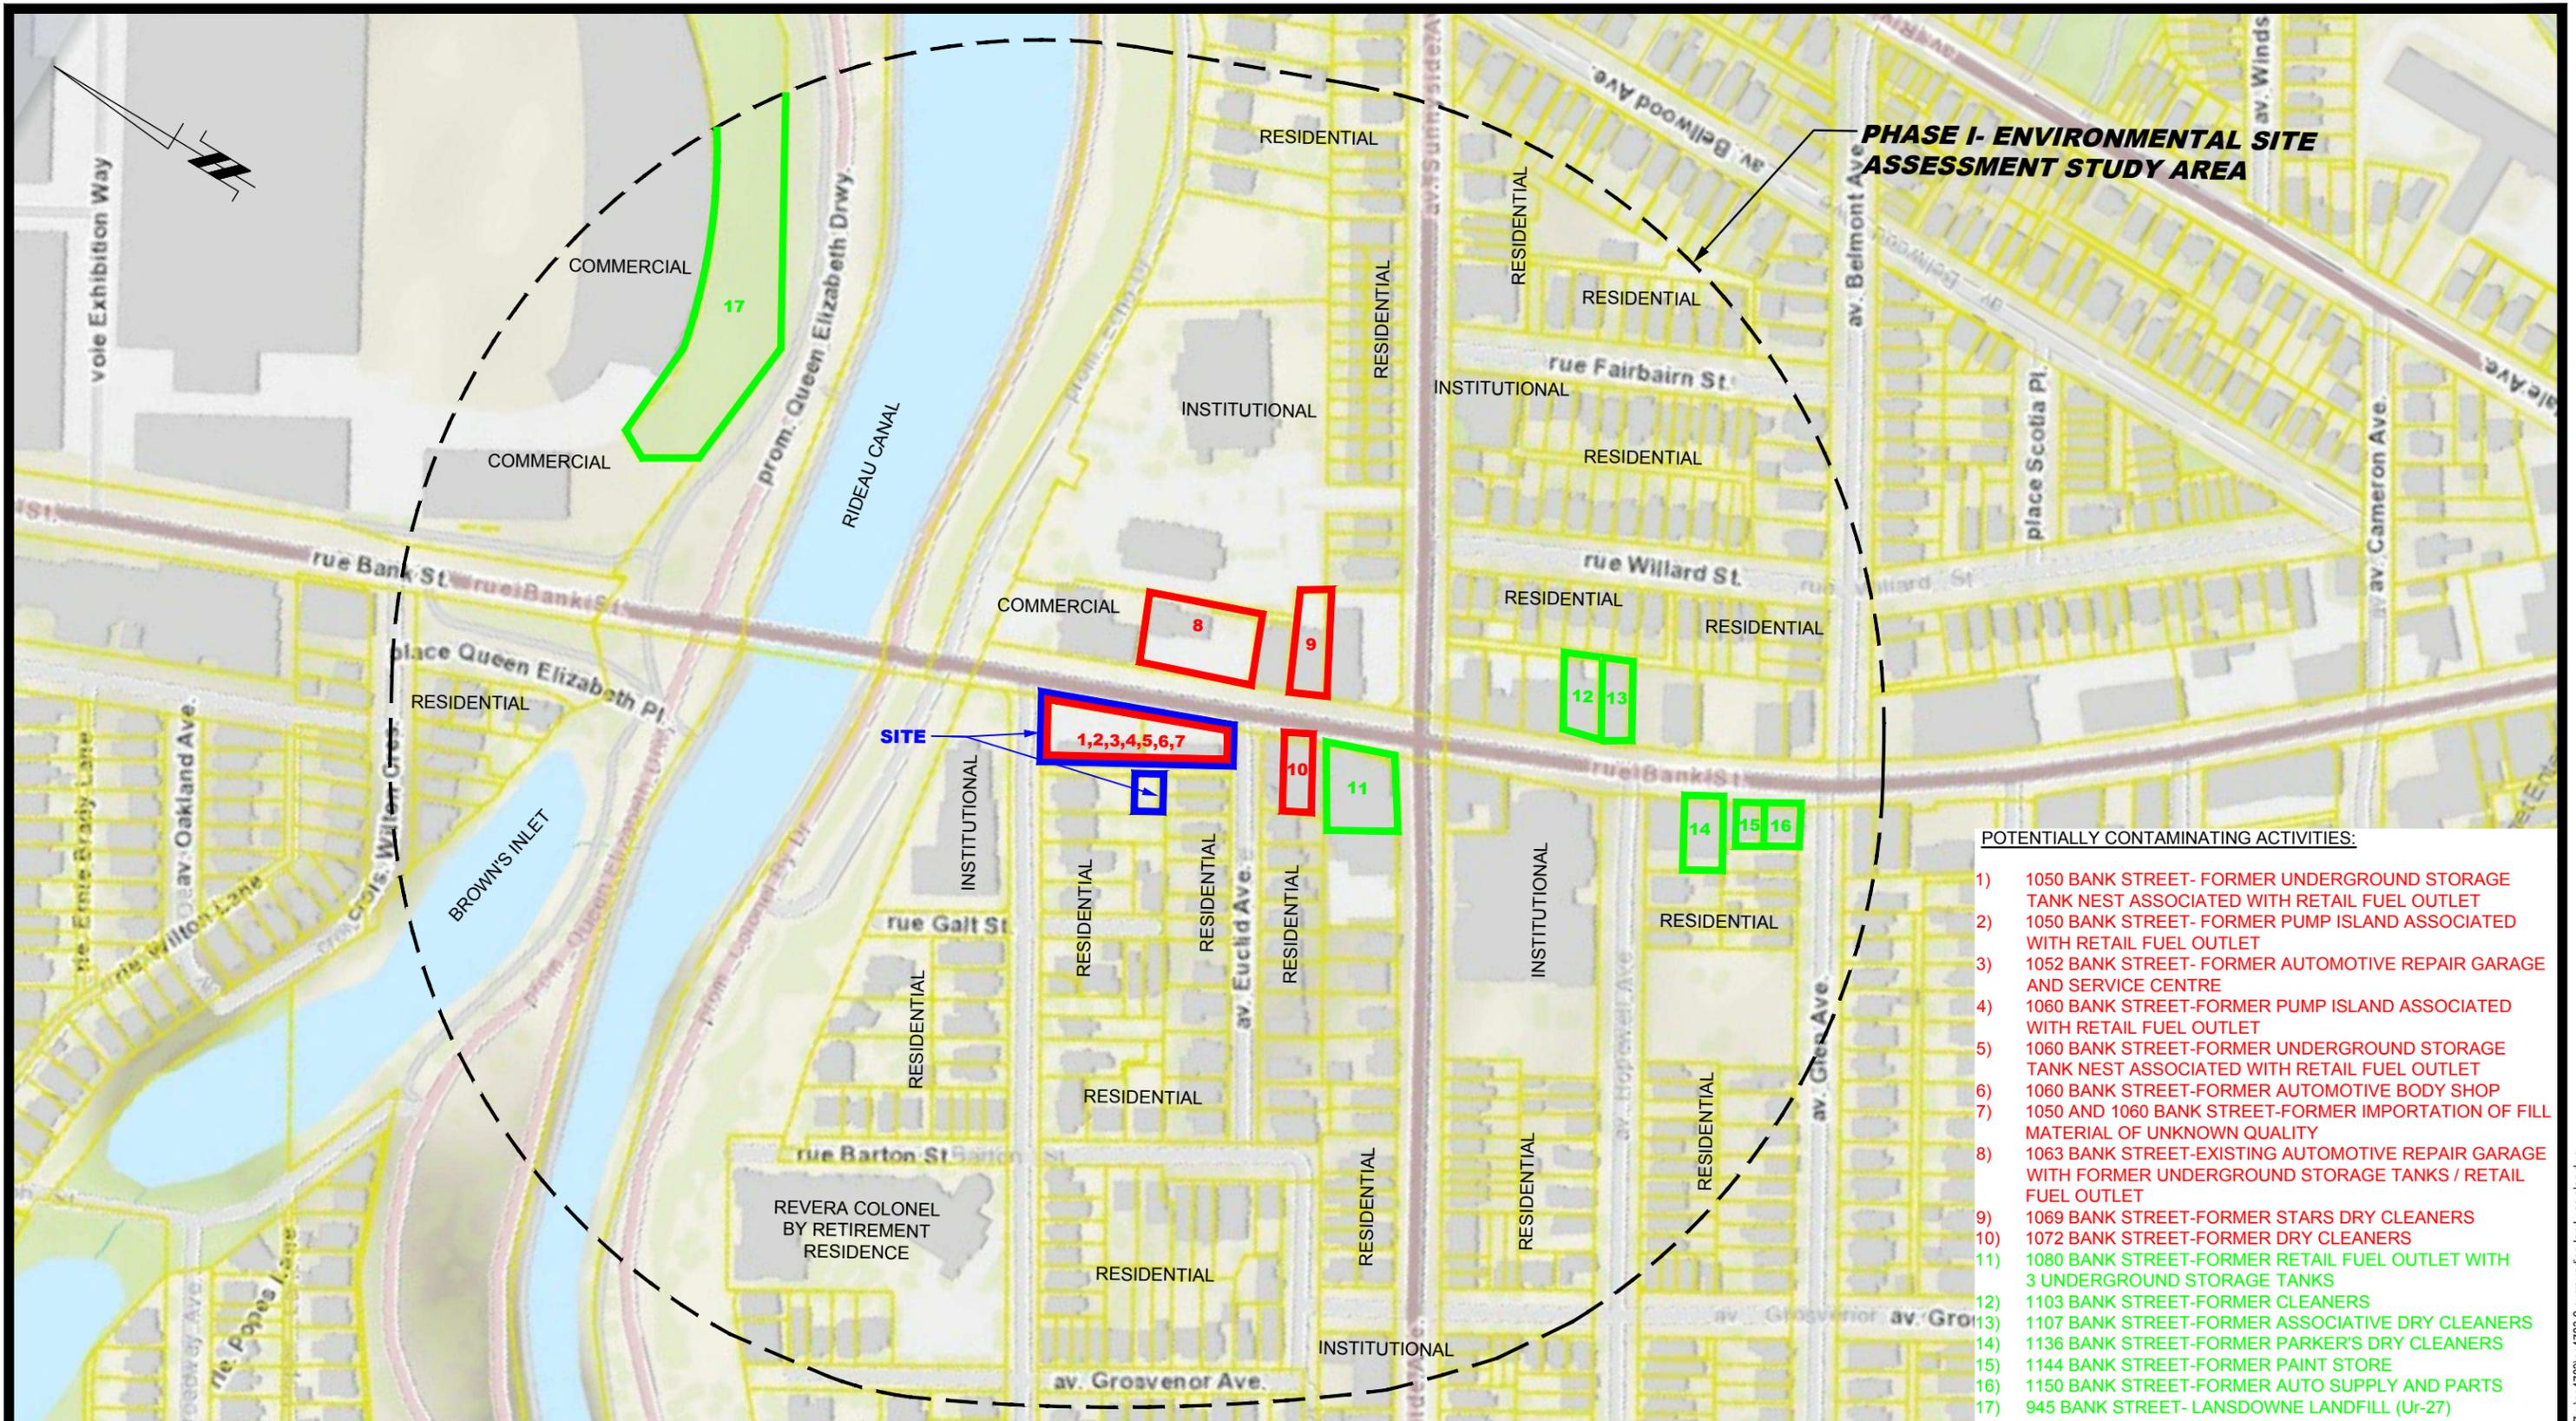
**DRAWING PE4783-2 – SURROUNDING LAND USE PLAN**

- POTENTIALLY CONTAMINATING ACTIVITIES:**
- 1) 1050 BANK STREET- FORMER UNDERGROUND STORAGE TANK NEST ASSOCIATED WITH RETAIL FUEL OUTLET
  - 2) 1050 BANK STREET- FORMER PUMP ISLAND ASSOCIATED WITH RETAIL FUEL OUTLET

- 3) 1052 BANK STREET- FORMER AUTOMOTIVE REPAIR GARAGE AND SERVICE CENTRE
  - 4) 1060 BANK STREET- FORMER PUMP ISLAND ASSOCIATED WITH RETAIL FUEL OUTLET

- 8) 1063 BANK STREET- EXISTING AUTOMOTIVE REPAIR GARAGE WITH FORMER UNDERGROUND STORAGE TANKS / RETAIL FUEL OUTLET
  - 9) 1069 BANK STREET- FORMER STARS DRY CLEANERS

Remaining land use within the Phase I Study Area is primarily residential with commercial land use along Bank Street, and parkland along the Rideau Canal. A previously noted automotive service garage building remains present at 1063 Bank Street although it is no longer operational; this property is currently operated as a commercial parking lot. No existing off-site PCAs were identified at the time of the site visit. Surrounding land use within the Phase I Study Area is presented on Drawing PE4783-2 – Surrounding Land Use Plan.

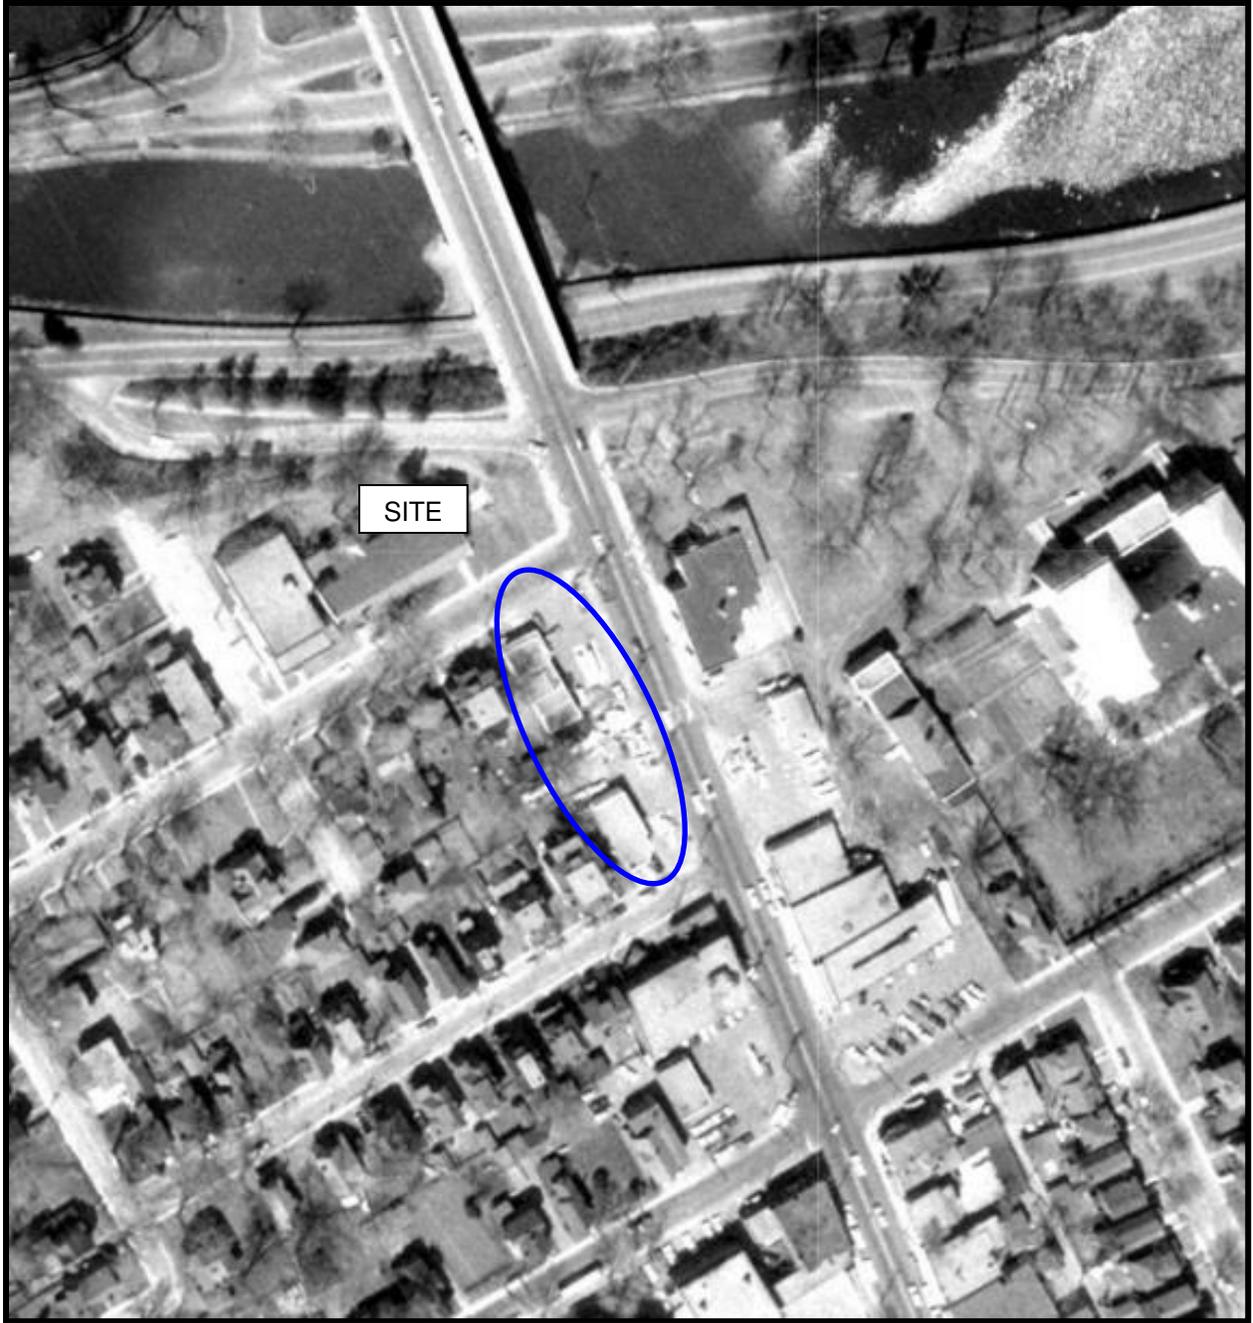
AERIAL PHOTOGRAPH  
1965

- 1965      One of the former on-site buildings, specifically the middle building appears to have been demolished and replaced by expanding the south end of the original building of 1050 Bank Street. A pump island can be seen on the northeast portion of the Phase I Property. Otherwise, no apparent changes to the Phase I Property. Neighbouring properties within the Phase I Study Area appear unchanged from the previous photograph.

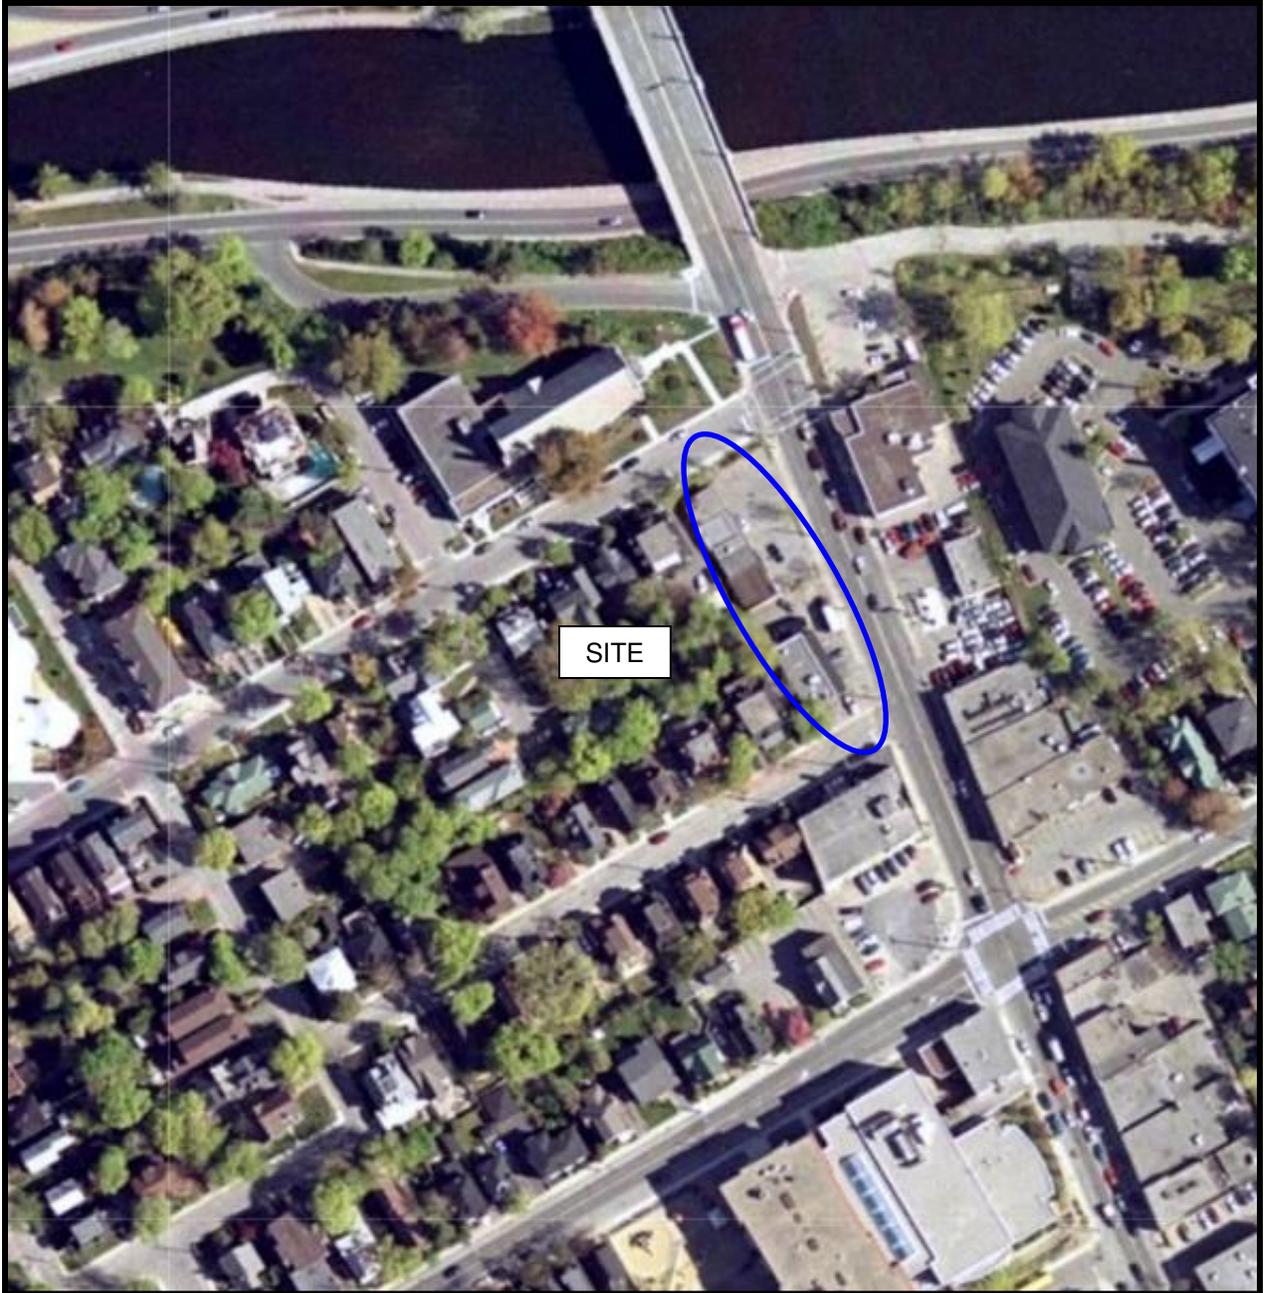
AERIAL PHOTOGRAPH  
2002

- 1991      The Phase I Property and neighbouring lands within the Phase I Study Area appear remains unchanged from the previous photograph.
- 2002      No significant changes are apparent on the Phase I Property. The retail fuel outlet two (2) properties south of the Phase I Property is no longer present at this time. The remaining lands appear unchanged from the previous photograph.

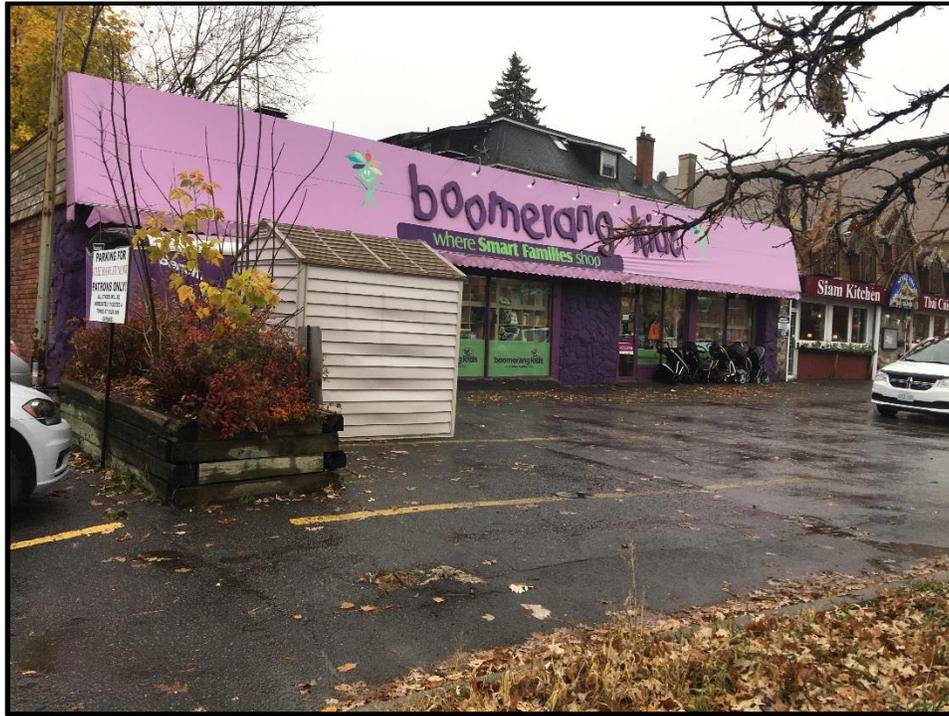
Photograph 1: Northwestern view of the Phase I Property (1050 Bank Street) from Bank Street looking northwest.

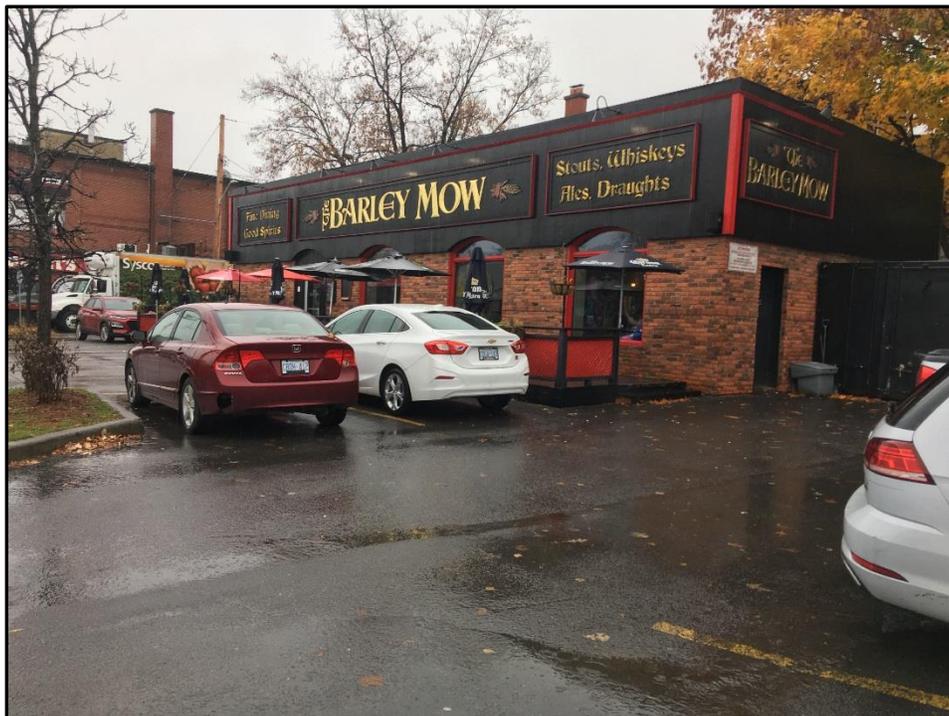
Photograph 2: Southwestern view of the Phase I Property (1060 Bank Street) from Bank Street, looking southwest.

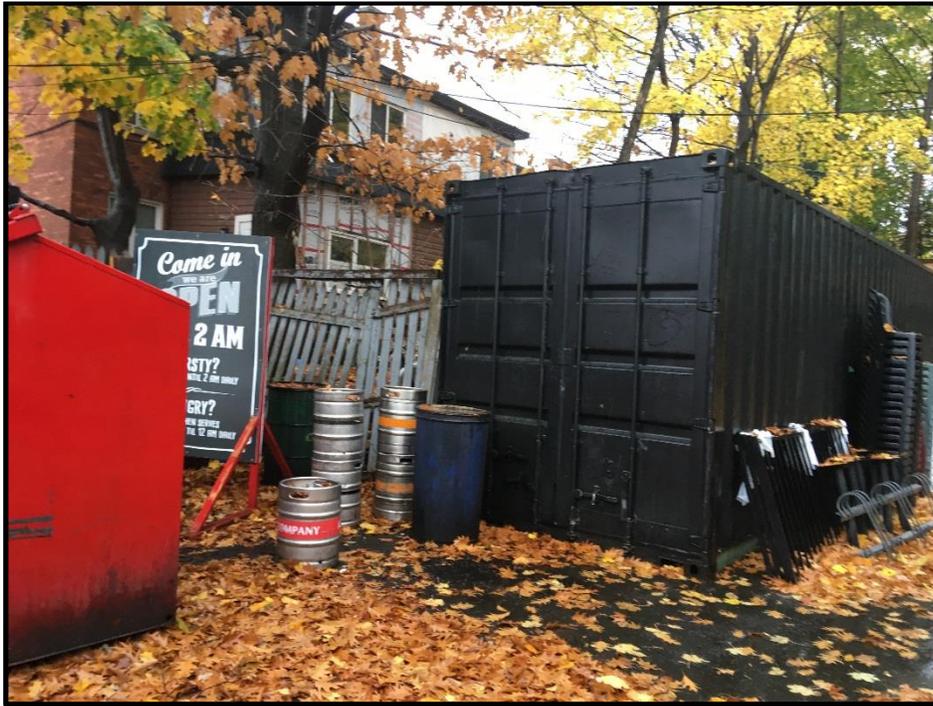
Photograph 3: Storage area behind Barley Mow, looking southwest. Photograph illustrates residential property adjacent to the west of 1060 Bank Street, across the easement.

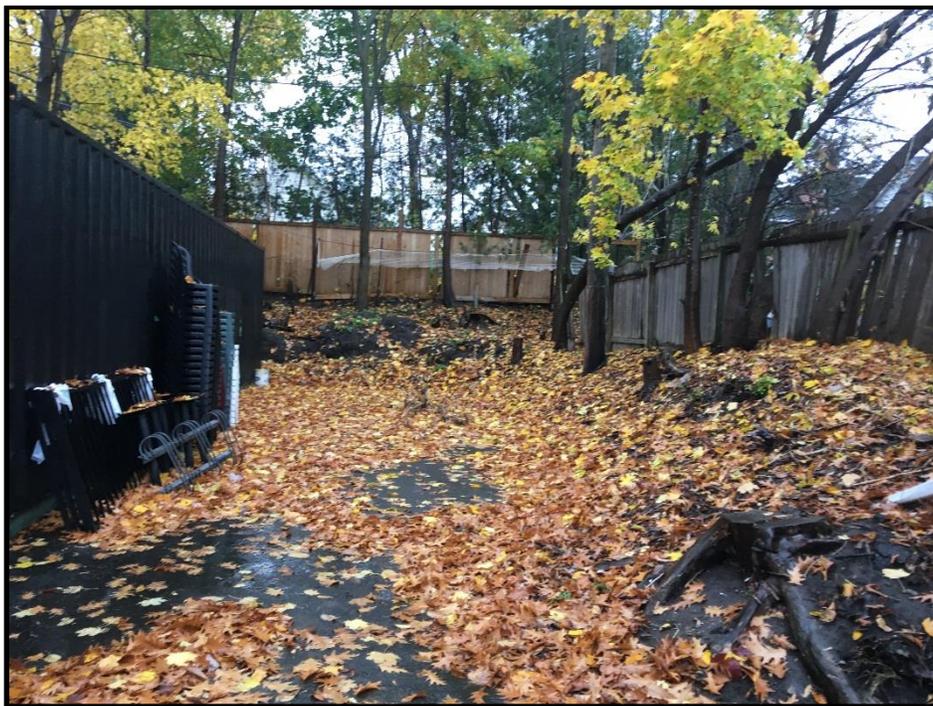
Photograph 4: West-central view of the Phase I Property (part of 1060 Bank Street), looking west.

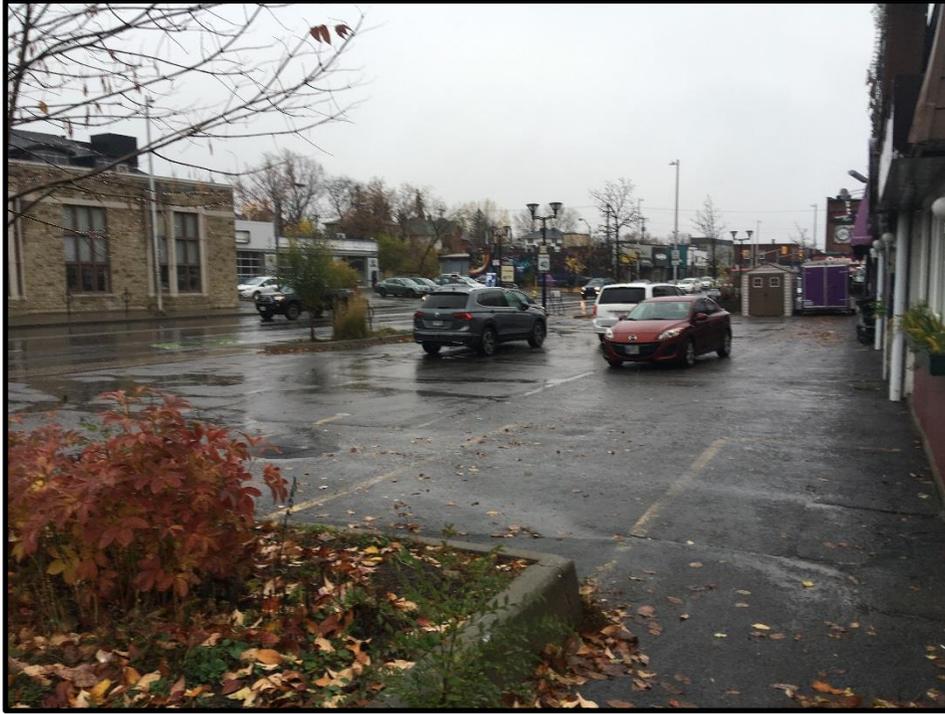
Photograph 5: View of the northern portion of the Phase I Property, looking southeast. Photograph illustrates commercial properties to the adjacent east, across Bank Street.

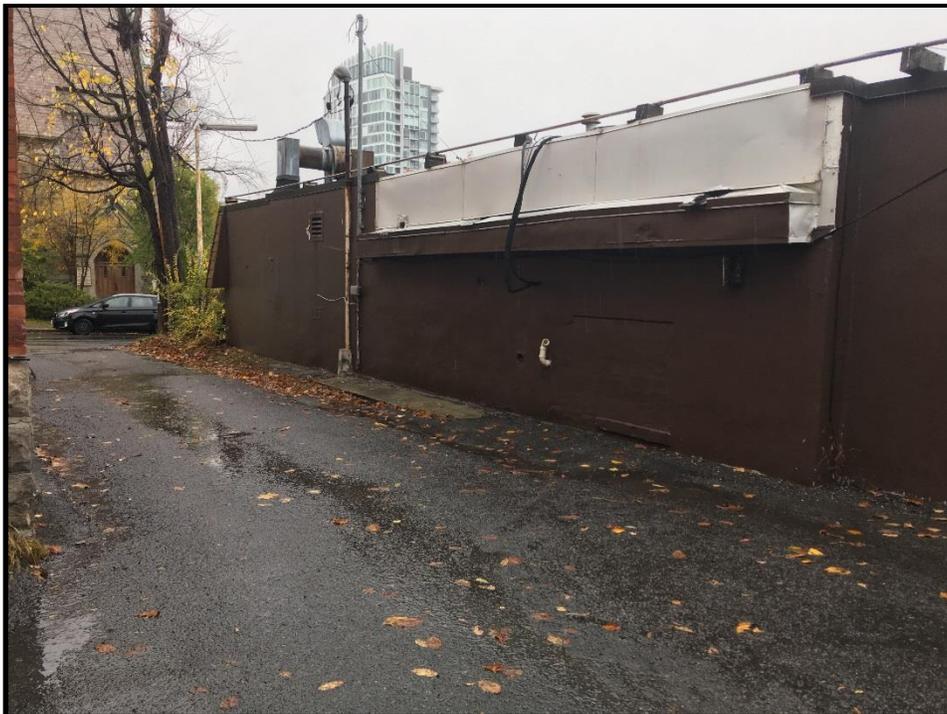
Photograph 6: Photograph illustrates access laneway/easement adjacent to the west of the Phase I property, facing north.
