16 October 2019

Project No. 19131354

**PHASE ONE ESA UPDATE, BLOCK 232, 1055 CEDAR CREEK DRIVE
 OTTAWA, ONTARIO**

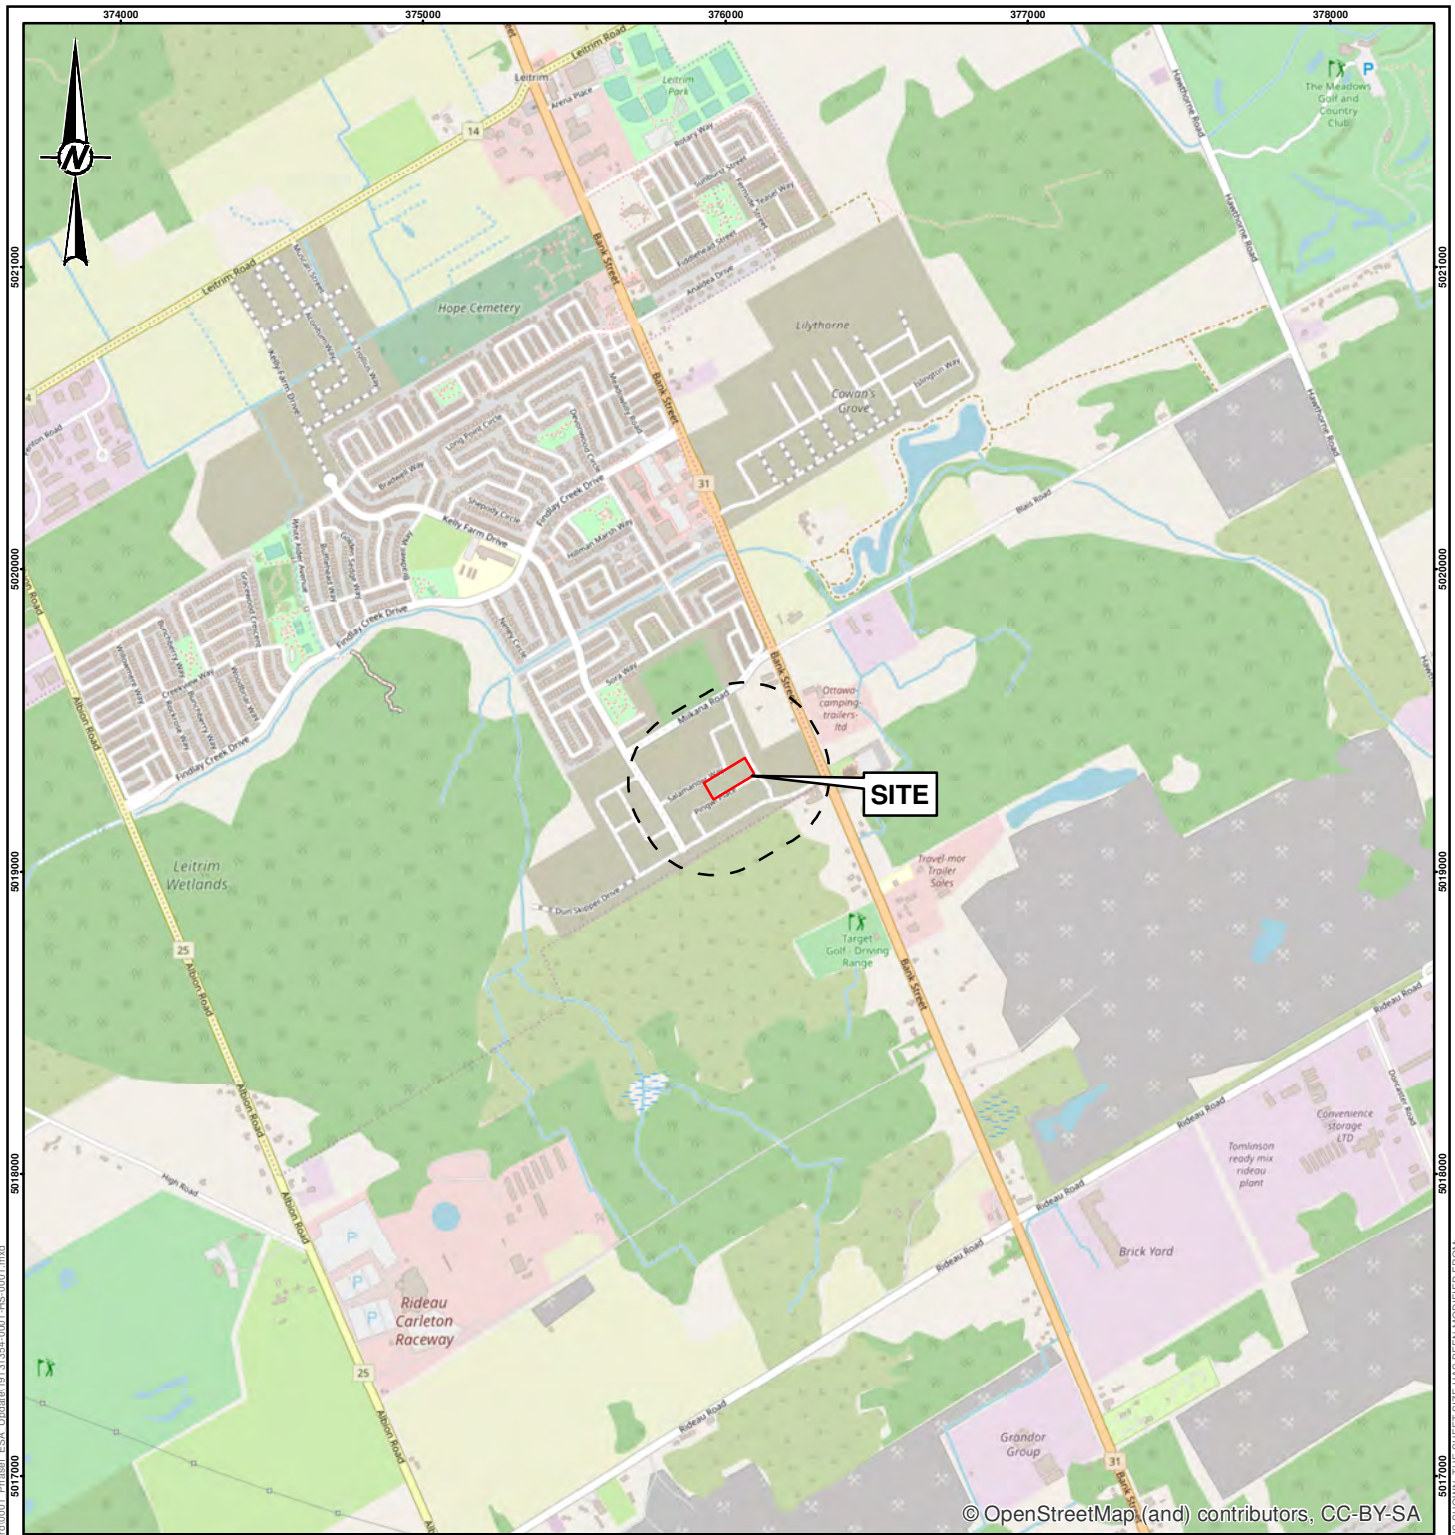
PROJECT NO. 19131354	CONTROL 0001	REV. 0	FIGURE 1
-------------------------	-----------------	-----------	--------------------

A plan of survey for the Site is provided in Attachment A. The Phase One Study Area is provided in Figure 1.

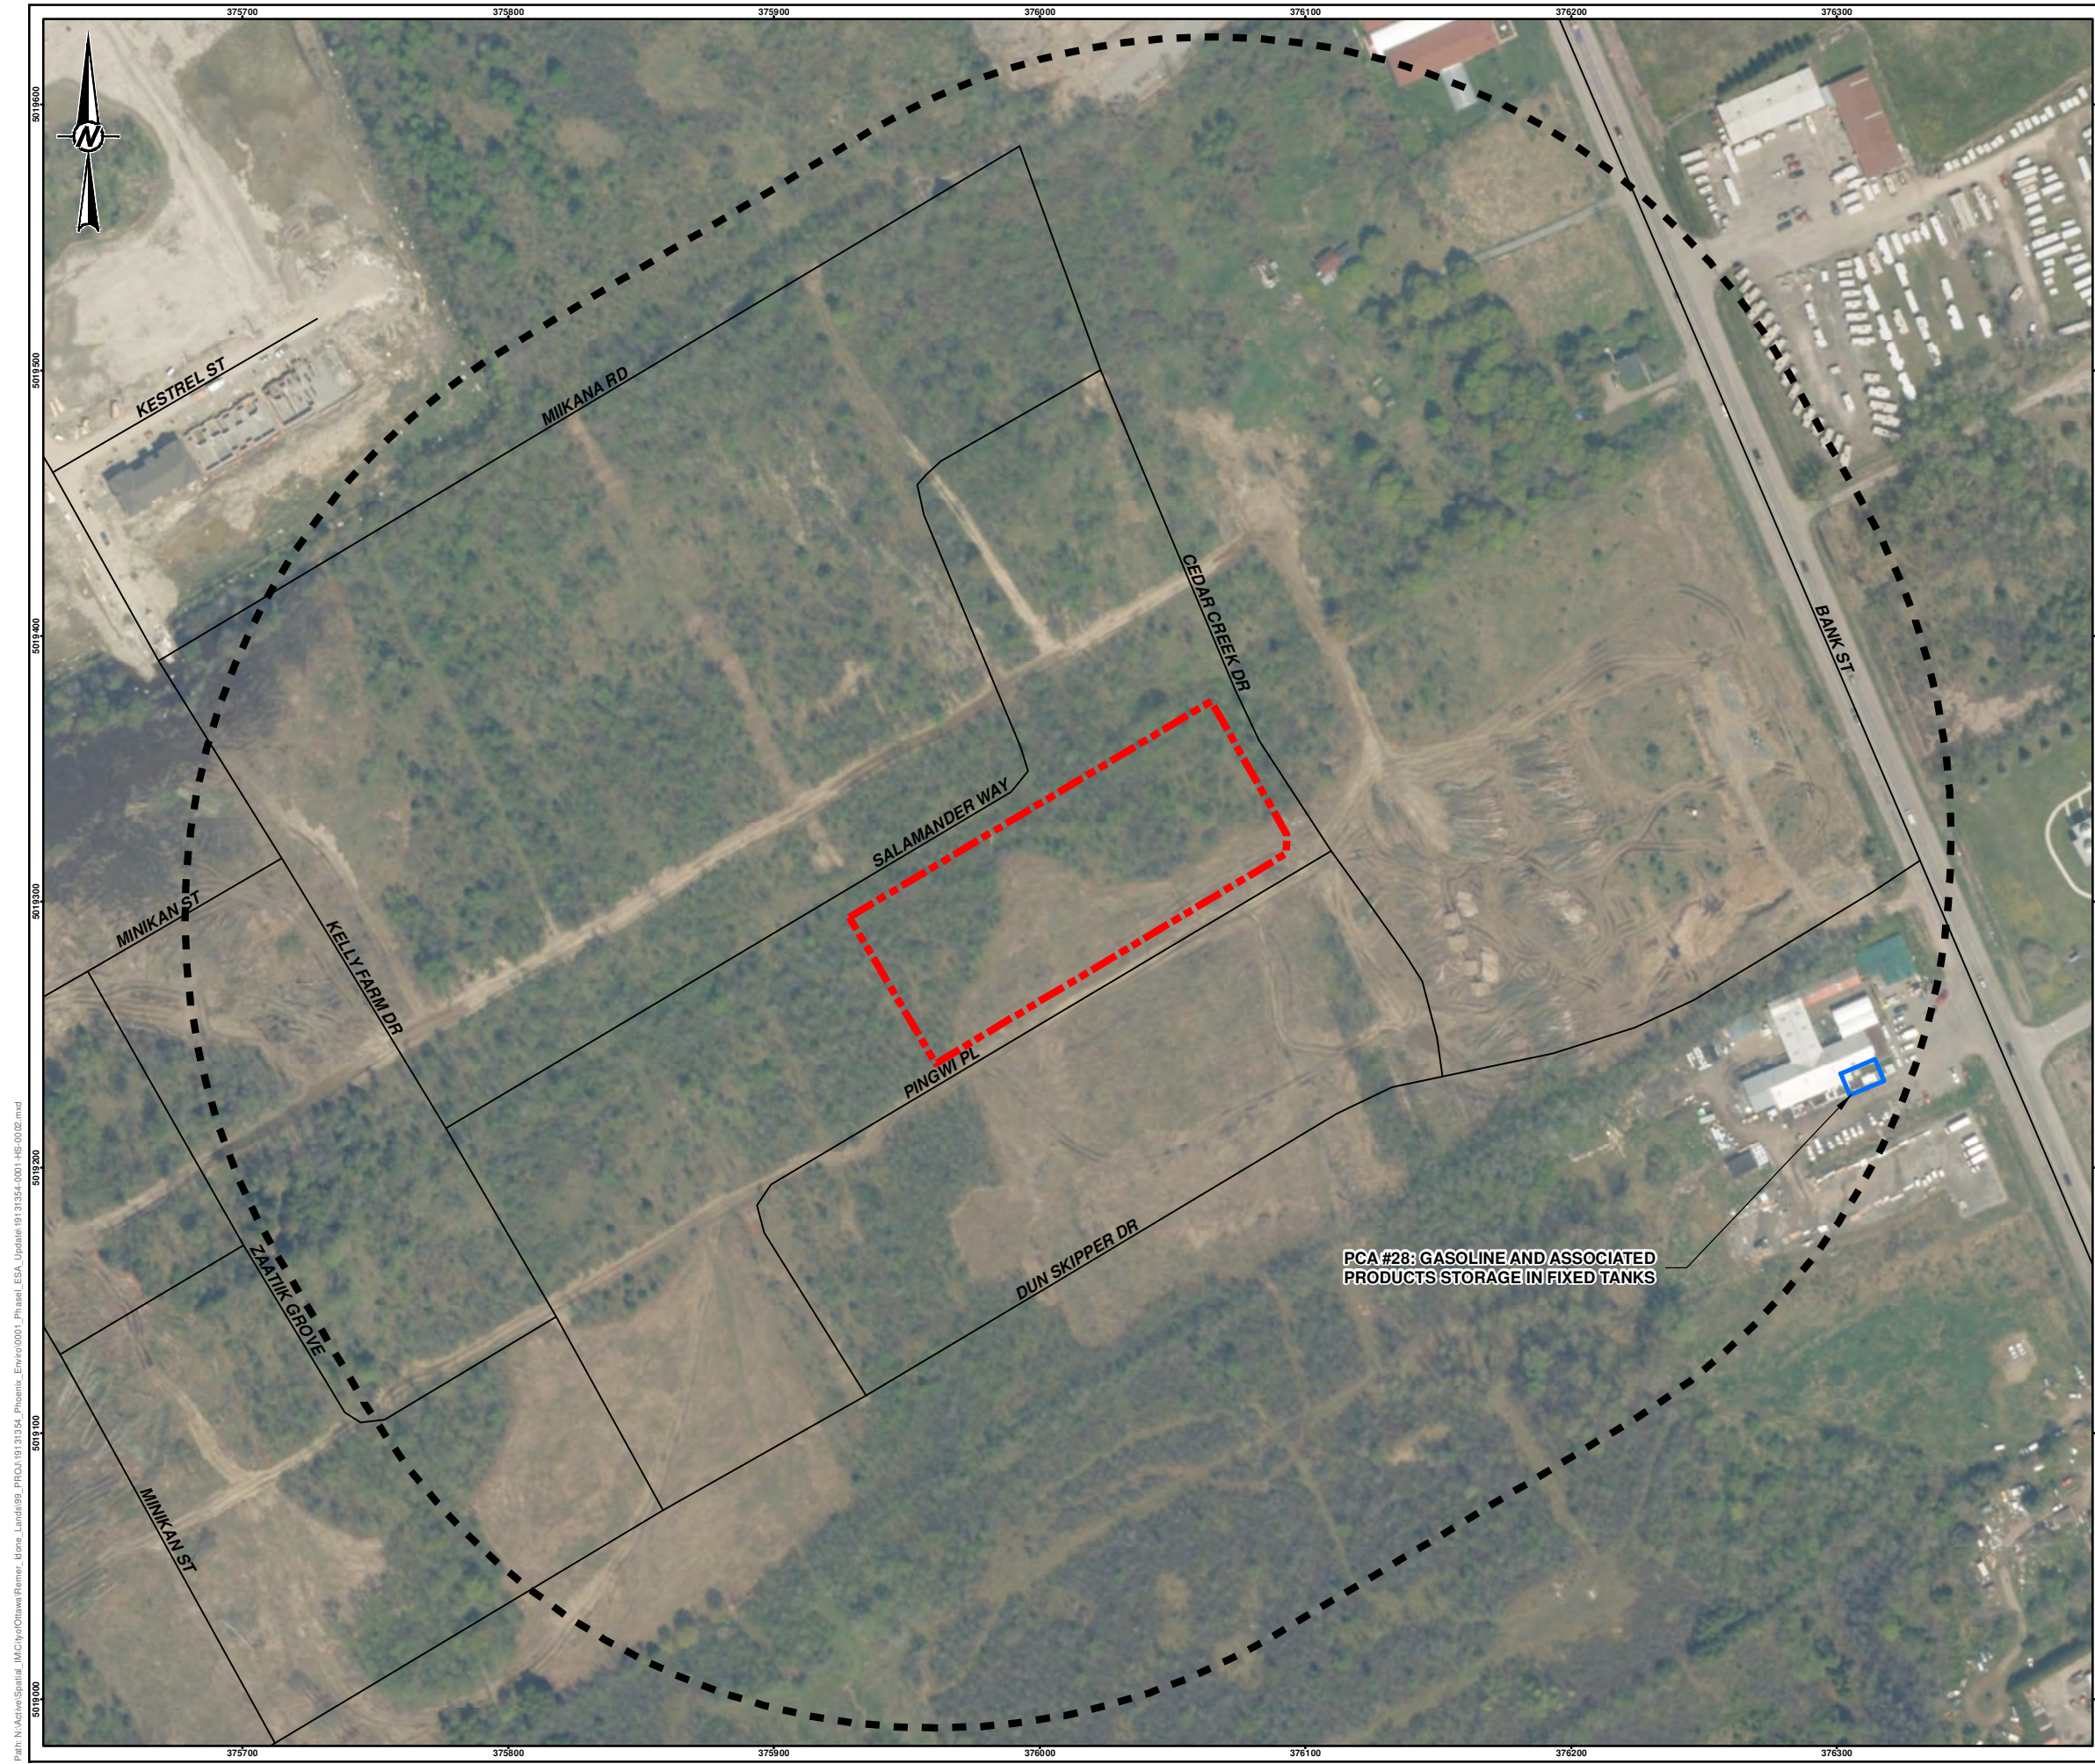
TITLE
SITE PLAN

parcel is used for light industrial purposes (communication tower). The commercial property to the south east was formerly operated as a retail fuel station. This location is shown on Figure 2 and is approximately 215 metres from the Site;

PCA #28: GASOLINE AND ASSOCIATED PRODUCTS STORAGE IN FIXED TANKS

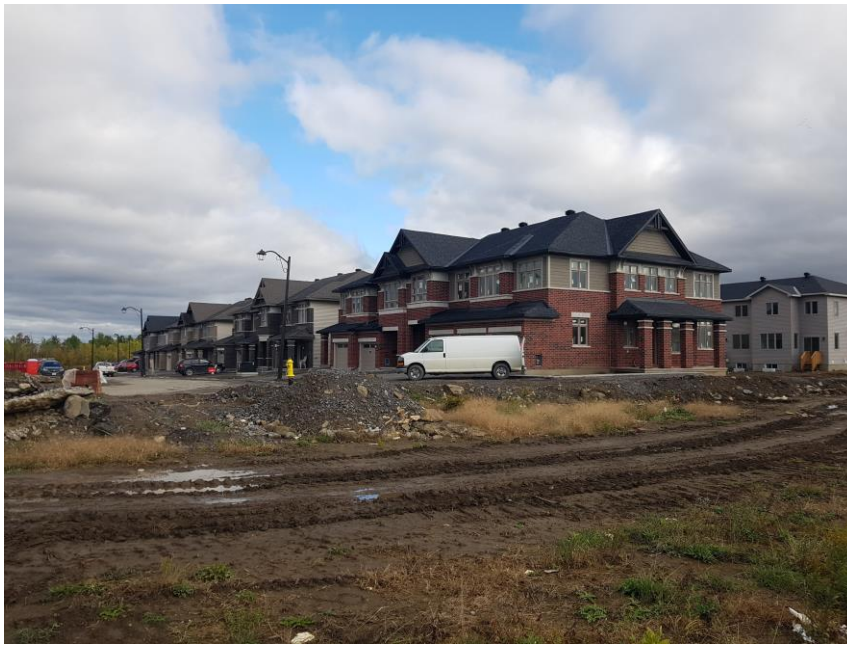
The Site is bounded to the north by Salamander Way followed by residential development. The eastern portion of the Site is bounded to the north by residential development. Further to the north, the tower site remains vegetated with light forest cover. No tower was observed on this property.

Photo 1 – Photo from the Site looking north towards residential development

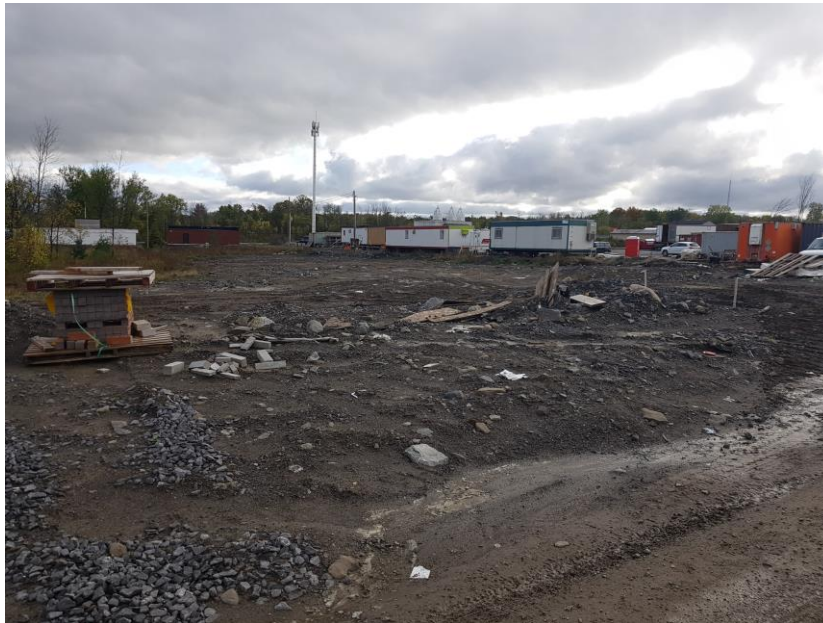
The Site is bounded to the east by Cedar Creek Drive followed by residential developments, construction staging (construction trailers, storage, sales centres) followed by Bank Street. East of Bank Street there is a temple, a communication tower and a recreational vehicle retailer.

Photo 2 – Construction Staging east of the Site, east of Cedar Creek Drive

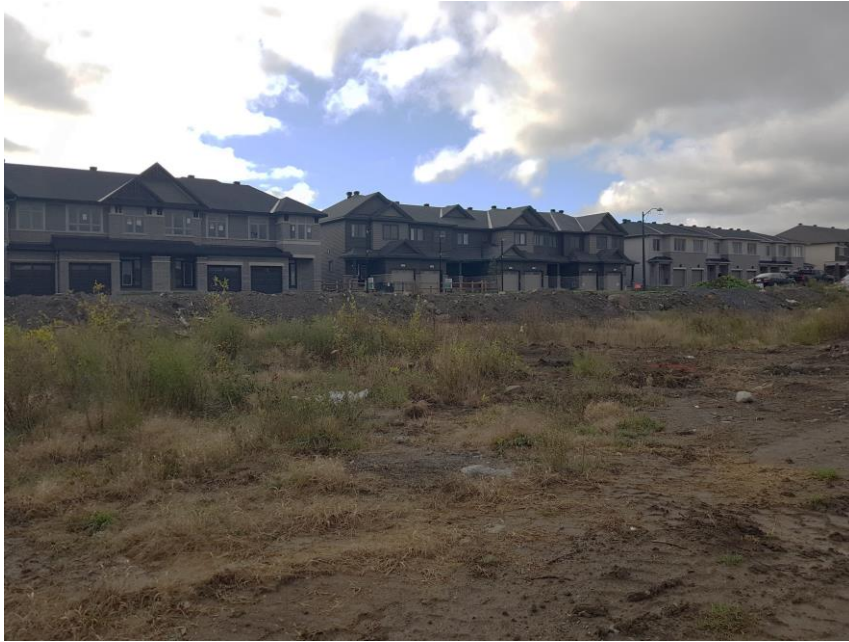
The Site is bounded to the south by Pingwi Place followed by residential developments. South of Dun Skipper Drive, further residential development was observed including vegetation clearing, topsoil stripping and lot servicing. Home Hardware is located approximately 150 metres southeast of the Site.

Photo 3 – Photo from the Site looking south towards residential development

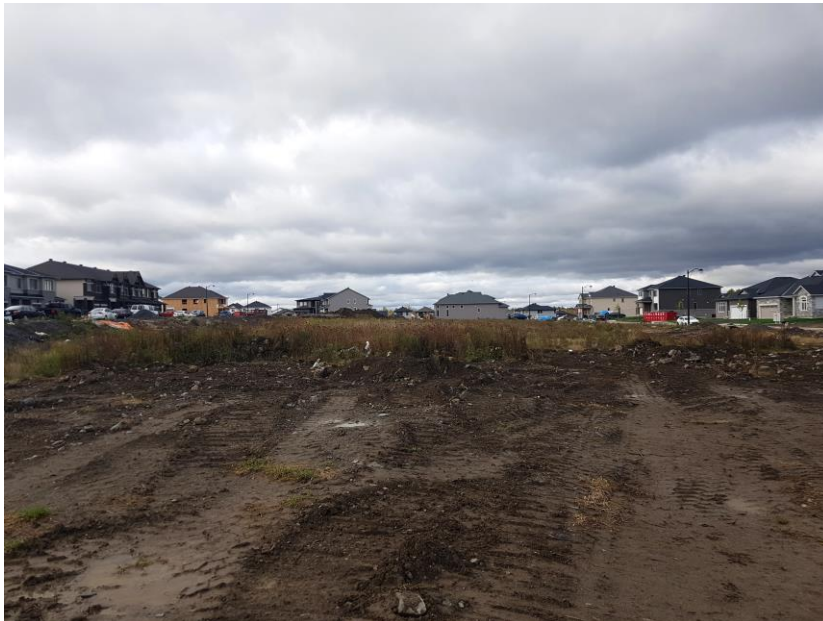
The Site is bounded to the west by residential properties. Further to the west, additional residential development was observed.

Photo 4 – Eastern portion of Site looking west across the Site and to residential development west of the Site

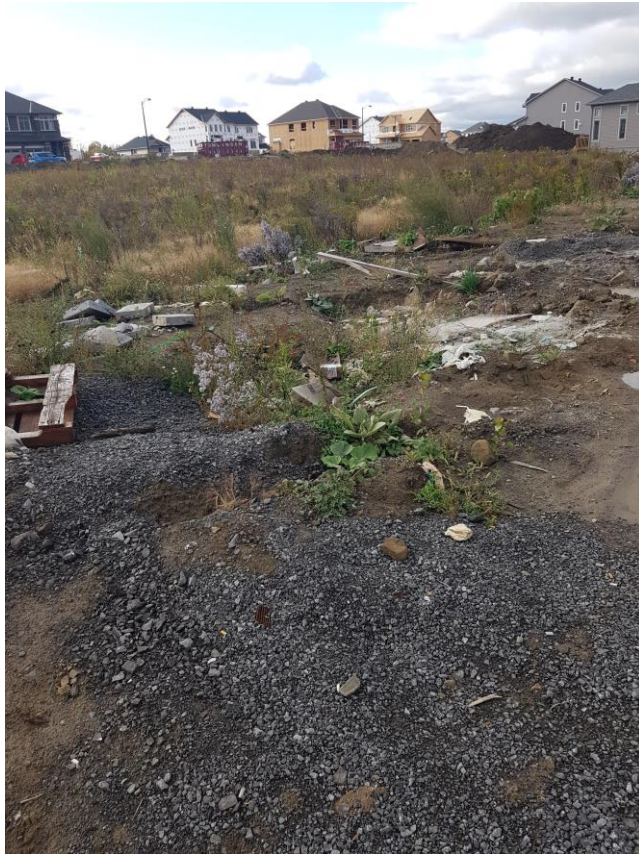
Topic	Observations	Comment / Source
Sanitary/Process Wastewater Receptor	Not applicable	No building
Sanitary Sewer Connection	Not applicable – sanitary sewer is stubbed 1 metre into the property line	No building
Septic Systems	None observed	Site observations
Storm Water Flow	Infiltration into surface soil or runoff to catch basins along Salamander Way to the north	Site observations
Storm Sewer Connection	Not applicable – Storm sewer is stubbed 1 metre into the property line	No building
Ground Cover (i.e. grass, gravel, soil, or pavement, etc.)	Eastern portion of the Site was bare topsoil, western portion of the Site was vegetated	Site observations
Current or Former Railway Lines or Spurs	None observed	Site observations and aerial photographs
Presence of Stained Soil, Vegetation, or Pavement	None observed	Site observations
Presence of Stressed Vegetation	None observed	Site observations
Presence of Fill and/or Debris Materials	Some construction related debris and gravel observed on Site.	Site observations

Photo 5 – Construction debris located on Site
