**Phase One Environmental
Site Assessment
365 Forest Street, 1420 Richmond
Road & 2589 Bond Street
Ottawa, Ontario**

OTT-00252625-A0

June 27, 2019

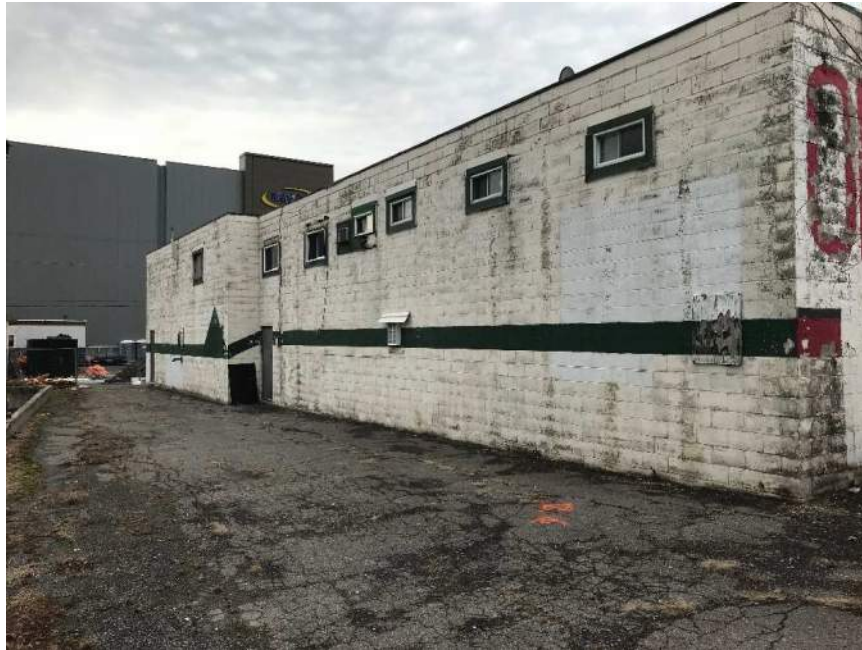
Photograph No. 9

The 365 Forest Street lot is improved with a single story, slab-on-grade multi-tenant building. The northern portion is a single bay automotive garage bay, with the southern portion formerly tenanted a restaurant. A mezzanine residential apartment was found at the southern side of the building but was not accessed due to structural concerns due to water damage. The building is built of painted masonry block with stucco on the western façade and the building has a flat roof.

View of east edge of 365 Forest Street building

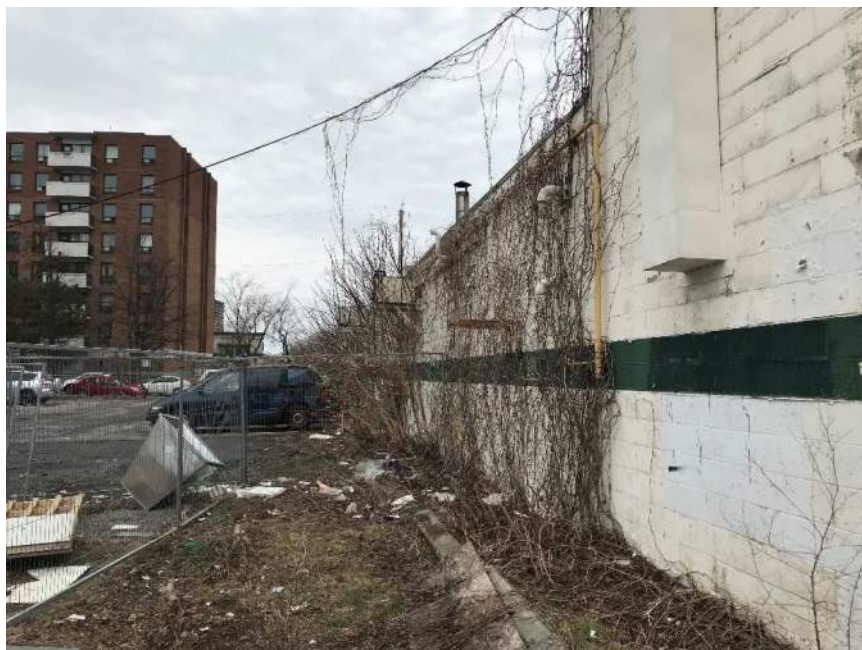
Photograph No. 10

View of south side of 365 Forest Street building

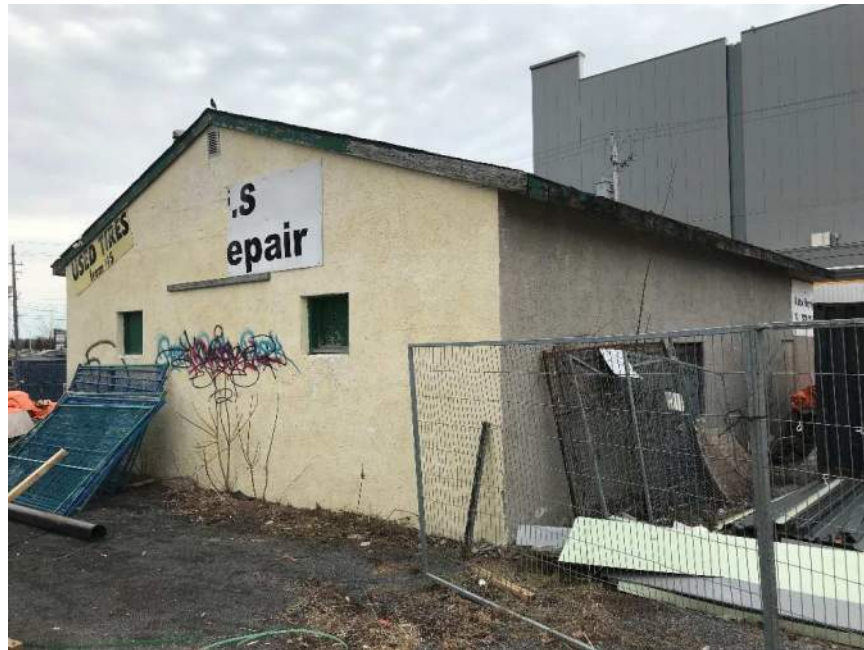
Photograph No. 11

The 2589 Bond Street property is improved with a single-story, peaked roofed, single bay garage building formerly used for automotive repairs. It is constructed of stucco covered block. At the time of the investigation, this lot and building were not accessible.

View of 2589 Bond Street building looking northwest

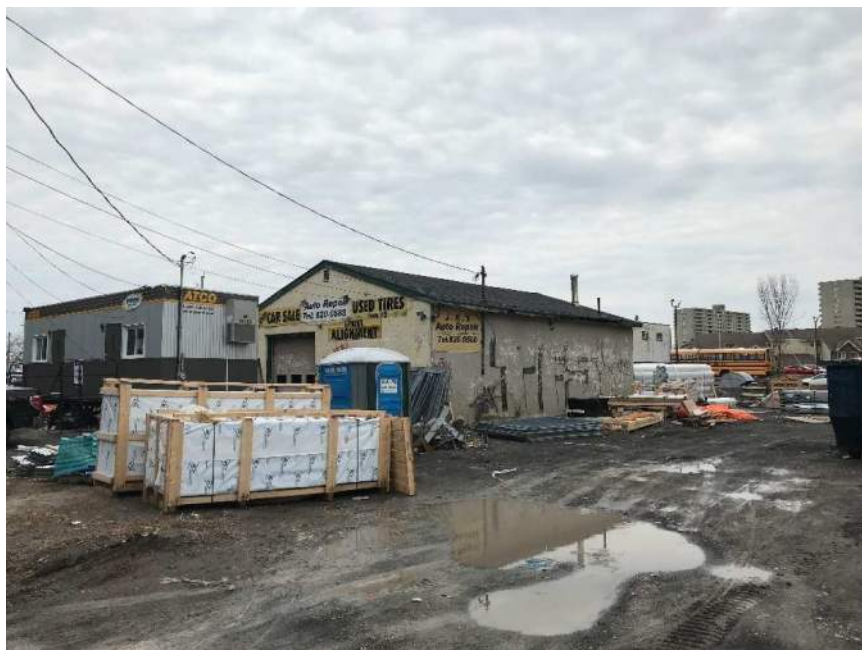
Photograph No. 14

View of 2589 Bond Street building looking northwest note temporary construction storage

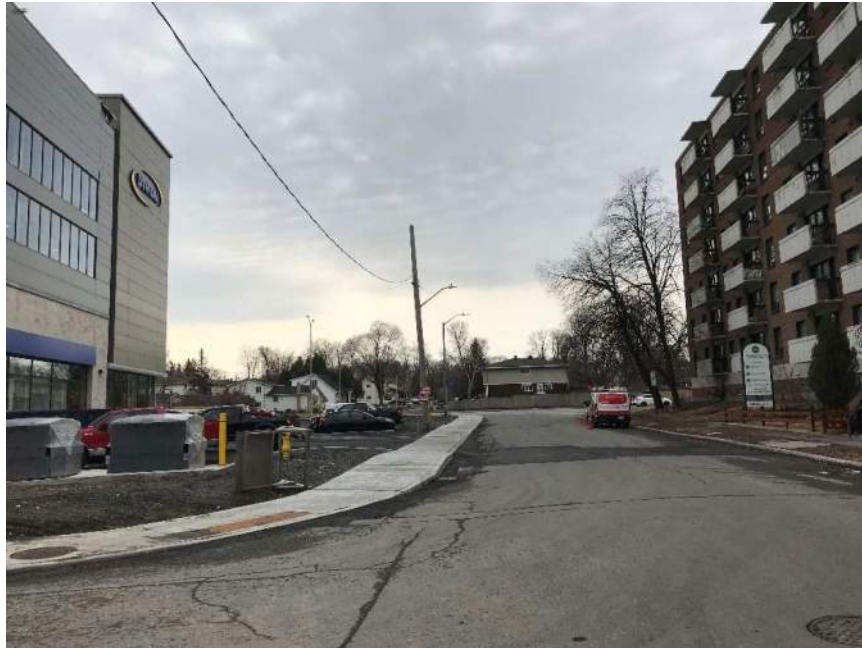
Photograph No. 15

3. Historic retail gasoline sales outlet and automotive repair garage at 2599 Carling Avenue	Southwest corner of 365 Forest Street lot	#10: Autobody Repair Shops #28: Gasoline & Associated Products Storage in Fixed Tanks	Adjacent to the south	PHCs, BTEX, VOCs, and lead	Soil and groundwater

View of Forest Street looking south at former gas station site, now large storage building

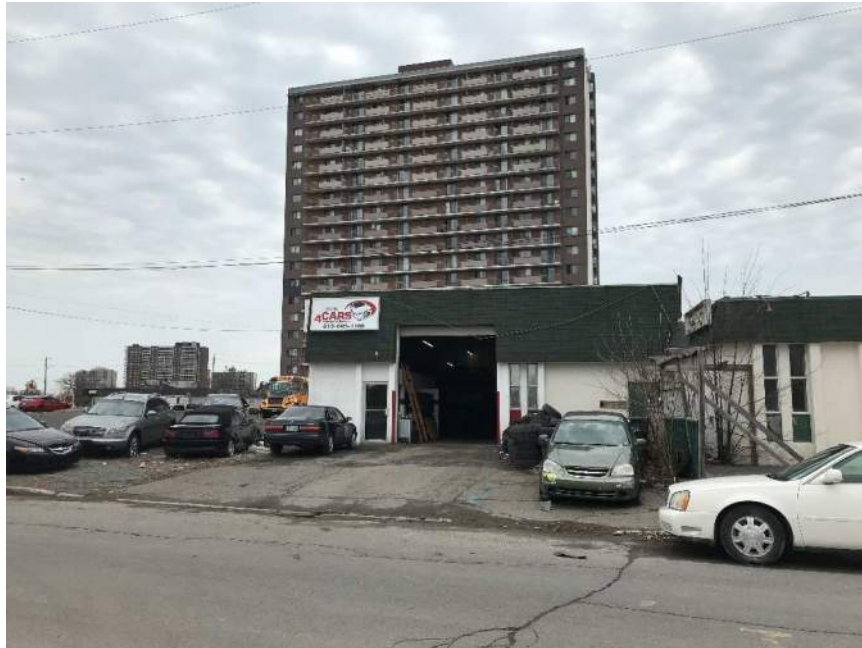
At the time of the investigation, the garage bay at 365 Forest Street was in use by an automotive tire sales/repair shop. The remaining tenant spaces were vacant.

No sumps or pits were observed on the Phase One property. Trench drains were observed in the garage bay at 365 Forest Street. No oil/water separator was observed for these drains, but it may have been obscured due to poor housekeeping/tire storage.

Photograph No. 17
View of 365 Forest Street service garage

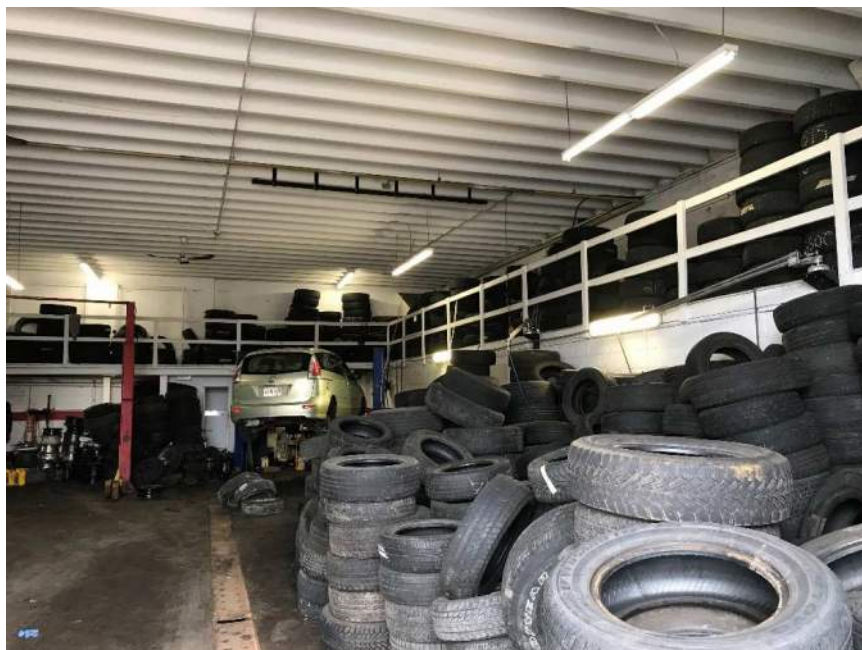
Heating systems observed at the Phase One property consisted of natural-gas fired convection blower in the garage bay of 365 Forest Street. None others were observed. No cooling systems were observed.

No areas of stressed vegetation or stained soil was observed. Areas of stained pavement was observed in the vicinity of the garage bay at 363 Forest Street. This is considered an APEC.

Photograph No. 18
View of interior of 365 Forest Street service garage
