**Phase One Environmental  
Site Assessment  
365 Forest Street, 1420 Richmond  
Road & 2589 Bond Street  
Ottawa, Ontario**

OTT-00252625-A0

Final

May 7, 2021

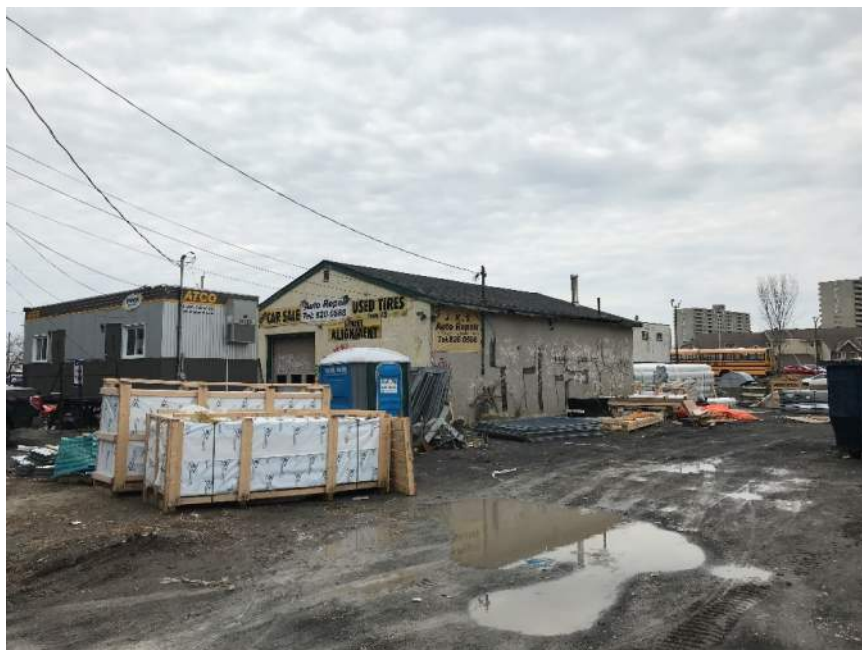
**Photograph No. 14**

View of 2589 Bond Street building looking northwest note temporary construction storage

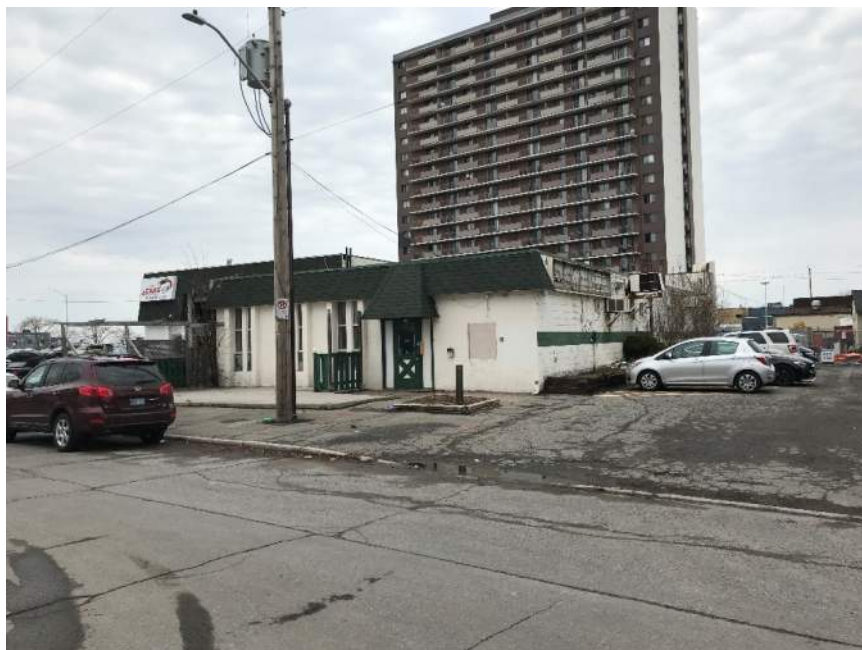
**Photograph No. 16**

Evidence of significant water damage in the restaurant section of portion of the 365 Forest Street building was observed.

View of vacant restaurant at 365 Forest Street, looking northeast

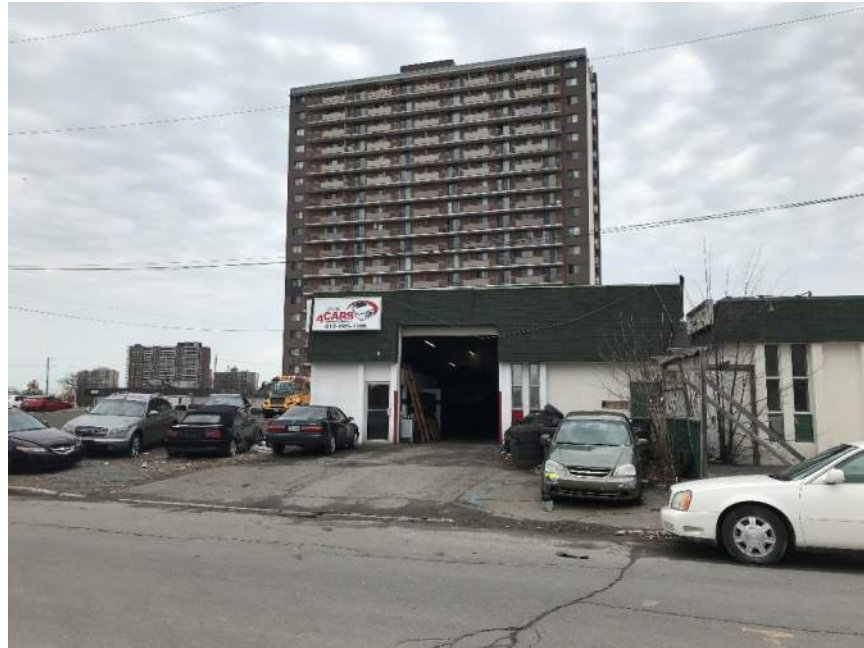
No areas of stressed vegetation or stained soil was observed. Areas of stained pavement was observed in the vicinity of the garage bay at 363 Forest Street. This is considered an APEC.

**Photograph No. 17**  
View of 365 Forest Street service garage

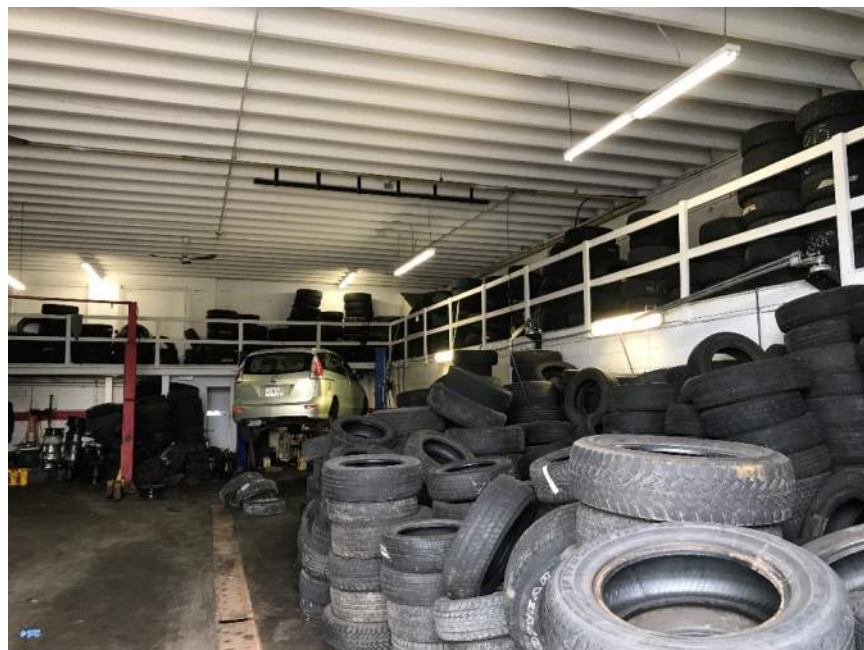
No sumps or pits were observed on the Phase One property. Trench drains were observed in the garage bay at 365 Forest Street. No oil/water separator was observed for these drains, but it may have been obscured due to poor housekeeping/tire storage.

**Photograph No. 18**  
View of interior of 365 Forest Street service garage

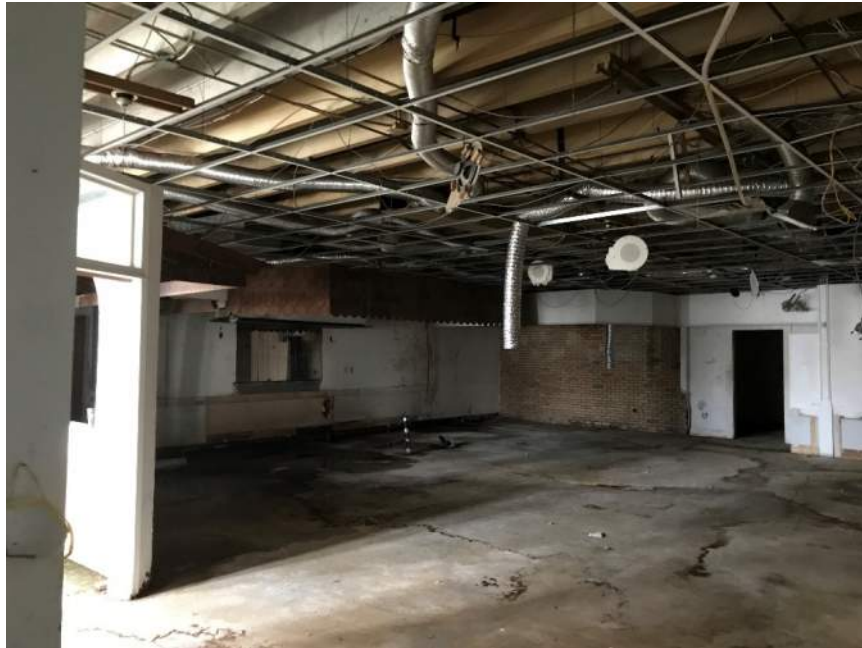
**Photograph No. 19**

View of interior of vacant restaurant at 365 Forest Street
