Phase I Environmental Site Assessment and Subsurface Investigation

The Hindu Temple of Ottawa Carleton
4835 Bank Street,
Ottawa, Ontario

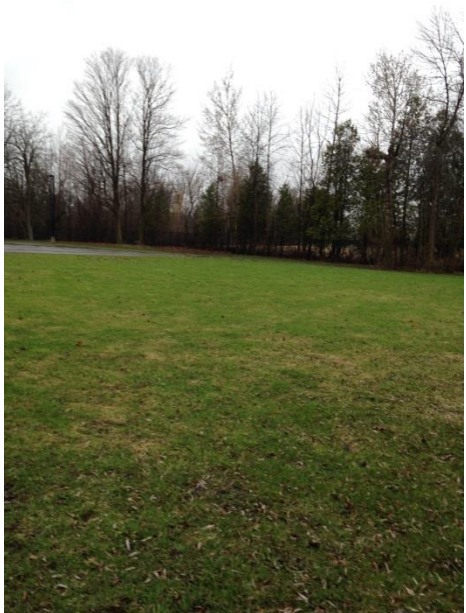
Date: 4/19/2017	
Description South to north across grassed area to the east of parking lot.

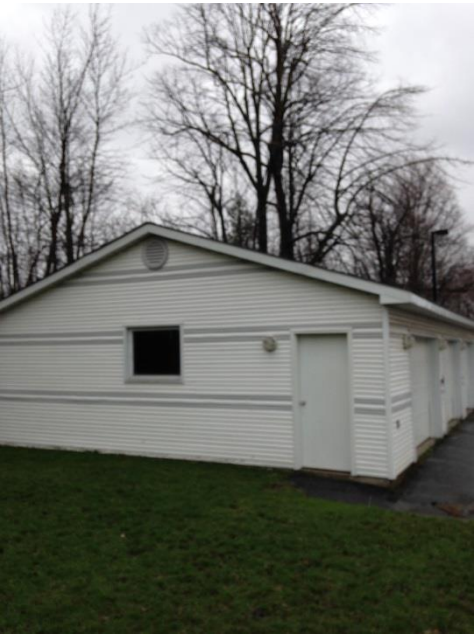
<p>Photograph No. 5</p>

<p>Date: 4/19/2017</p>	
<p>Description Garage, north west corner of parking lot.</p>	
<p>Photograph No. 6</p>

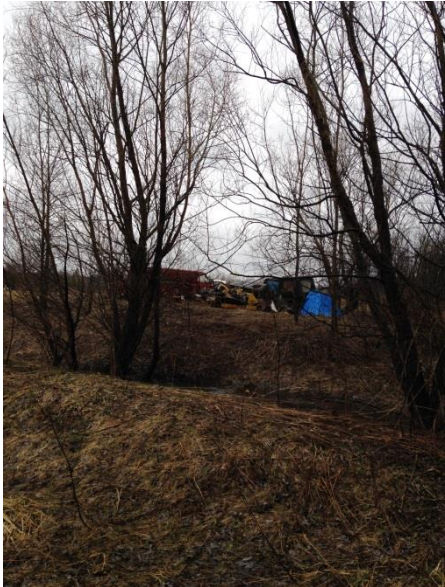
Wells:	Not observed.
Sewage disposal:	Two (2) private septic systems located to the north and south side of the building on Site. Appears to be in good condition.
Pits and lagoons:	Not observed.
Wastewater:	Not observed.
Solid waste:	Not observed.
Stained material:	Not observed.
Stressed vegetation:	Not observed.
Fill or previous fill activities:	The presence of significant amounts of fill material (beyond that required for normal construction and/or grading was not observed with the exception to piles of concrete and soil along the eastern portion of the Site. It is suspected these materials were placed here during the construction activities on the Site in the 1980's, however this was not confirmed.
Earth-moving activity:	Not observed.
Other	Vehicles were parked on the adjacent land to the north. They appeared to no longer be operational.

Date: 4/19/2017	
Description Adjacent land north of Site, waste pile.
