Phase I-Environmental Site Assessment

1330 Carling Avenue and 815 Archibald Street
Ottawa, Ontario

August 9, 2021

Report: PE4789-1R

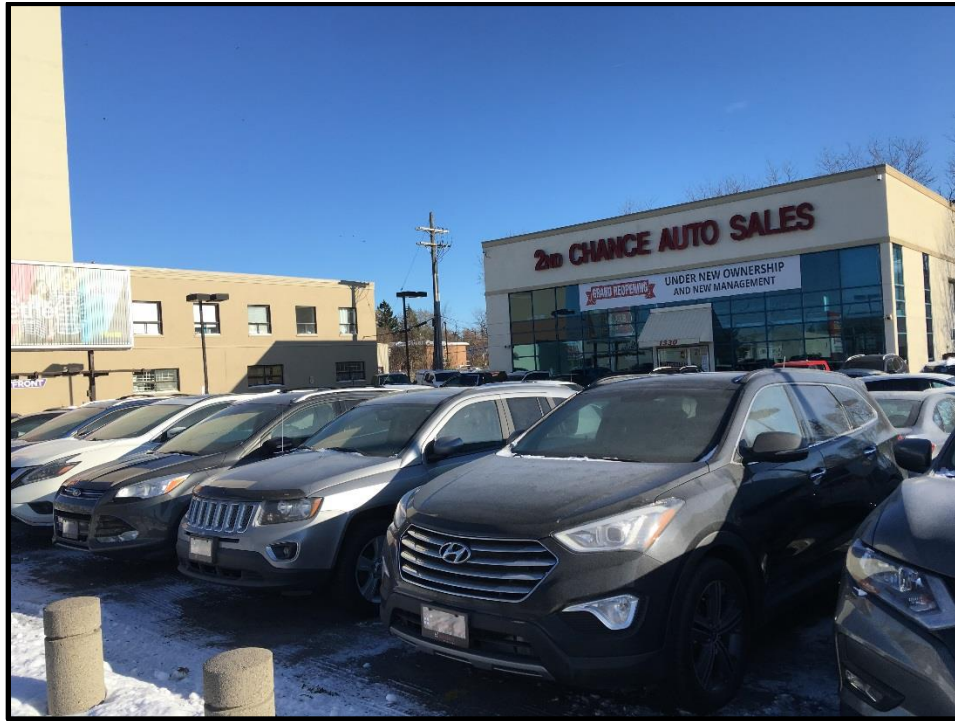
Photograph 1: View of the Phase I Property, taken from the Carling Avenue and Archibald intersection, looking southeast.

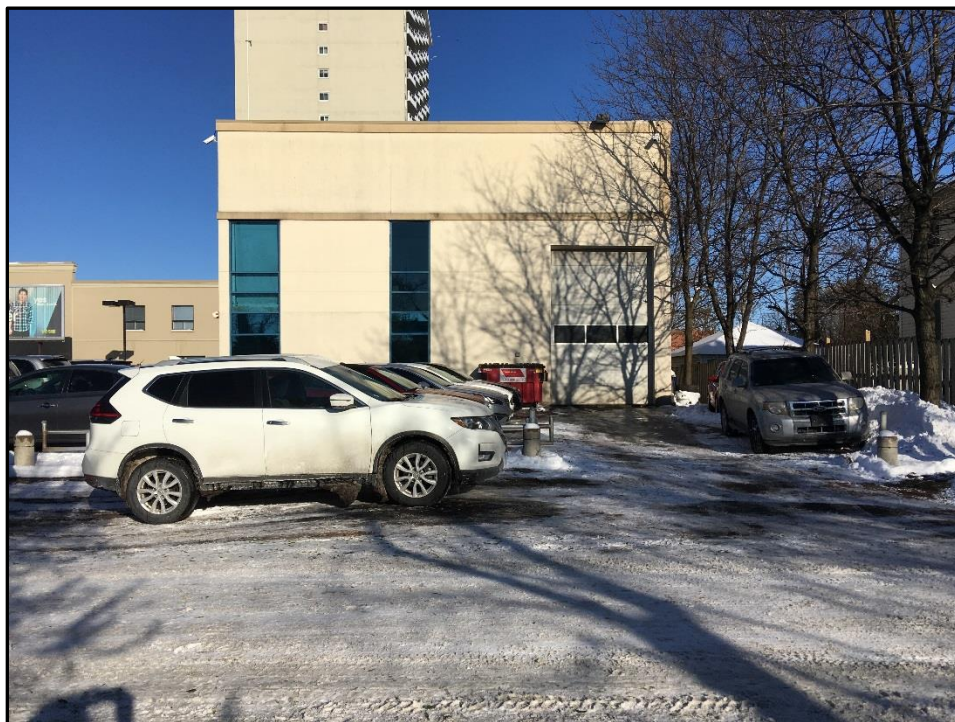
Photograph 2: Southern view of the Phase I Property and subject building, taken from Archibald Street, looking east.
