## Phase II Environmental Site Assessment

1330 Carling Avenue and 815 Archibald Street  
Ottawa, Ontario

Report: PE4789-2

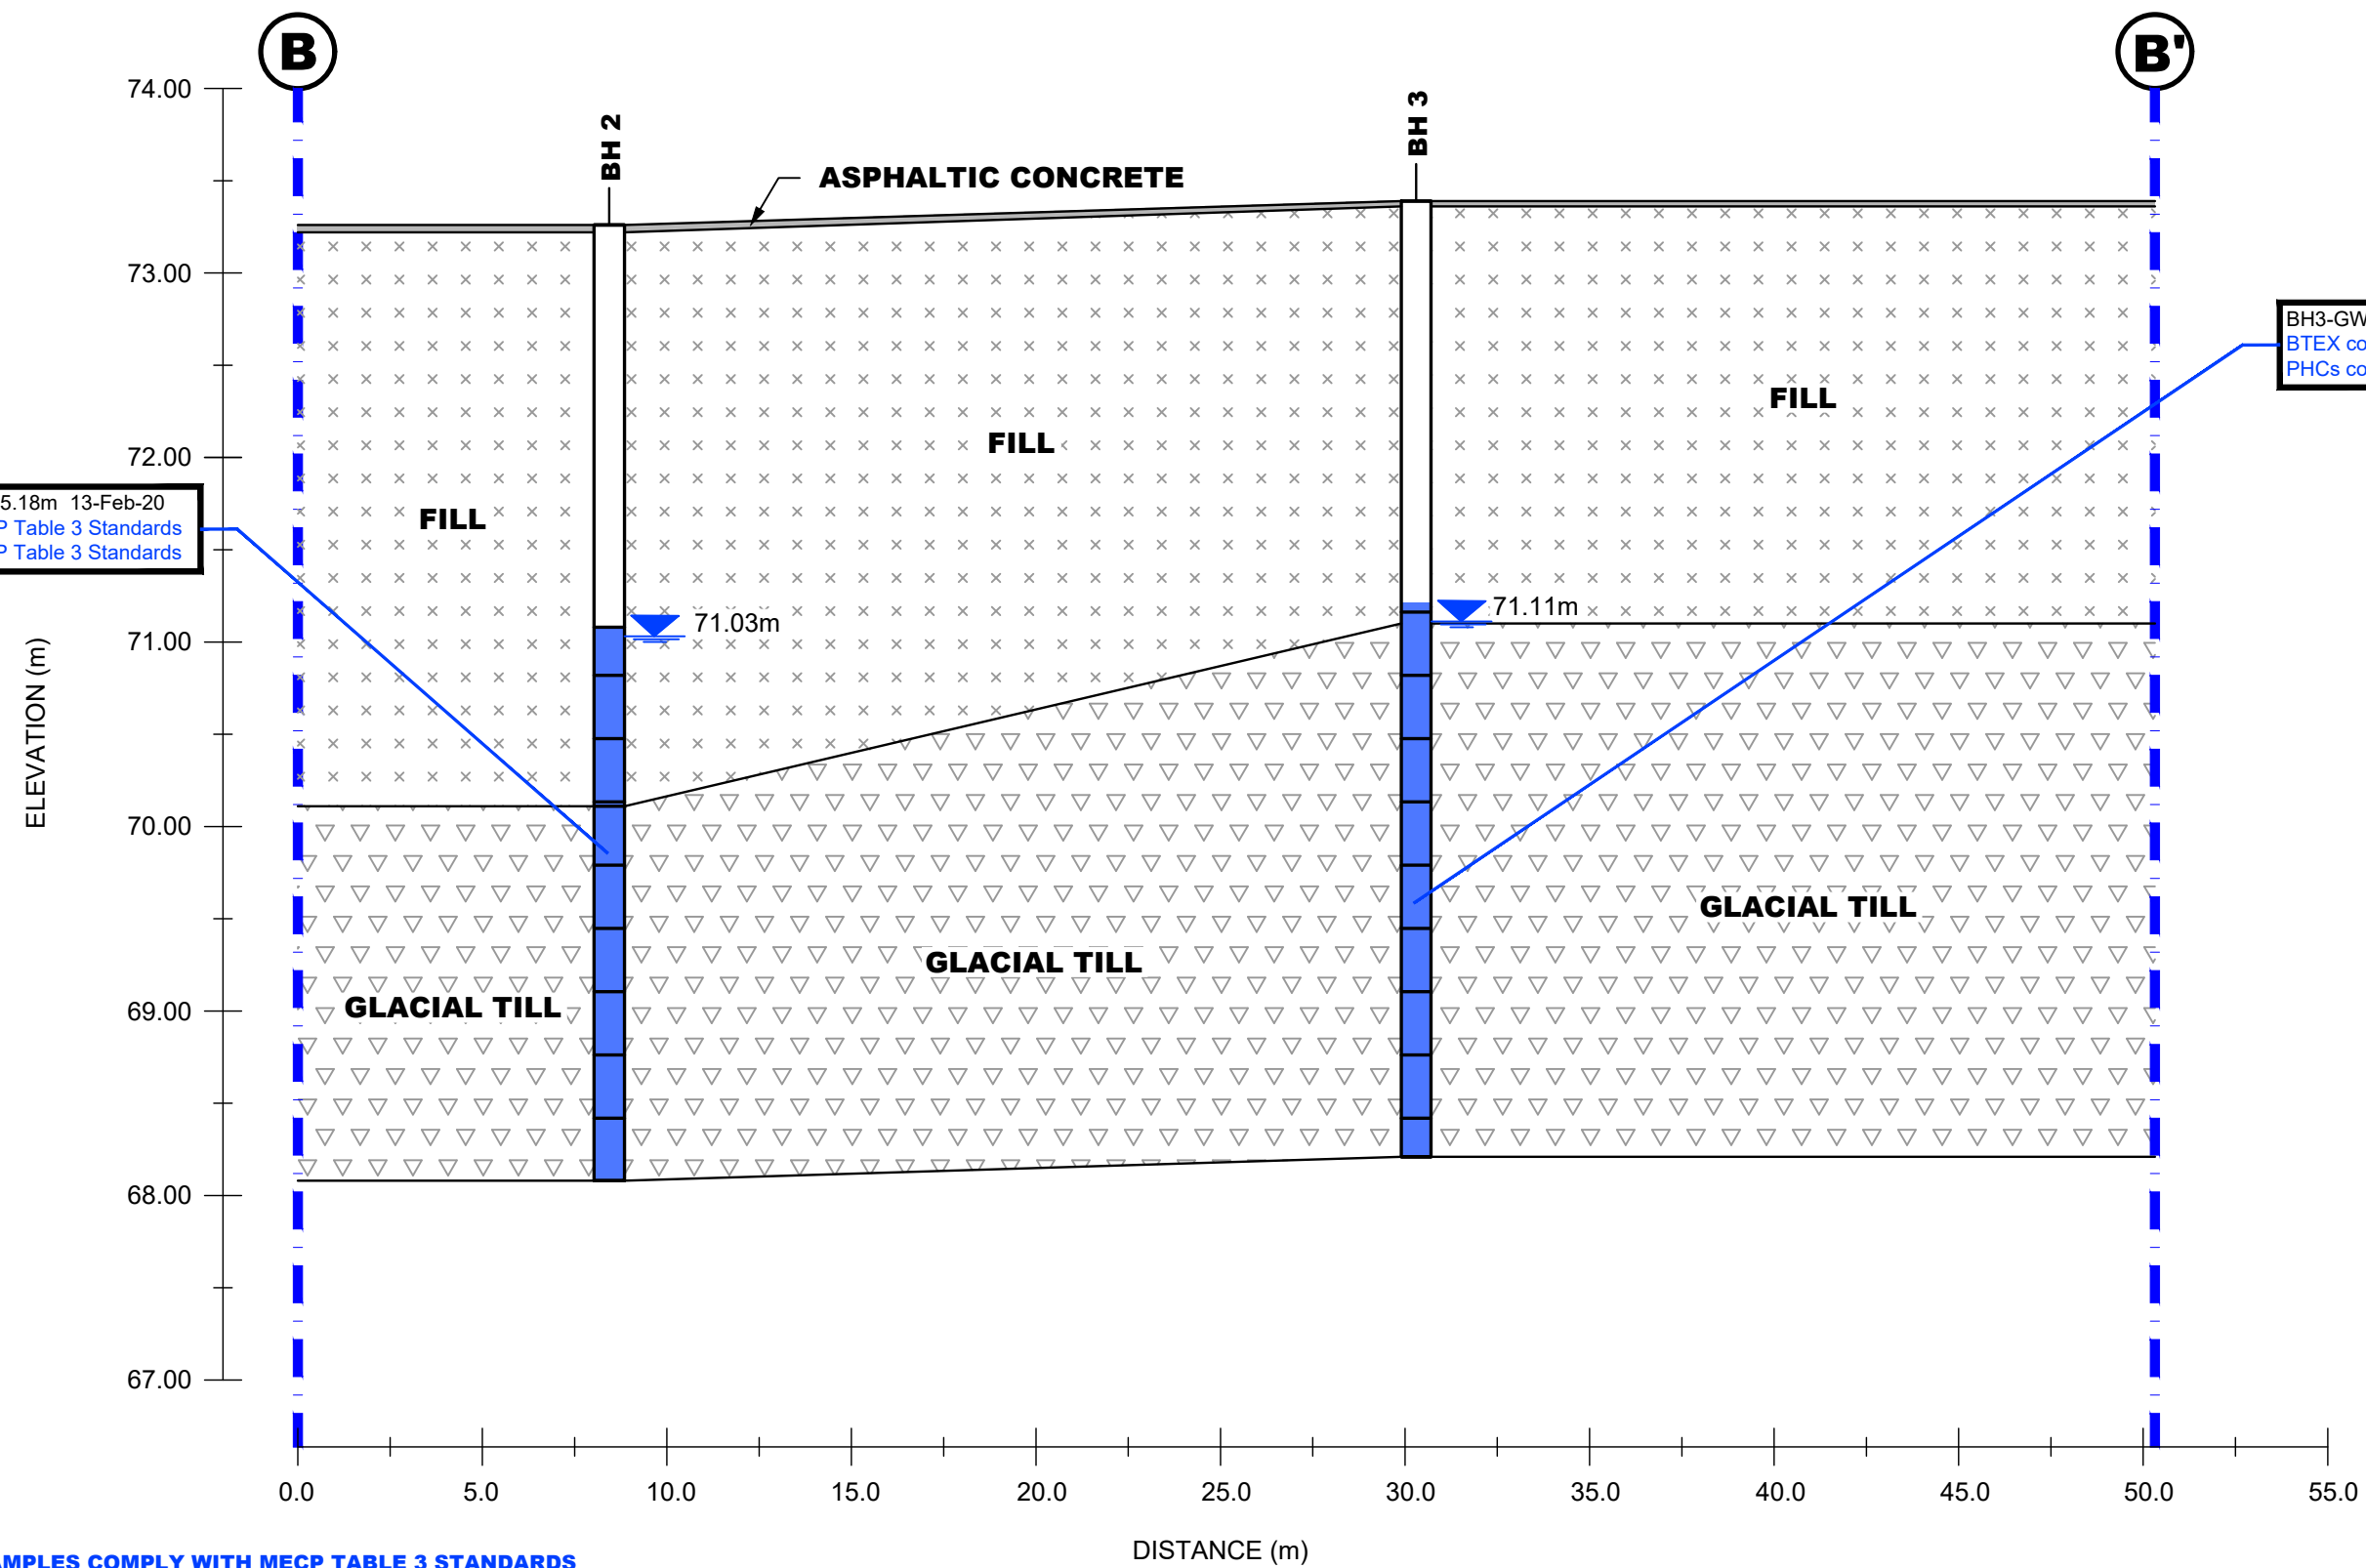
GROUNDWATER SAMPLES COMPLY WITH MECP TABLE 3 STANDARDS
