Phase I-Environmental Site Assessment

381 Churchill Avenue
319, 325 and 327-331 Richmond Road
380 Winona Avenue
Ottawa, Ontario

Prepared For
Richmond Churchill Limited Partnership

Report: PE4909-1R

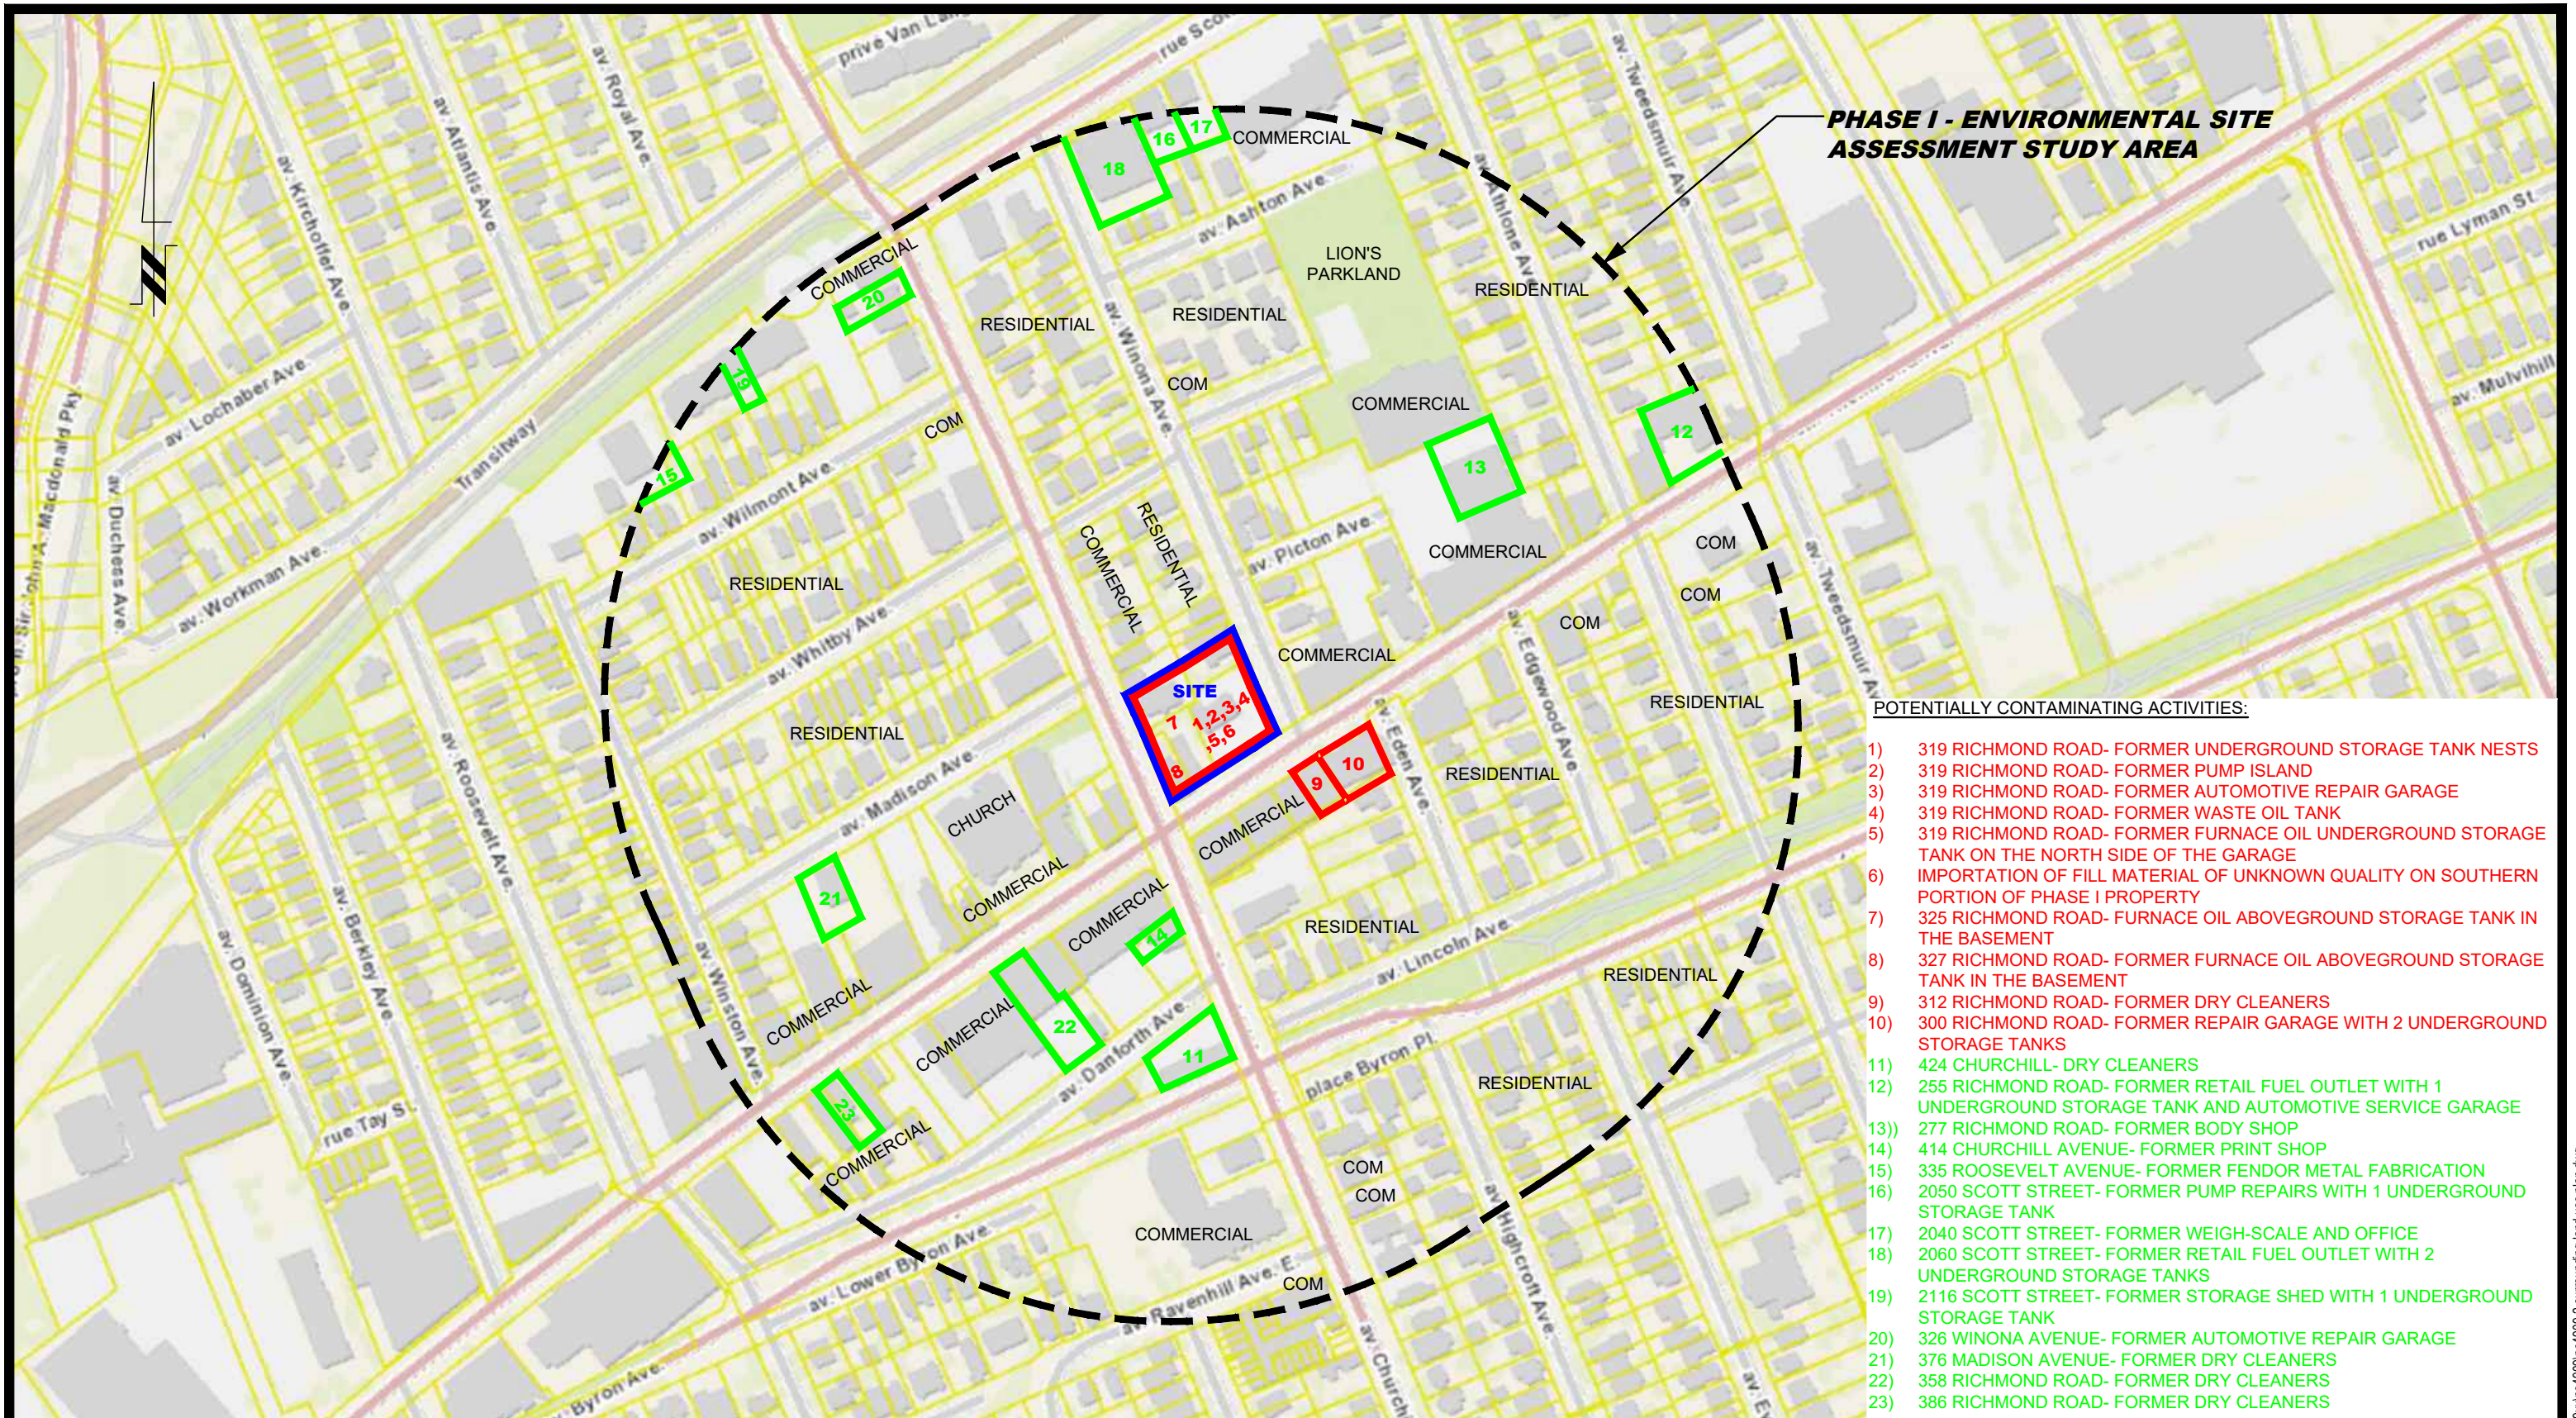
DRAWING PE4909-2 – SURROUNDING LAND USE PLAN

As previously noted, off-site PCAs identified during the historical review are presented on Drawing PE4909-2 – Surrounding Land Use Plan.

PHASE I - ENVIRONMENTAL SITE ASSESSMENT STUDY AREA

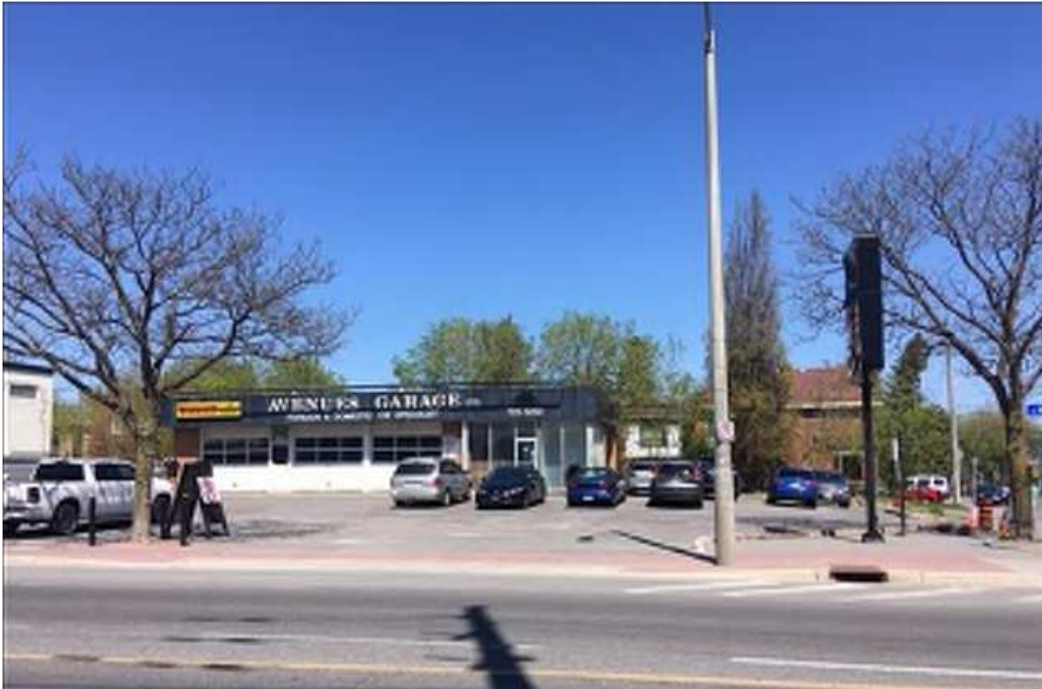
The parcel of land addressed 319 Richmond Road is occupied by a single-storey automotive garage with a partial basement level. The building constructed circa 1976 is of a slab-on-grade construction with a partial basement on the eastern side of the building with a concrete block foundation. The building exterior is finished with red brick with a flat, tar-and-gravel style roof. The garage is presently unoccupied by any active business and used solely for storing landscaping equipment.

Photograph 1: View of the former automotive repair garage at 319 Richmond Road.

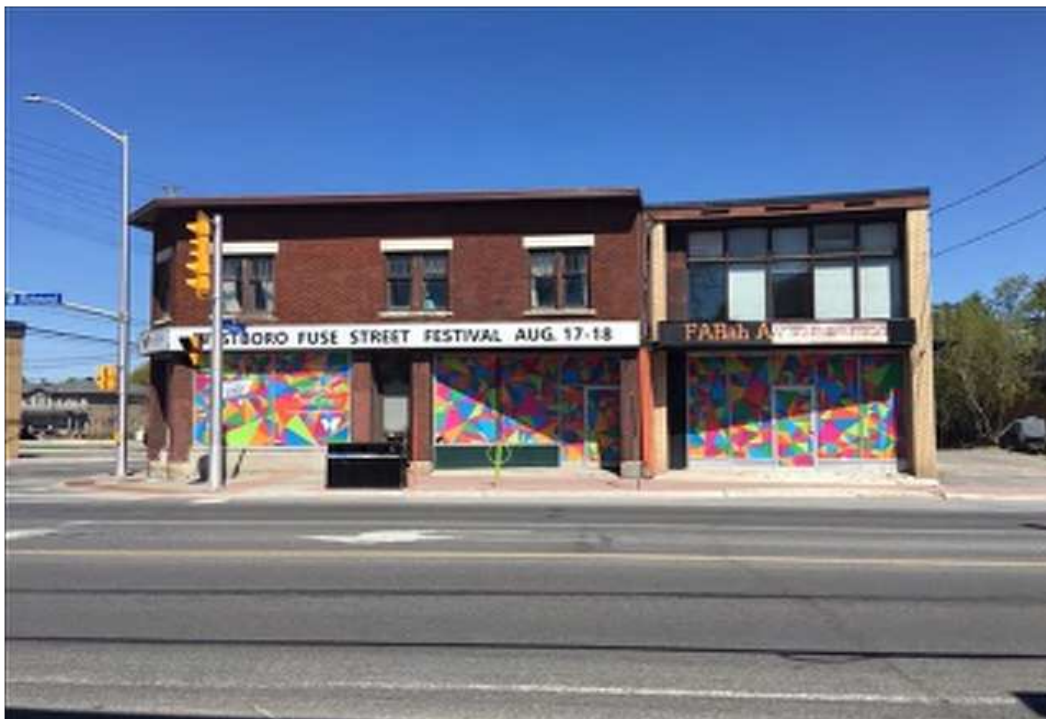
Photograph 2: View of commercial and mixed-used buildings at 325 and 327 Richmond Road, respectively.

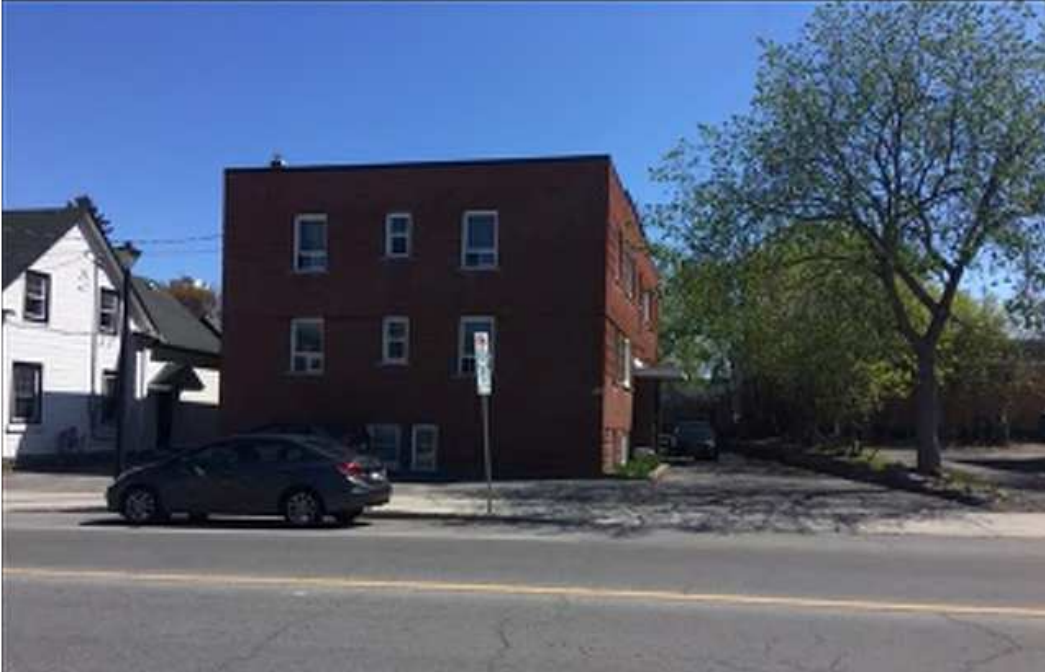
The parcel of land addressed 381 Churchill is occupied by a 3-storey residential apartment building. The building, considered to have been constructed circa 1928, is of a poured concrete foundation construction with an exterior finished in red brick with a flat, tar-and-gravel style roof.

Photograph 5: View of the residential apartment building at 381 Churchill Avenue.

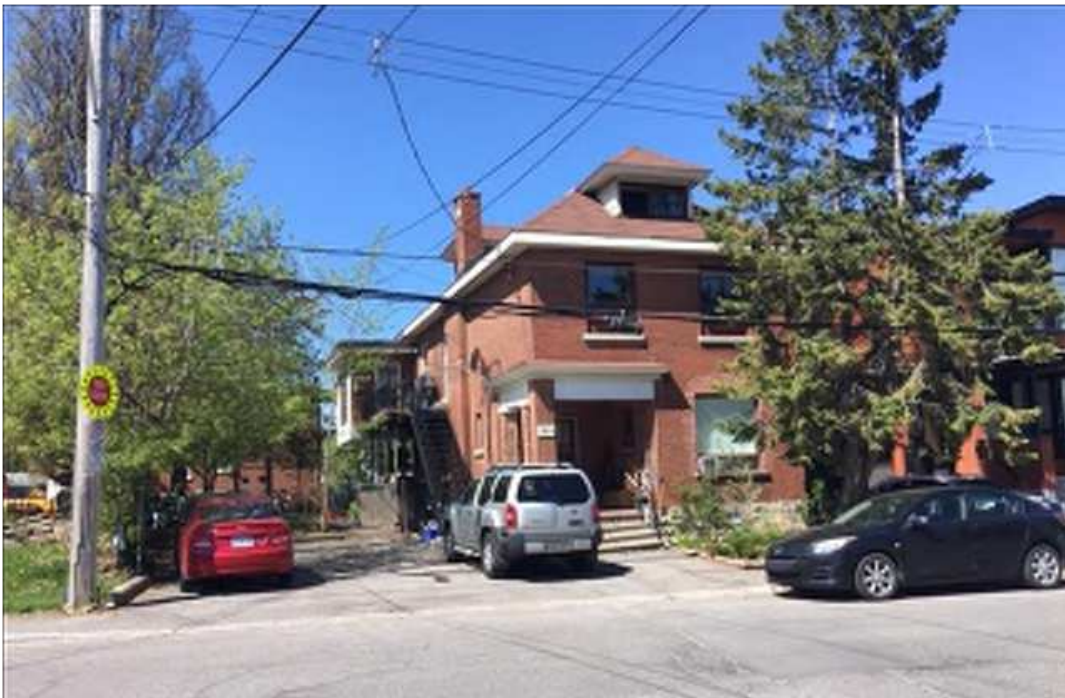
The parcel of land addressed 380 Winona Avenue is occupied by a 2-storey residential apartment building constructed circa 1928 with an addition constructed circa 1970. The building foundation is of a poured concrete construction with an exterior finished in red brick with a sloped shingle style roof.

Photograph 6: View of the residential building at 380 Winona Avenue.
