Project:  
**327 RICHMOND ROAD**  
**RICHMOND CHURCHILL**  
**LIMITED PARTNERSHIP**  
OTTAWA., ONTARIO

Drawing:  
**TREE CONSERVATION**  
**REPORT**

Scale: AS SHOWN	Date: 22 MAY, 2020
Design By: PG	Drawn By: PG
Project Number: 1942-12	Sheet Number: TCR 01

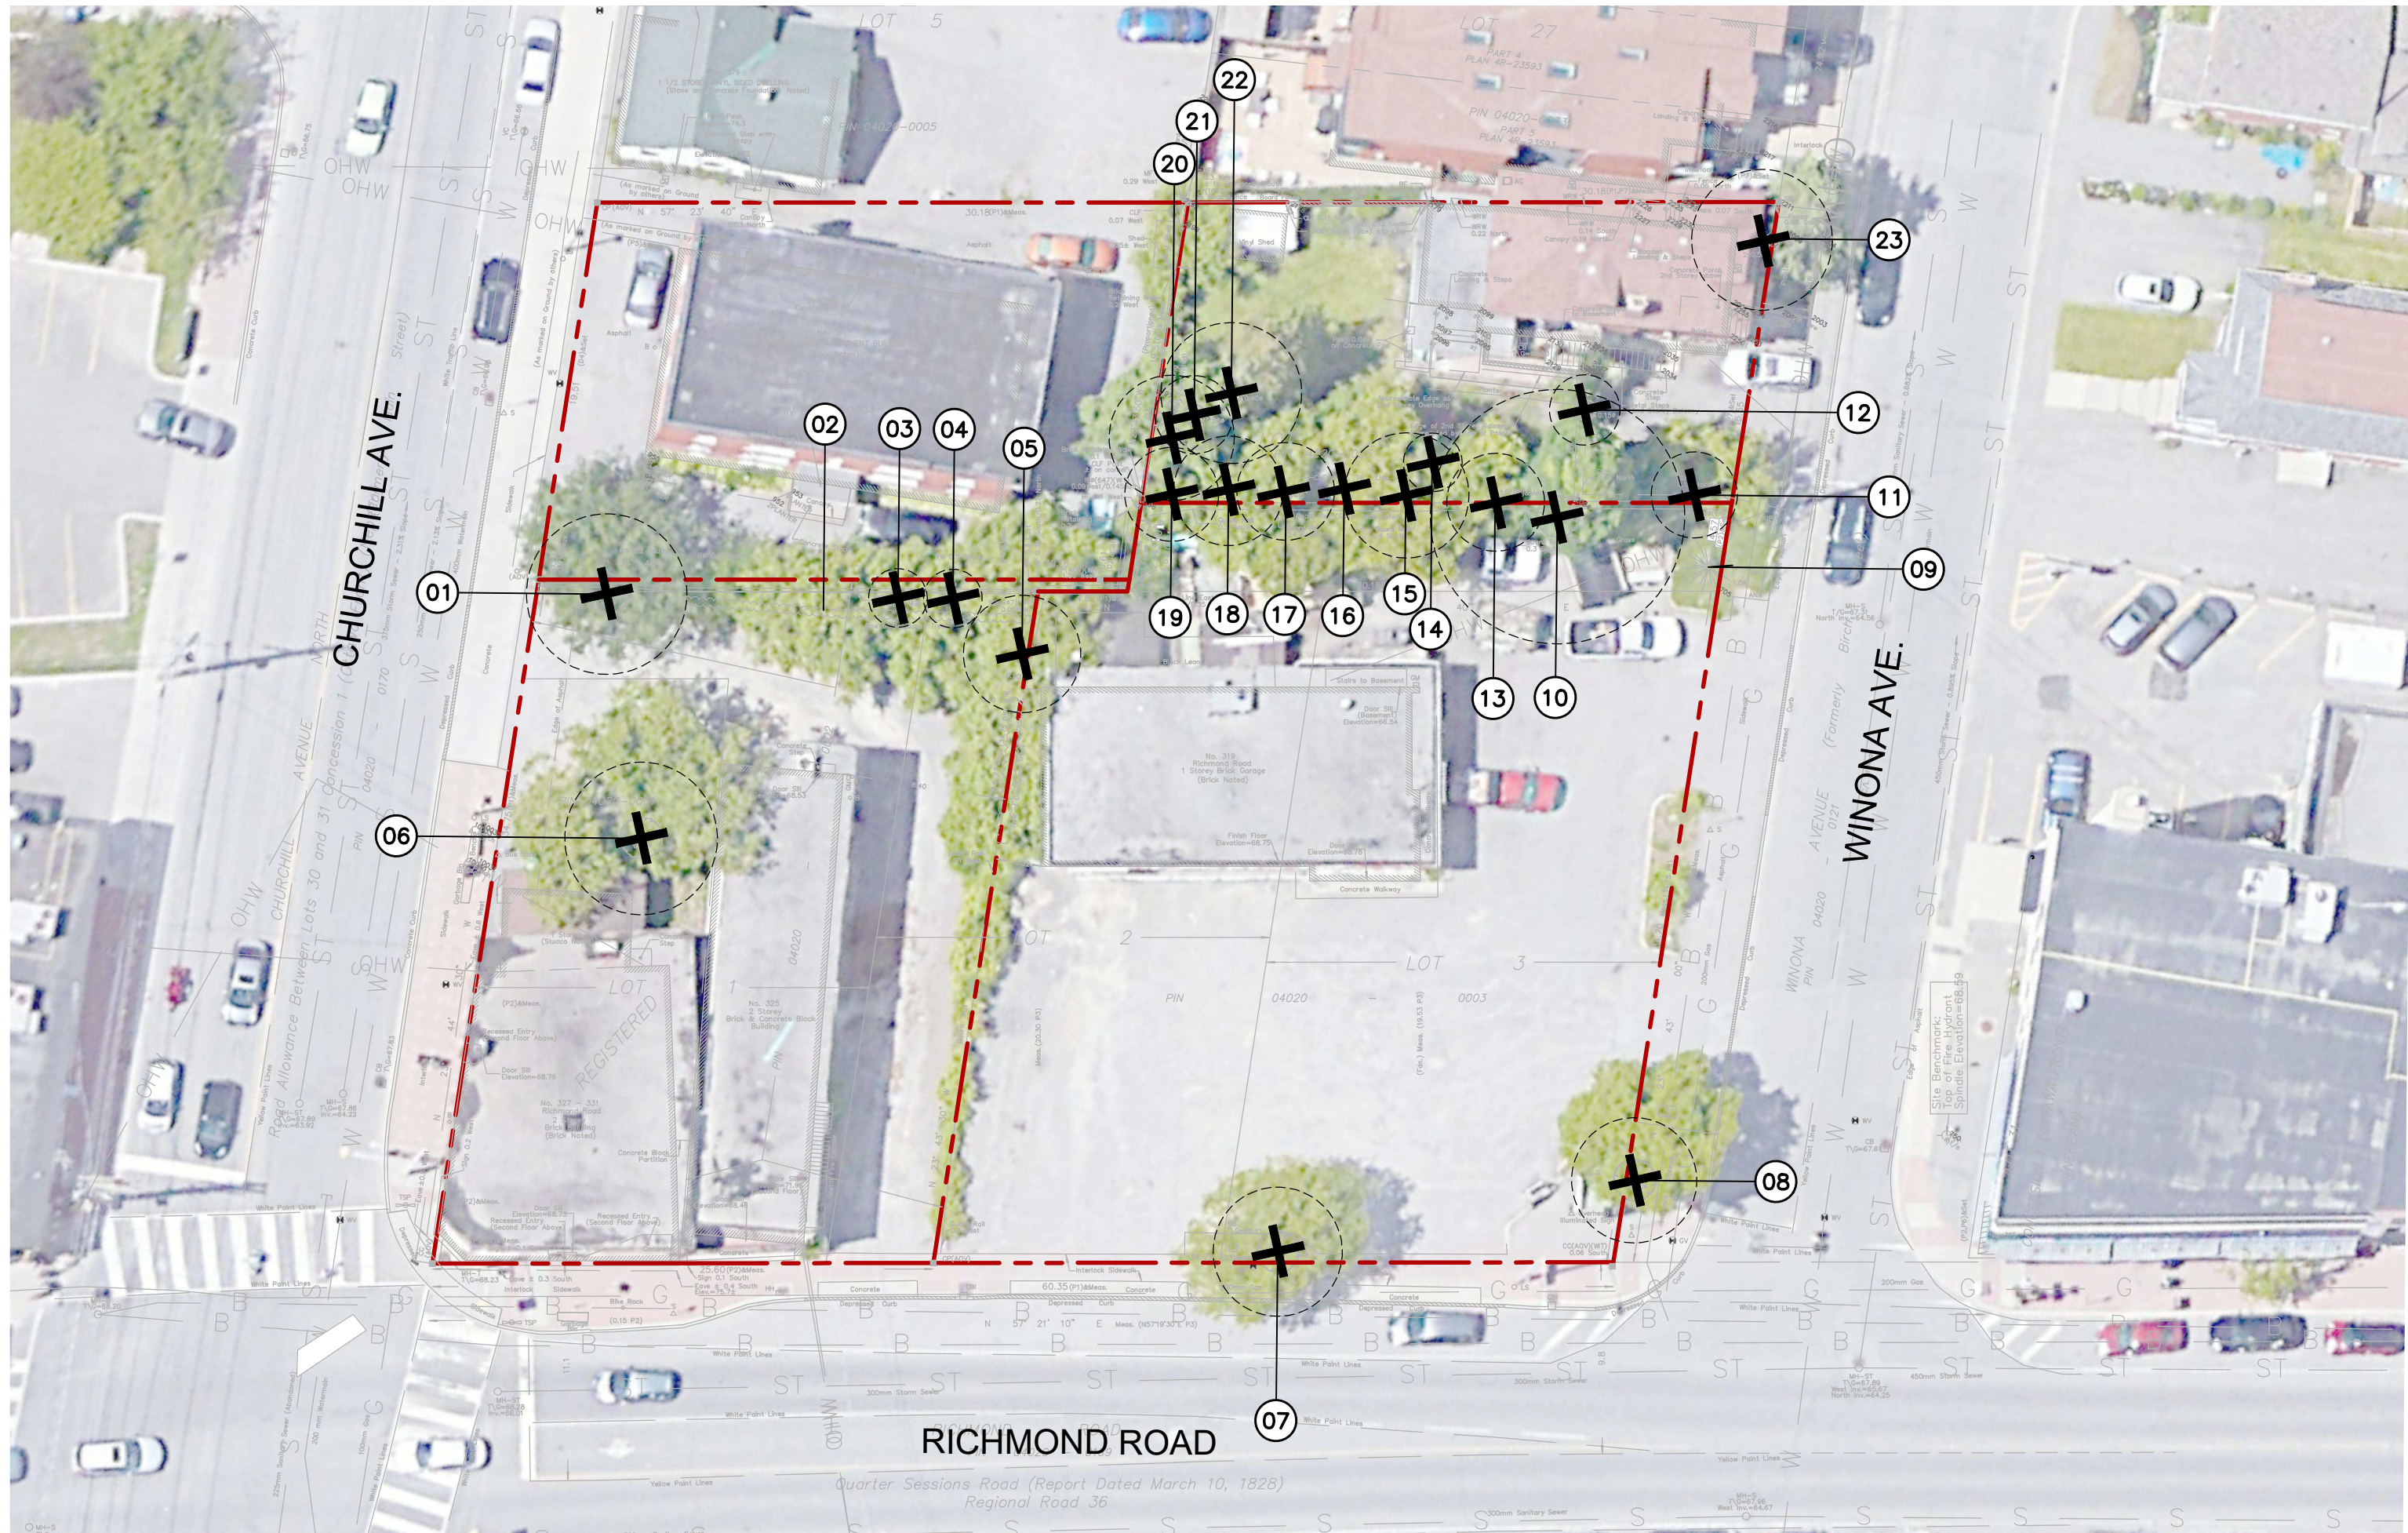
1 EXISTING SITE

Tree #	Botanical Name	Common Name	Caliper (cm)	Condition	High Quality Tree	Rare Tree	Comments	Disposition
1	Ulmus pumila	Siberian Elm	41	Good	No	No	Privately owned, Symmetrical canopy, Single stem, Co-dominant leaders: 2 @ ~3m above grade, Die back: ~5% @ branches	Remove
2	Group: Acer negundo / Rhamnus carthartica	Group: Manitoba Maple / Common Buckthorn	<10	Moderate	No	No	Privately owned, Row of volunteer Manitoba Maple & Common Buckthorn along property line.	Remove
3	Acer negundo	Manitoba Maple	12 to 15	Poor	No	No	Privately owned, Asymmetrical canopy, Multi-stem, Pruned, Broken limbs, included bark, Asphalt paving over CRZ	Remove
4	Acer negundo	Manitoba Maple	10 to 15	Moderate	No	No	Privately owned, Asymmetrical canopy, Multi-stem, Broken limbs.	Remove
5	Acer negundo	Manitoba Maple	30	Poor	No	No	Privately owned, Asymmetrical canopy, Single stem, Pruned leader, Broken limbs, Heart rot & Bark rot @ trunk.	Remove

6	Acer negundo	Manitoba Maple	25, 31, 39	Moderate	No	No	Privately owned, Asymmetrical canopy, Single stem, Co-dominant leaders: 3 @ ~1m above grade, leaning, bark damage @ leader.	Remove
7	Gleditsia triacanthos	Honey Locust	33	Good	No	No	City owned, Symmetrical canopy, Single stem, Bark rot @ trunk.	Remove
8	Gleditsia triacanthos	Honey Locust	32	Moderate	No	No	City owned, Symmetrical canopy, Single stem, Co-dominant leaders: 3 @ ~2.5m above grade, Tree guard grown into trunk.	Remove
9				Missing				
10	Quercus robur 'Fastigiata'	Pyramidal English Oak	65	Good	Yes	No	Privately owned, Symmetrical canopy, Single stem, Bark rot @ trunk.	Remove
11	Acer negundo	Manitoba Maple	22	Poor	No	No	Privately owned, Asymmetrical canopy, Single stem, Leaning, Broken limbs, Bark damage.	Remove
12	Ulmus pumila	Siberian Elm	18	Moderate	No	No	Privately owned, Symmetrical canopy, Single stem.	Remove
13	Acer negundo	Manitoba Maple	24	Moderate	No	No	Privately owned, Asymmetrical canopy, Single stem, Poor branch angle.	Remove

14	Picea glauca	White Spruce	15	Poor	No	No	Private property, Asymmetrical canopy, Single stem, 70% die-back @ canopy.	Remove
15	Acer negundo	Manitoba Maple	32	Moderate	No	No	Private property, Asymmetrical canopy, Single stem, Leaning	Remove
16				Dead				
17	Acer negundo	Manitoba Maple	25	Moderate	No	No	Privately owned, Asymmetrical canopy, Single stem, Grown into chain link fence	Remove
18	Acer negundo	Manitoba Maple	28	Moderate	No	No	Privately owned, Asymmetrical canopy, Single stem, Leaning, Grown into chain link fence.	Remove
19	Acer negundo	Manitoba Maple	24	Moderate	No	No	Privately owned, Asymmetrical canopy, Single stem.	Remove
20	Acer saccharum	Sugar Maple	36	Good	No	No	Private property, Asymmetrical canopy, Single stem, Co-dominant leaders: 2 @ 1.5m above grade, Broken limbs.	Remove
21	Picea glauca	White Spruce	20	Good	No	No	Privately owned, Symmetrical canopy, Single stem, Existing feature: lumber fastened to trunk.	Remove

22	Thuja occidentalis	Eastern White Cedar	36	Good	No	No	Privately owned, Symmetrical canopy, Single stem, Existing feature: lumber fastened to trunk.	Remove
23	Picea pungens	Colorado Spruce	32, 28	Moderate	No	No	Privately owned, Asymmetrical canopy, Single stem, Co-dominant leader: 2 @ 0.1m above grade, Pruned @ hydro.	Remove

- THE SITE CONTAINS ASPHALT PARKING AREAS. APPROXIMATELY 2450m<sup>2</sup> IS HARD SURFACES.
- THERE ARE A TOTAL OF TWENTY-THREE (23) EXISTING TREES INCLUDED IN THE TREE CONSERVATION REPORT, IN VARYING CONDITIONS. THE MAJORITY OF TREES ARE LOCATED WITHIN THE SITE BOUNDARY, WITH ONE LOCATED WITHIN THE CITY ROW. TREES LOCATED ALONG THE NORTHERN PROPERTY LINE OF #325, #327, & #319 RICHMOND ROAD ARE PRIMARILY VOLUNTEER ACER NEGUNDO.

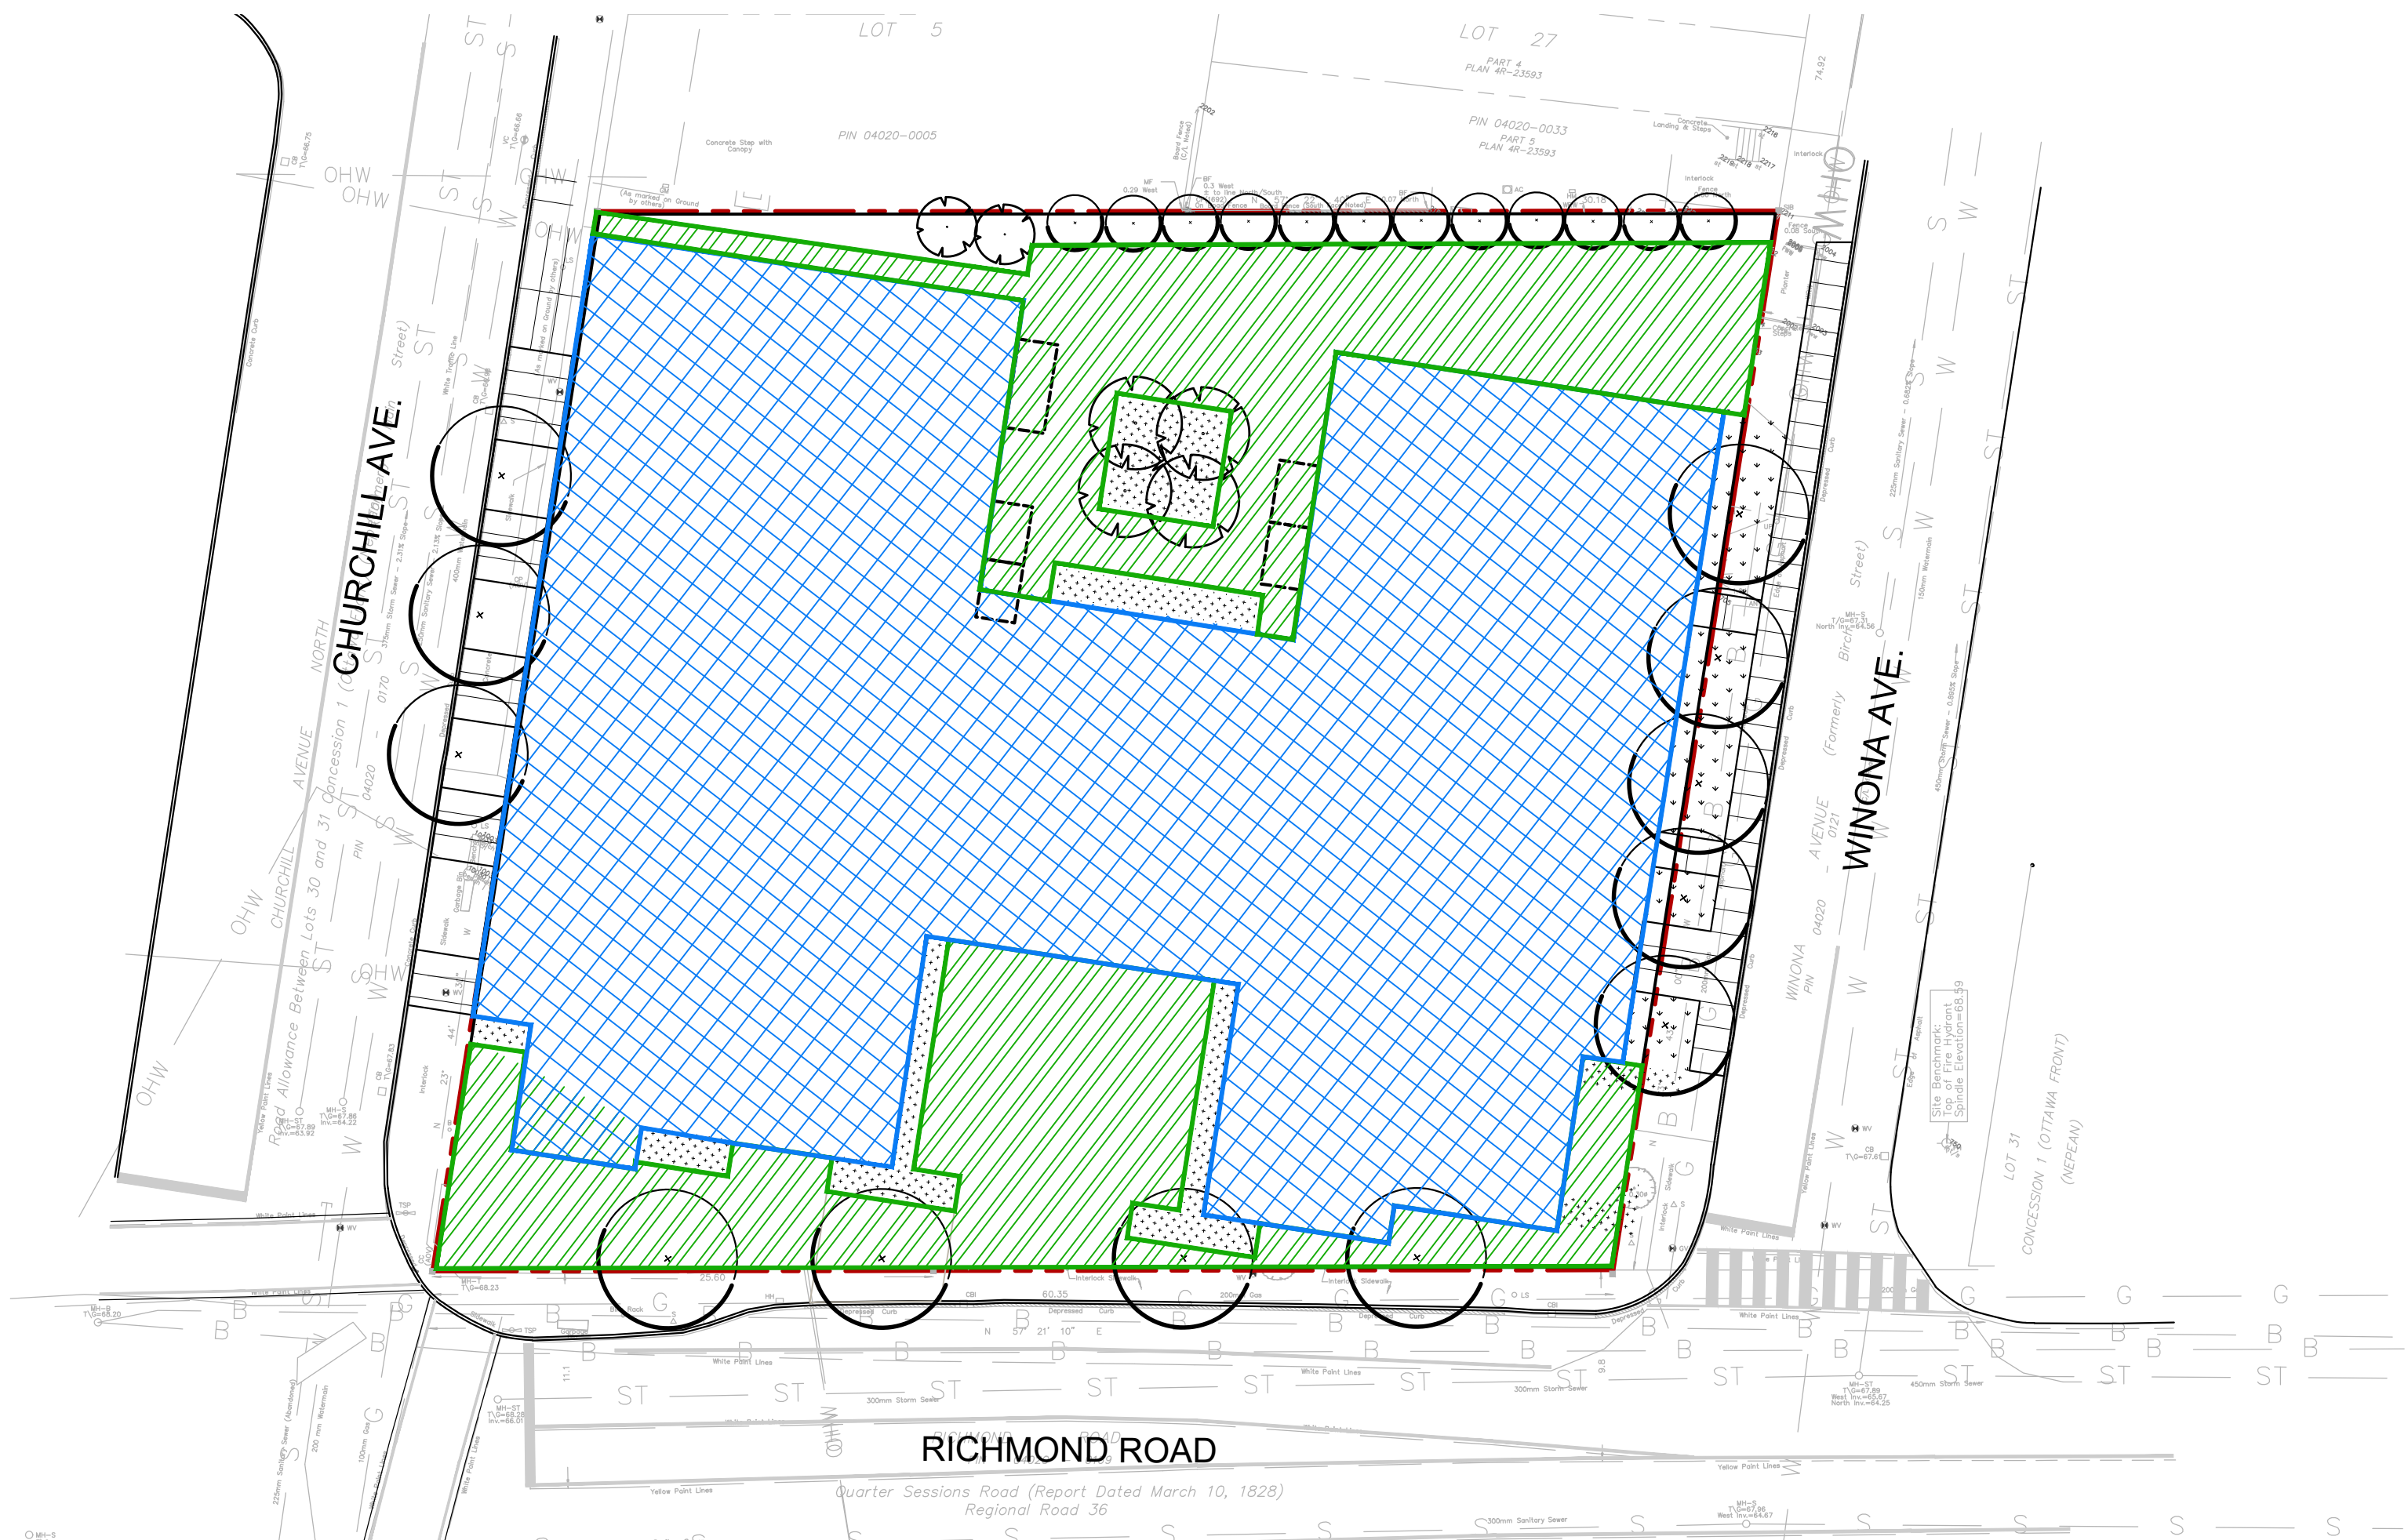
2 PROPOSED DEVELOPMENT

- THE PROPOSED DEVELOPMENT REQUIRES THE REMOVAL OF TWENTY-THREE (23) TREES.
- THE PROPOSED DEVELOPMENT WILL INCLUDE THIRTY-ONE (31) NEW TREES. REFER TO LANDSCAPE PLAN FOR SPECIES LIST.
