## Phase I - Environmental Site Assessment

2487 Innes Road  
Ottawa, Ontario

December 17, 2019

Report: PE4800-1

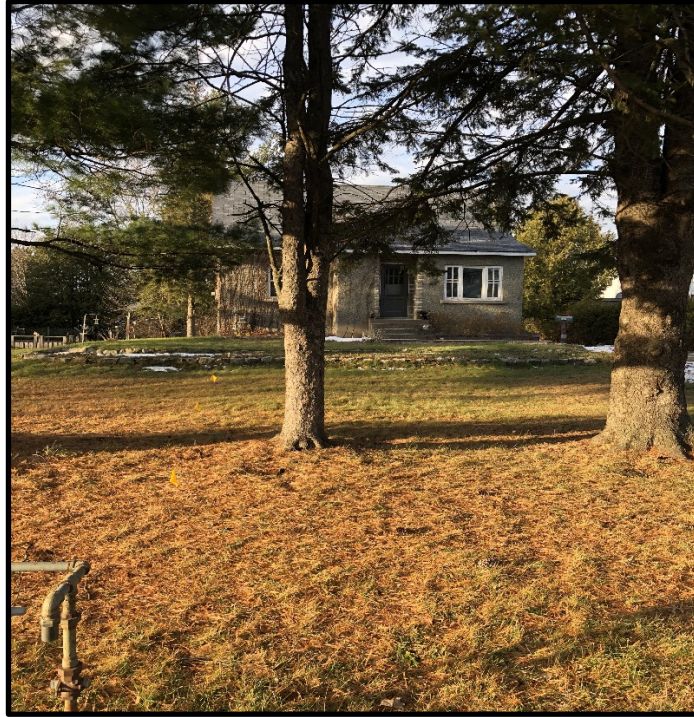
Photograph 1: Front view of the subject property, looking north.

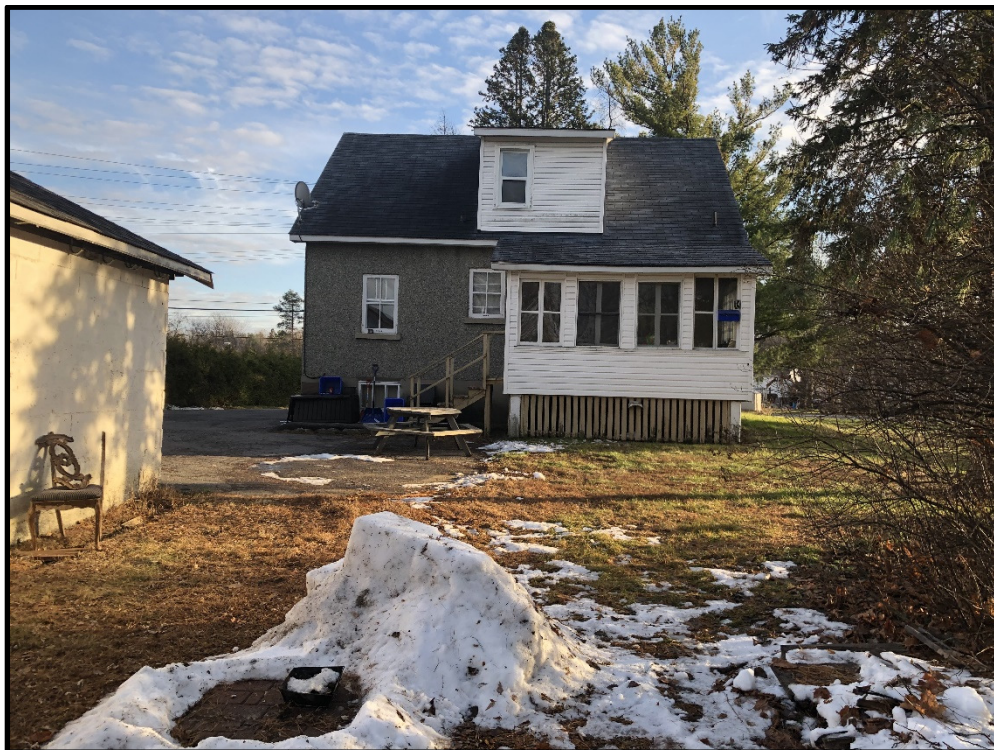
Photograph 2: Rear view of subject property, looking south.
