Combined Environmental Impact Statement &  
Tree Conservation Report  
910/920 March Road Development (Revised)

June 2020

Prepared for Wexford Commercial Developments Ltd.

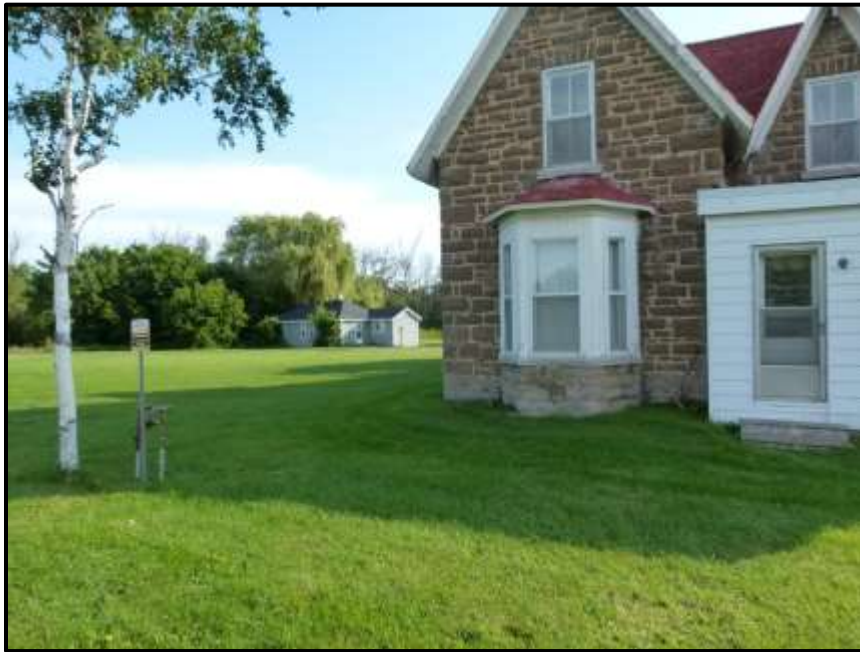
**Photograph 1:** Looking northeast at 910 March Road (Building #1) (foreground) and 920 March Road (Building #5) (background). Note the manicured lawn in the western part of the Site (August 14<sup>th</sup>, 2017).

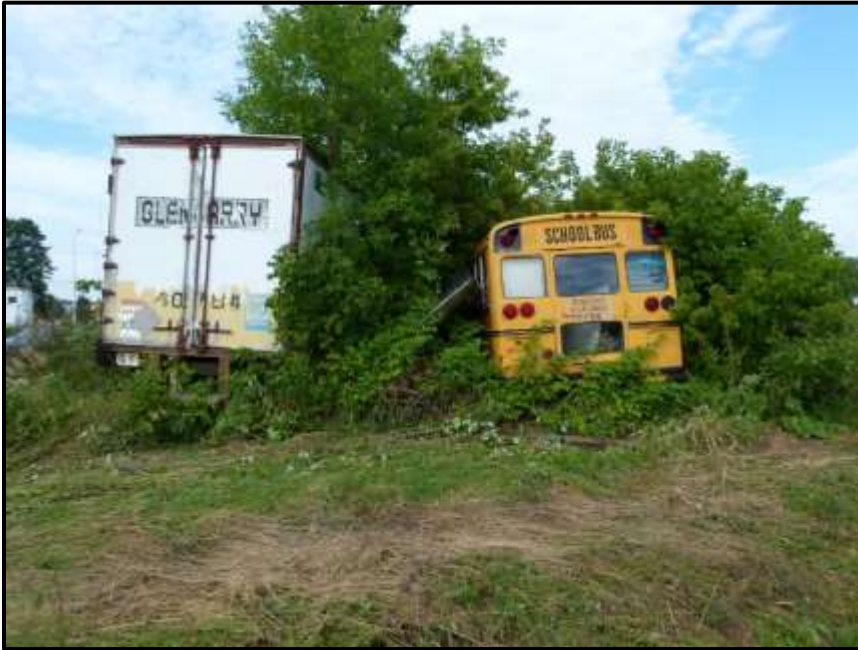
**Photograph 10:** Example of vehicle storage and recent regrowth shrub/tree cover within the central part of the Site (August 14<sup>th</sup>, 2017).

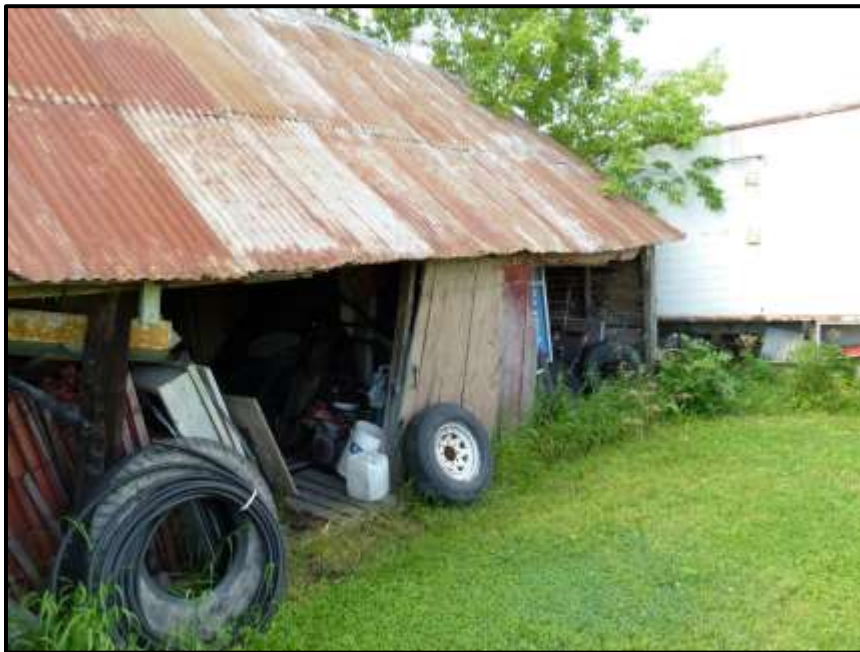
- **Building 4:** Building #4 is a small collapsing barn with a tin roof. The middle section of the building has a raised wooden steeple roof. One (1) intact nest and one (1) degraded nest were noted within the middle section of the building.

Photograph 22: Building #4 – one (1) intact and one (1) degraded Barn Swallow nest were noted (August 14<sup>th</sup>, 2017).

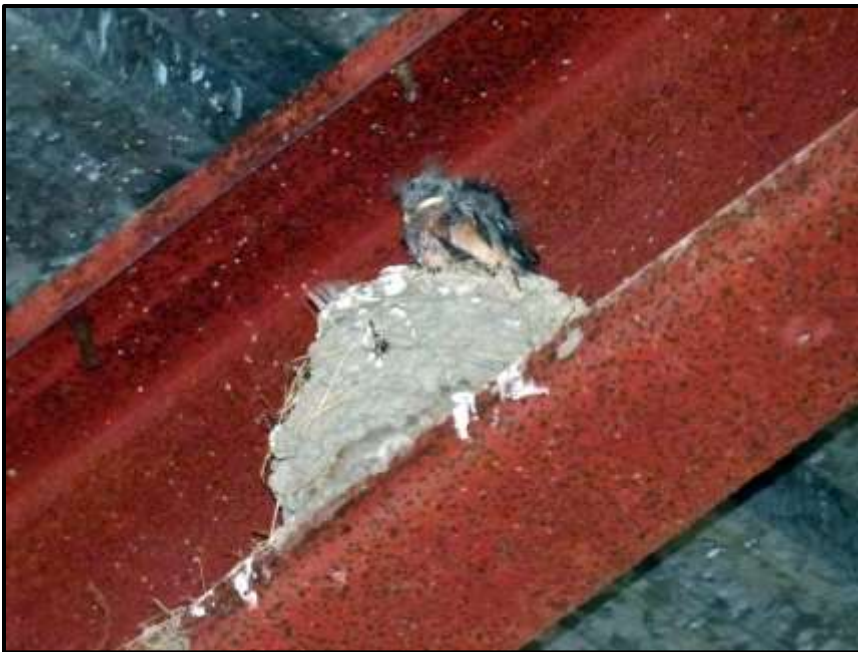
Photograph 26: Active Barn Swallow nest in Building #7 with baby bird visible (August 14<sup>th</sup>, 2017).

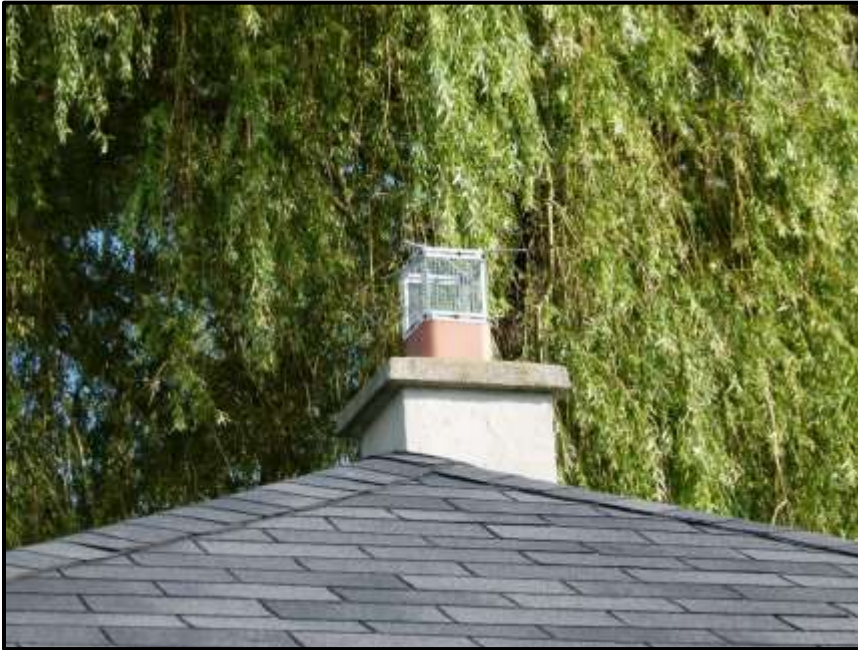
**Photograph 31:** 920 March Road (Building #5) chimney with metal cap (August 14<sup>th</sup>, 2017).

- **Chimney Swift:** Chimney Swifts nest in open chimneys with rough interior surfaces made from brick and/or stone (SARO 2020). There are three (3) chimneys found within the Site. Photographs of the chimneys are included below. 910 March Road includes a brick chimney with a ceramic liner and a second brick chimney with a metal cap. 920 March Road has a concrete chimney with a metal cap. Chimney Swifts will not nest in chimneys with ceramic liners, as they are unable to affix their nests to the smooth interior surface (SARO 2020). Chimney Swifts are unable to enter chimneys with metal caps. There are therefore no chimneys within the Site which may be suitable for Chimney Swift nesting.

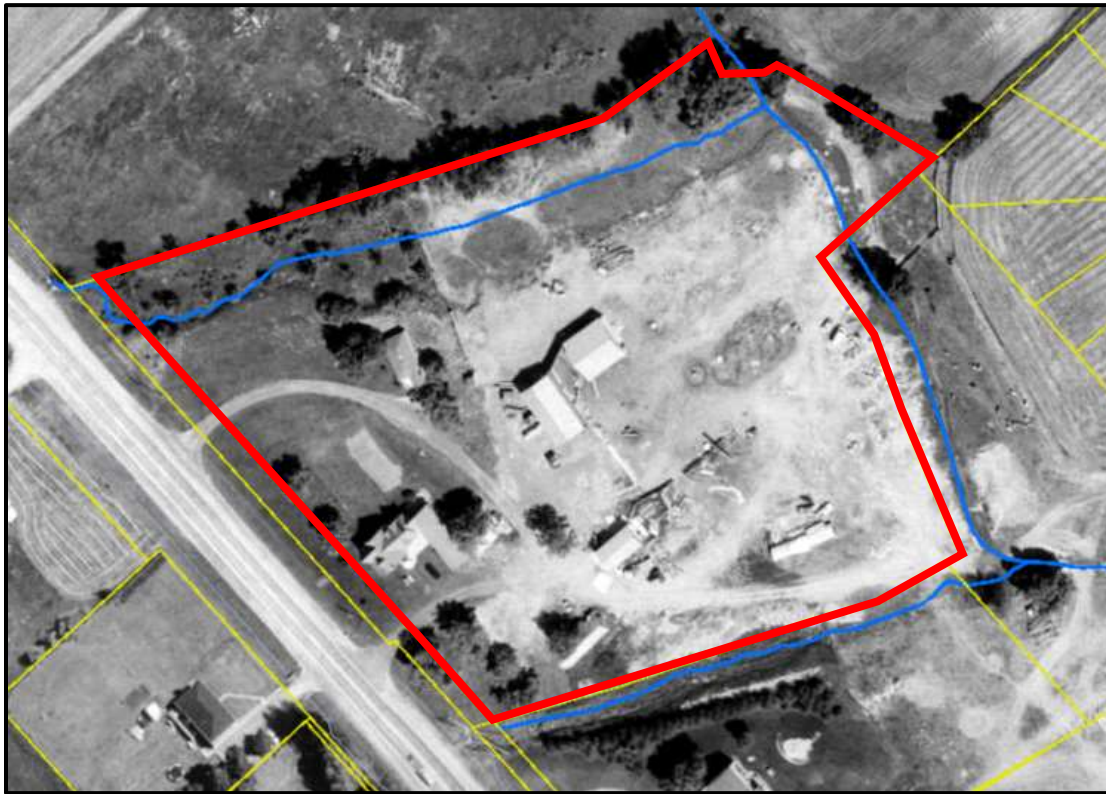
**Photograph 2:** Historic Air Photo from 1991 (property boundary shown in red). Note that the Site is predominantly cleared and devoid of mature trees. Surrounding areas appear to be farmed and/or rural residences. A few mature trees are present around the houses at 910 and 920 March Road, and along the northern and southern property boundaries (Photo from City of Ottawa 2020).

Air photos from 1976, 1991 and 2002 are included below (Photos from City of Ottawa 2020). A recent air photo is included in Figure 2. The oldest available historic air photo (from 1976), shows that the Site has been predominantly cleared and devoid of mature trees since at least 1976. The areas surrounding the Site appear to be farmed and/or rural residences in 1976. In 1976, a few mature trees are present around the house at 910 March Road and along the northern property boundary. This suggests that some of the older trees in the Deciduous Hedgerow have been growing since before 1976. Conditions within the Site appear similar in 1991, although a few additional mature trees are present around the houses at both 910 and 920 March Road, and along the northern property boundary in 1991. The Site layout and usage in 2002 is similar to current conditions. In 2002, the Site was predominantly cleared and devoid of mature trees. Surrounding areas appear to be farmed and/or rural residences. In 2002, a few mature trees are present surrounding the house at 920 March Road and along the northern property boundary. The historic air photos indicate that the only older trees found within the Site include those growing within the Deciduous Hedgerow along the northern Site boundary. Some of the Deciduous Hedgerow trees have been growing since before 1976. A few older trees are also shown to be present around the house at 920 March Road, and have been growing there since before 1991. The majority of other trees found within the Site, including the Manitoba Maples growing along the southern Site boundary, are comparatively young recent regrowth.
