## Phase II Environmental Site Assessment

910 March Road  
Ottawa, Ontario

Wexcom Developments (March Rd.) Ltd.

Report: PE4760-2

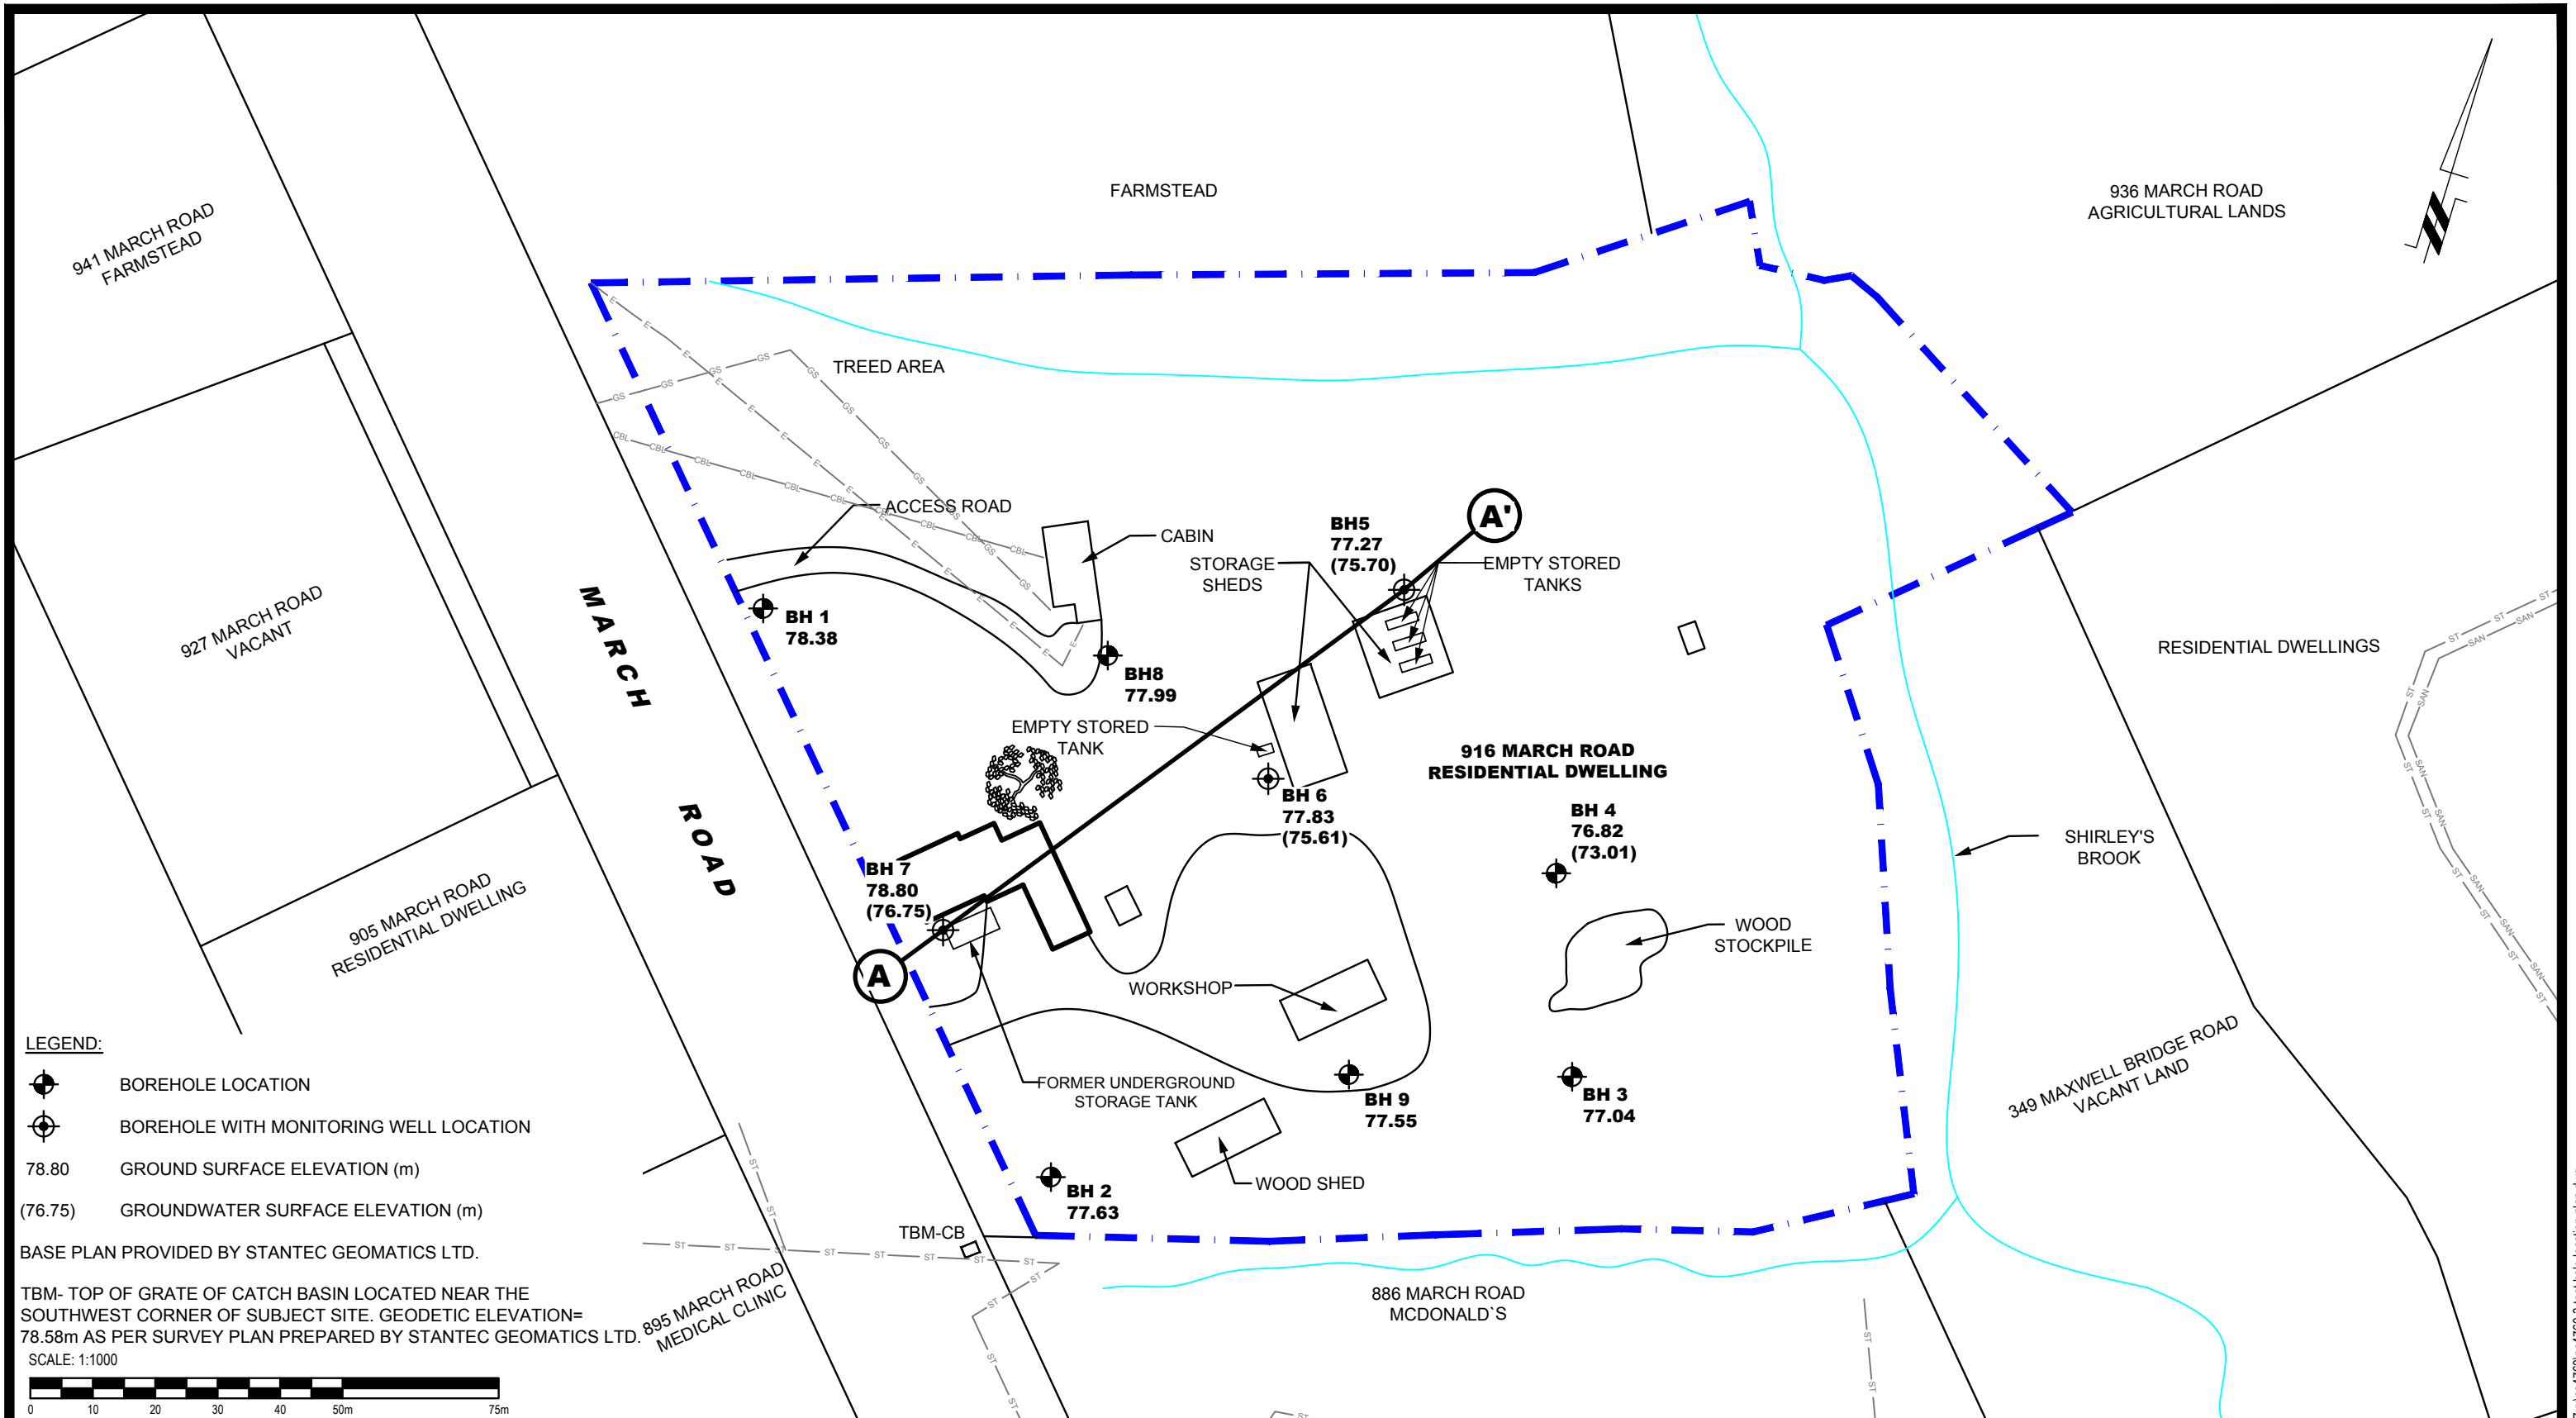
**TEST HOLE LOCATION PLAN**

The approximate locations of above and below ground services, are shown on Drawing PE4760-3 –Test Hole Location Plan.

The boreholes (BH1 through BH3) were placed to address the aforementioned APECs, as presented in Table 1, as well as completed for geotechnical purposes. The boreholes were drilled using a track mounted drill rig provided by George Downing Estate Drilling Ltd. of Hawkesberry, Ontario, under the full-time supervision of Paterson personnel. The borehole locations are indicated on the attached Drawing PE4760-3 – Test Hole Location Plan, appended to this report.

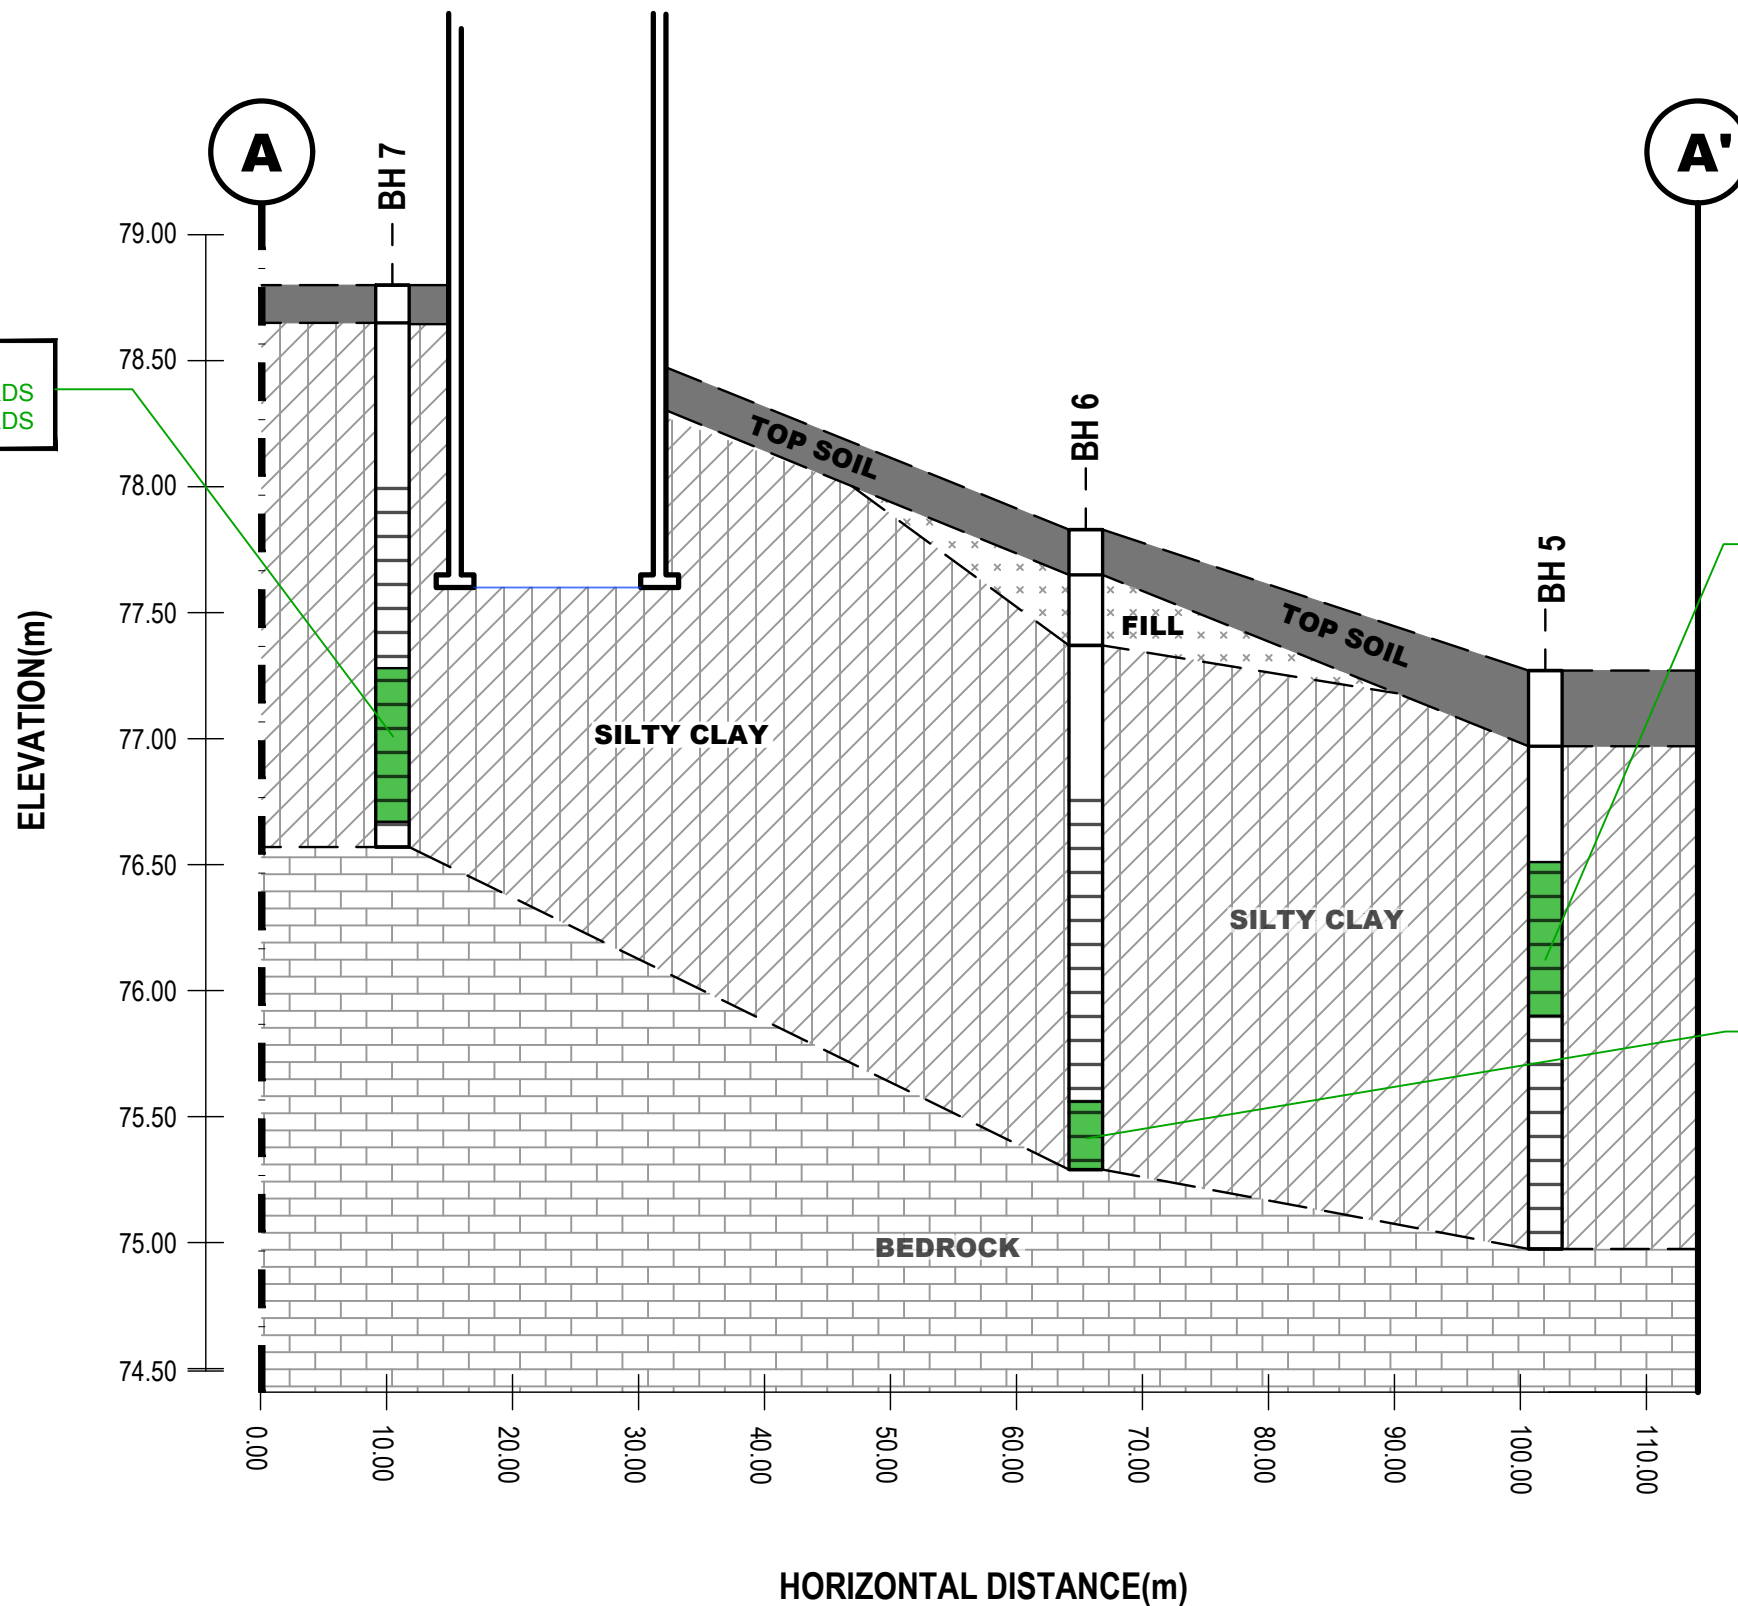
WEXCOM DEVELOPMENTS (MARCH ROAD) LTD.  
 PHASE II - ENVIRONMENTAL SITE ASSESSMENT  
 910 MARCH ROAD  
 OTTAWA, ONTARIO  
 Title:  
**CROSS SECTION A-A - SOIL**

BH7-SS3 1.52-2.13m 15-OCT-19  
 BTEX COMPLY WITH MECP TABLE 8 STANDARDS  
 PHCs COMPLY WITH MECP TABLE 8 STANDARDS

BH5-SS2 0.76-1.37m 15-OCT-19  
 BTEX COMPLY WITH MECP TABLE 8 STANDARDS  
 PHCs COMPLY WITH MECP TABLE 8 STANDARDS
