Phase I Environmental Site Assessment

Vacant Land
Trim Road and Portobello Boulevard
Ottawa, Ontario

January 20, 2018

Report: PE4111-1

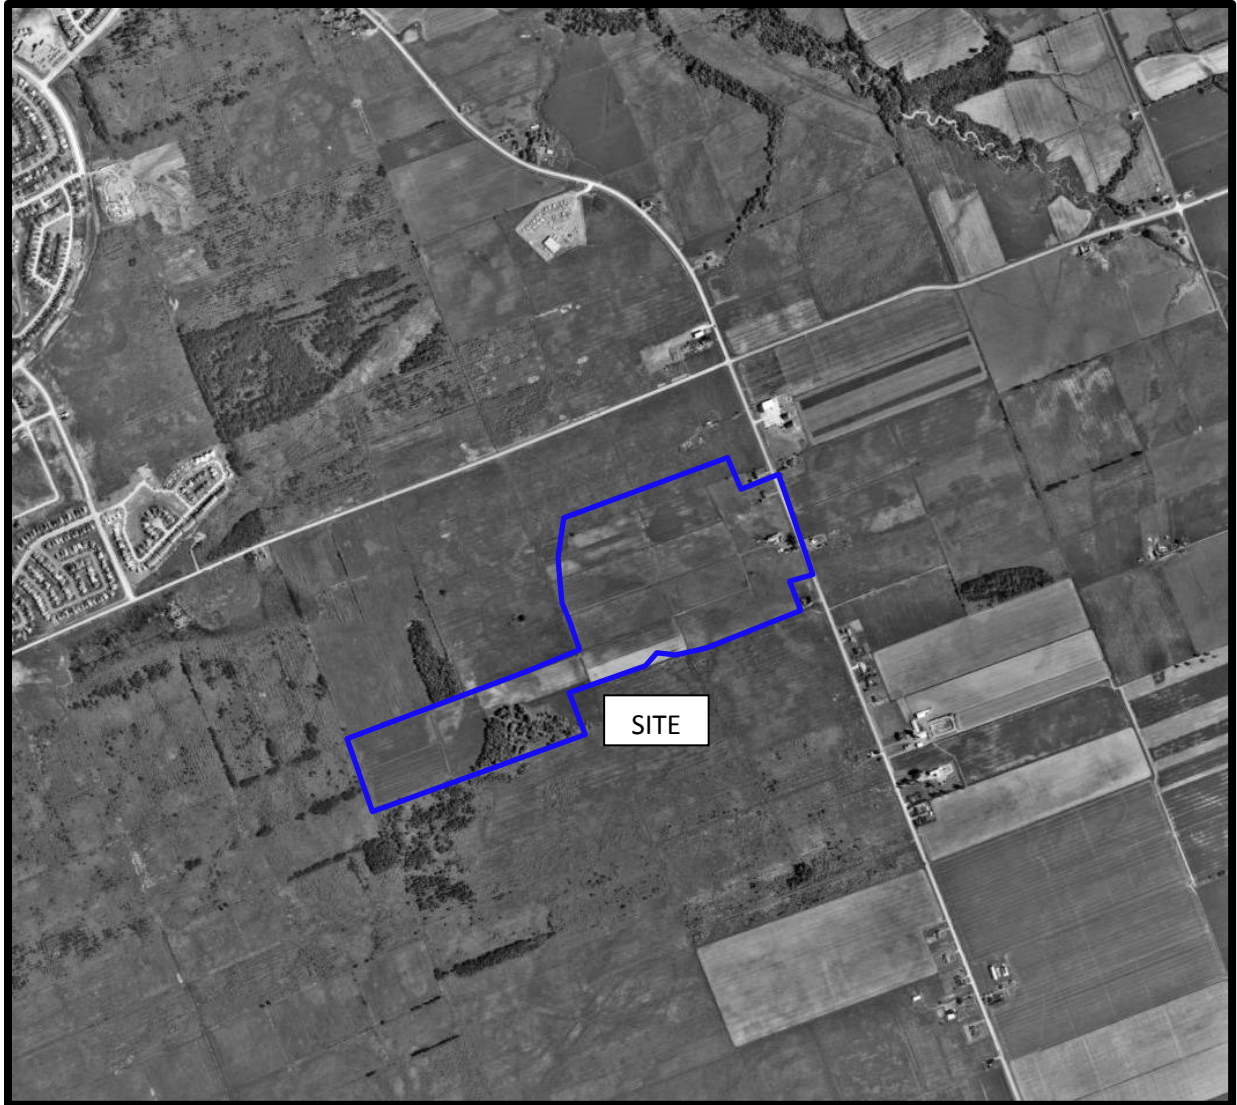
AERIAL PHOTOGRAPH
1991

| 1991 | (City of Ottawa website) No significant changes have been made to the subject site. Residential dwellings have been developed adjacent to the subject site along Trim Road. |
