# **Phase I Environmental Site Assessment**

280 Eric Czapnik Way  
Ottawa, Ontario

Landric Homes Inc.  
1173 Cyrville Road, Suite 202  
Ottawa, Ontario  
K1J 7S6

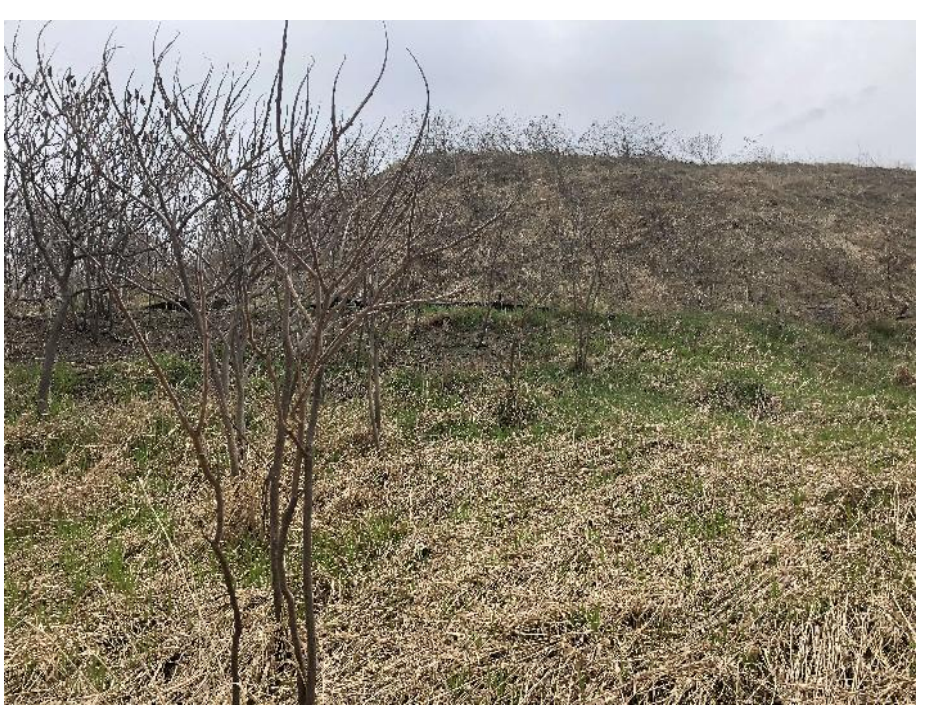
Photograph No. 2

Date: 5/4/2020	
<p><b>Description</b></p> <p>From the north facing south along the eastern portion of the Site. Large fill mound present in background.</p>

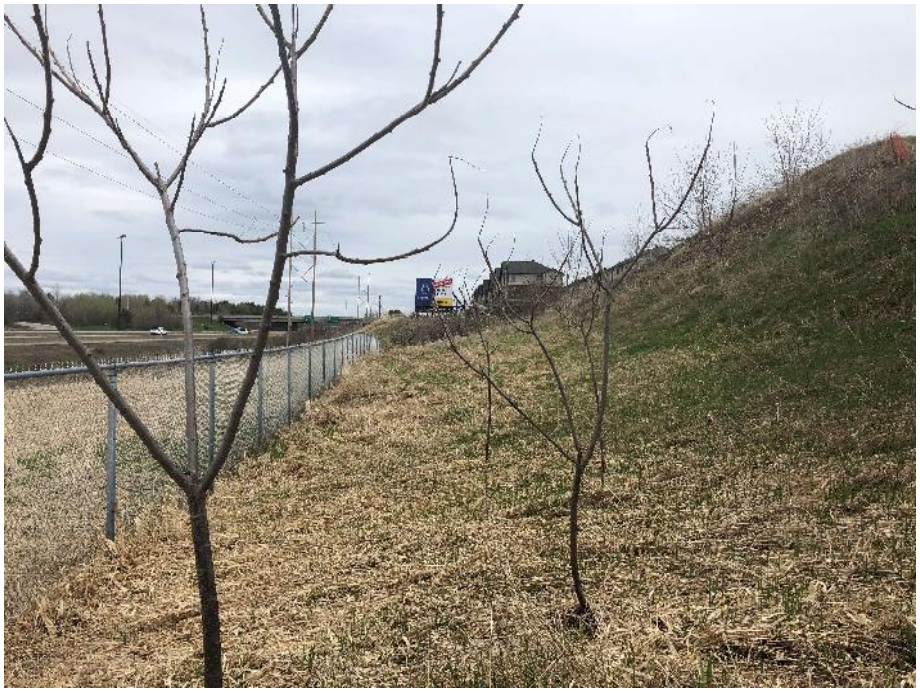
Photograph No. 4

Date: 5/4/2020	
<p><b>Description</b></p> <p>General Site conditions along the northern extent of the Site, from west facing east. The large fill mound is visible along the right limit of the photograph.</p>

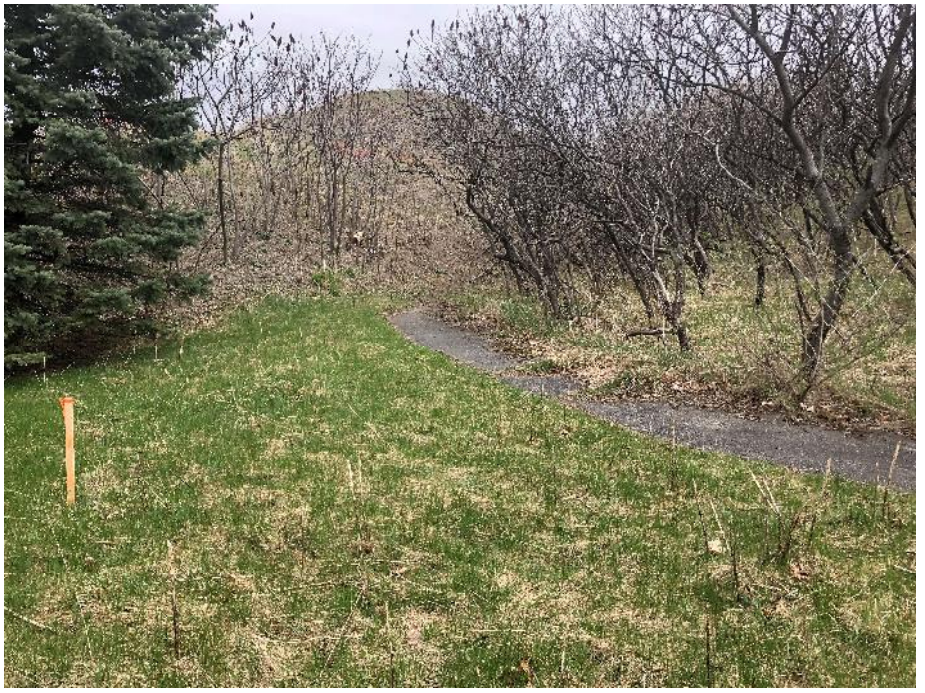
Photograph No. 6

Date: 5/4/2020	
Description  Southwester portion of the Site facing east. Large fill mound is present in the background.

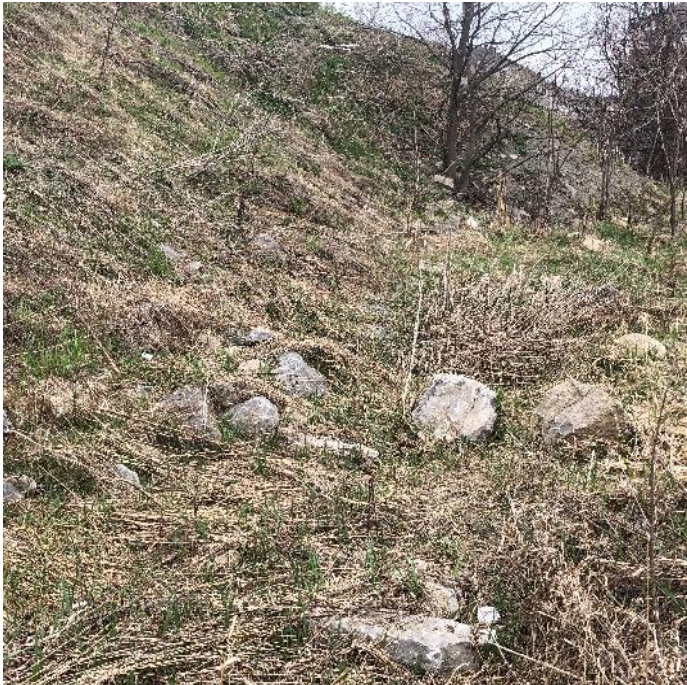
<p>Photograph No. 8</p>

<p>Date: 5/4/2020</p>	
<p>Description</p> <p>South-central base of fill mound. Evidence of concrete waste.</p>

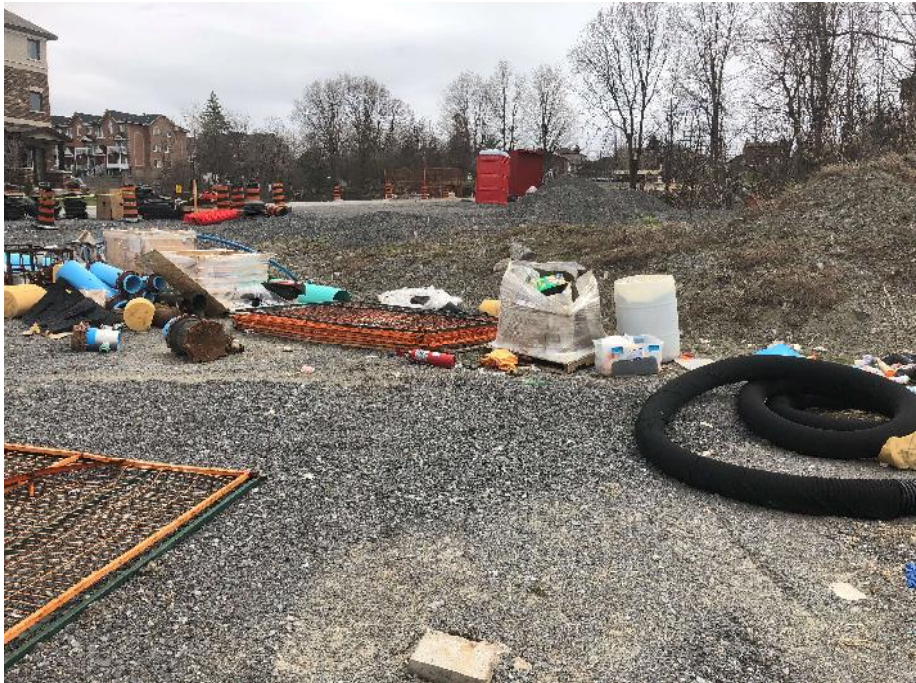
Photograph No. 10

Date: 5/4/2020	
Description Construction staging yard at the eastern portion of the Site. General material observed include modu-loc fencing, water and sanitary/storm sewer utility piping and components.

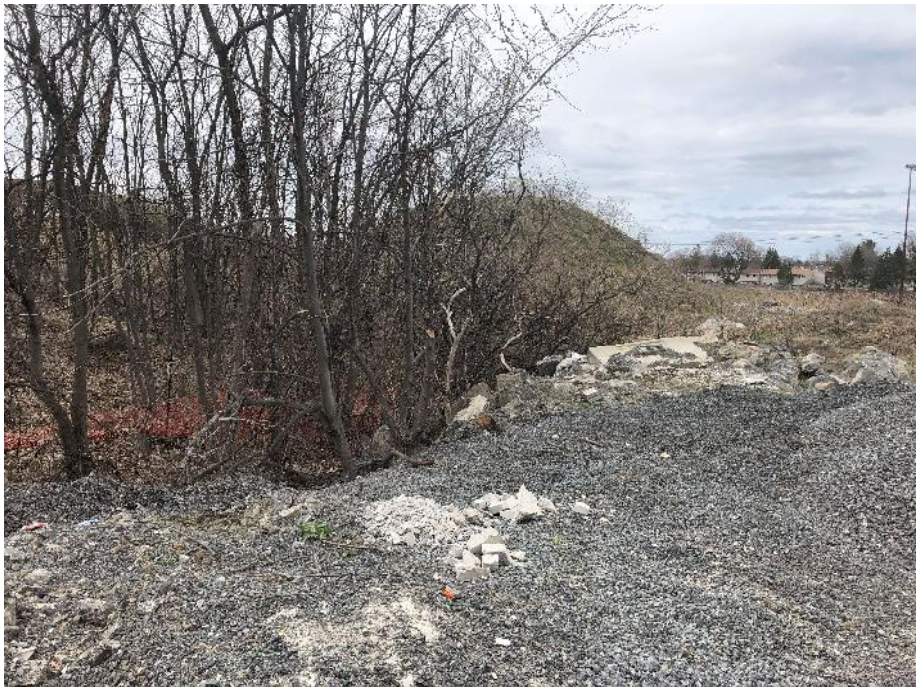
Photograph No. 12

Date: 5/4/2020	
Description Cement, granular and traces of asphalt debris across the northeastern portion of the Site.

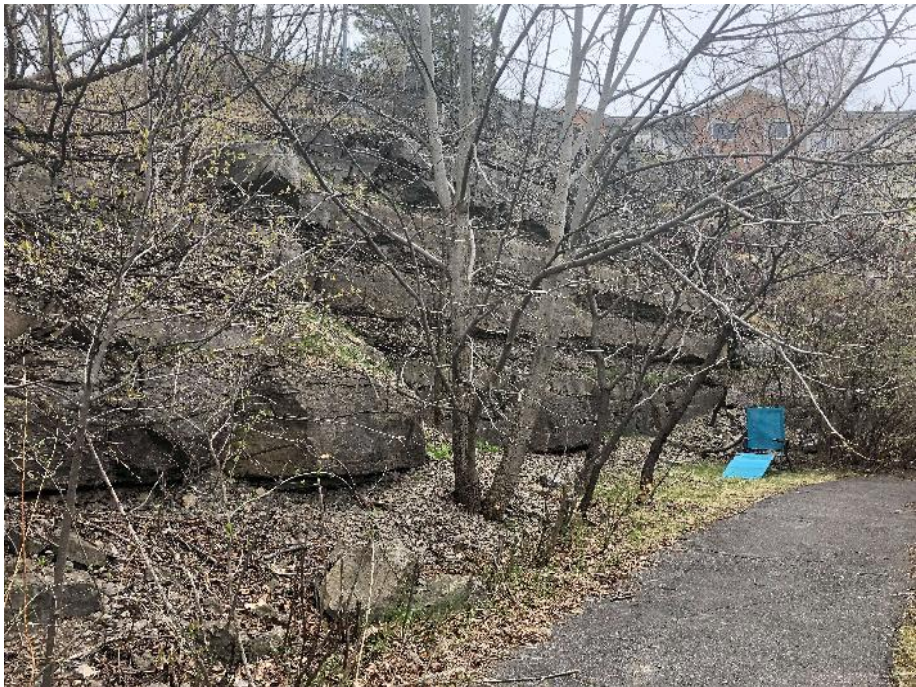
<p>Photograph No. 16</p>

<p>Date: 5/4/2020</p>	
<p>Description</p> <p>Bedrock outcrop along the southern extent of the western portion of the Site.</p>

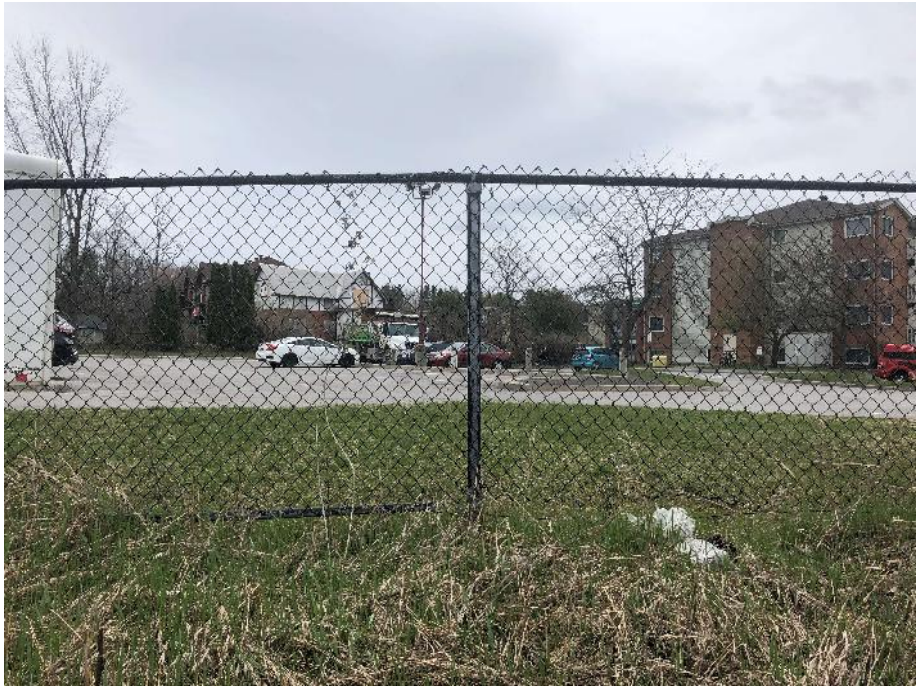
<p>Photograph No. 18</p>

<p>Date: 5/4/2020</p>	
<p>Description</p> <p>Adjacent property to the south of the Site: Multi-tenant residence and associated parking and circulation area.</p>
