Transportation Impact Assessment – Step 1 & 2: Screening & Scoping

4639 Bank Street

CLIENT:	Glenview Homes
PROJECT NAME:	4639 Bank Street
REPORT TITLE:	Transportation Impact Assessment
IBI REFERENCE:	125600
VERSION:	Draft
DIGITAL MASTER:	J:\125600_4639BankSt\6.0_Technical\6.23_Traffic\03_Tech-Reports\TTR_4639BankSt_MASTER_2020-05-07.docx
ORIGINATOR:	Eric McLaren, Ben Pascolo-Neveu
REVIEWER:	David Hook
AUTHORIZATION:	Justin Date
CIRCULATION LIST:	Josiane Gervais - City of Ottawa Transportation Project Manager Jake Shabinsky - Glenview Homes Jennifer Murray - J. Murray Consulting Demetrius Yannoulopoulos - IBI Group
HISTORY:	TIA Step 1 & 2 Submitted for City Review – May 20, 2020

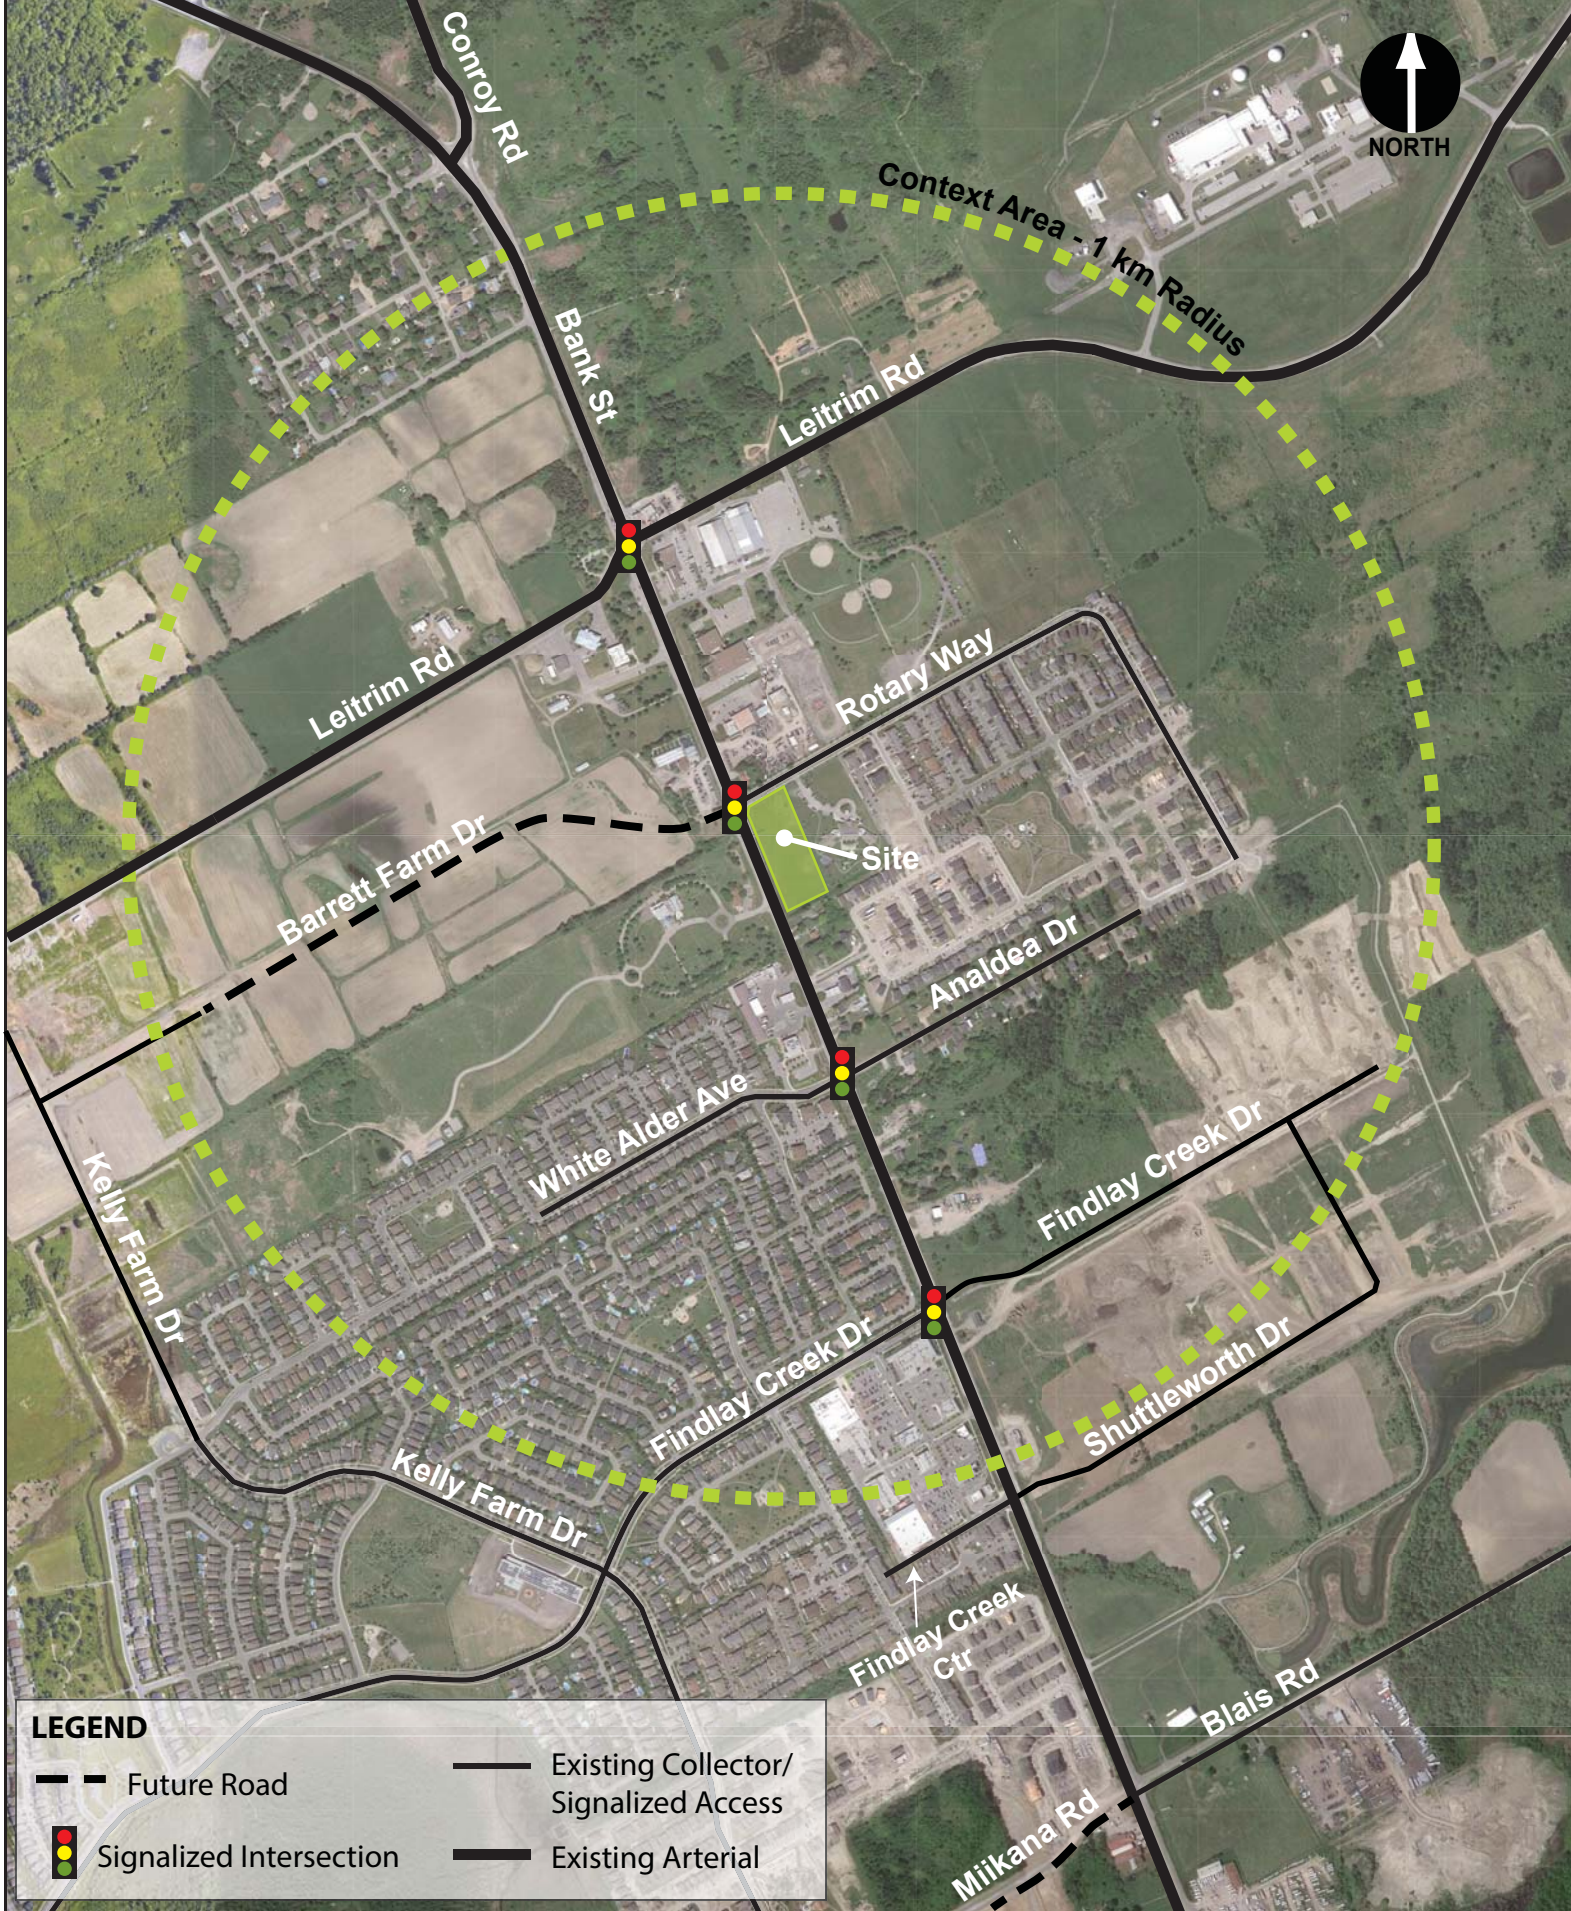
The proposed development is within the Leitrim Community and is approximately 1.2 hectares in size. It is bound by Bank Street to the west, Rotary Way to the north, the Ottawa Rotary Home to the east and residential dwellings to the south.

The site location is illustrated in **Exhibit 1**.

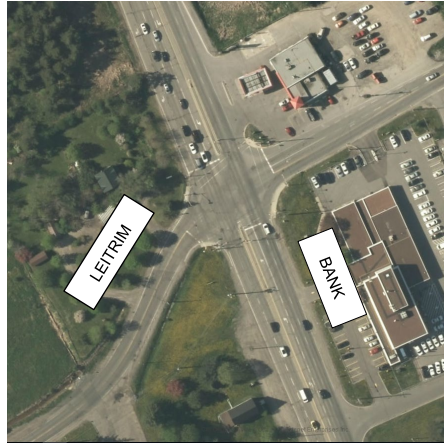
- **Bank Street & Leirim Road** is a four-legged signalized intersection with left-turn lanes on the northbound, southbound and westbound approaches and right-turn lanes on the southbound and westbound approaches. The intersection is located 520m north of the proposed development and has documented capacity issues during weekday peak periods.

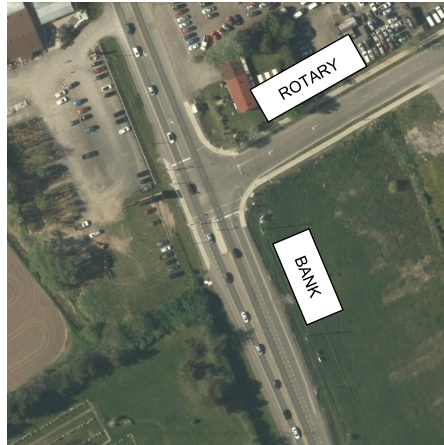
- **Bank Street & Rotary Way** is a 3-legged signalized intersection with auxiliary left-turn lanes on the southbound and westbound approaches, and an auxiliary right-turn lane on the northbound approach. The intersection is located immediately adjacent to the subject site and will be most impacted by the addition of site-generated traffic. The intersection will ultimately be reconfigured as a 4-legged intersection with the planned extension of Barrett Farm Drive.

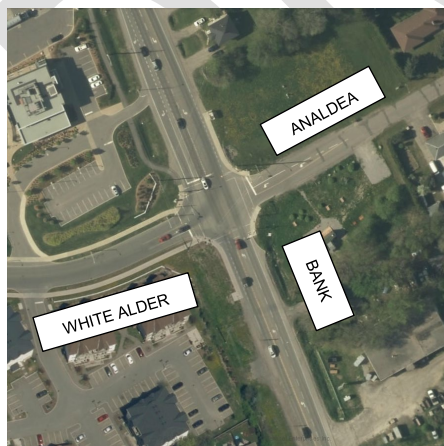
- **Bank Street & Analdea Drive / White Alder Avenue** is a 4-legged signalized intersection with auxiliary left-turn lanes on all approaches and an auxiliary right-turn lane on the southbound approach. The intersection is located approximately 350m south of the proposed development and may only experience a nominal increase in traffic associated with the proposed development.
