Phase II Environmental Site Assessment

200 Baribeau Street
Ottawa, Ontario

July 5, 2019

Report: PE4597-2

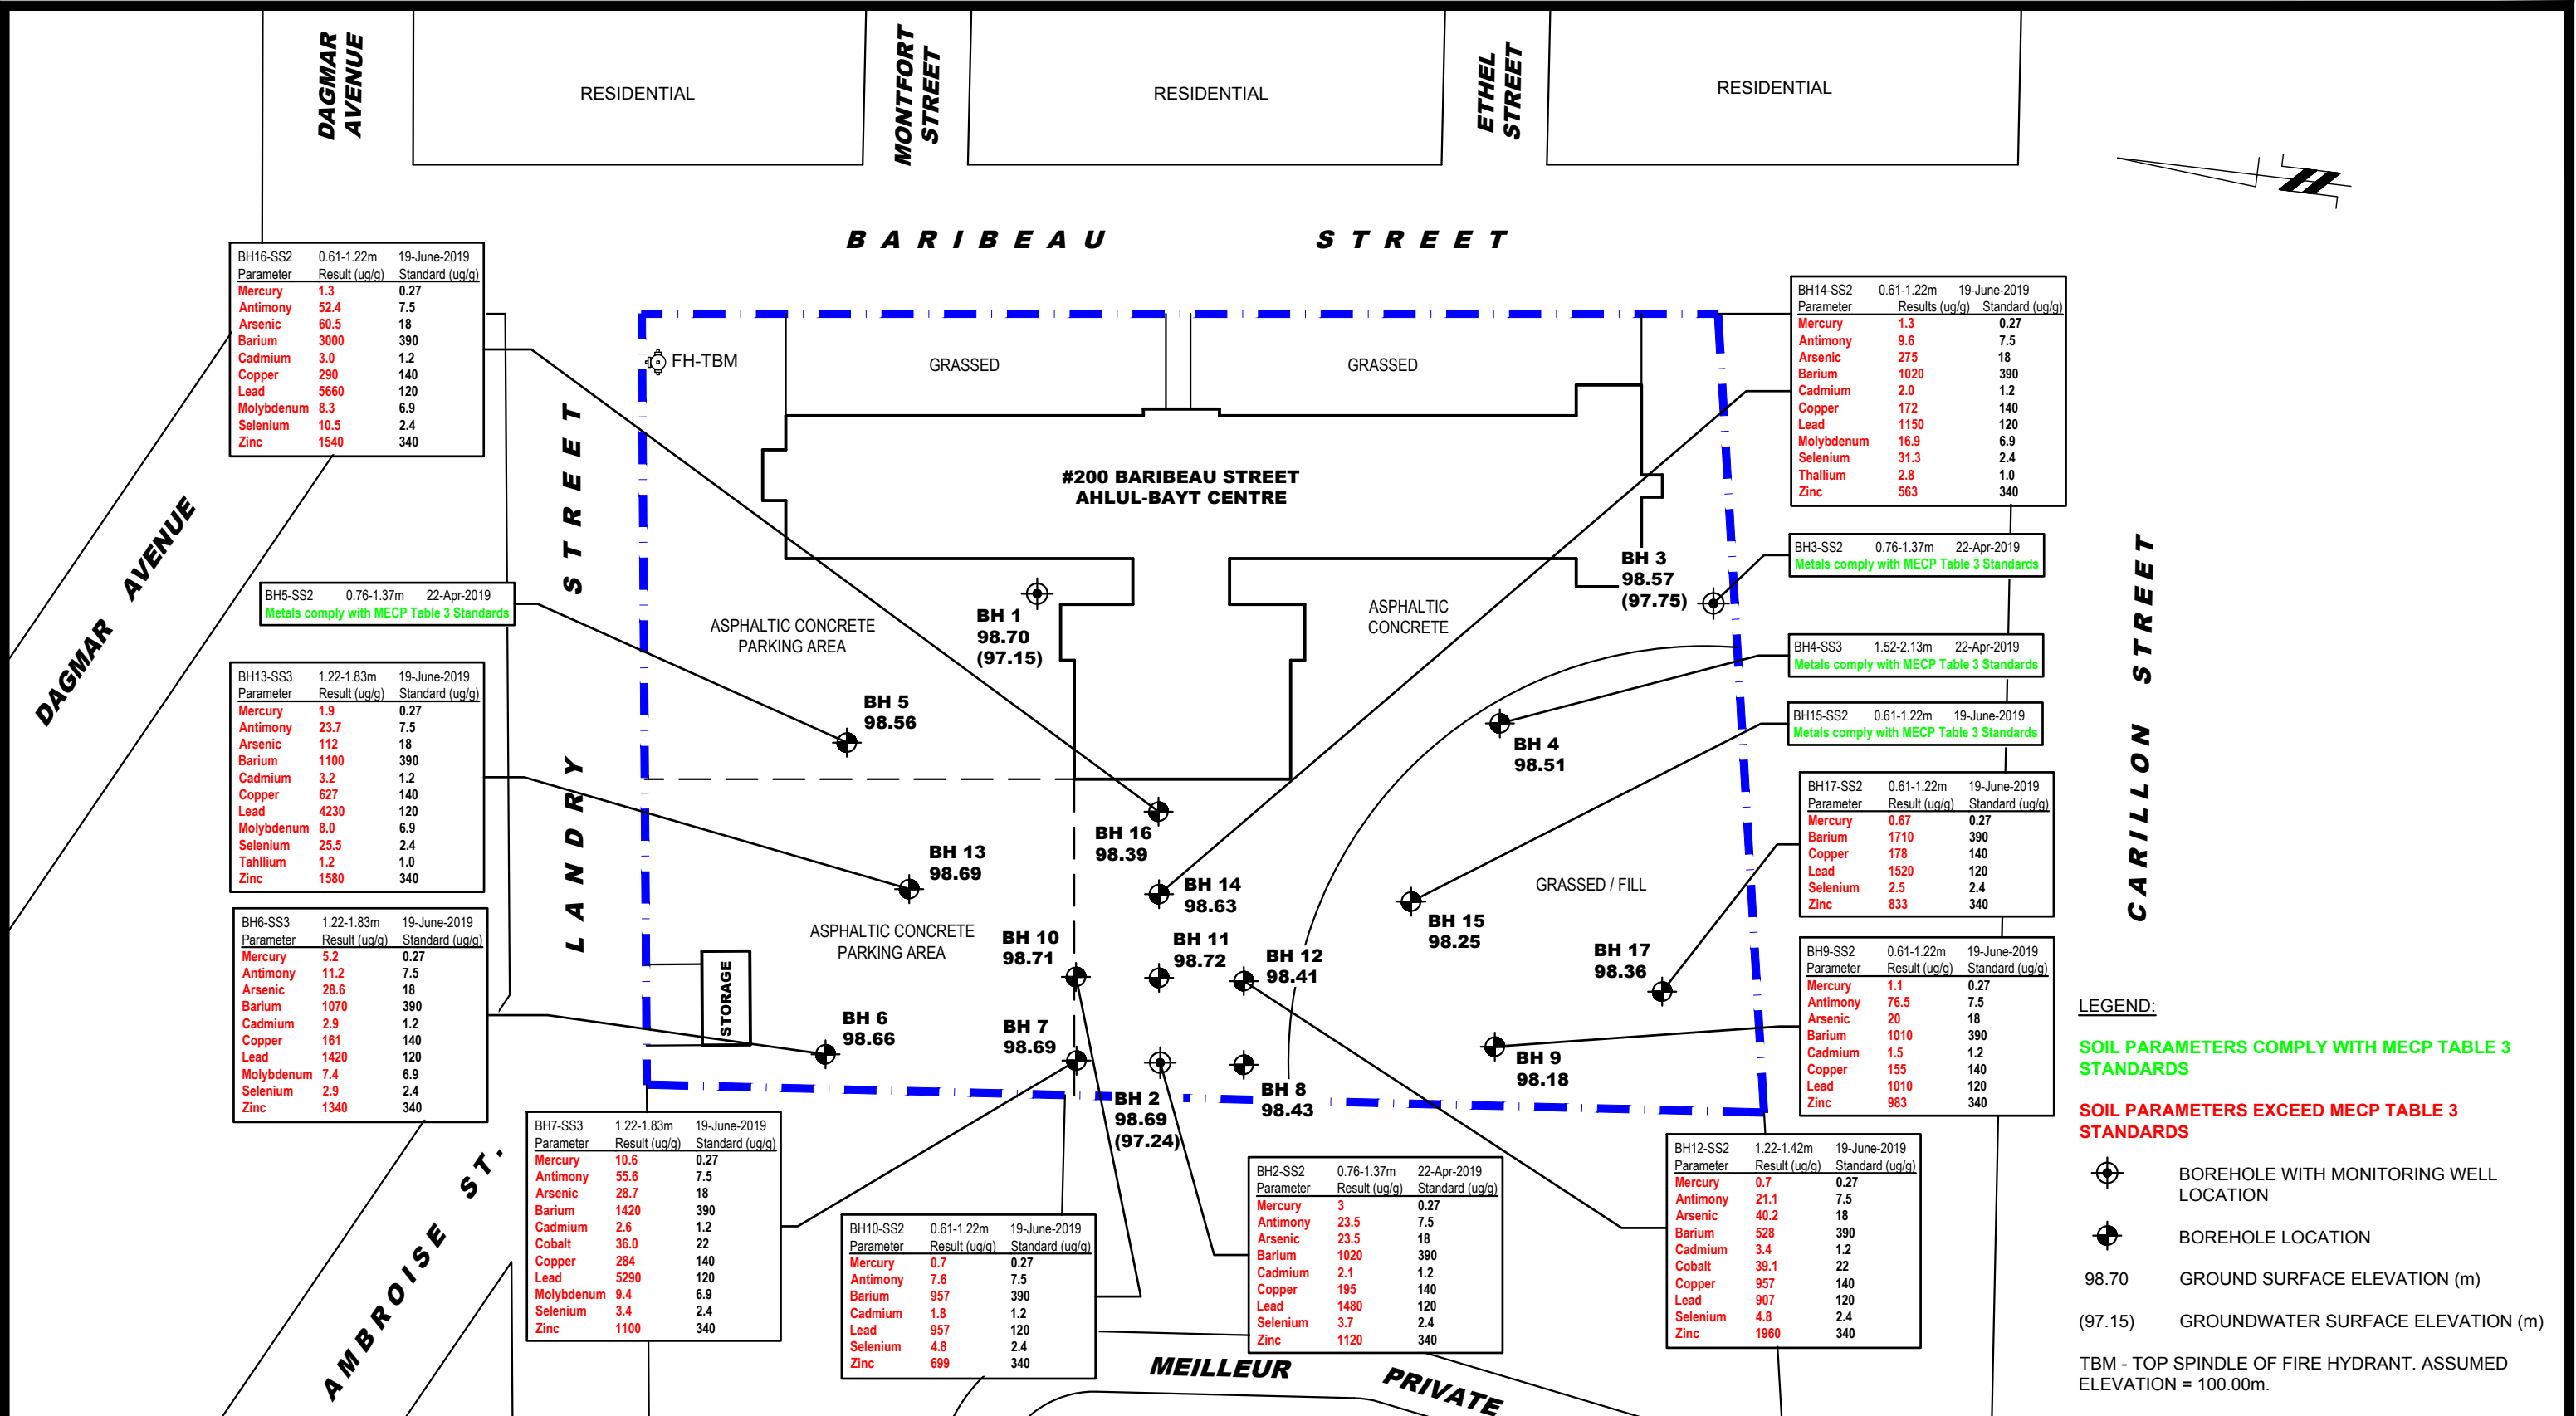
p:\autocad\drawings\environmental\pe4597\pe4597-4b.dwg

BH16-SS2 0.61-1.22m 19-June-2019		
Parameter	Result (ug/g)	Standard (ug/g)
Mercury	1.3	0.27
Antimony	52.4	7.5
Arsenic	60.5	18
Barium	3000	390
Cadmium	3.0	1.2
Copper	290	140
Lead	5660	120
Molybdenum	8.3	6.9
Selenium	10.5	2.4
Zinc	1540	340

BH14-SS2 0.61-1.22m 19-June-2019		
Parameter	Results (ug/g)	Standard (ug/g)
Mercury	1.3	0.27
Antimony	9.6	7.5
Arsenic	275	18
Barium	1020	390
Cadmium	2.0	1.2
Copper	172	140
Lead	1150	120
Molybdenum	16.9	6.9
Selenium	31.3	2.4
Thallium	2.8	1.0
Zinc	563	340

Based on the findings of the Phase II ESA, fill impacted with Metals and PAHs is present on the western portion of the Phase II Property at concentrations which exceed the MECP Table 3 standards. It is our understanding that the subject site is to be redeveloped with multiple residential townhomes. It is our recommendation that an environmental site remediation program, involving the removal of all contaminated soil, be completed concurrently with the site redevelopment.

Prior to off-site disposal at a registered landfill site, a representative sample of the impacted soil will require a leachate analysis, in accordance with Ontario Regulation 558, to confirm the material is non-hazardous. It is also recommended that a member of this firm be present at the time of the removal of the impacted soil in order to provide direction and to obtain confirmatory soil samples upon the completion of the remediation program.

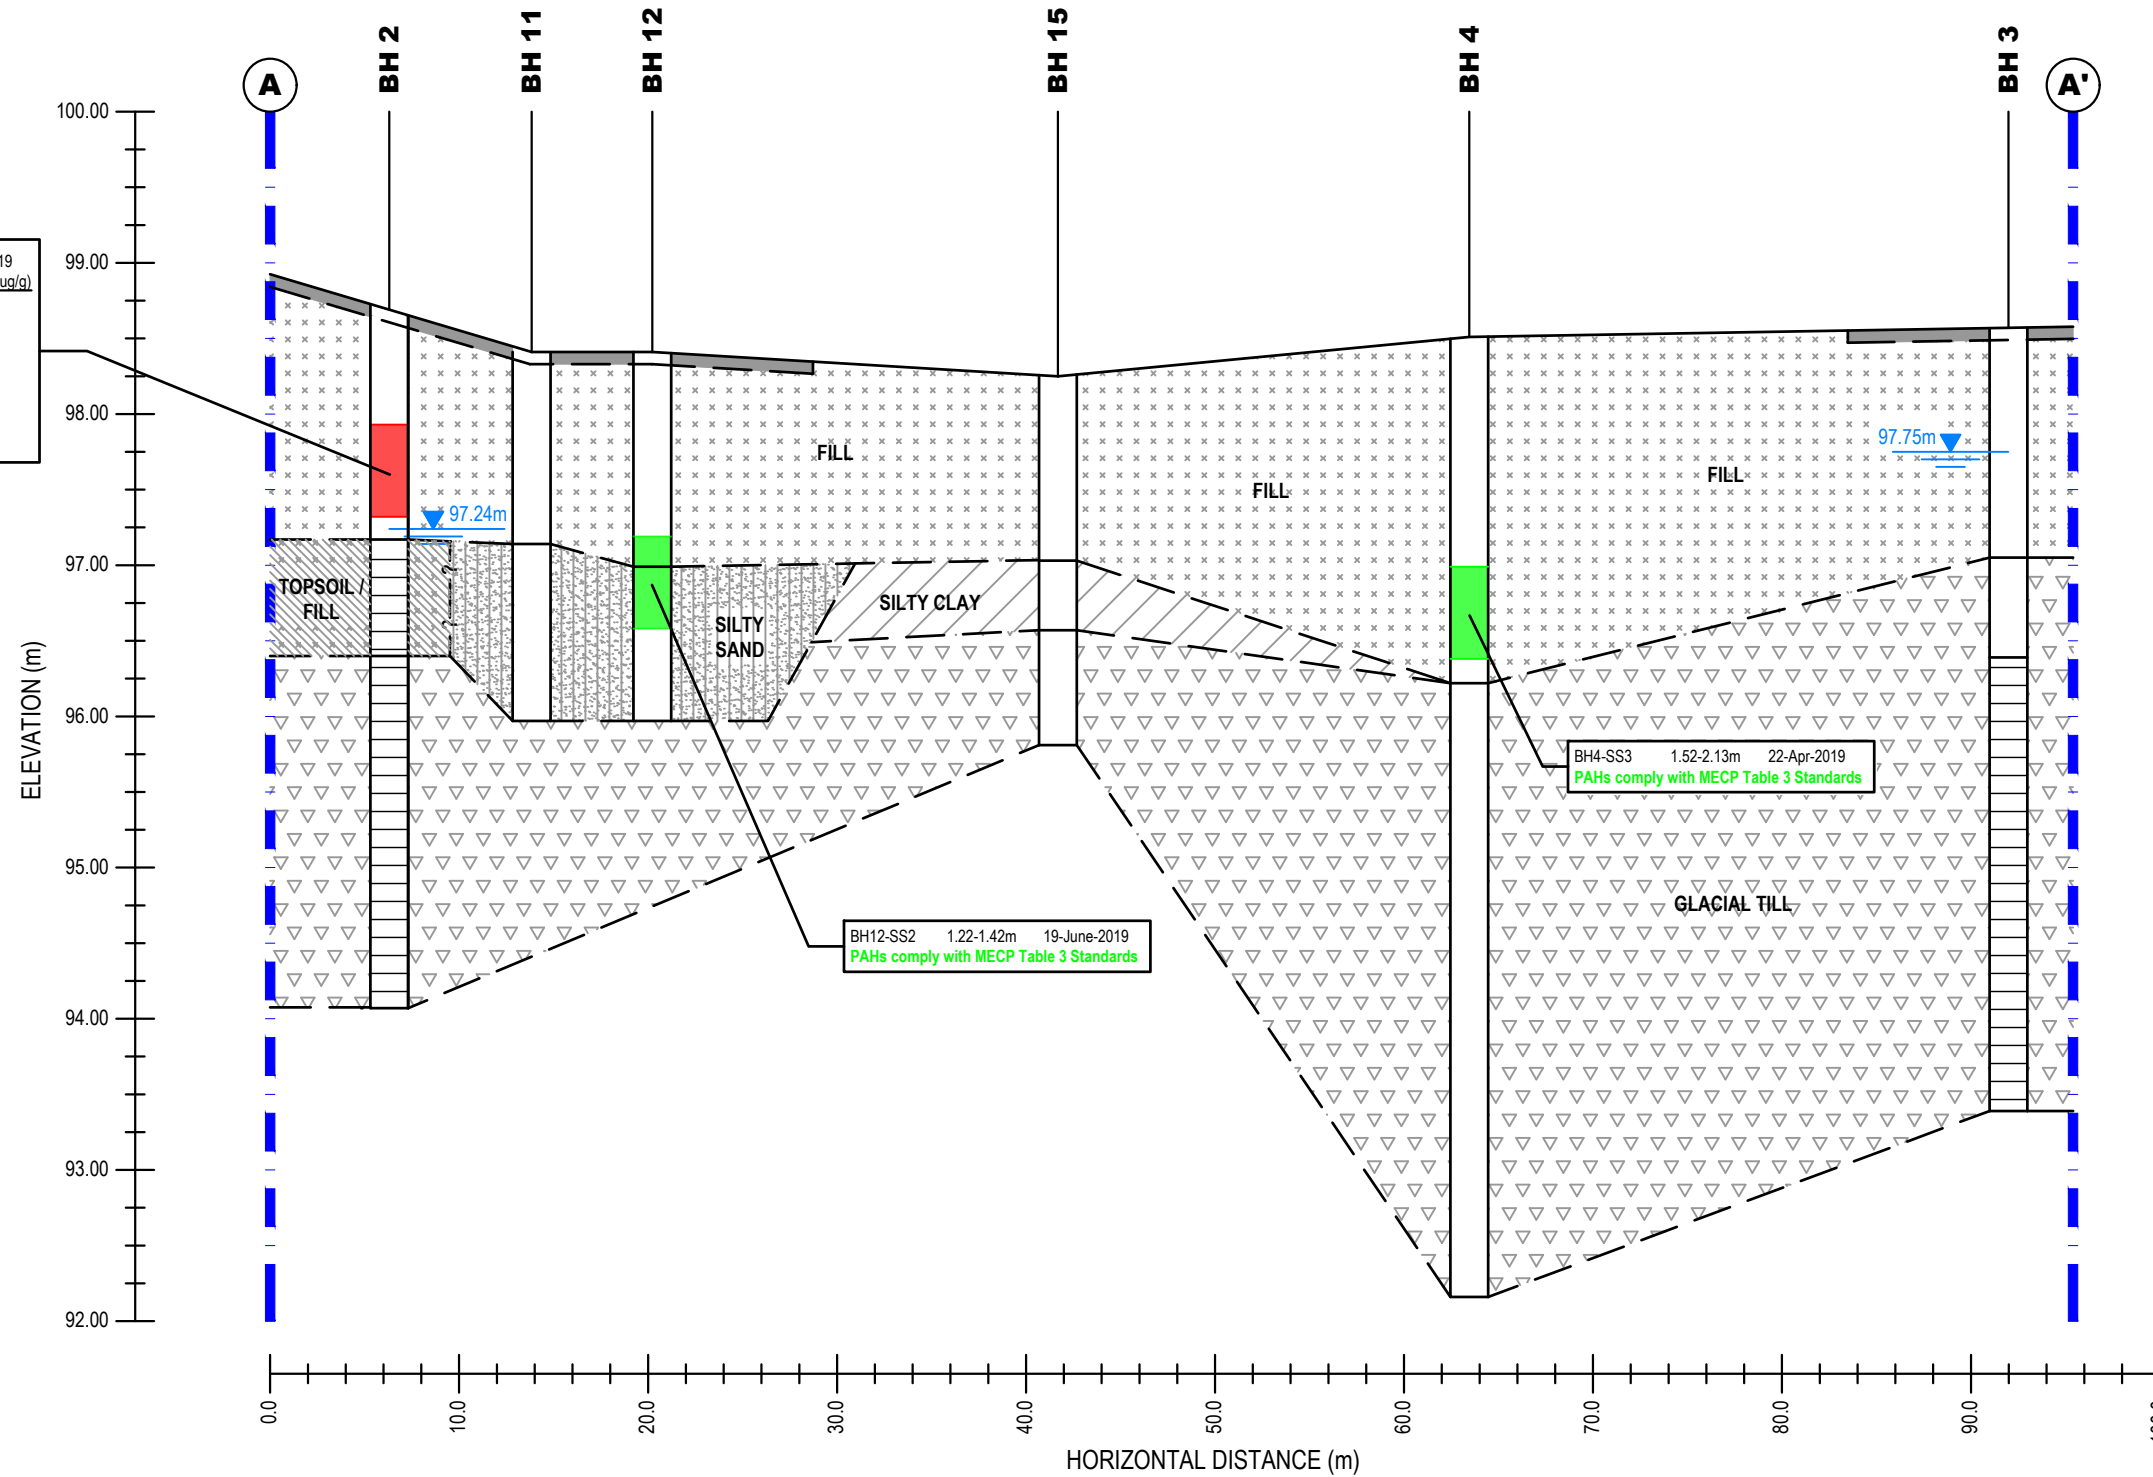
Date: 06/2019
Report No.: PE4597-2
PE4597-6B
Revision No.:

Parameter	Result (ug/g)	Standard (ug/g)
Acenaphthylene	0.36	0.15
Benzo[a]anthracene	2.56	0.5
Benzo[a]pyrene	1.96	0.3
Benzo[b]fluoranthene	2.67	0.78
Benzo[k]fluoranthene	1.53	0.78
Dibenzo[a,h]anthracene	0.30	0.1
Flouranthene	4.97	0.69
Indeno[1,2,3-cd]pyrene	1.02	0.38

SOIL PARAMETERS COMPLY WITH MECP TABLE 3 STANDARDS

SOIL PARAMETERS EXCEED MECP TABLE 3 STANDARDS
