**Project:**  
**200 BARIBEAU STREET RESIDENTIAL DEVELOPMENT**

**Drawing:**  
**TREE CONSERVATION REPORT**

Scale: 1:300	Date: 28 FEB, 2020
Design By: PG	Drawn By: PG
Project Number: 2053-01	Sheet Number: TCR 01

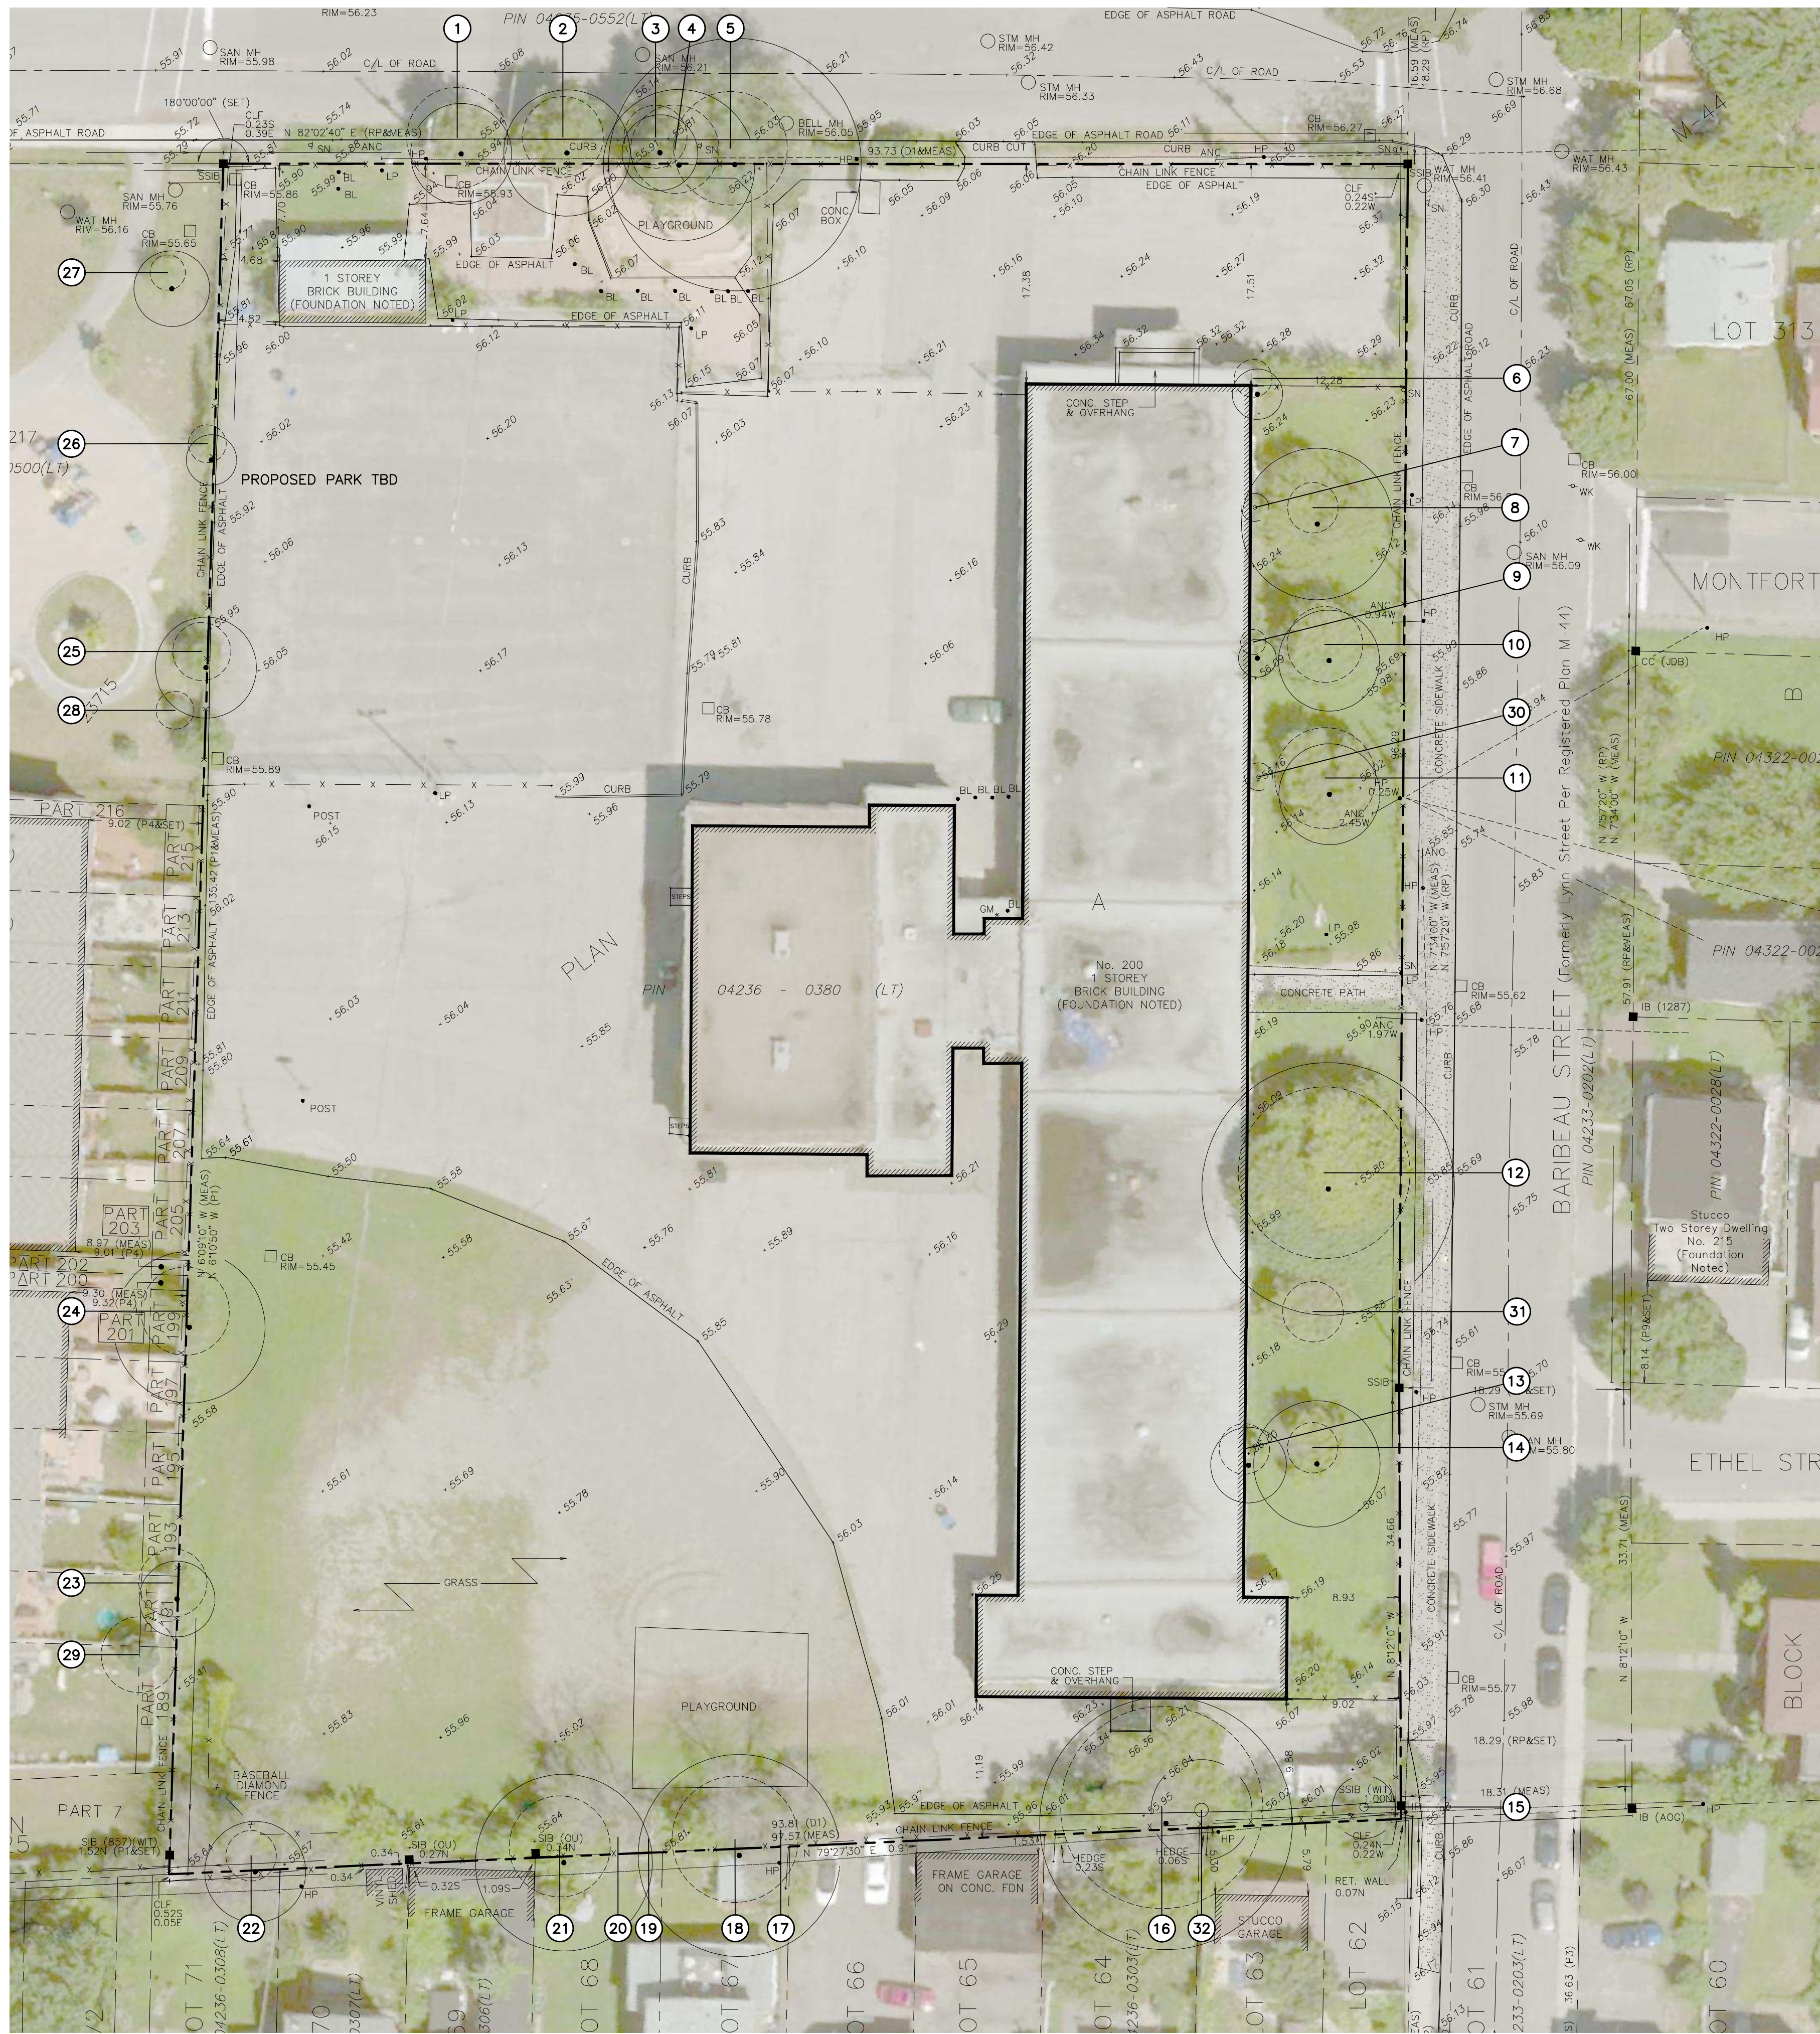
Tree #	Botanical Name	Common Name	Caliper (cm)	Condition	High Quality Tree	Rare Tree	Comments	Disposition
1	Tilia cordata	Littleleaf Linden	40	Moderate	No	No	City owned, Symmetrical canopy, Pruned @ OH Utilities, Single stem, Co-dominant leaders: 2 @ ~2m above grade, Included bark, Suckering @ base	Remove
2	Tilia cordata	Littleleaf Linden	32	Good	No	No	City owned, Symmetrical canopy, Co-dominant leaders: 2 @ ~2m above grade, Included bark	Remove
3	Tilia cordata	Littleleaf Linden	24	Moderate	No	No	City owned, Asymmetrical canopy, Die back ~10% @ branches, Single stem, Included bark	Remove
4	Ulmus pumila	Siberian Elm	35	Moderate	No	No	Privately owned, Asymmetrical canopy, Pruned @ OH Utilities, Poor branch angle, Single stem, Co-dominant leaders: 2 @ ~2.5m above grade	Remove
5	Ulmus pumila	Siberian Elm	45	Moderate	No	No	Privately owned, Asymmetrical canopy, Broken limbs, Pruned @ OH Utilities, Single stem, Co-dominant leaders: 3 @ ~2m above grade, Bark rot @ limbs	Remove

6	Thuja nigra	Black Cedar	15, 17	Good	No	No	Privately owned, Asymmetrical canopy, Multi stem: 2	Remove
7				Dead				Remove
8	Acer ginnala	Amur Maple	23, 25, 20	Moderate	No	No	Privately owned, Asymmetrical canopy, Pruned leader branches, Multi stem: 3, Heart rot @ trunk, Broken leader	Remove
9	Thuja nigra	Black Cedar	15	Poor	No	No	Privately owned, Die back ~40% @ canopy, Single stem, Co-dominant leaders: 3 @ ~0.5m above grade, Bark damage	Remove
10	Acer saccharum	Sugar Maple	32	Good	No	No	Privately owned, Symmetrical canopy, Broken limbs, Single stem, Bark rot @ crotches, Included bark	Remove
11	Acer ginnala	Amur Maple	18, 24, 15, 12	Moderate	No	No	Privately owned, Symmetrical canopy, Pruned leader, Multi stem: 4, Bark rot @ limbs, Existing feature: Bird house	Remove
12	Acer rubrum	Red Maple	68	Moderate	No	No	Privately owned, Broken limbs, Pruned, Heart & Bark rot @ limbs, large split in limb.	Remove

13	Thuja nigra	Black Cedar	18	Moderate	No	No	Privately owned, Asymmetrical canopy, Single stem, Co-dominant leaders: 2 @ ~1.5m above grade, Leaning	Remove
14	Acer ginnala	Amur Maple	15, 12, 12	Moderate	No	No	Privately owned, Symmetrical canopy, Multi stem: 3	Remove
15			23	Dead				Remove
16	Acer saccharum	Sugar Maple	72	Poor	No	No	Privately owned, Asymmetrical canopy, Pruned @ OH Utilities, Poor branch angle, Single stem, Co-dominant leaders: 2 @ ~2.5m above grade, Bark rot @ trunk & crotches	Remove
17				Missing				
18	Acer negundo	Manitoba Maple	50	Poor	No	No	Privately owned by adjacent homeowner, Pruned @ OH Utilities, Poor branch angle, Multi stem: 5, Bark rot @ trunk, Included bark	Retain
19				Missing				
20				Missing				
21	Acer negundo	Manitoba Maple	40, 20	Moderate	No	No	Privately owned by adjacent homeowner, Asymmetrical canopy, Broken limbs, Poor branch angle, Multi stem: 2, Bark rot @ limbs, Included bark	Retain

22	Rhamnus cathartica	Common Buckthorn	12, 20, 18		No	No	Privately owned by adjacent homeowner, Bush	Retain
23	Populus balsamifera	Balsam Poplar	27, 23	Moderate	No	No	Privately owned, Symmetrical canopy, Single stem, Co-dominant leaders: 2 @ ~1.5m above grade, grown into chain link fence	Retain
24	Populus balsamifera	Balsam Poplar	35	Good	No	No	Privately owned, Symmetrical canopy, Single stem, Included bark	Remove
25	Ulmus pumila	Siberian Elm	23	Moderate	No	No	City owned: Park property, Symmetrical canopy, Pruned @ lower limbs, Single stem, Bark rot @ crotches, Grown into chain link fence	Retain
26	Ulmus pumila	Siberian Elm	>10 (4)	Poor	No	No	City owned: Park property, Symmetrical canopy, Pruned @ main leader, Single stem, Co-dominant leaders: 4 @ ~0.5m above grade, Grown into chain link fence	Retain
27	Gleditsia triacanthos var. inermis	Thornless Honey Locust	14	Good	No	No	City owned: Park property, Symmetrical canopy, Single stem, Co-dominant leaders: 2 @ ~1.5m above grade, Bark rot @ crotches	Retain

28	Picea glauca	White Spruce	12	Good	No	No	City owned: Park property, Symmetrical canopy, Single stem	Retain
29	Acer platanoides	Norway Maple	20	Good	No	No	Privately owned by adjacent homeowner, Symmetrical canopy, Single stem	Retain
30				Dead				Remove
31	Acer Saccharum	Sugar Maple	24	Good	No	No	Privately owned, Symmetrical canopy, Single stem, Bark rot @ limbs, Included bark	Remove
32				Dead				Remove

- THE EXISTING SITE CONTAINS TWO SINGLE-STORY BRICK BUILDINGS, A LARGE ASPHALT-PAVED AREA, AN OPEN GRASS FIELD, AND A SAND-PLAY AREA.
  - APPROXIMATELY 85m<sup>2</sup> IS OCCUPIED BY BUILDING FOOTPRINTS.
  - APPROXIMATELY 5685m<sup>2</sup> IS HARD SURFACES.
- THERE ARE A TOTAL OF THIRTY-TWO TREES INCLUDED IN THE TREE CONSERVATION REPORT, IN VARYING CONDITIONS. TREES ARE LOCATED WITHIN THE SITE BOUNDARY, WITHIN THE CITY RIGHT-OF-WAY, WITHIN AN ADJACENT CITY PARK, AND ON ADJACENT HOMEOWNER PROPERTY.
- THE EXISTING ON-SITE GREENSPACE IS MAINLY COMPRISED OF TURFGRASS.
- THE DEVELOPMENT SITE IS NOT CONSIDERED OF PRIMARY OR SUPPORTING SIGNIFICANCE AS NATURAL LANDS IN THE GREENSPACE MASTER PLAN.

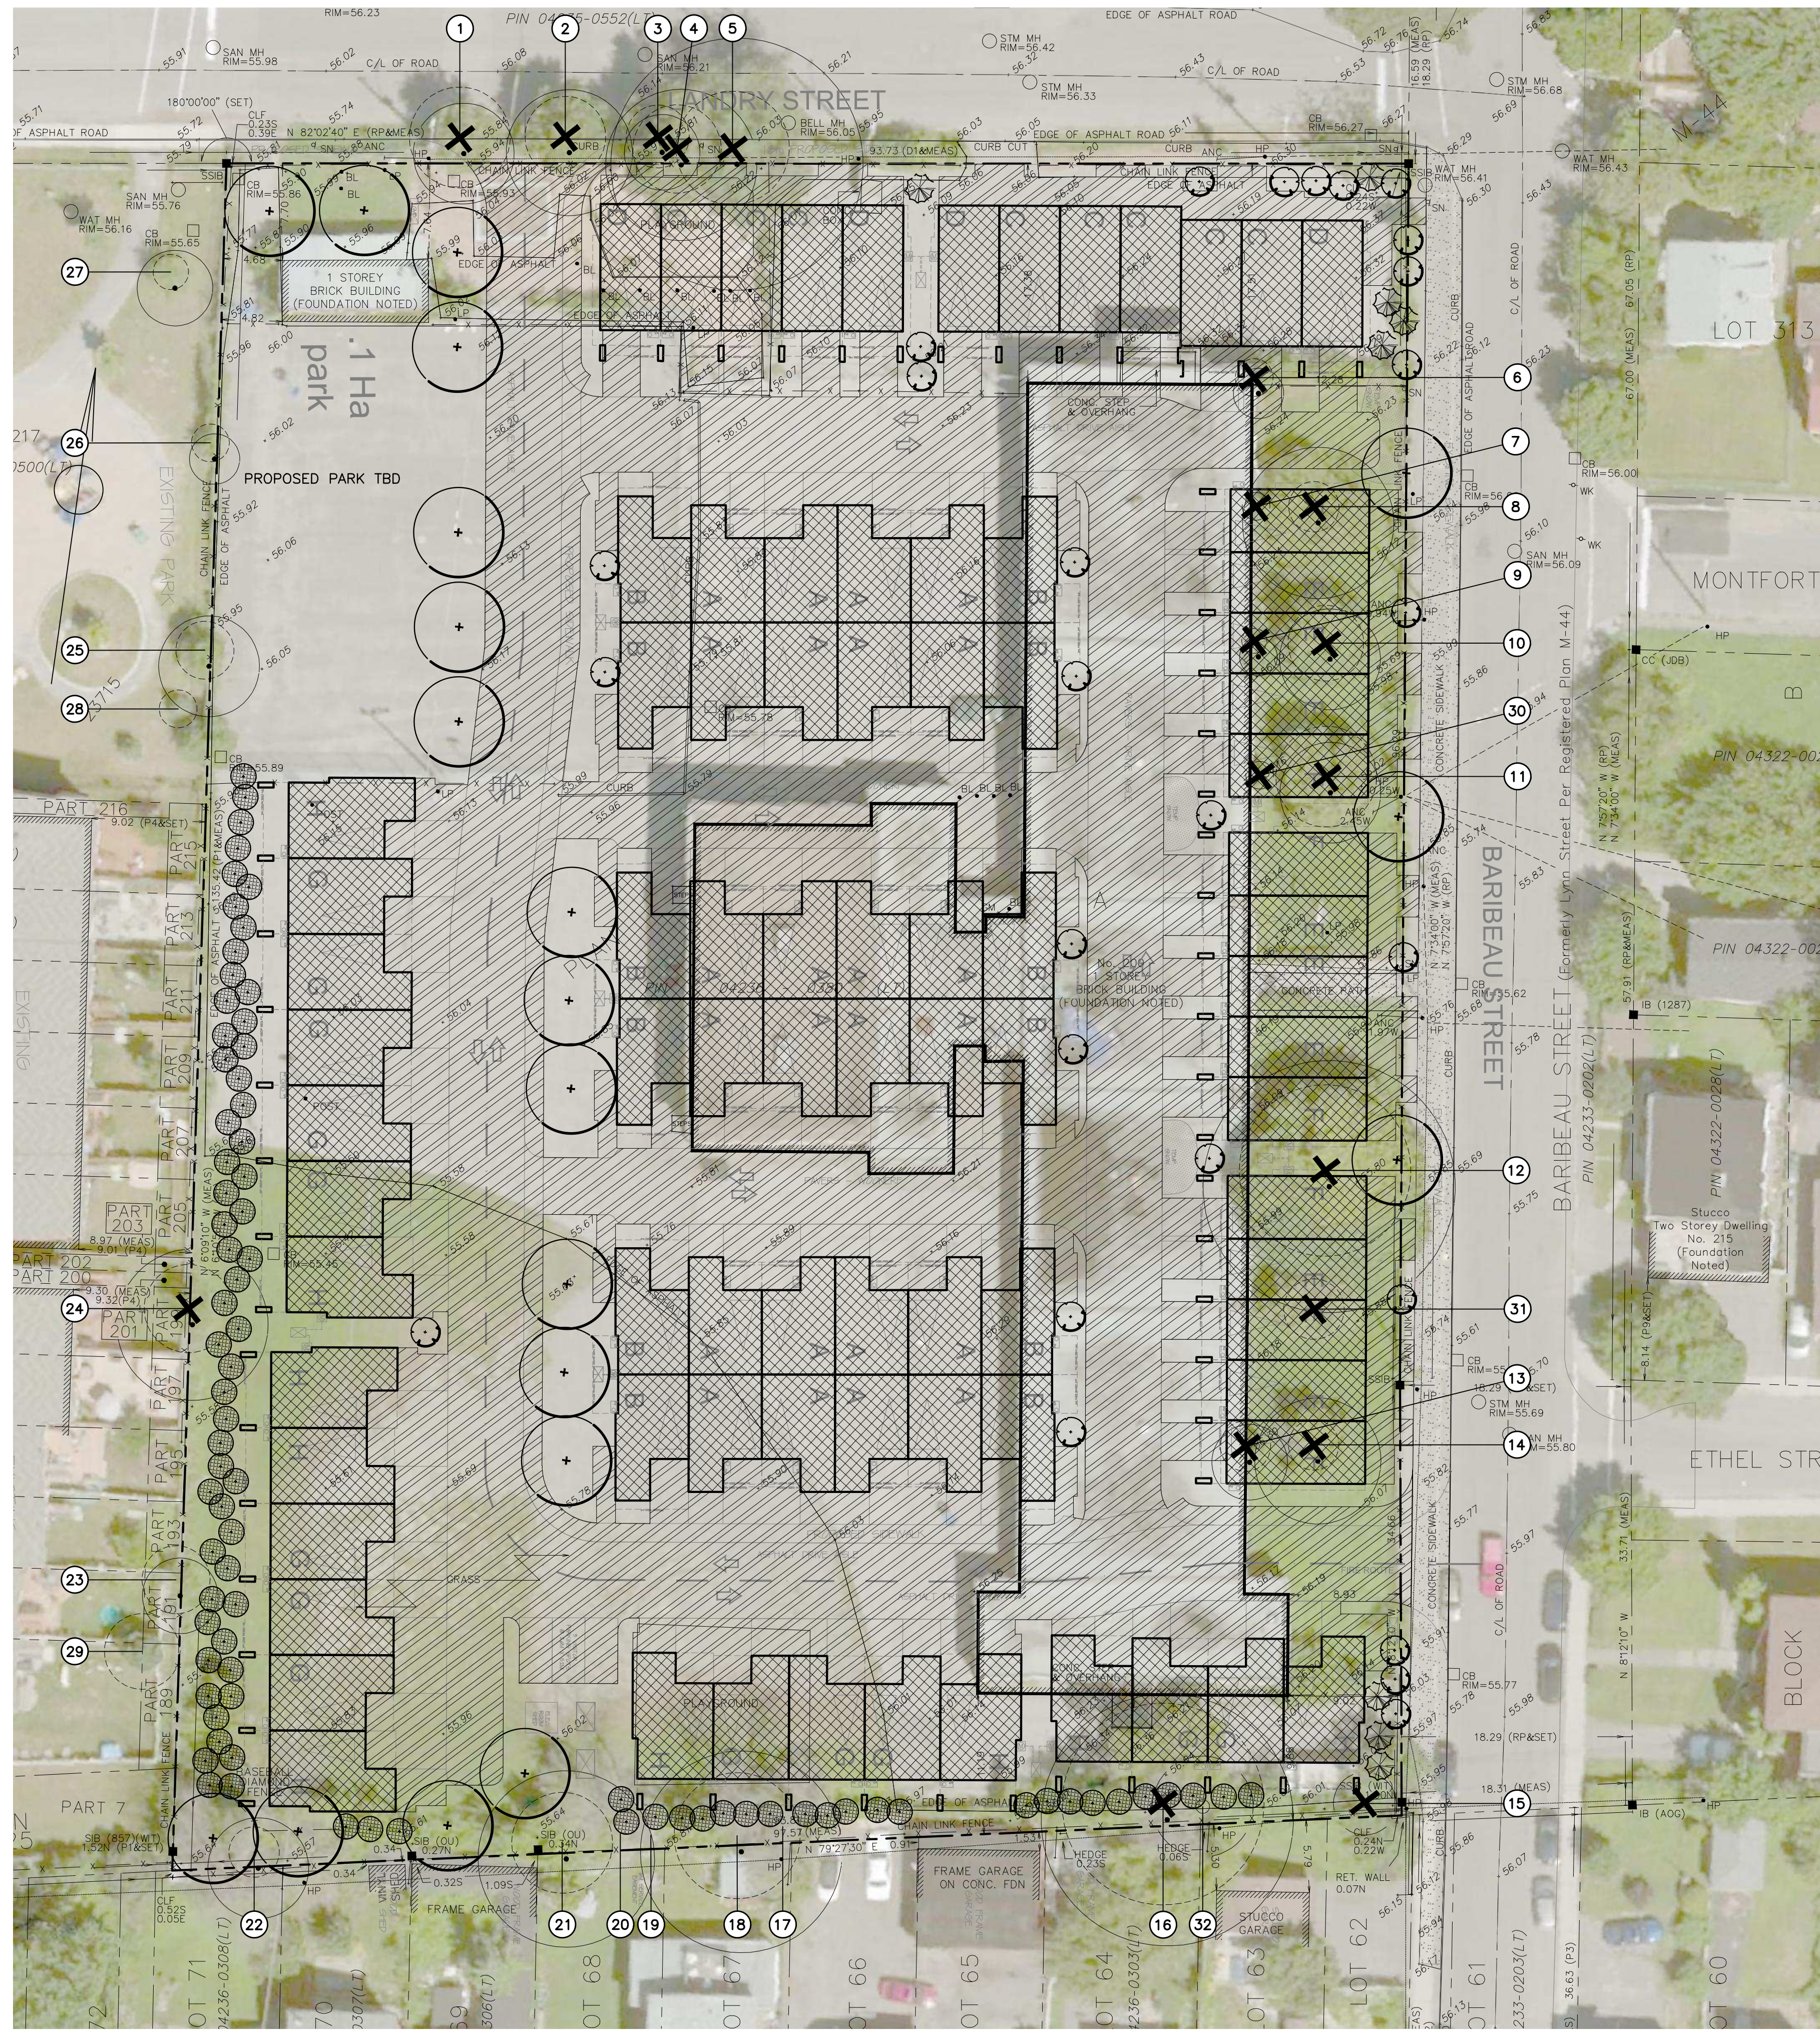
Scale:	1:300	Date:	
Design By:	SMc	Drawn By:	SMc
Project Number:	2053-01	Sheet Number:	TCR 02

- LEGEND
- CRITICAL ROOT ZONE (CRZ)
  - EXISTING TREE TO REMAIN
  - EXISTING TREE TO BE REMOVED
  - DEAD TREE
  - PROPOSED DECIDUOUS TREES
  - PROPOSED CONIFEROUS TREES
  - PROPOSED BUILDING / STRUCTURE
  - PROPOSED HARD / IMPERMEABLE SURFACE
