**Phase I-Environmental Site Assessment**

200 Baribeau Street  
Ottawa, Ontario

July 2, 2019

Report: PE4597-1

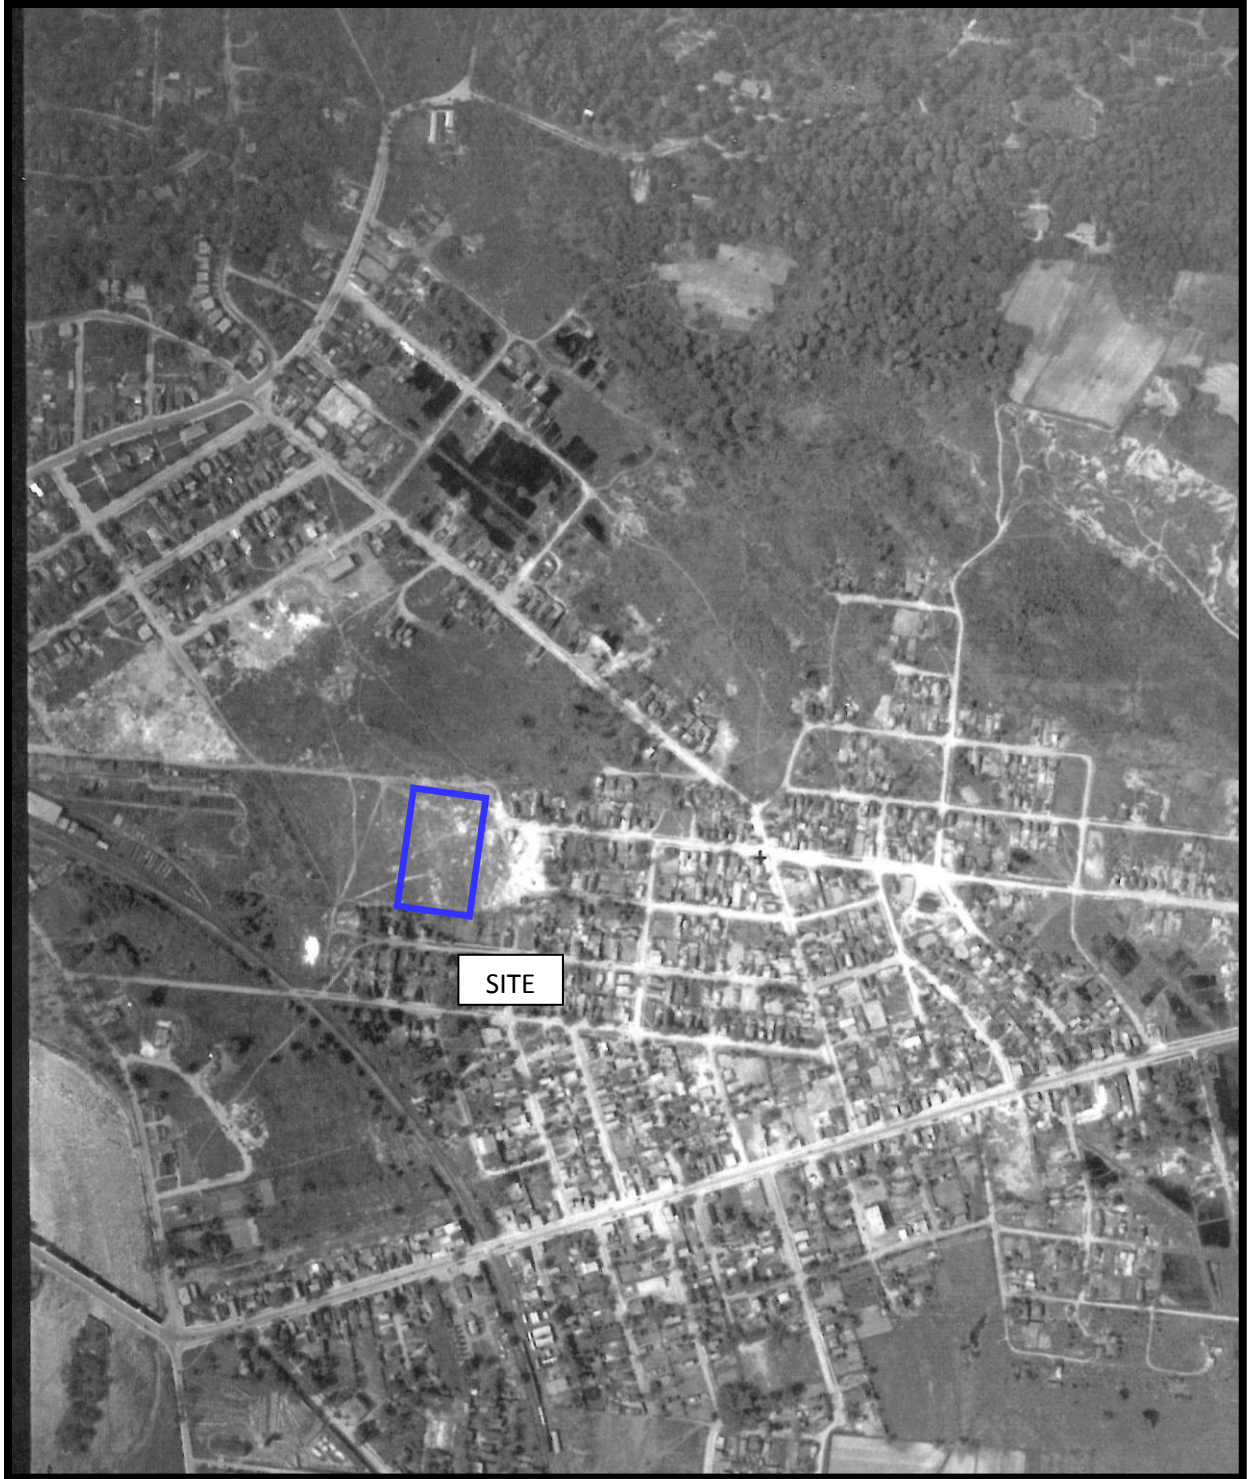
AERIAL PHOTOGRAPH  
1937

| 1937 | The subject site appears have significant fill placement occurring with the low lying areas filled in. The surrounding properties remain unchanged from the previous photograph with the exception of the former steel fabrication yard to the west. The activities appear to be intensifying on the Dominion Bridge Company property. |

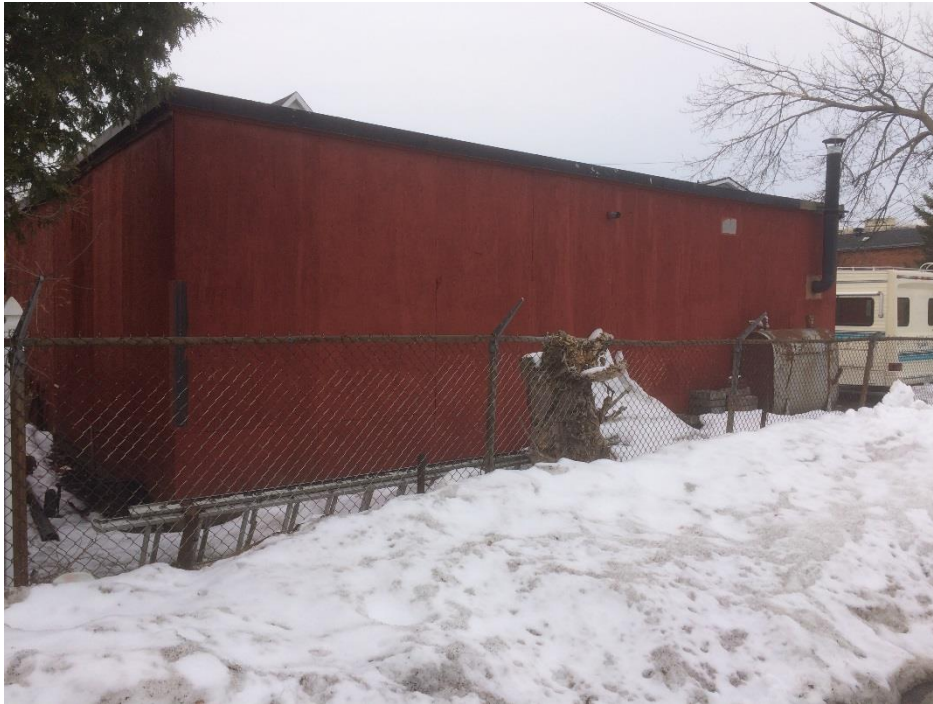
The presence of a private automotive service garage to the south of the subject site is considered to pose a potential environmental concern to the subject site.

Photograph 1: Adjacent private automotive service garage and exterior AST.

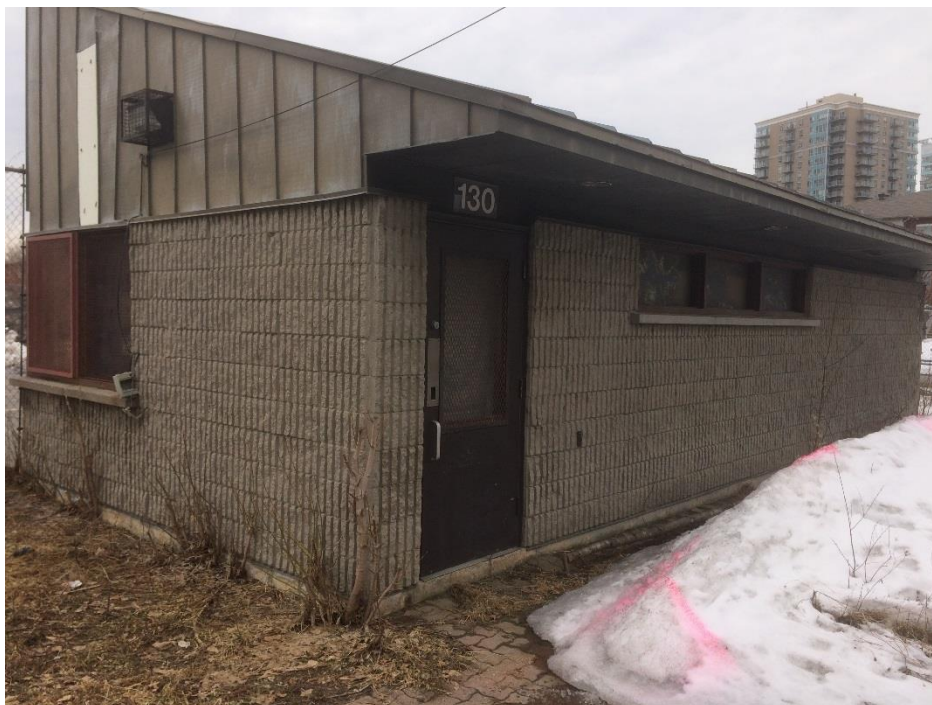
Photograph 4: Storage building near parking area. No access was provided to the interior of this building.
