**TREE
CONSERVATION
REPORT**
349 Danforth

Tree Conservation Report submitted as Partial
Requirements for a Site Plan Control Application,
October 8, 2020

Address: 349 Danforth

Date: October 8, 2020

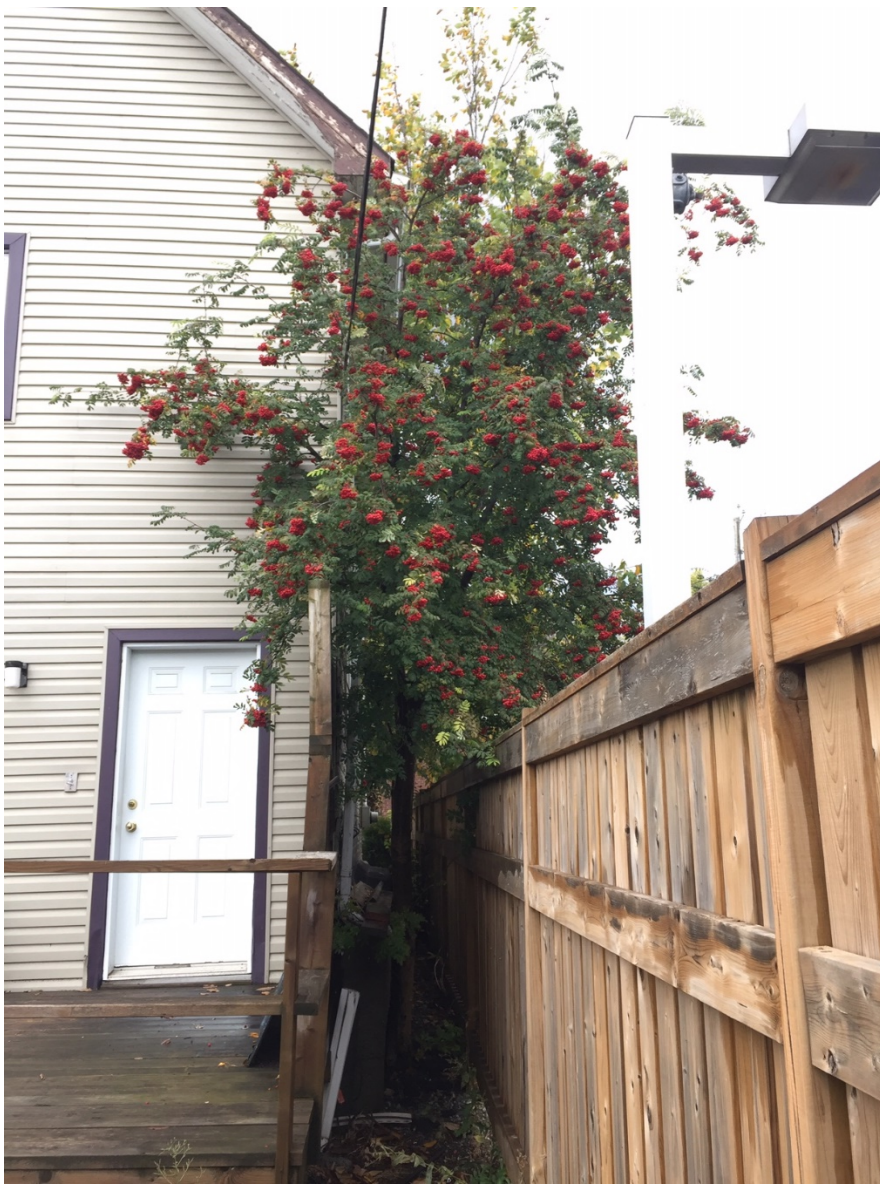
Figure 1: Tree 1 - showy mountain ash to be removed

Tree ¹	Species	Diameter at breast height (dbh)	Ownership ²	Condition	Action
1	Showy mountain-ash (<i>Sorbus decora</i>)	14 cm	Private	Good	Proposed removal to accommodate new building
2	American elm (<i>Ulmus americana</i>)	11 cm	Private	Good	Proposed removal to accommodate new building
3	American elm (<i>Ulmus americana</i>)	10 cm	Private	Fair	Proposed removal to accommodate new building
4	American elm (<i>Ulmus americana</i>)	22 cm	Private, possibly jointly owned with 358 Richmond	Good	Proposed removal to accommodate new building

The proposed development at this site will be a 3-story mixed use building with a footprint that will encompass almost of the extent of the entire lot. The trees that are currently onsite have seeded naturally and are not well placed to accommodate the proposed development and the level of construction activity and excavation that will take place on this site. To accommodate the proposed development, removal of these tree is recommended.

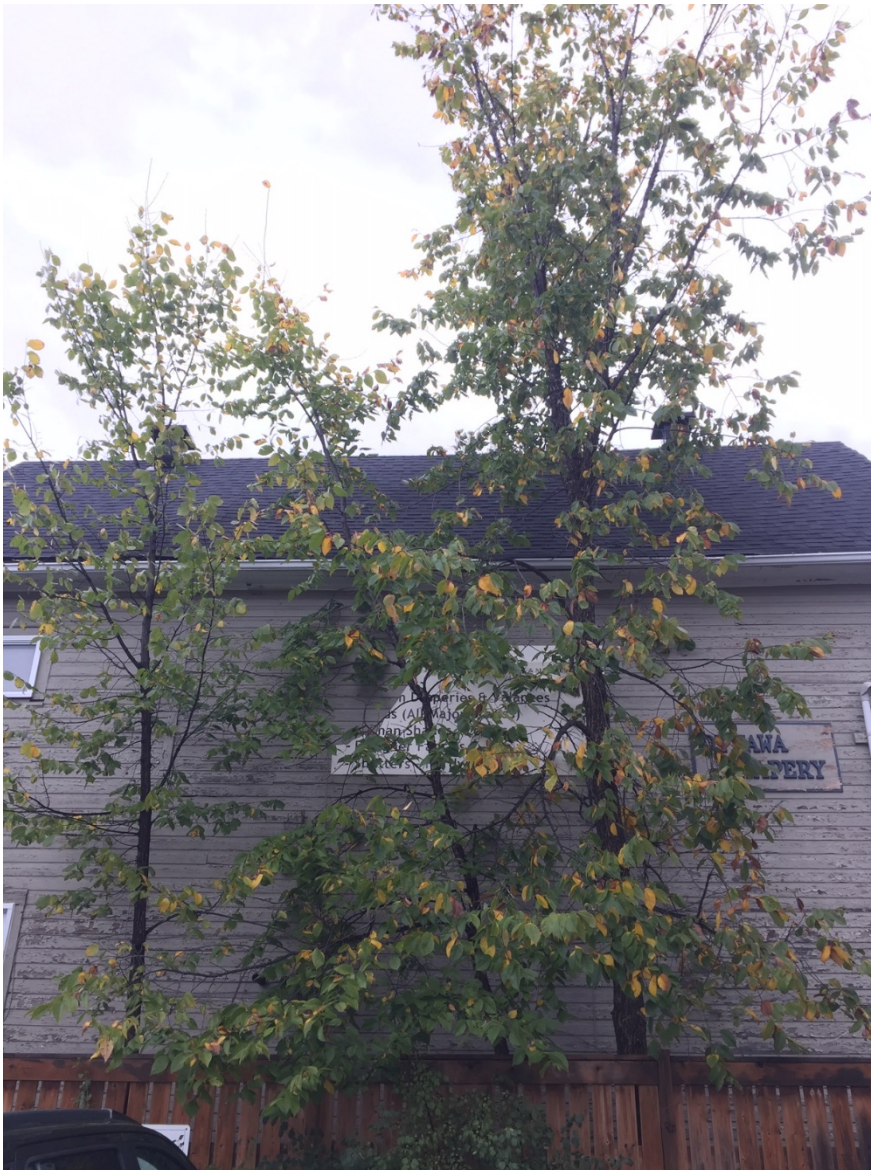
Figure 2: American elms (trees 2-4) growing along the side of the building - to be removed
