349 Danforth Avenue, Ottawa  
Environmental Site Assessment Phase I

Project # E-01-21

March 2021

Arch-NOVA Design Inc. was retained by “RN Development Inc.”, 337 Sunnyside Ave, Suite 101, Ottawa, ON K1S 0R9, to conduct a Phase I Environmental Site Assessment (ESA) at the property on 349 Danforth Avenue in Ottawa, Ontario.

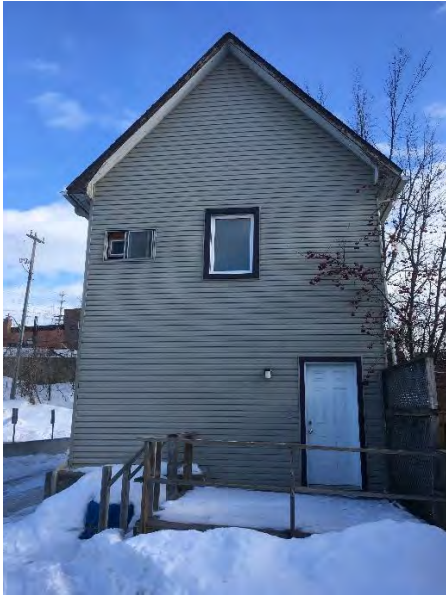
**View from rear**

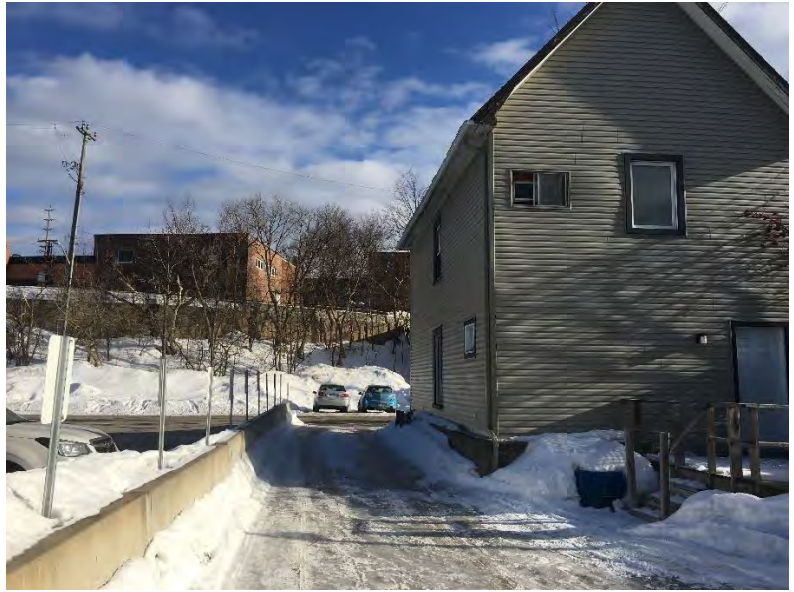
**Driveway(east)**

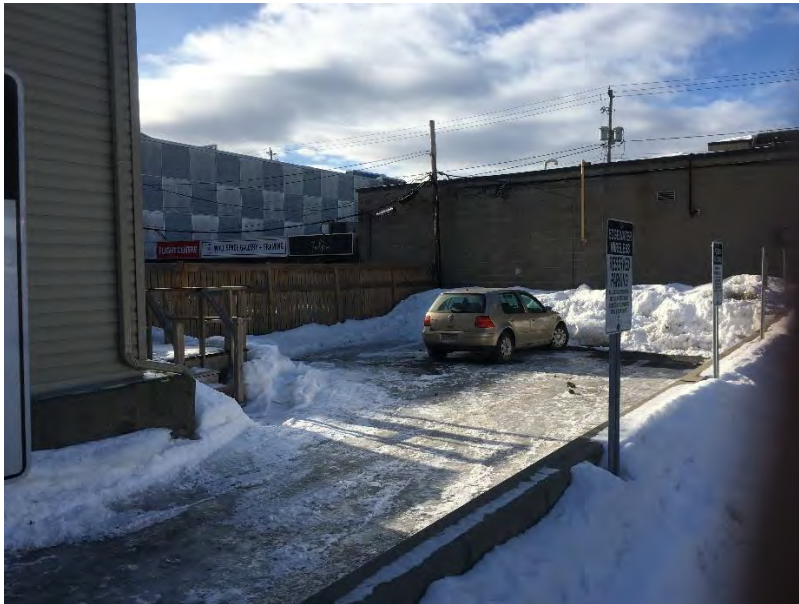
**Parking (north)**

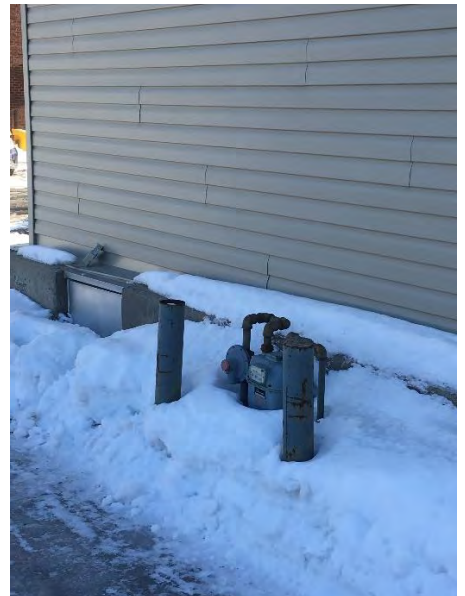
**Gas connection & meter (east)**

The building is connected to the gas services. Currently the house is heated by furnace-forced air heating system. There is no evidence of above ground tanks. In case that the underground tank is found during the construction, an excavation and proper disposal of the tank must be planned and report provided in accordance to current regulation. Soil inspection and subsequently the soil remediation must be performed and recorded.

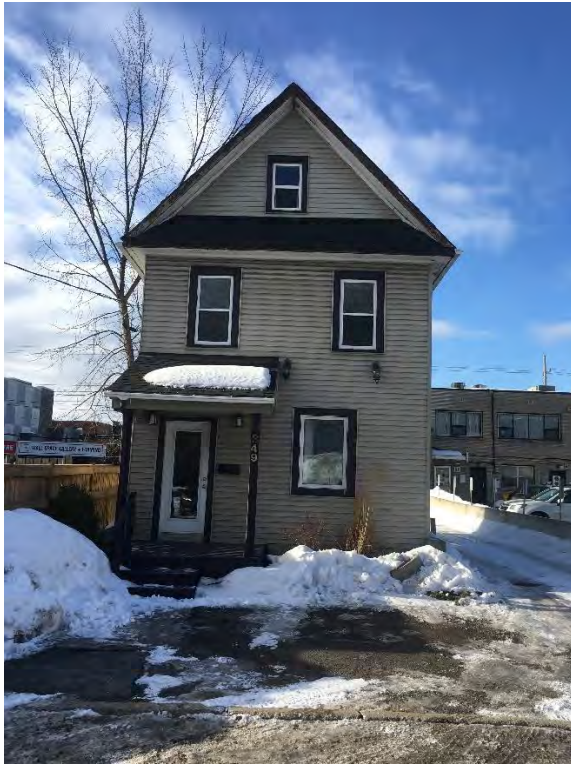
**Front view (south)**

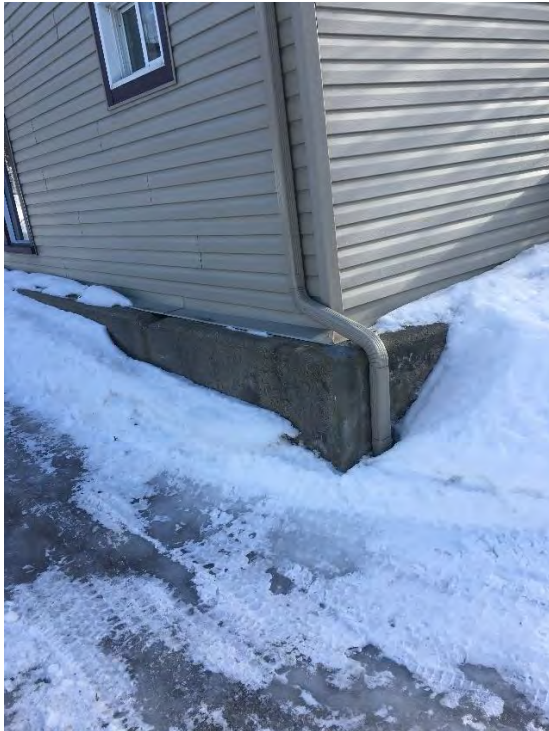
**Roof drainage (east)**

2. Surface water flow paths do not suggest that any contamination is transferred from one to another property. Most of drainage is directed toward the drainage along Danforth Avenue. Minimum infiltration is anticipated as all surfaces are either asphalt, gravel and shingle roofs

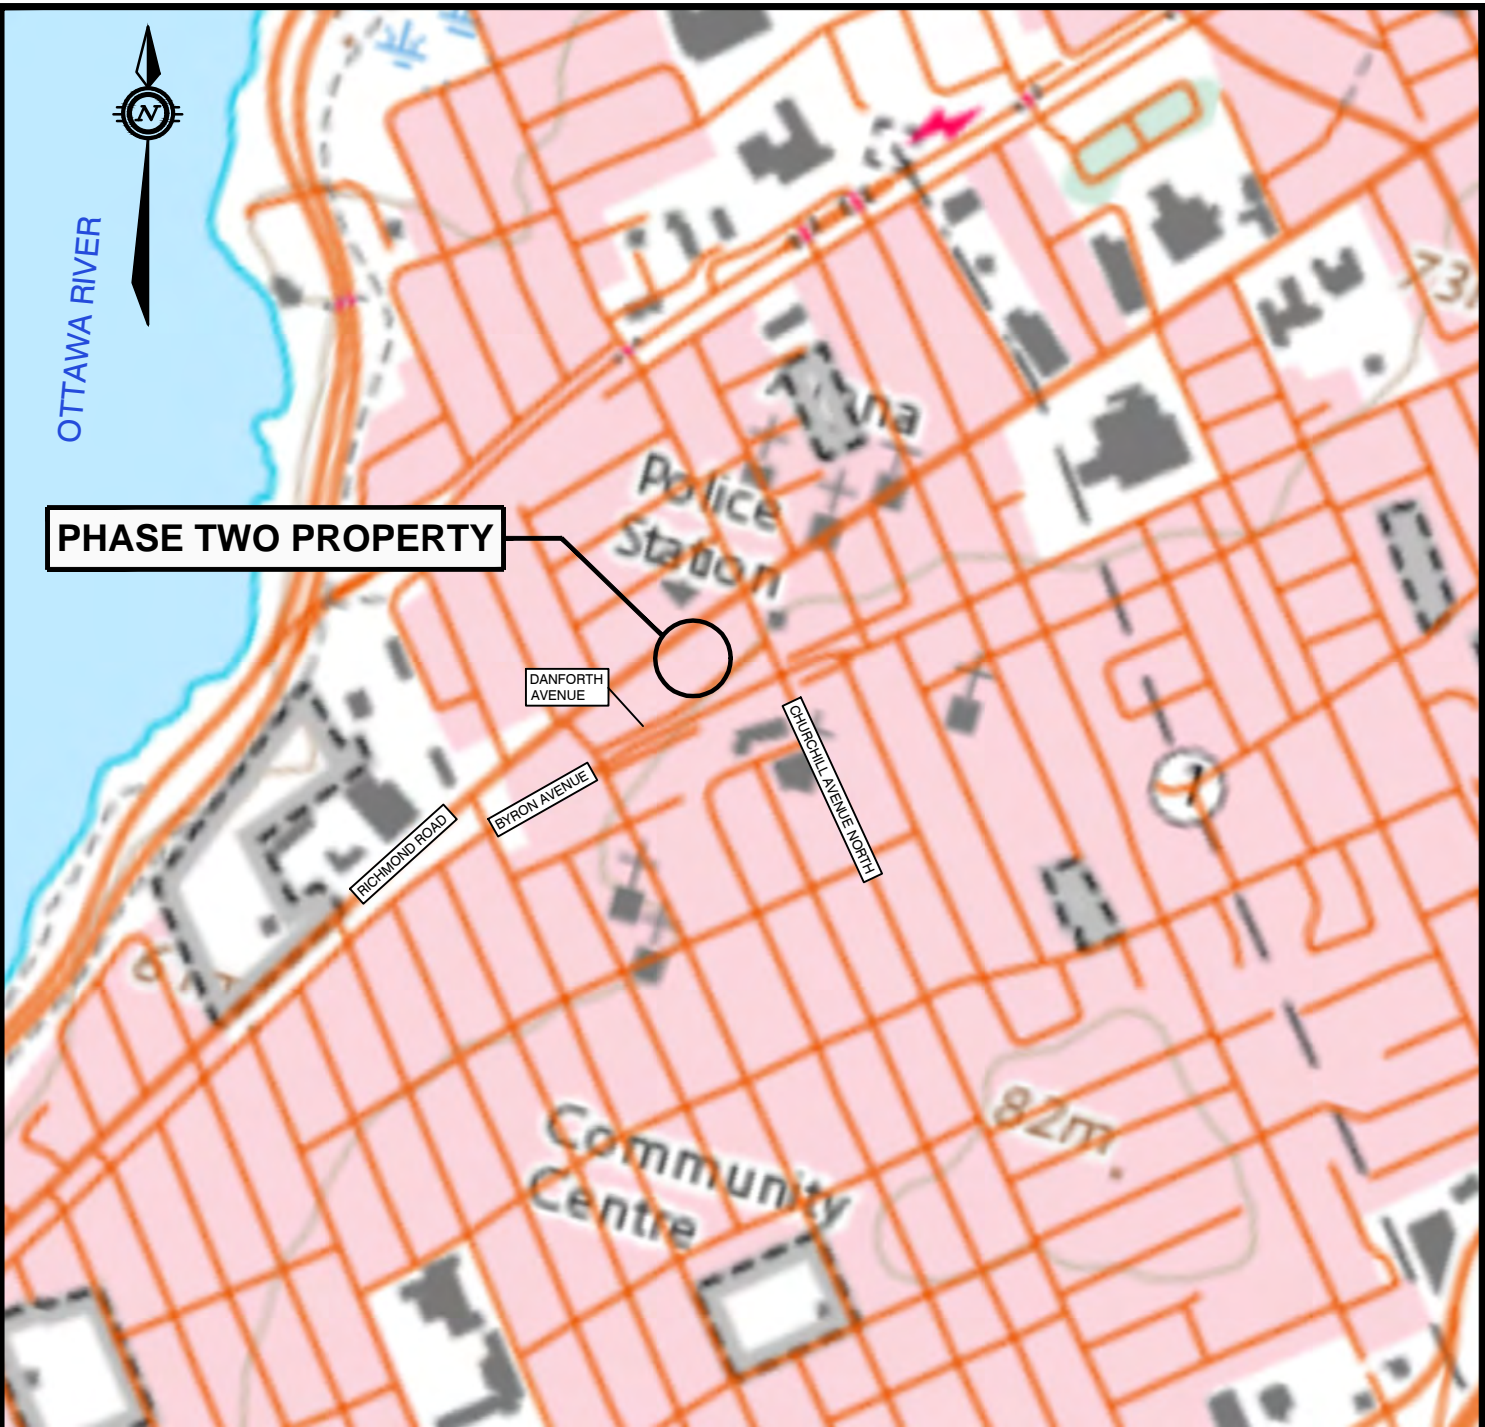
DATE JULY 2020		CLIENT: <b>OTTAWA CARLETON CONSTRUCTION GROUP LTD.</b>	project no. OTT-00259161-A0
DESIGN O.V.	CHECKED P.S.		scale 1:10,000
DRAWN BY M.P.		TITLE: <b>SITE LOCATION PLAN</b> 349 DANFORTH AVENUE, OTTAWA, ON	<b>FIG 1</b>

A geotechnical investigation was undertaken at the site of the proposed three (3) storey with basement commercial/residential building at 349 Danforth Avenue, City of Ottawa, Ontario (Figure 1). Terms and conditions of the assignment were outlined in EXP's Proposal dated March 12, 2020.

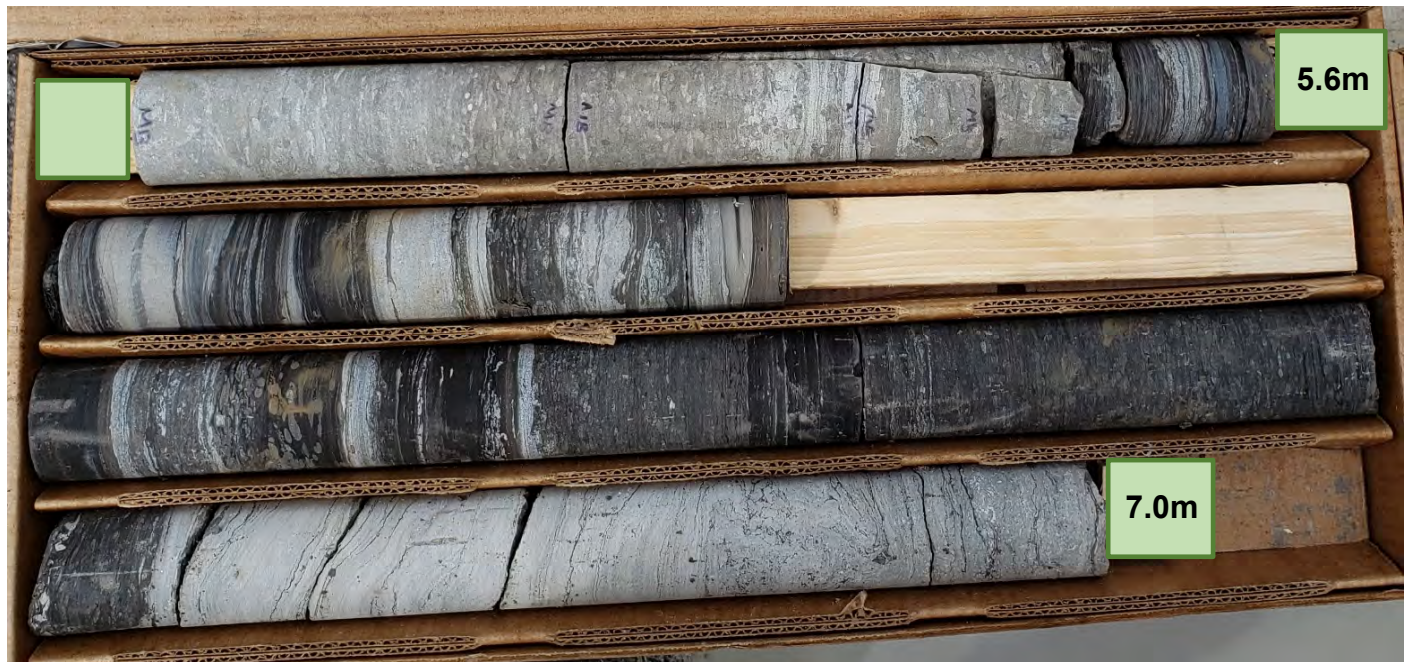
borehole no. <b>MW3</b>	core runs Run 1: 0.8m-1.1m Run 2: 1.1m-2.6m Run 3: 2.6m-4.2m Run 4: 4.2m-5.6m	PROJECT PIIESA and Geotechnical Investigation 349 Danforth Avenue, Ottawa, Ontario	project no. OTT-00259161-A0
date cored Jun 30, 2020		ROCK CORE PHOTOGRAPHS	FIG. 8A

**Geologic strata:** *“The investigation has revealed that the subsurface conditions comprise of very loose to loose fill underlain by bedrock encountered at depths ranging from 0.6 m and 0.8 m below ground surface. Wash boring and core drilling used to advance all boreholes into bedrock to depths ranging from 9.5 m to 10.2 m below ground surface”<sup>9</sup>.*
