Phase One Environmental Site Assessment 349 Danforth Avenue

Ottawa, Ontario

April 8, 2022

Project: 100602.003

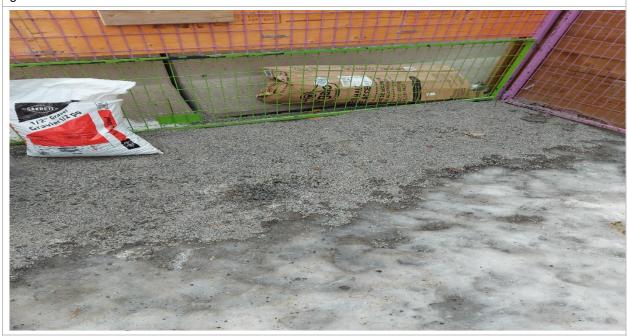
Photograph Plate I1: Ground cover was gravel with fines (fill material). Snow cover limited visibility of the ground cover.

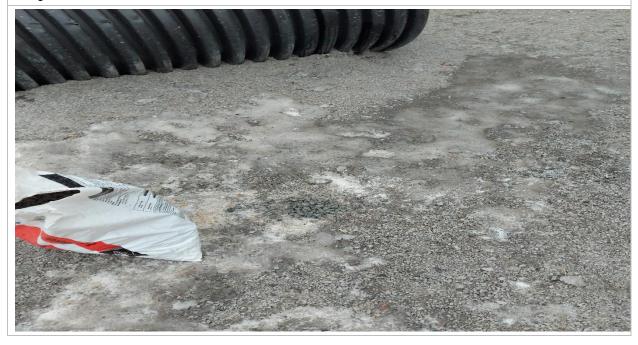
Photograph Plate I2: Ground cover was gravel with fines (fill material). Snow cover limited visibility of the ground cover.

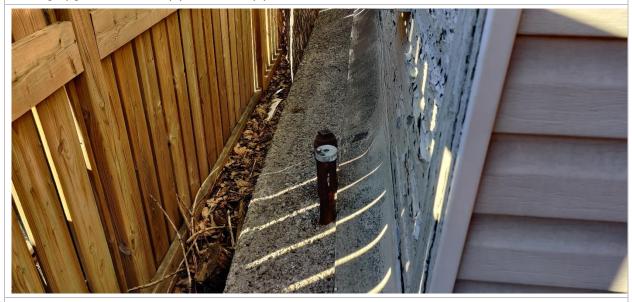
Photograpgh Plate I3: Fill pipe and vent pipes.
