Phase I - Environmental Site Assessment

1619 Carling Avenue Ottawa, Ontario

Surface Developments

Report: PE4987-2

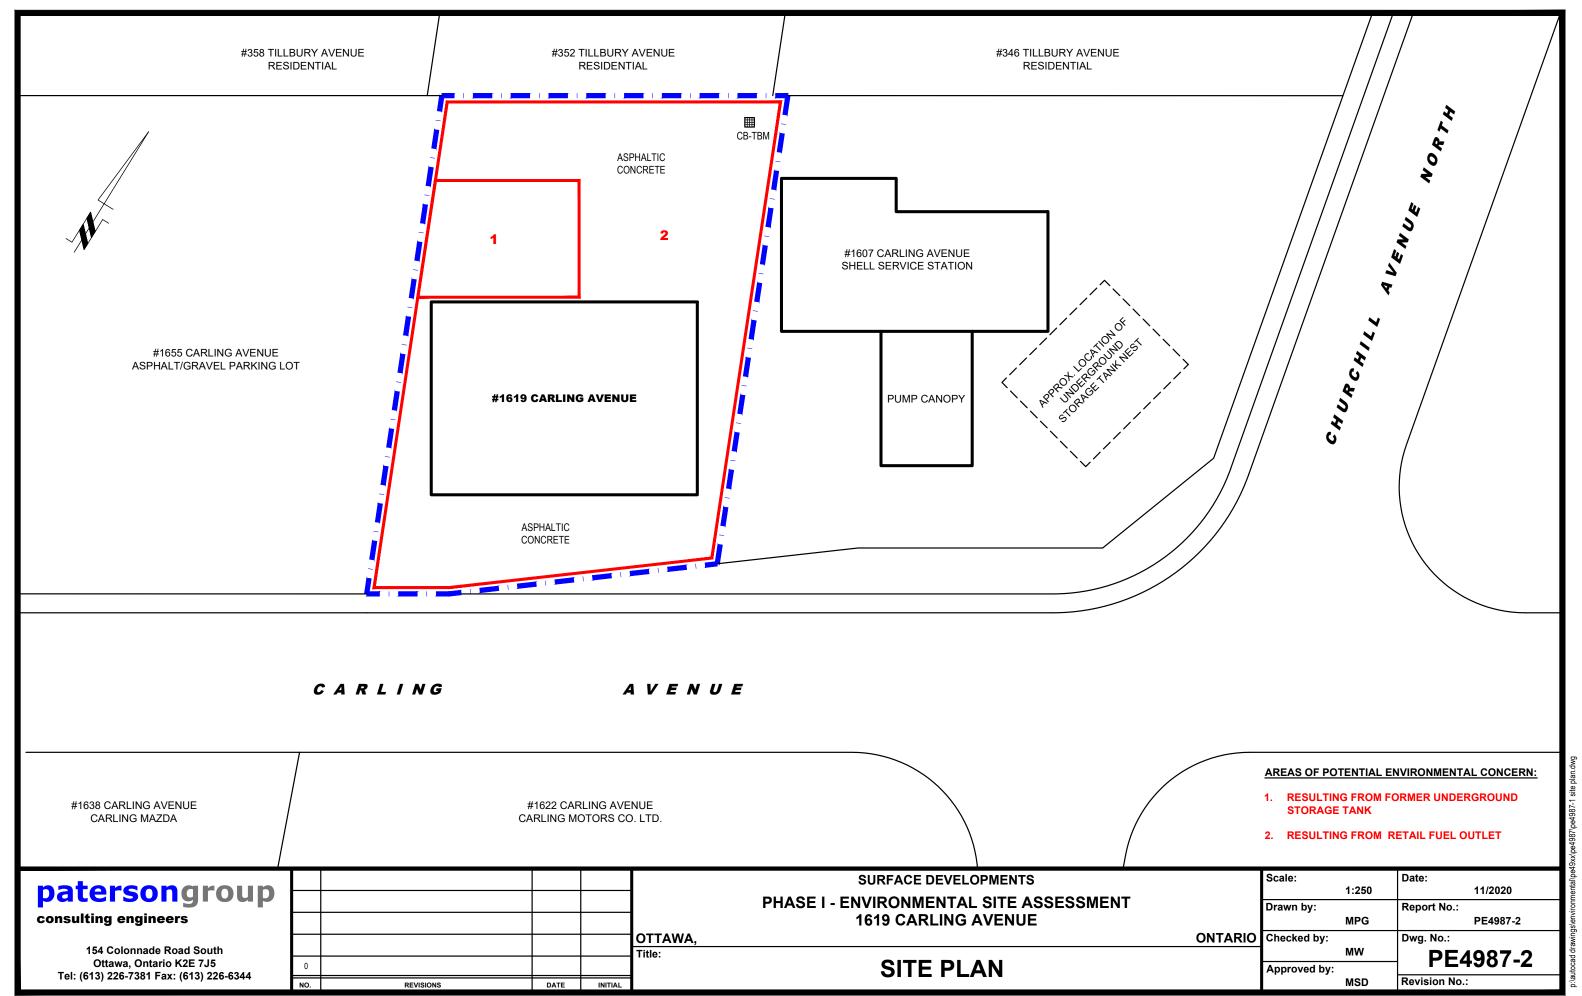
DRAWING PE4987-1 – SITE PLAN

Six (6) groundwater monitoring wells were noted on-site at the time of the site visit. Three (3) monitoring wells were located on the eastern and western property boundaries.

No ponded water was observed on the subject site. No signs of staining or indications of potential sub-surface contamination were observed at the time of the site visit. A depiction of the Phase I Property is presented on Drawing PE4987-2 – Site Plan, in the Figures section of this report.

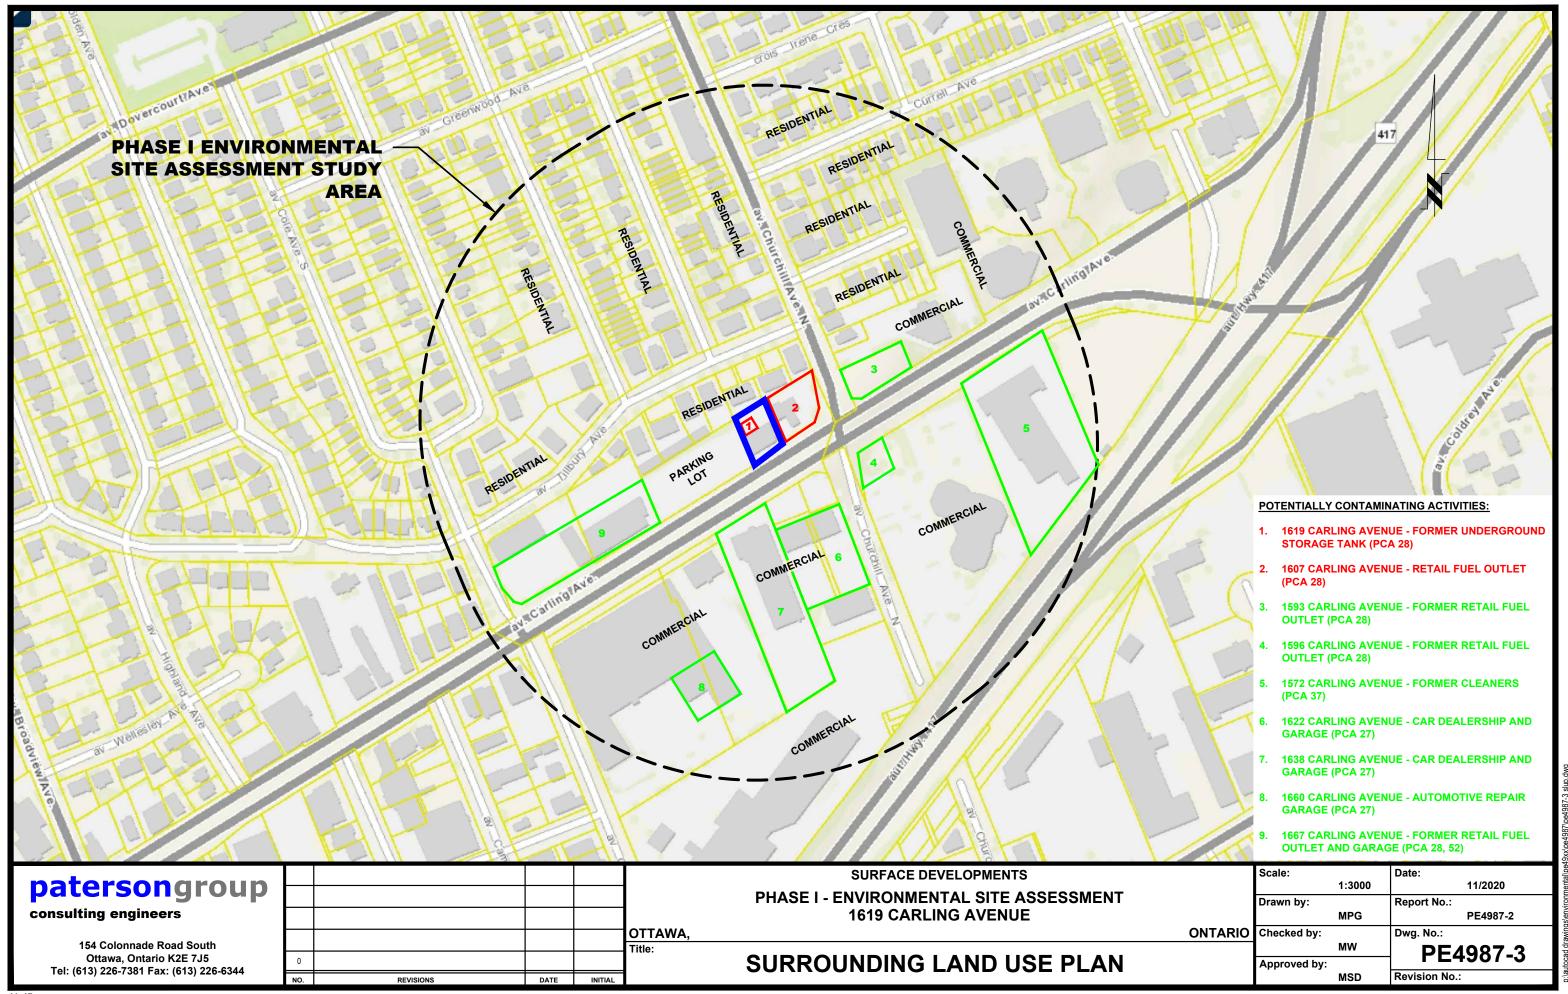
DRAWING PE4987-2 – SURROUNDING LAND USE PLAN

An inspection of the neighbouring properties was conducted from publicly accessible roadways at the time of the site inspection. Land use adjacent to the Phase I Property was observed to be as follows:

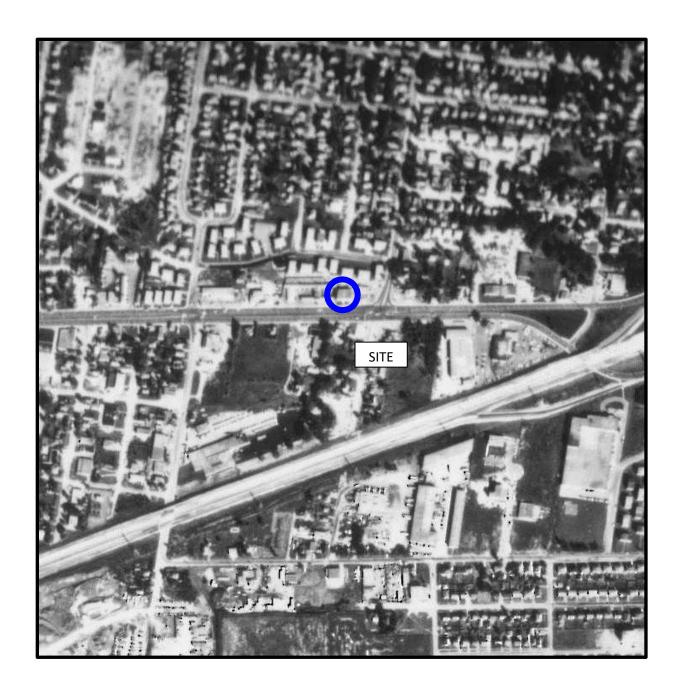
AERIAL PHOTOGRAPH 1962

commercial properties along Carling Avenue with some residential on the adjacent streets.		
1962	The subject site is occupied by the present-day commercial building, while the surrounding lands appear unchanged from the previous photograph.		
1976	No apparent changes are noted with the subject land and surrounding properties.		
2002	The subject site and surrounding lands appear unchanged from the previous photograph, with the exception of the parking lot immediately west of the site, which was previously occupied by a motel.		
2011	The subject site and surrounding lands appear unchanged from the previous photograph.		
2017	No significant changes are apparent with respect to the subject site or neighbouring lands.

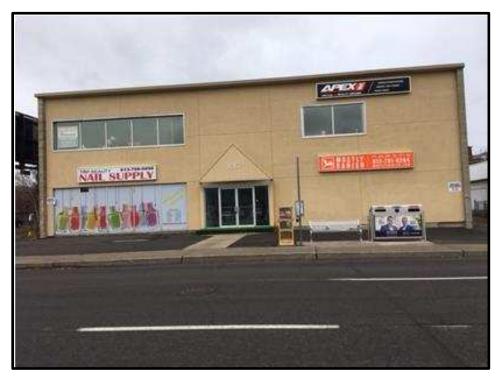
Photograph 1: View of the Phase I Property, taken from Carling Avenue looking north.

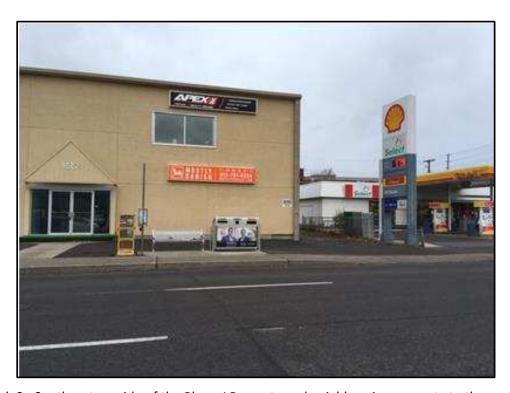
Photograph 2: Southeastern side of the Phase I Property and neighbouring property to the east.

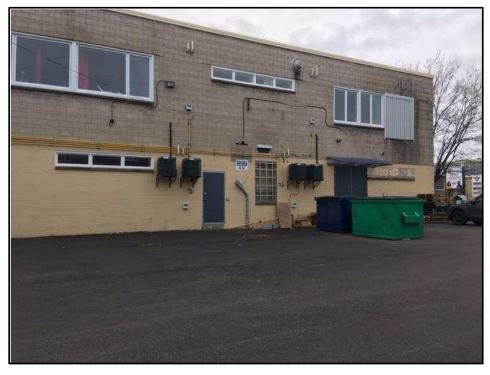
Photograph 3: Northern view of the Phase I Property and subject building, looking southwest.
