Phase I Environmental Site Assessment

1655 Carling Avenue Ottawa, Ontario

Report: PE4229-1

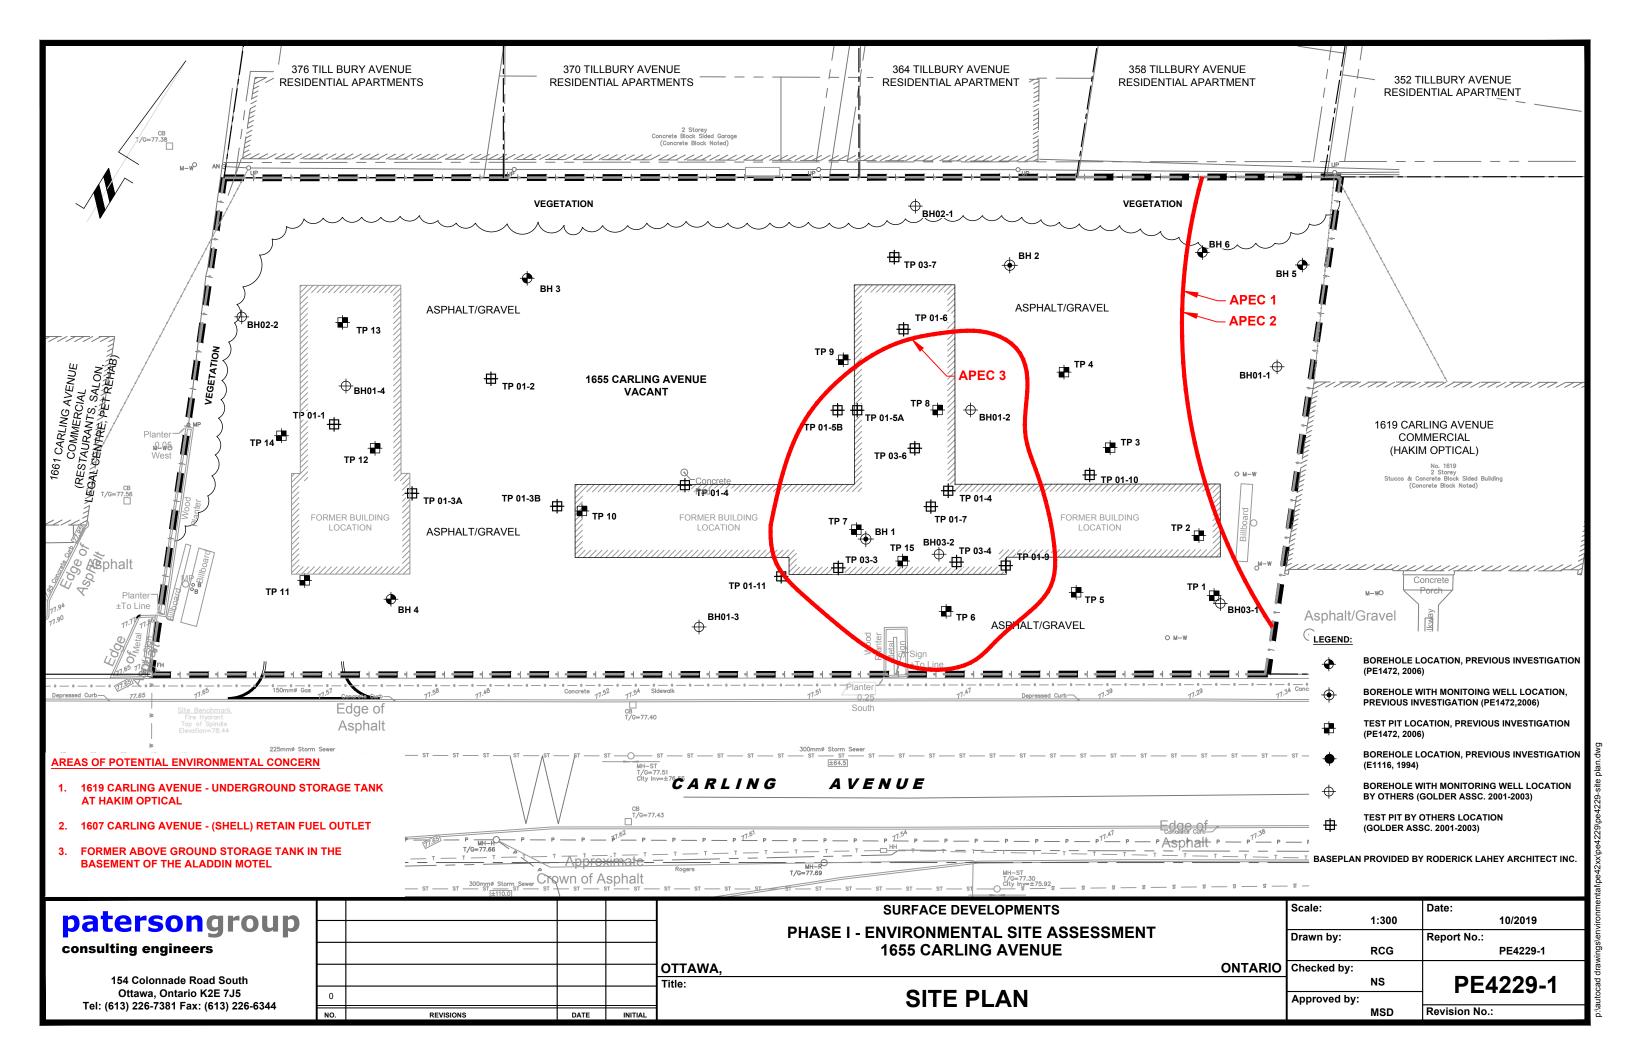
DRAWING PE4229-1 - SITE PLAN

The subject site operates as a parking lot, surfaced with gravel. Surface water infiltrates directly into the ground and drains to catch basins on Carling Avenue. Adjacent properties are approximately at grade with respect to the subject site. No structures were noted on the subject site.

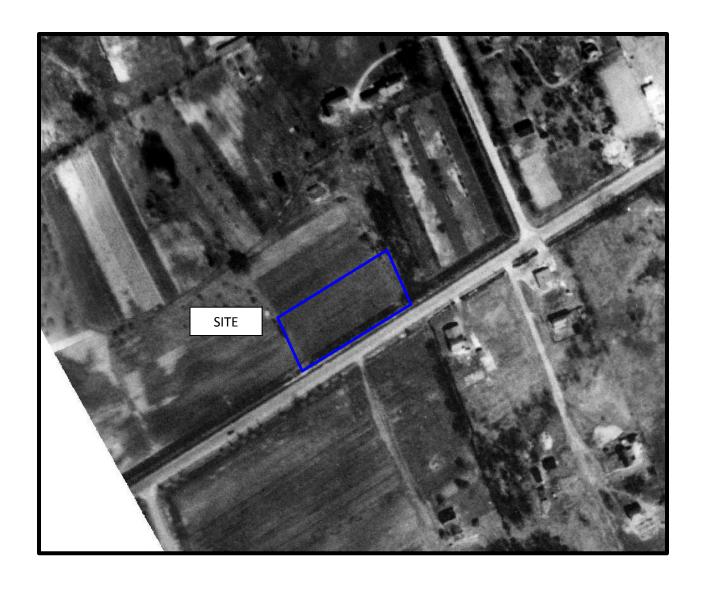
AERIAL PHOTOGRAPH 1928

The subject site is a vacant parcel of possibly agricultural land, bound on the southern side by Carling Avenue. The surrounding lands appear to be agricultural in use with fields and occasional agricultural buildings present.
