TREE CONSERVATION REPORT

1655 and 1619 Carling Ave

Tree Conservation Report submitted as
Partial Requirements for a Site Plan Control
Application

Date: August 9, 2020

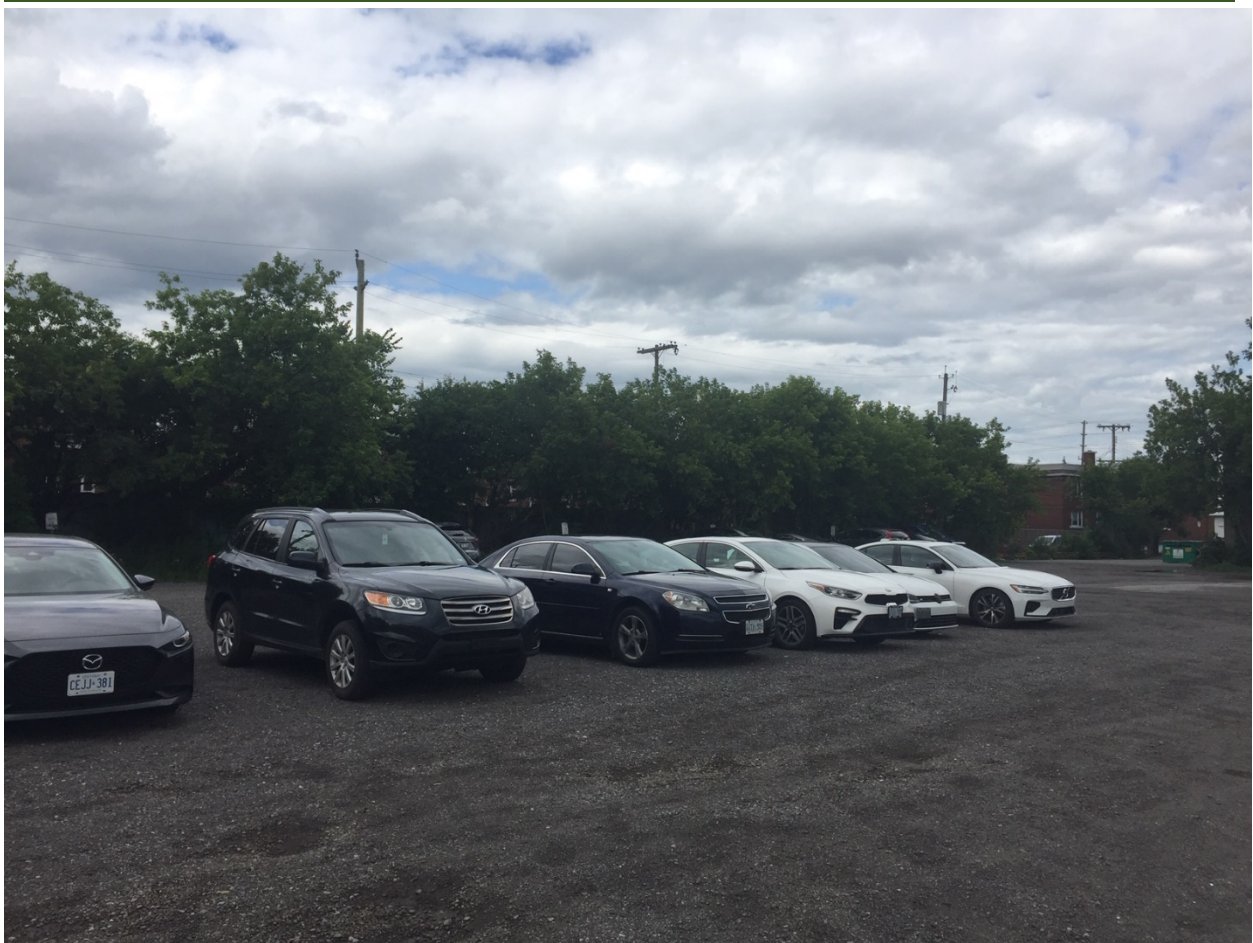
Figure 1: Trees along the northeast side of the property

Considering the level of construction proposed for the site combined with the low retention potential for the trees, removal is recommended for all the trees on site. Note that some along the southern property line are jointly owned with neighbours on Tillbury who should be contacted prior to removal.

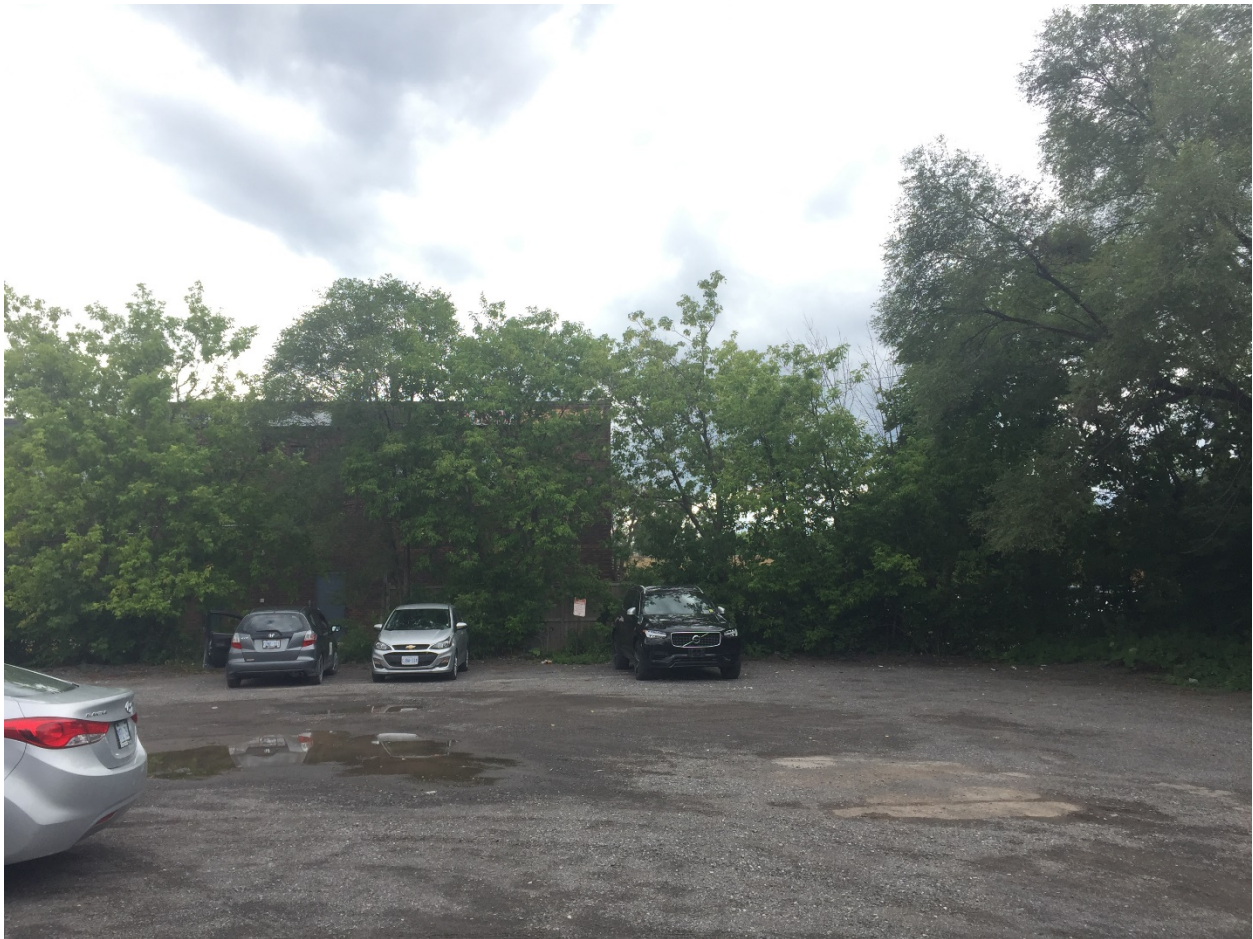
Figure 2: Trees along the west side of the property
